EMILIA EARTHQUAKE OF MAY 20, 2012 IN NORTHERN ITALY: REBUILDING A COMMUNITY RESILIENT TO MULTIPLE HAZARDS

by
Gian Paolo Cimellaro, Marco Chiriatti,
Andrei M. Reinhorn and Lucia Tirca

Technical Report MCEER-13-0006

June 30, 2013

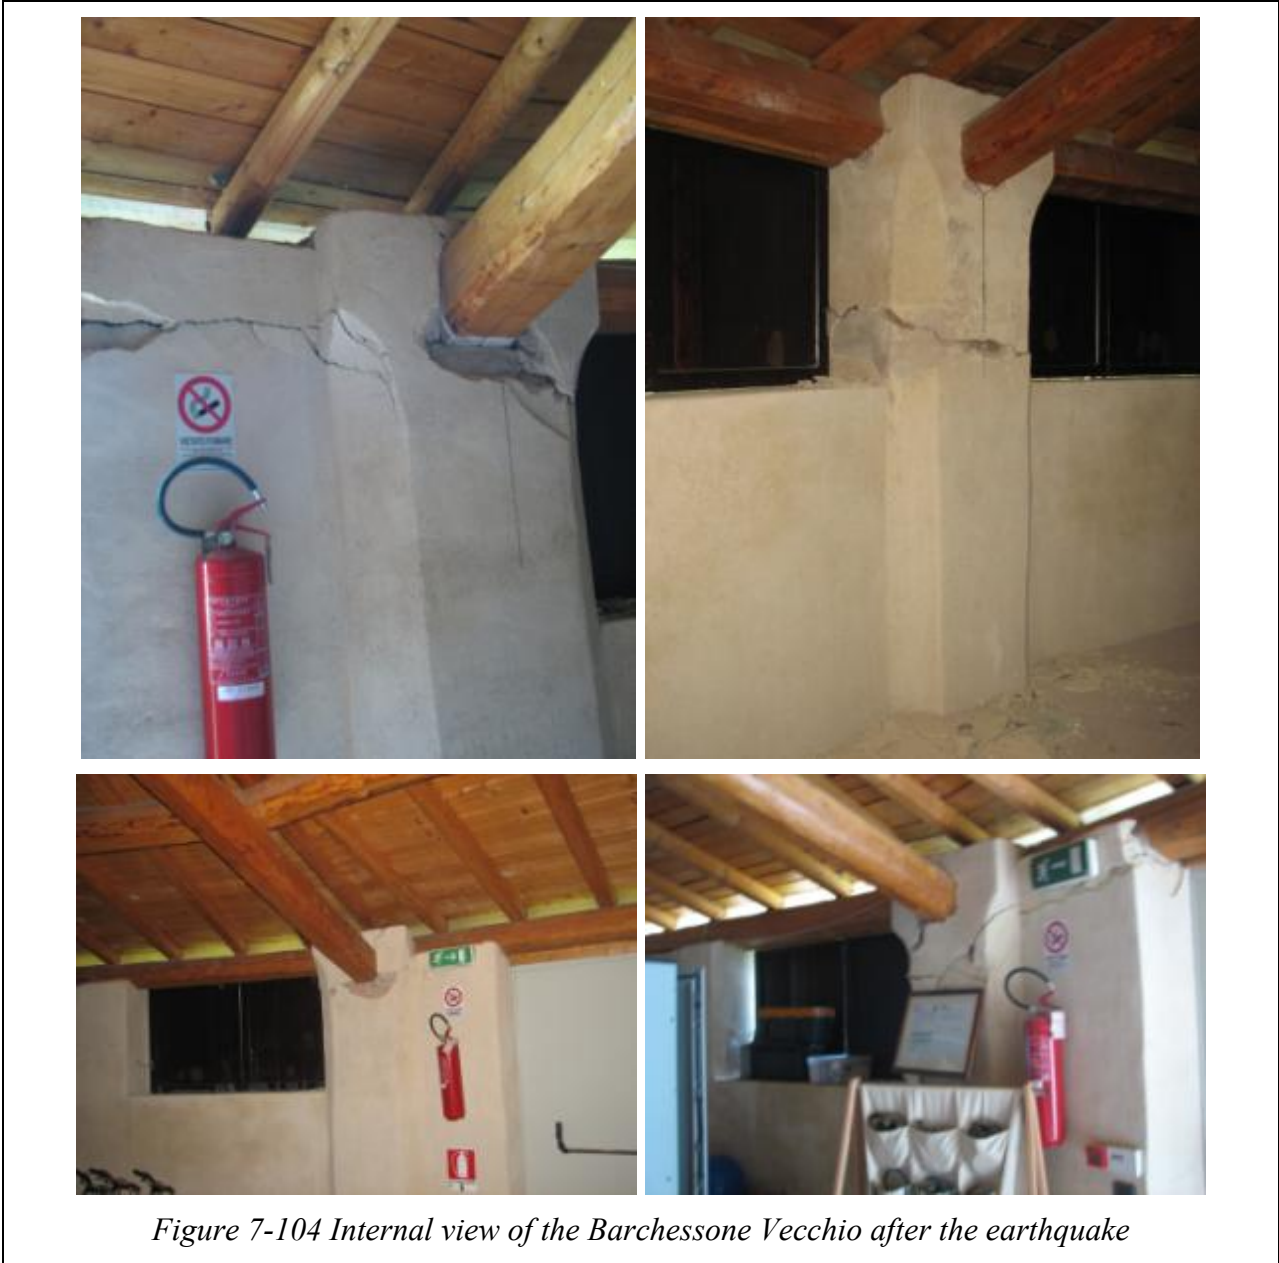
Figure 7-104 Internal view of the Barchessone Vecchio after the earthquake

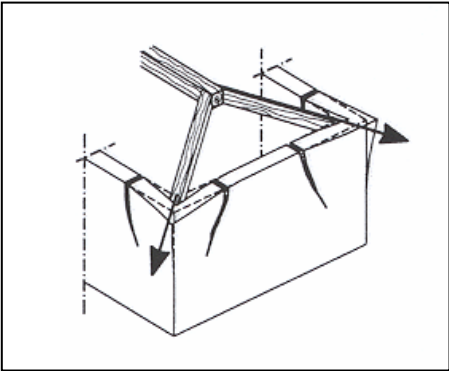
Figure 7-105 Pushing of the strut coverage

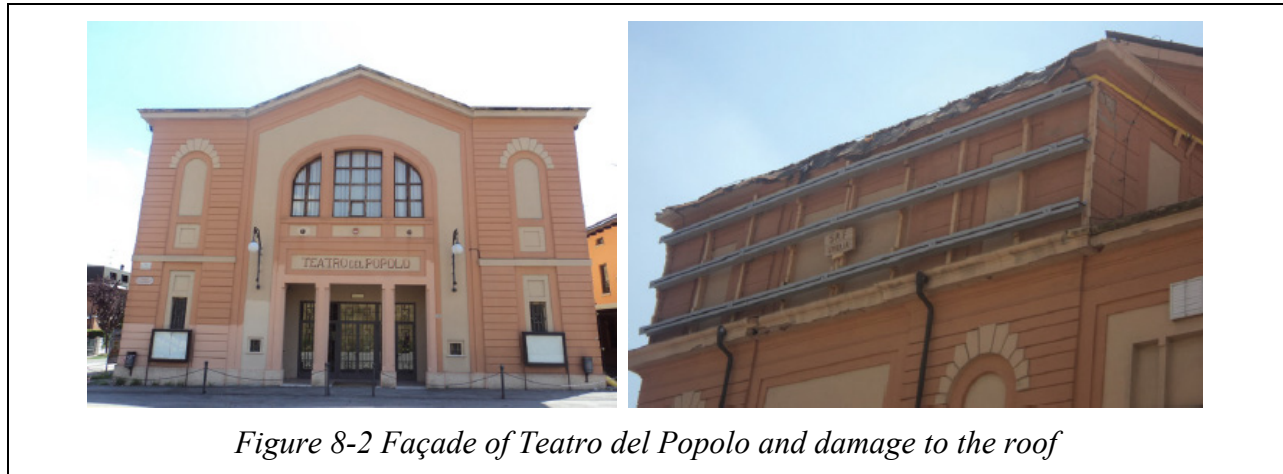
Figure 8-2 Façade of Teatro del Popolo and damage to the roof

The earthquake caused the collapse of the eastern part of the roof. The perimeter walls are damaged and off-axis.

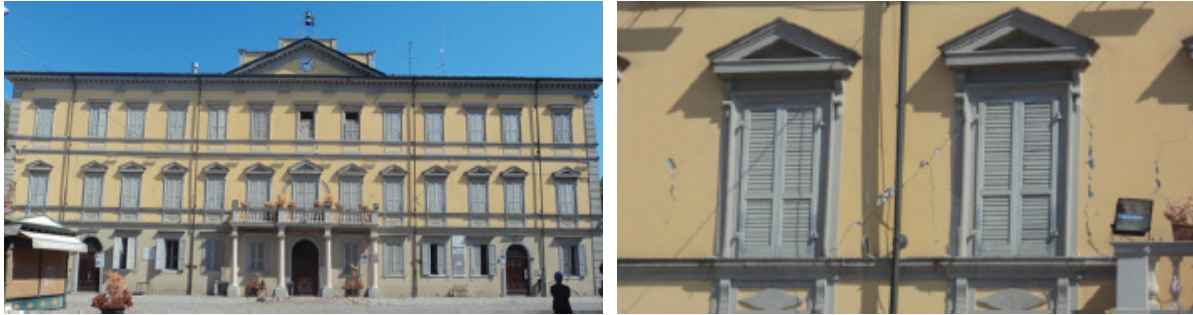
Figure 8-3 Façade of Corbelli Palace and cracked walls

After the earthquakes, the third floor of the building partially collapsed, and the walls of the façade cracked slightly.

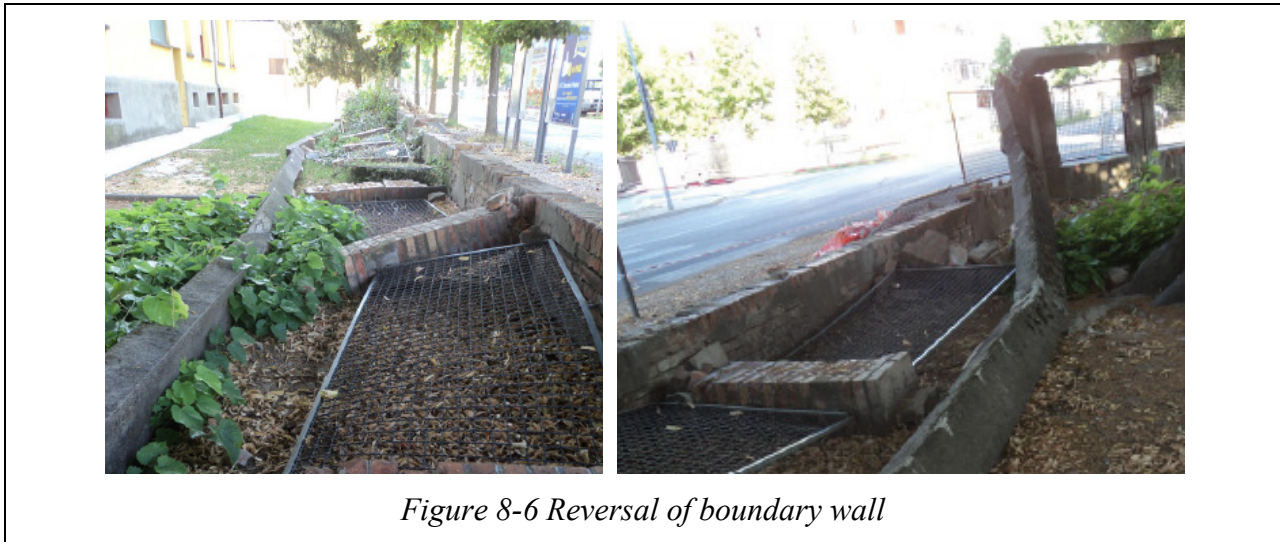
The boundary wall suffered a reversal during the earthquake.

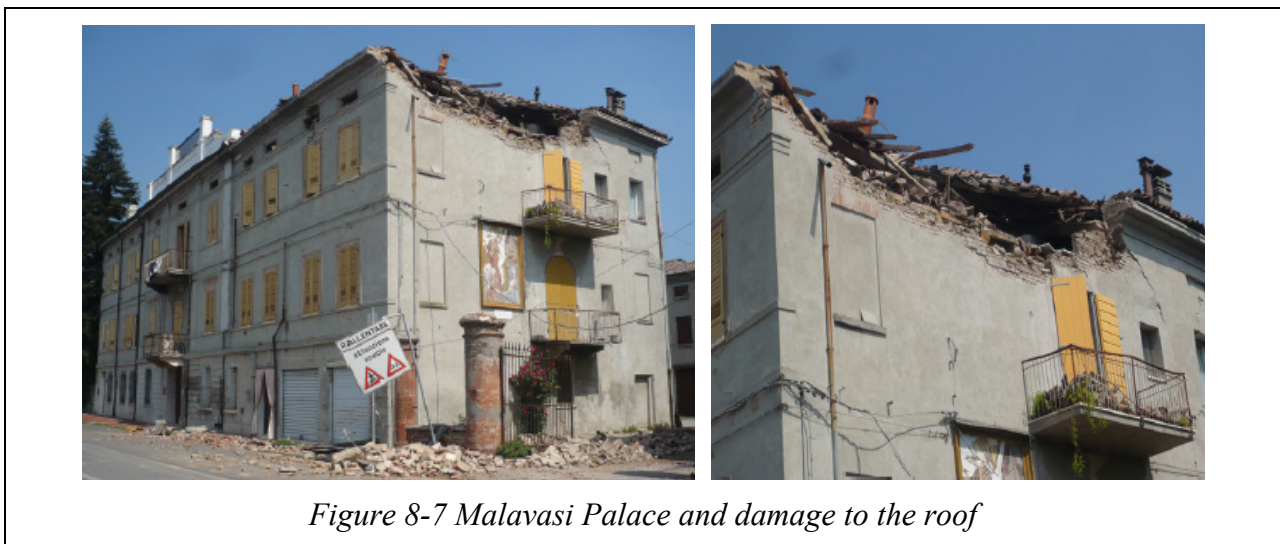
After the earthquakes, the tower separated from the rest of the structure; the cover partially collapsed and the inner walls cracked.

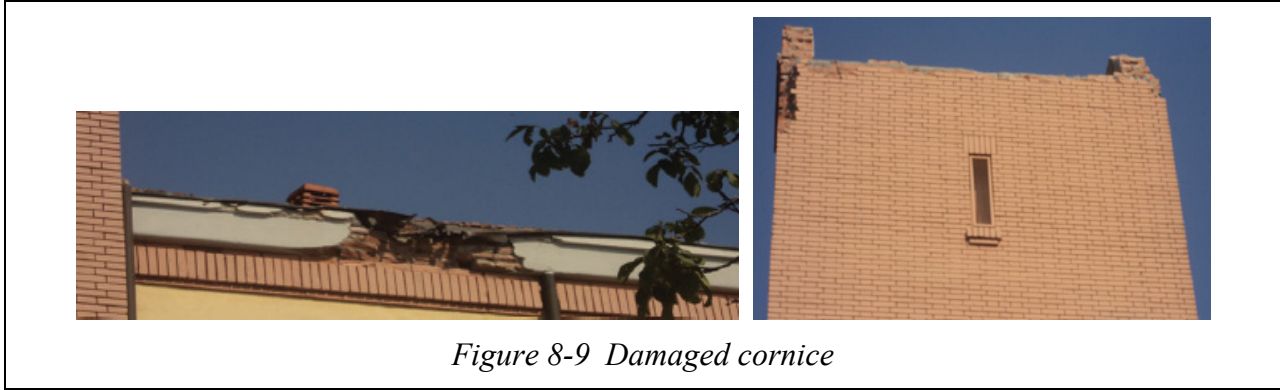
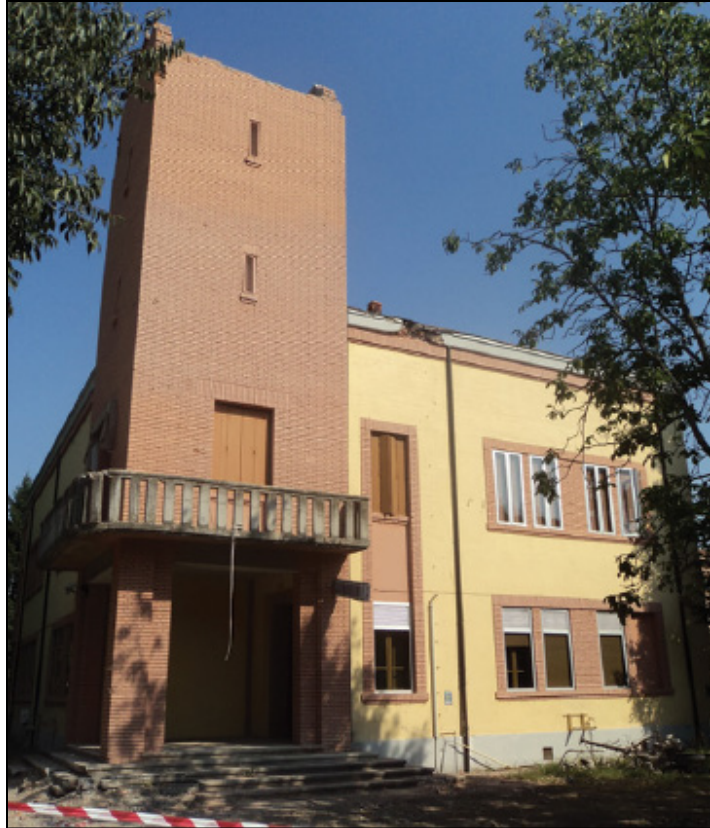
Figure 8-10 Police station

The tower partially collapsed and was partially demolished. Also, part of the cornice in Via Carducci collapsed.

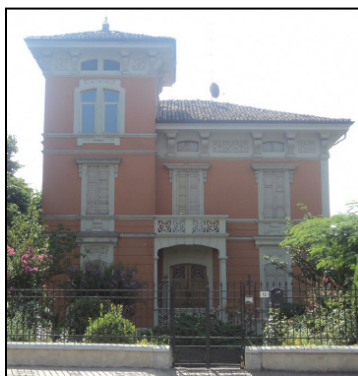
Figure 8-11 Mazzuchelli Palace

The structure held up well in the earthquakes.

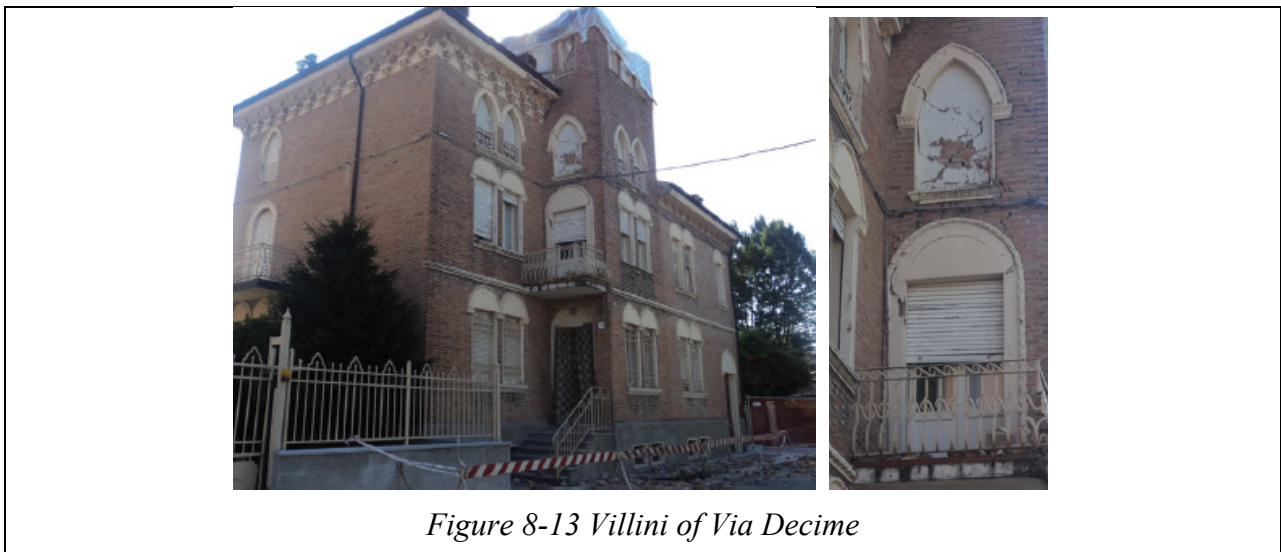
Figure 8-13 Villini of Via Decime

The protruding sections were severely damaged.

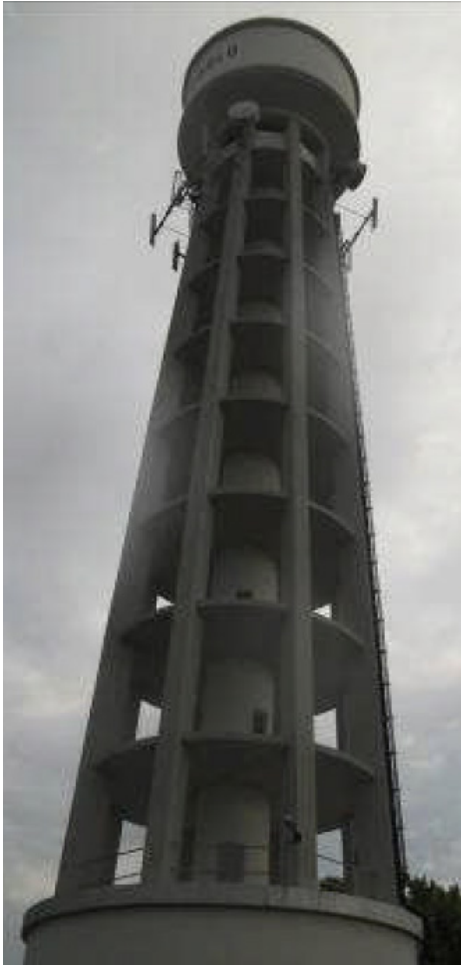
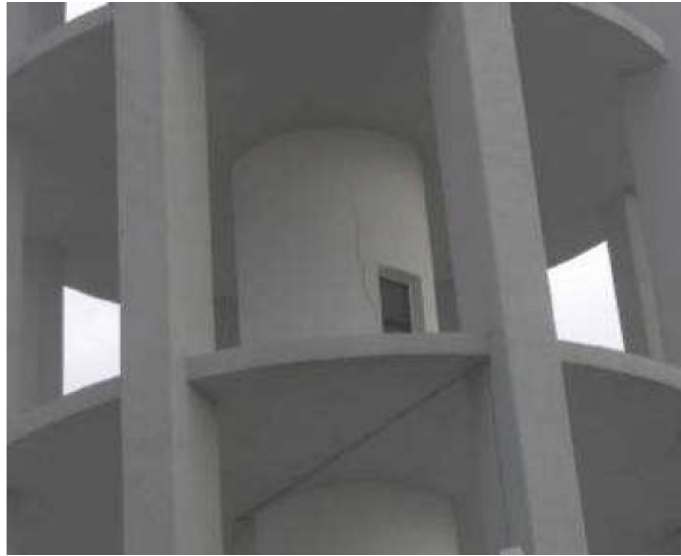
Some vertical cracks were observed in the water tower at San Carlo. The tower is made with a reinforced concrete circular core and six columns connected by reinforced concrete diaphragms at various intervals.

Figure 9-1 Water tank in San Carlo and localized crack in the interior reinforced concrete core

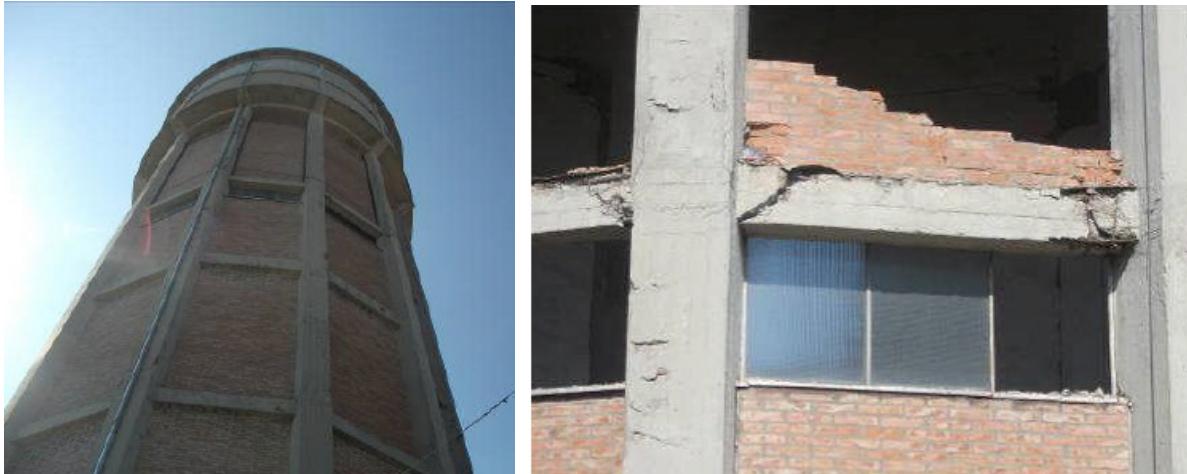
The structure of the water tower in San Felice sul Panaro is an octagonal reinforced concrete frame, with masonry infill panels and only one reinforced concrete horizontal diaphragm. As seen in Figure 9-2, various masonry panels fell out of plane. At the two lower levels of the frame, some shear failure is visible. Some plastic hinges are visible in some of the columns at the bottom.

Figure 9-2 Water tank in San Felice sul Panaro and plastic hinges in the beam

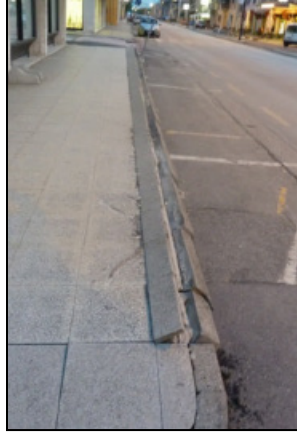
The earthquake did not damage the main roads connecting the affected towns. Many roads in residential areas were closed to prevent injury from the collapse of unstable or damaged buildings. Soil liquefaction and ground movement caused the road damage in the center of San Carlo. On the main street of Mirabello, some cracks occurred in the road surface and damage to the footpath was observed, both of which were mainly due to the lateral movement of the ground. According to the local population, this street was built on the site of an old river.

Figure 9-3 Damage to the footpath in Mirabello due to lateral spreading

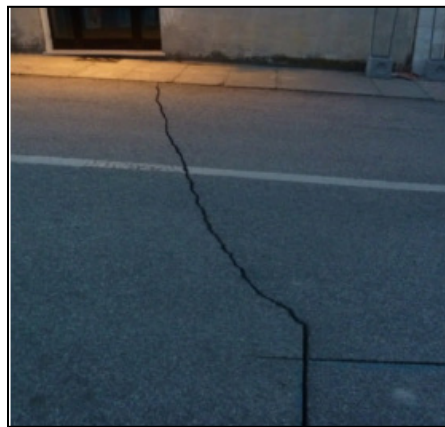
Figure 9-4 Cracking phenomena in a road in Mirabello
