REPORT ON THE WHITTIER-NARROWS,
CALIFORNIA EARTHQUAKE OF
OCTOBER 1, 1987

J. Pantelic and A. Reinhorn

Technical Report NCEER-87-0026

November, 1987

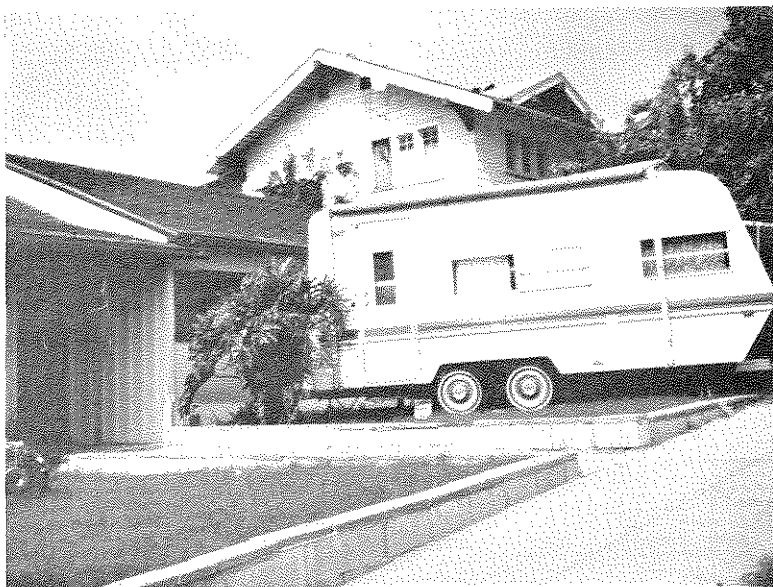
*Figure 2-1
Residents of lesser
damaged homes
moved into mobile
homes parked in their
front yards for
emergency housing.*

It is estimated that about 12,000 family and individual households, or approximately 30,000 people, were made homeless after this earthquake. Many camped in tents and trailers in the yards of their damaged homes (see Figure 2-1). Twenty-one emergency shelters provided by the Red Cross (see Figure 2-2) and other relief groups housed 2,534 families, or almost 10,000 people, at the peak of their occupancy. In contrast to experiences from other disasters, following this earthquake the use of shelters grew with the passage of time. It reached its peak approximately a week after the first shock, and dramatically increased following the Sunday aftershock.

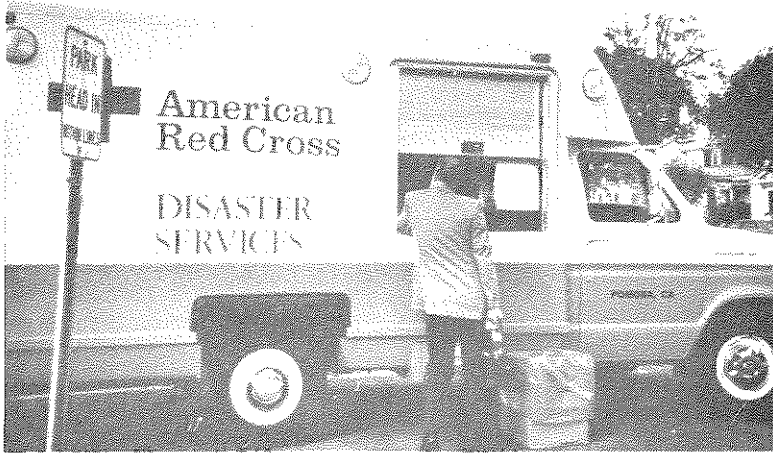
*Figure 2-2
The American Red Cross extended help not only in the 21 emergency shelters, but also through the numerous mobile units.*

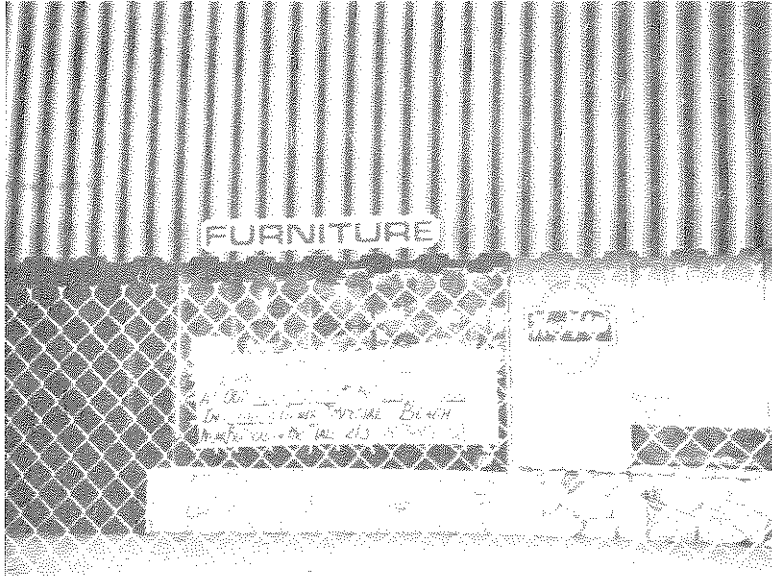
Especially affected are small and medium businesses, for which building and capital loss mean interruption of entire business operation, displacement, and potential loss of clientele (see Figure 2-4). It is uncertain whether many of such businesses will be able to survive this earthquake. First reports show that the businesses that had earthquake preparedness plans fared much better in this earthquake than those that did not.

*Figure 2-4
Many businesses and retail stores had to relocate - if only temporarily. This furniture shop is organizing an "earthquake sale" at their new location. Whether they will be able to return to the prime retail area of Greenleaf Boulevard is uncertain.*

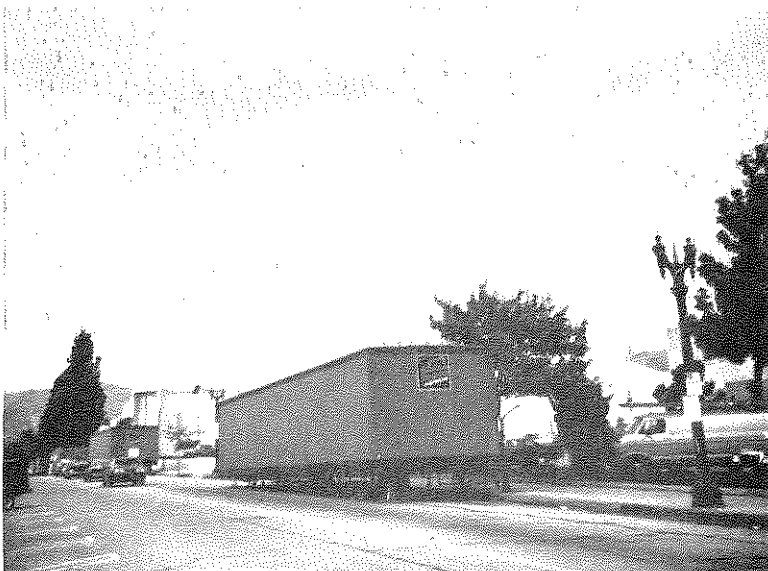
*Figure 2-5
Frequently, the displaced businesses moved into temporary locations, such as this row of trailers on an avenue just west of Greenleaf Blvd. The City of Whittier assisted with water connection and portable toilets.*

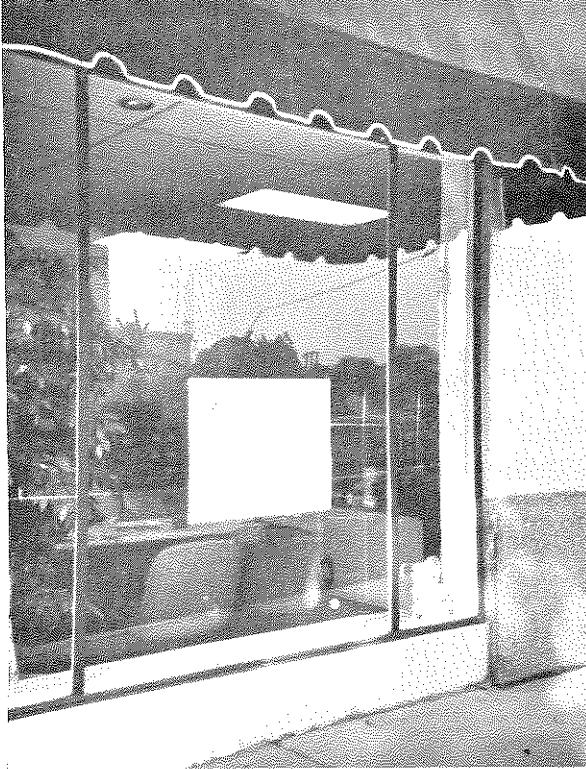
*Figure 2-6
Not all the businesses
were affected by the
earthquake. Here is
an example of a travel
agency that emerged
unharmful from the
October 1 shaking.*

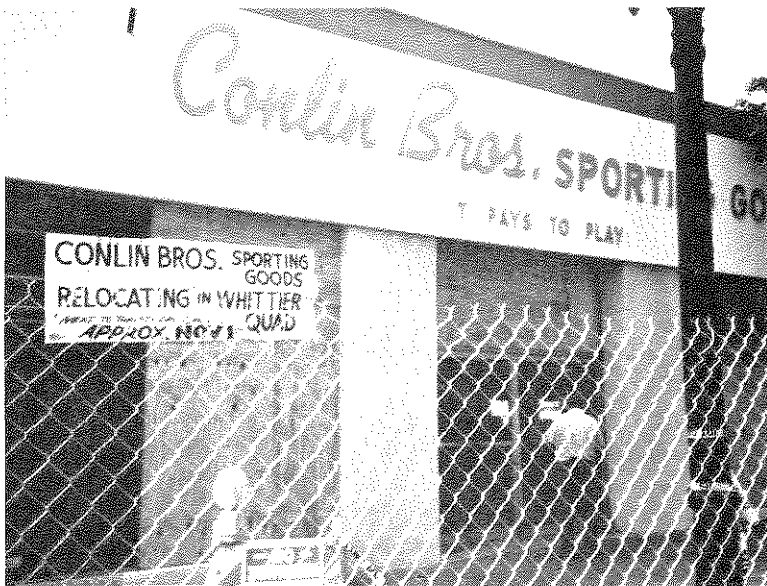
*Figure 2-7
Example of another
Uptown Whittier
business which was
displaced after the
October 1, 1987
earthquake. Busi-
nesses which were not
adequately prepared
for an earthquake
suffered serious
economic setbacks.*
