GEOTECHNICAL AND LIFELINE ASPECTS OF THE OCTOBER 17, 1989 LOMA PRIETA EARTHQUAKE IN SAN FRANCISCO

T. D. O'Rourke, H. E. Stewart, F. T. Blackburn, and T. S. Dickerman

Technical Report NCEER-90-0001

January, 1990

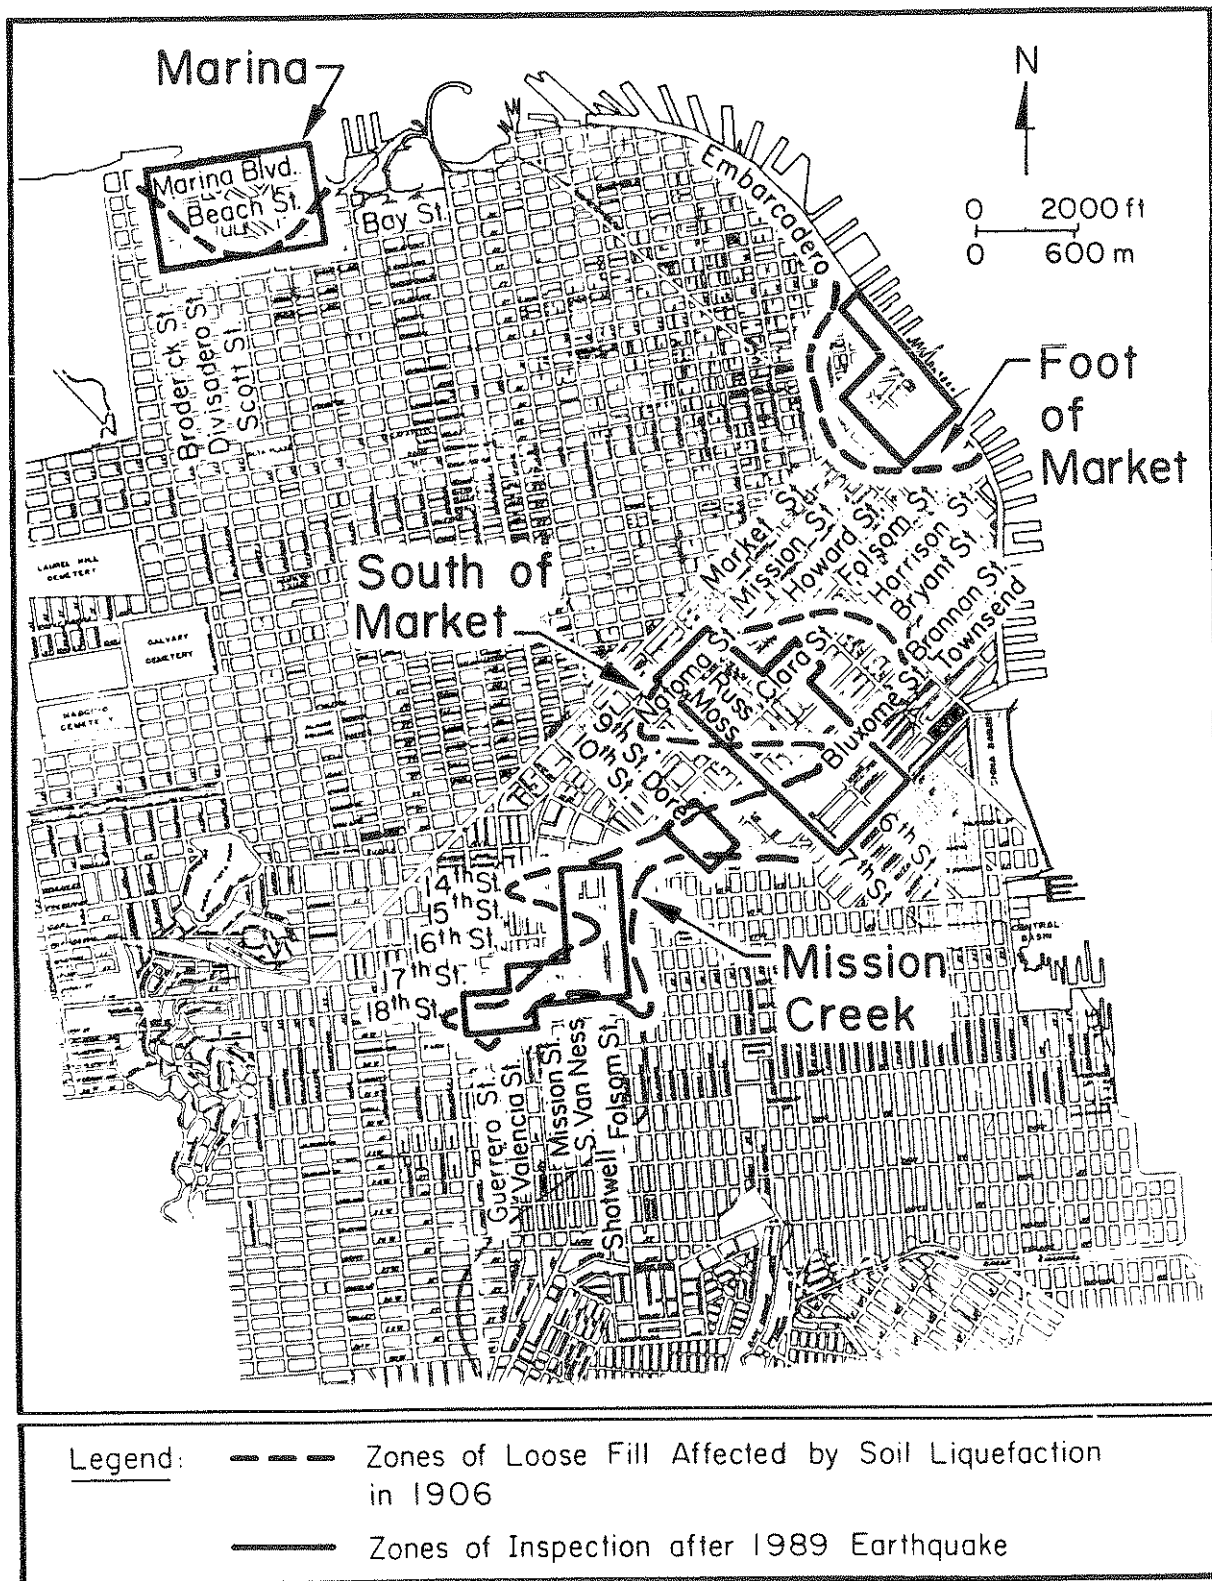
Figure 2-1 shows four areas within San Francisco for which there is historical evidence of soil liquefaction and large ground deformations during the 1906 earthquake. These areas, which are bounded by dashed lines, include the Mission Creek, South of Market, Foot of Market, and Marina districts. Each of these areas was investigated after the 1989 earthquake within the approximate boundaries shown by the solid lines.

FIGURE 2-1. Plan View of San Francisco Showing Zones of 1906 Soil Liquefaction and Inspection after the 1989 Earthquake

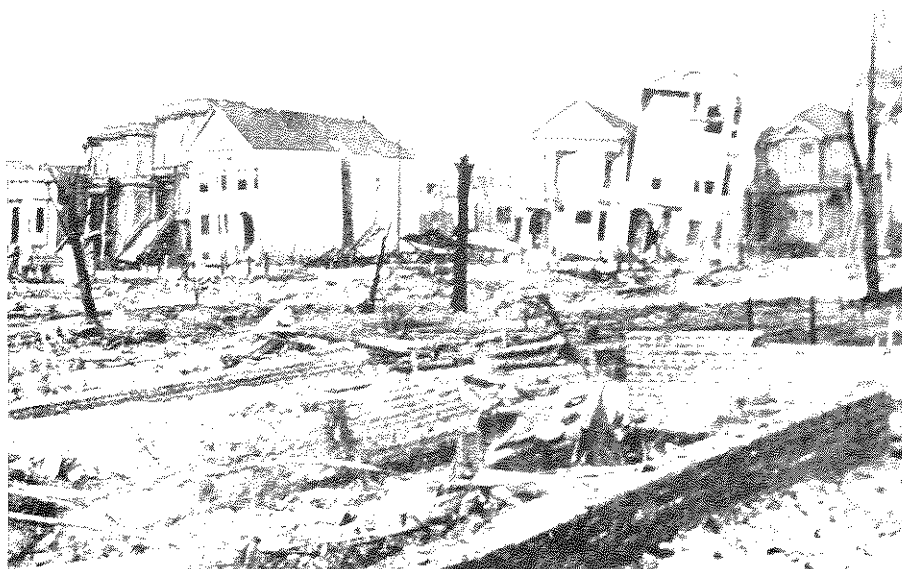
East of Mission and Capp Sts., soil liquefaction occurred in the same places it had been observed after the 1906 earthquake. The most prominent damage caused by soil liquefaction occurred as differential settlement, racking, and tilting of Victorian two to four-story timber frame buildings on South Van Ness, Shotwell, and Folsom Sts. between 17th and 18th Sts. Sand boils were observed at all these locations. The most severe damage was observed at the middle west side of Shotwell St., where maximum building settlements on the order of 0.2 to 0.4 m occurred. Figure 2-2 shows differential settlement and tilting of timber structures in 1906 on the east side of South Van Ness between 17th and 18th Sts. Figure 2-3 shows differential settlement and tilting of similar structures in 1989 on the west side of Shotwell St. between 17th and 18th Sts.

FIGURE 2-2. Racking and Settlement of Houses on South Van Ness Between 17th and 18th Sts. in 1906 [after Lawson, et al., 1908]

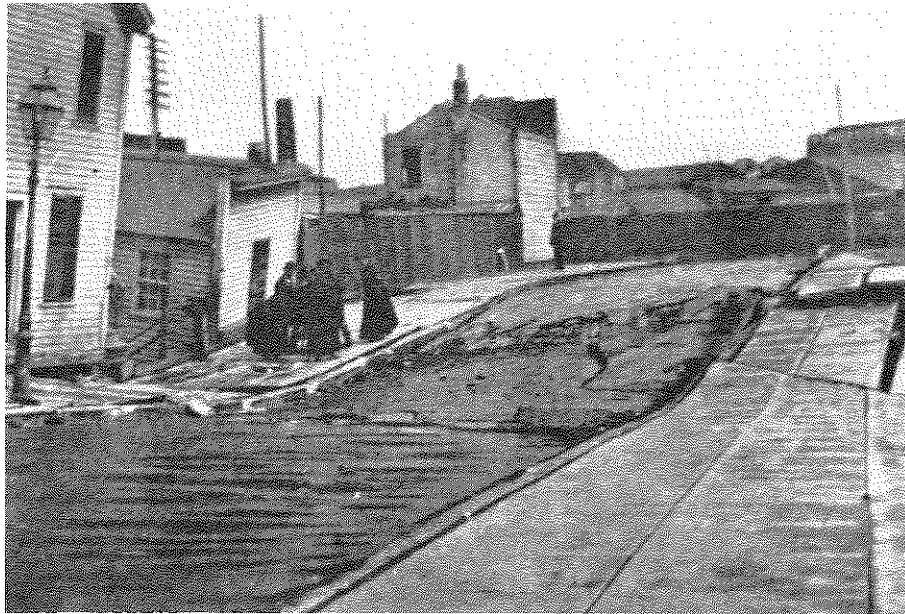
About 0.3 m of subsidence was observed in a parking lot off Dore St. approximately 30 m north of its intersection with Bryant St. This was a location of substantial settlement and lateral spreading in 1906. There was about 100 mm of settlement of the sidewalk adjacent to the building on the northeast corner of Dore and Bryant Sts. and differential settlement of the structure. The sidewalk along Bryant St. adjacent to the building was buckled and a water service had been ruptured. Figure 2-4 shows differential settlement of 1.5 m on Dore St. in 1906 compared with approximately 0.3 m of differential settlement on Dore St. in 1989, as shown in Figure 2-5.

FIGURE 2-4. Large Differential Settlement on Dore St. Between Bryant and Brannon Sts. in 1906 [after Lawson, et al., 1908]

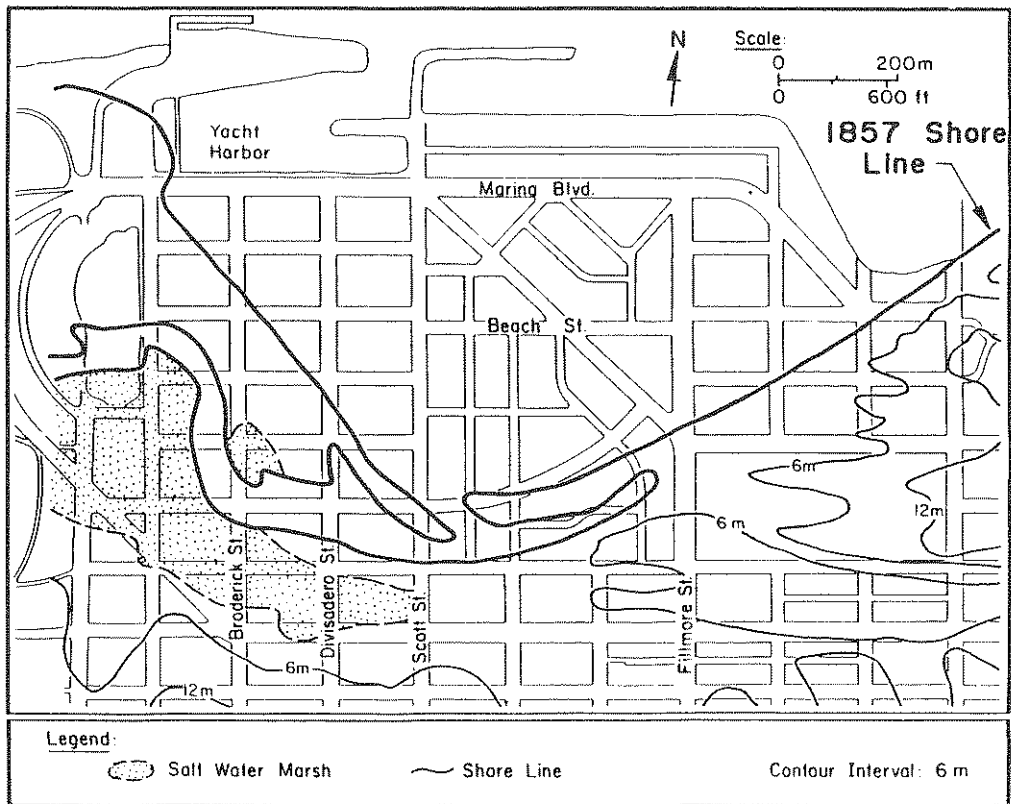
Figure 2-14 shows a plan view of the Marina on which is superimposed the 1857 shoreline, as mapped by the U.S. Coast Survey [1857]. Along its western boundary, there was a prominent sand bar known as Strawberry Island, with adjacent salt water marshes. Sand dunes, 6 to 12 m high, were located south of the shoreline and marshy ground.

FIGURE 2-14. Marina District Showing 1857 Shoreline

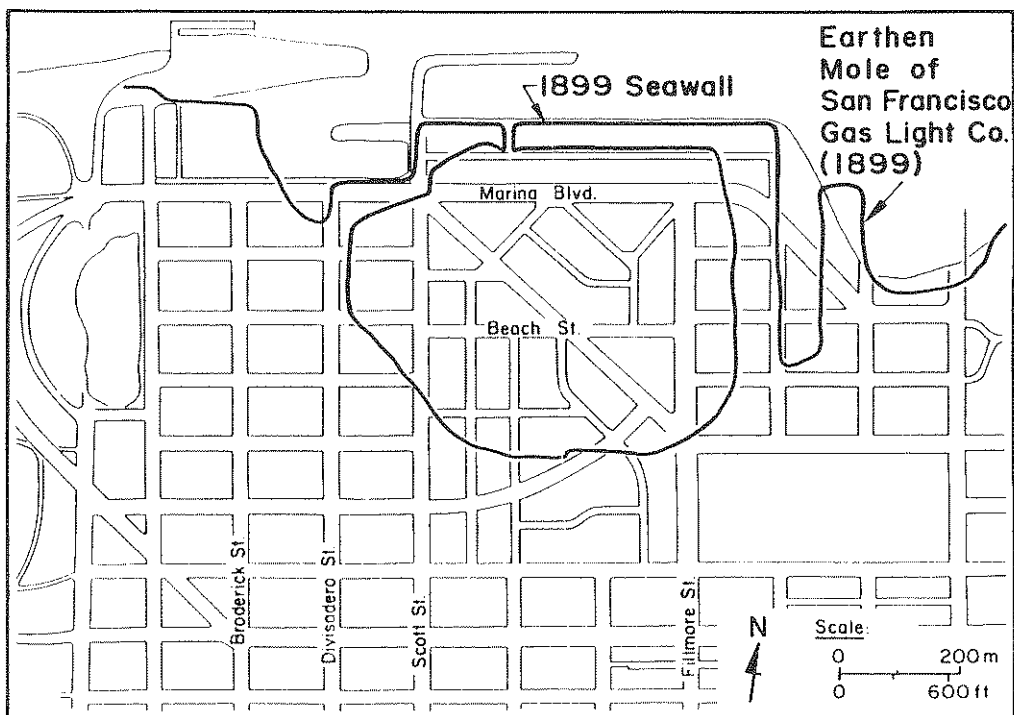
FIGURE 2-15. Marina District Showing 1899 Shoreline

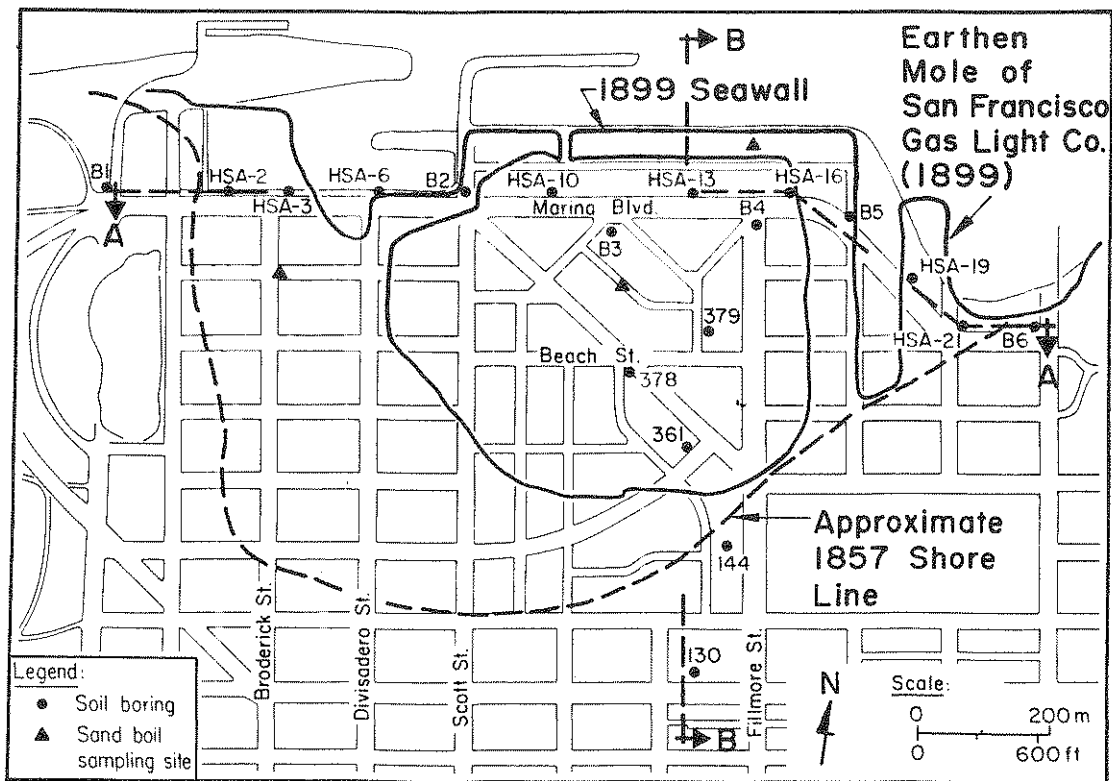
Figure 2-18 shows the locations of two subsurface cross-sections, A-A' and B-B'. Cross-section A-A' in Figure 2-19 is along Marina Blvd. from Lyon to Laguna Sts., and was developed primarily from borings performed for the North Shore and Channel Outfalls Consolidation Project [Dames and Moore, 1977]. Cross-section

FIGURE 2-18. Plan View of Soil Profile Locations for the Marina District

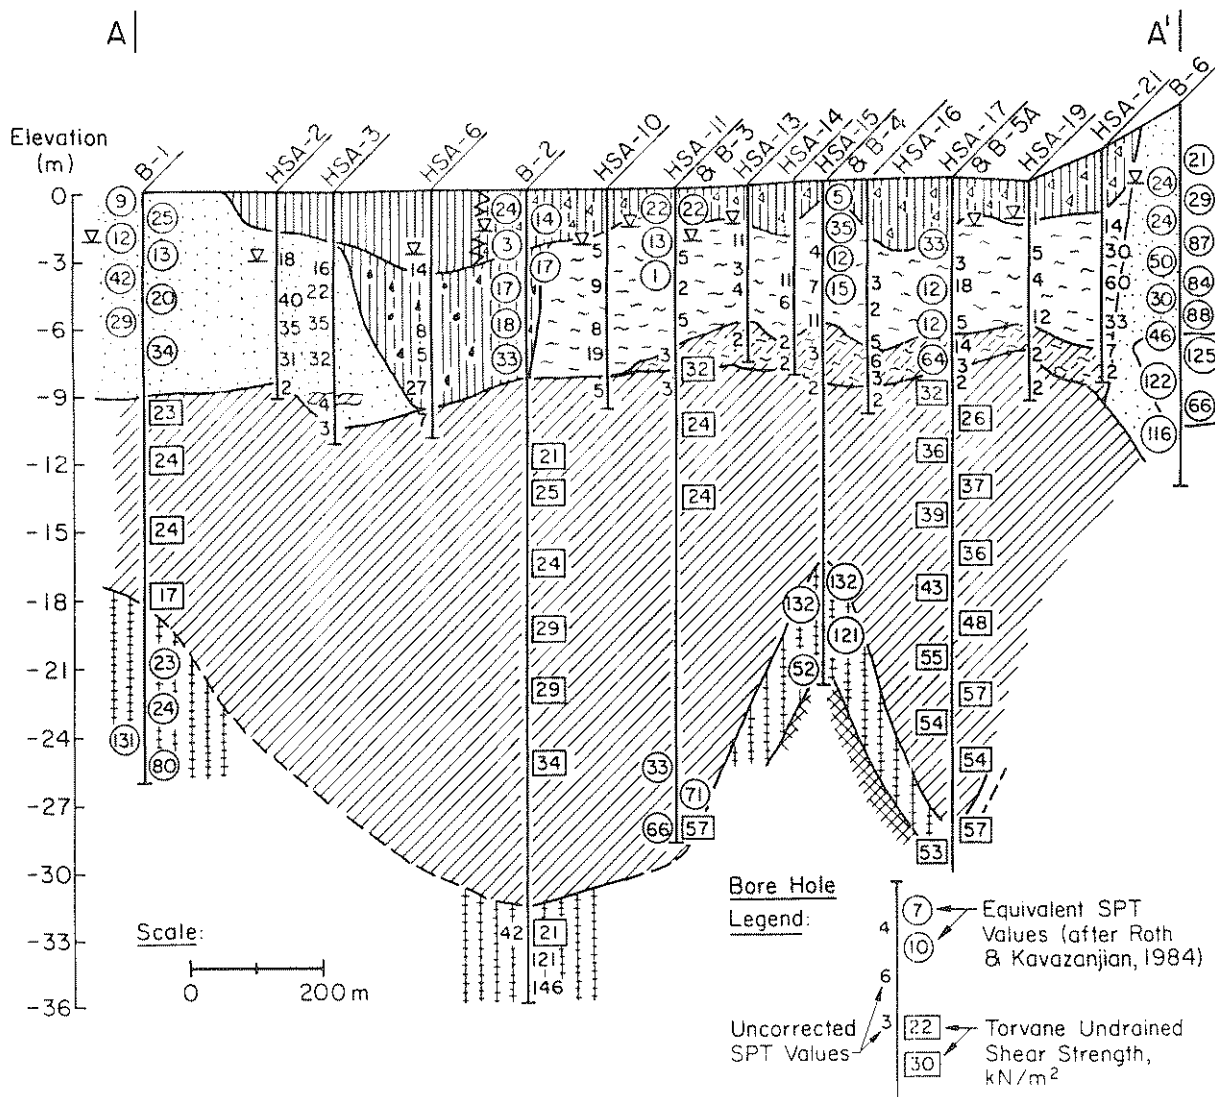
Figure 2-19 shows loose fill with a maximum depth of about 9 m extending along Marina Blvd. from approximately Baker to Buchanan Sts. This distance correlates well with the distance between locations of the 1857 shoreline shown in Figure

FIGURE 2-19. Soil Profile A-A' Along Marine Boulevard

2-14. The depth to water table is between 1.5 and 2 m in the Marina. Underlying the loose fills and natural sand deposits is a stratum of Recent Bay Mud, which varies in thickness along Marina Blvd. from 9 to 23 m and extends to a maximum depth of 32 m. Underlying the Recent Bay Mud are dense sands and stiff to hard clays. Figure 2-20 shows that weathered bedrock at a location near Lombard and Filmore Sts. was encountered at a depth of roughly 45 m below zero San Francisco datum.

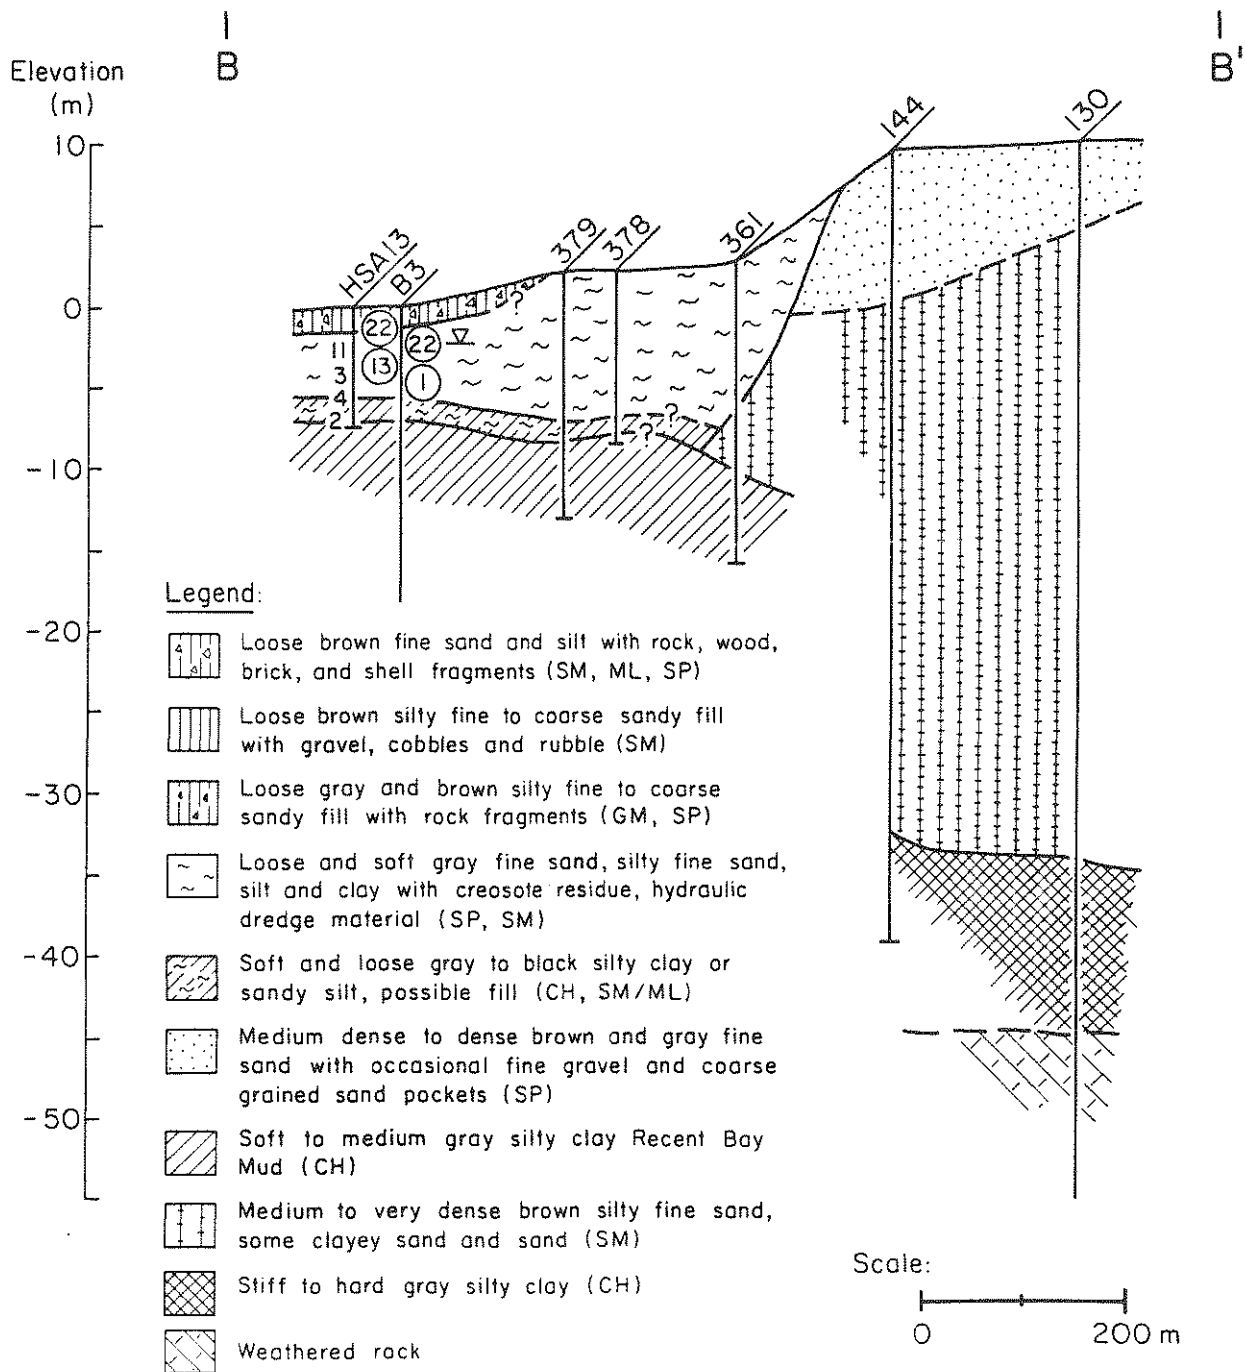
B-B' in Figure 2-20 is from Marina Blvd. to approximately Lombard St., and was developed primarily from borings performed for the aforementioned project as well as data summarized by the Institute of Transportation and Traffic Engineering [1950]. Data for each borehole are summarized in the form of uncorrected Standard Penetration Test (SPT) values, equivalent SPT, and Torvane undrained shear strengths, as explained by the borehole legend in Figure 2-19. Symbols and descriptions of the soils and rock encountered are summarized in the legend of Figure 2-20. All uncorrected SPT measurements were consistent with ASTM specifications [ASTM, 1989]. Equivalent SPT readings were estimated from blow count measurements performed with nonstandard equipment according to the recommendations of Roth and Kavazanjian [1984].

FIGURE 2-20. Soil Profile B-B' in Marina District

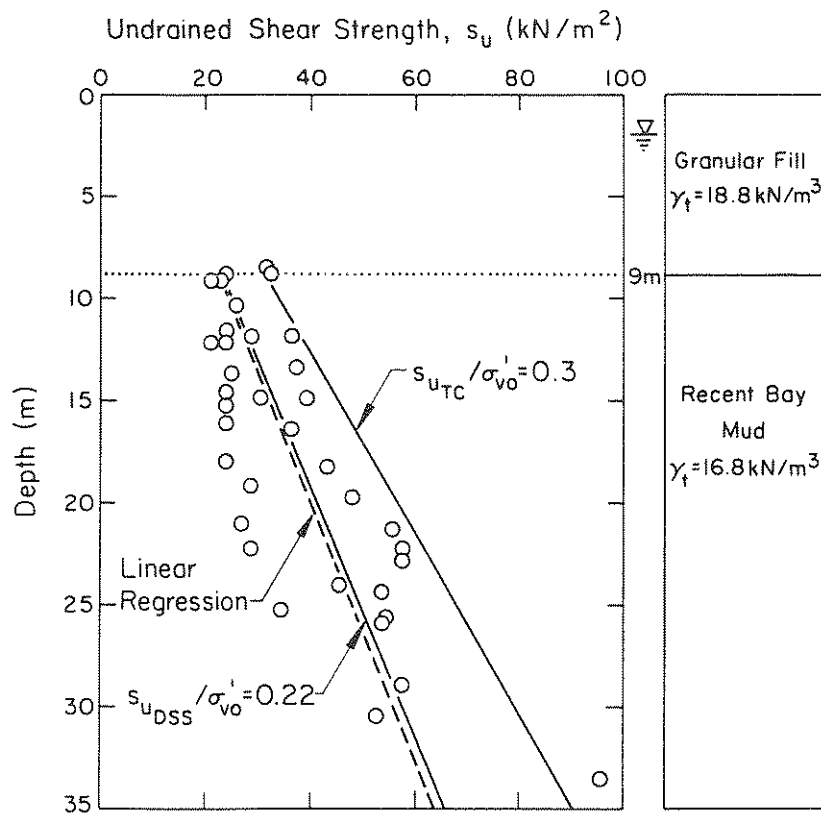
Undrained shear strengths obtained with a Torvane device indicate that the clay is soft to medium in consistency. Figure 2-21 shows a soil profile in which the

Torvane undrained shear strengths are plotted as a function of depth. For comparison, the ratios of undrained shear strength to effective vertical stress for triaxial compression (s_{uTC}/σ_{vo}') and direct simple shear (s_{uDSS}/σ_{vo}') also

FIGURE 2-21. Soil Profile and Torvane Shear Strength Characteristics of Recent Bay Mud at the Marina

are plotted. The $s_{u_{DSS}}/\sigma_{vo}'$ profile is consistent with trends recommended for a normally consolidated clay [e.g., Mesri, 1989]. Both the $s_{u_{DSS}}/\sigma_{vo}'$ and $s_{u_{TC}}/\sigma_{vo}'$ profiles are consistent with trends established for Recent Bay Mud [Dames and Moore, 1989]. The linear regression of the Torvane strengths plots close to the $s_{u_{DSS}}/\sigma_{vo}'$ line, and implies that the clay is normally consolidated. It should be recognized, however, that Torvane tests involve substantial sample disturbance and thus are useful only as an index of shear strength.

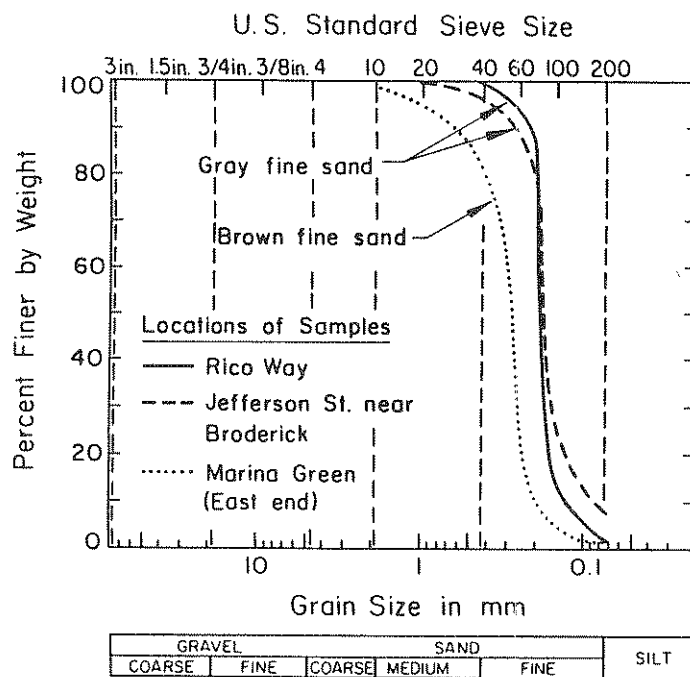
FIGURE 2-22. Grain Size Distribution Plots for Soil Collected in the Marina at Sand Boils and Vents

Figure 2-22 presents grain size distribution plots of material ejected from sand boils and vents at three different locations in the Marina, which are shown in Figure 2-18. All materials are fine uniform sand with very low to negligible fines content. The gray fine sand was subrounded to subangular in shape, composed of quartz and ferromagnesium minerals. The fine brown sand contained the highest percentage by weight of quartz and also some shell fragments.

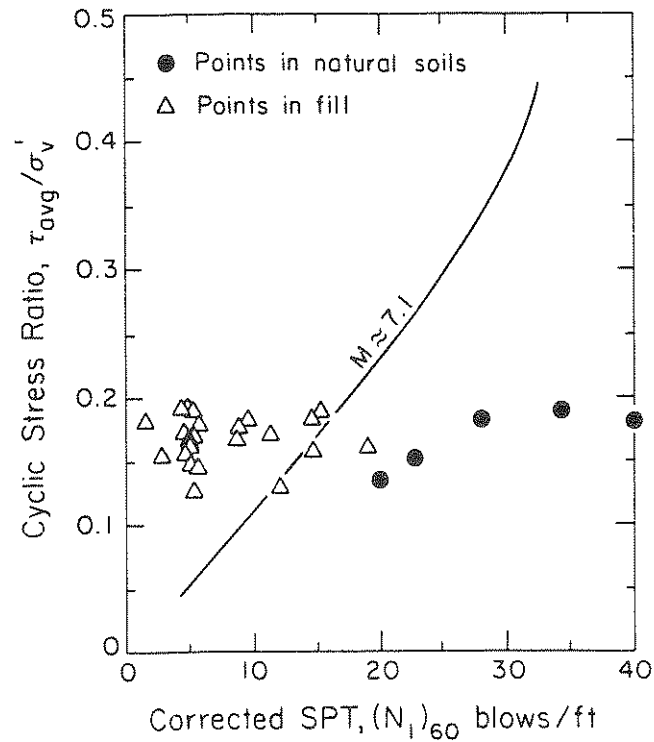
FIGURE 2-23. Chart for Evaluation of Liquefaction Potential with Points Representing Granular Fill and Native Materials in the Marina

A liquefaction potential analysis was performed using the empirical relationship between cyclic stress ratio and the corrected SPT values developed by Seed, et al. [1983]. As plotted in Figure 2-23, SPT values were corrected from field measurements according to the recommendations of Seed, et al. [1983]. The cyclic stress ratios for various depths were calculated assuming a maximum acceleration of 0.2 g, which is consistent with the peak horizontal component of acceleration measured at the nearby Presidio. The curve shown in Figure 2-21 is the empirical dividing line between liquefiable and nonliquefiable soils for a magnitude 7.1 earthquake. It is clear that the fill, shown as open triangles, plot within the liquefiable zone. The natural soils, shown as solid circles, fall into the nonliquefiable zone. The natural soils are predominantly sand bar and beach sand deposits. No correction in Figure 2-21 was made for silt content.
