RECONNAISSANCE REPORT ON THE
NORTHERN IRAN EARTHQUAKE OF
JUNE 21, 1990

M. Mehrain

Technical Report NCEER-90-0017

October 4, 1990

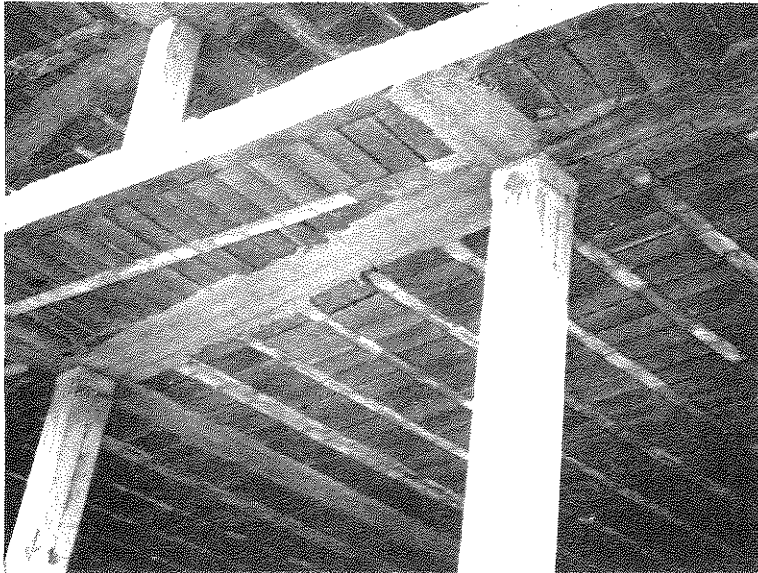
This system provides a flat surface under the floor structure (Fig. 3-14) to receive gypsum trowled-on ceiling.

Figure 3-14 Typical concrete frame construction in Iran
