Observations on Water System and
Pipeline Performance in the Limon Area of Costa Rica
Due to the April 22, 1991 Earthquake

M. J. O'Rourke

Technical Report NCEER-92-0017

June 30, 1992

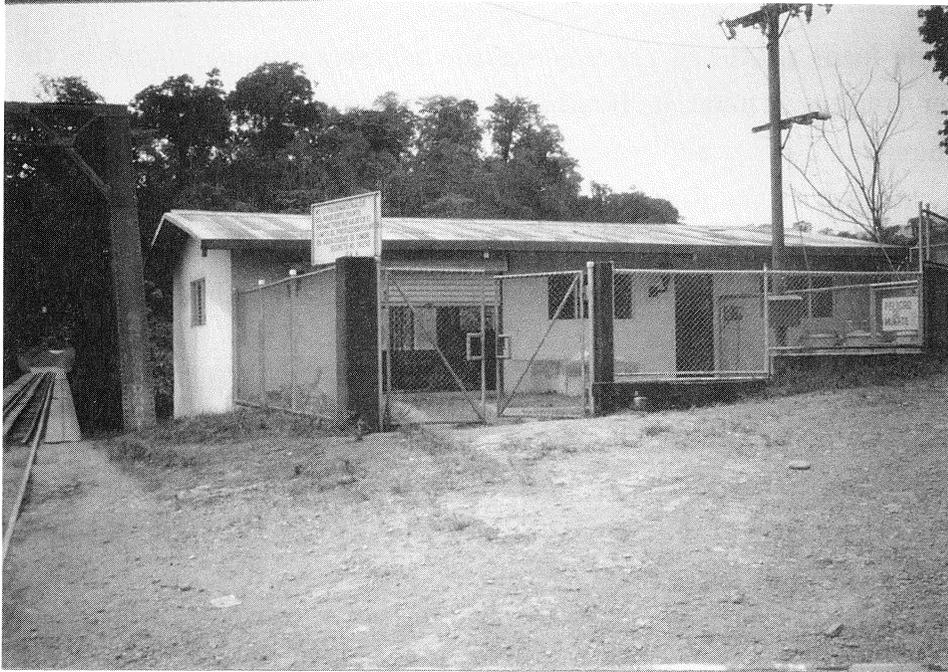
FIGURE 2-1 Undamaged Raw Water Pump Station on the Banano River

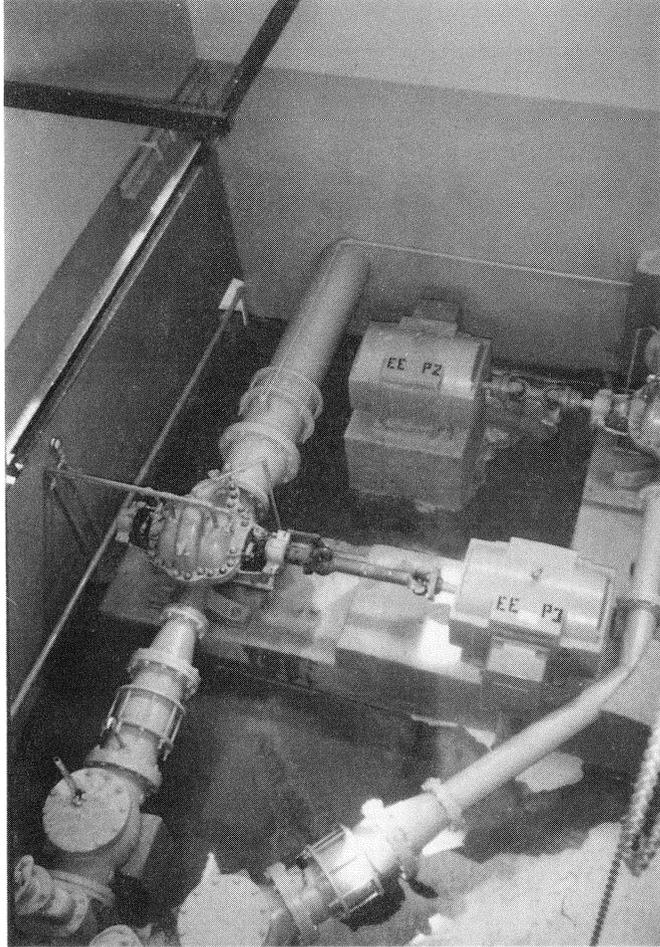
FIGURE 2-2 Split Case Pump in Raw Water Station on the Banano River

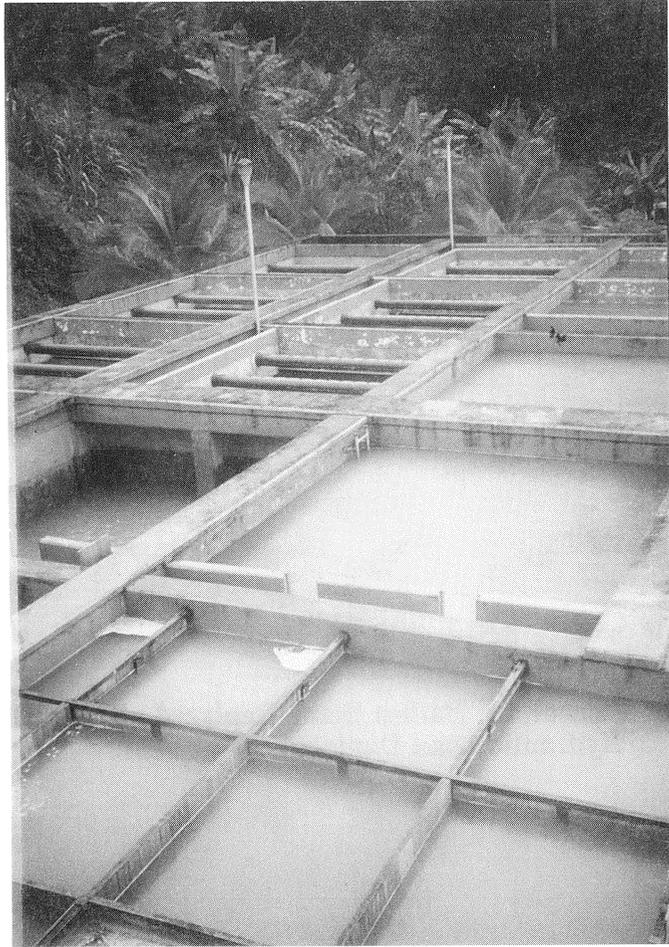
Asbestos cement baffles in the flocculators and asbestos cement clarifier plates were broken as shown in Figure 2-6 through 2-9. One concrete channel cracked. Glassware in the lab and the portable radio, sitting on the shelf, were undamaged. There was no reported damage to the filters.

FIGURE 2-6 Operating Flocculators in Foreground with Clarifiers Beyond

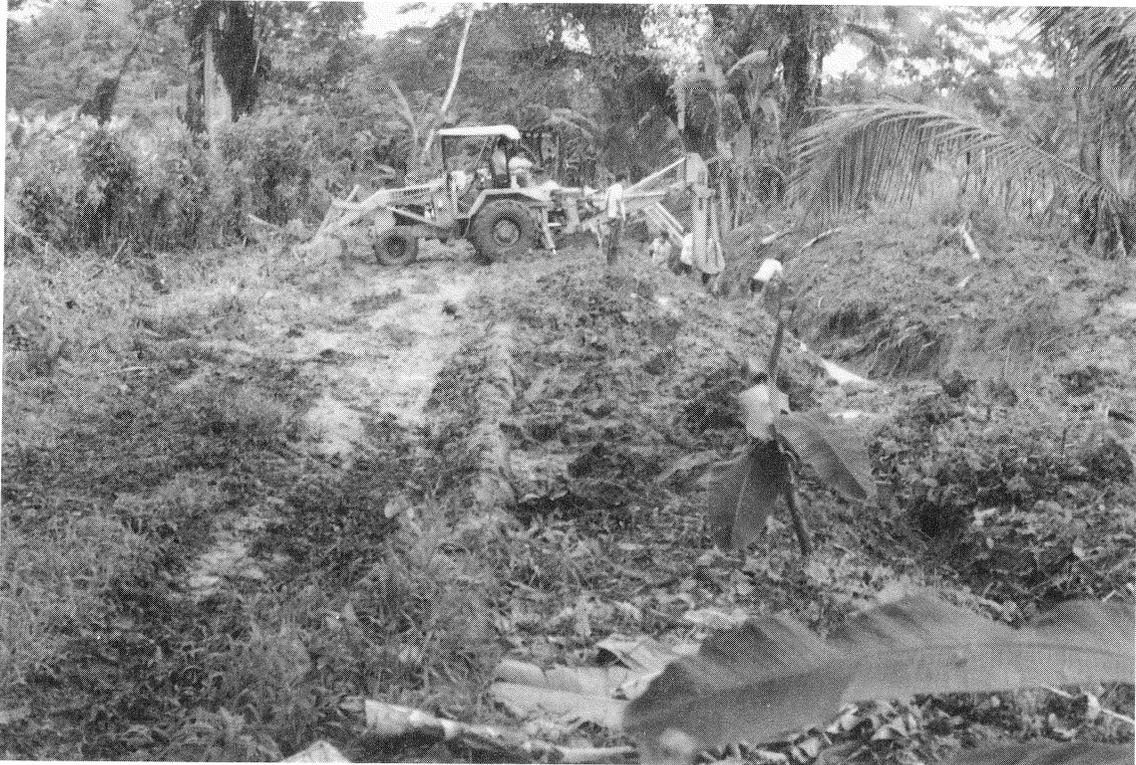
FIGURE 3-2 Transmission Pipelines from Banano River, 300 mm (12 in) Diameter Cast Iron (CI) Pipe under Backhoe Wheel, 500 mm (20 in) Reinforced Concrete Cylinder Pipe (RCCP) Being Repaired on Right.

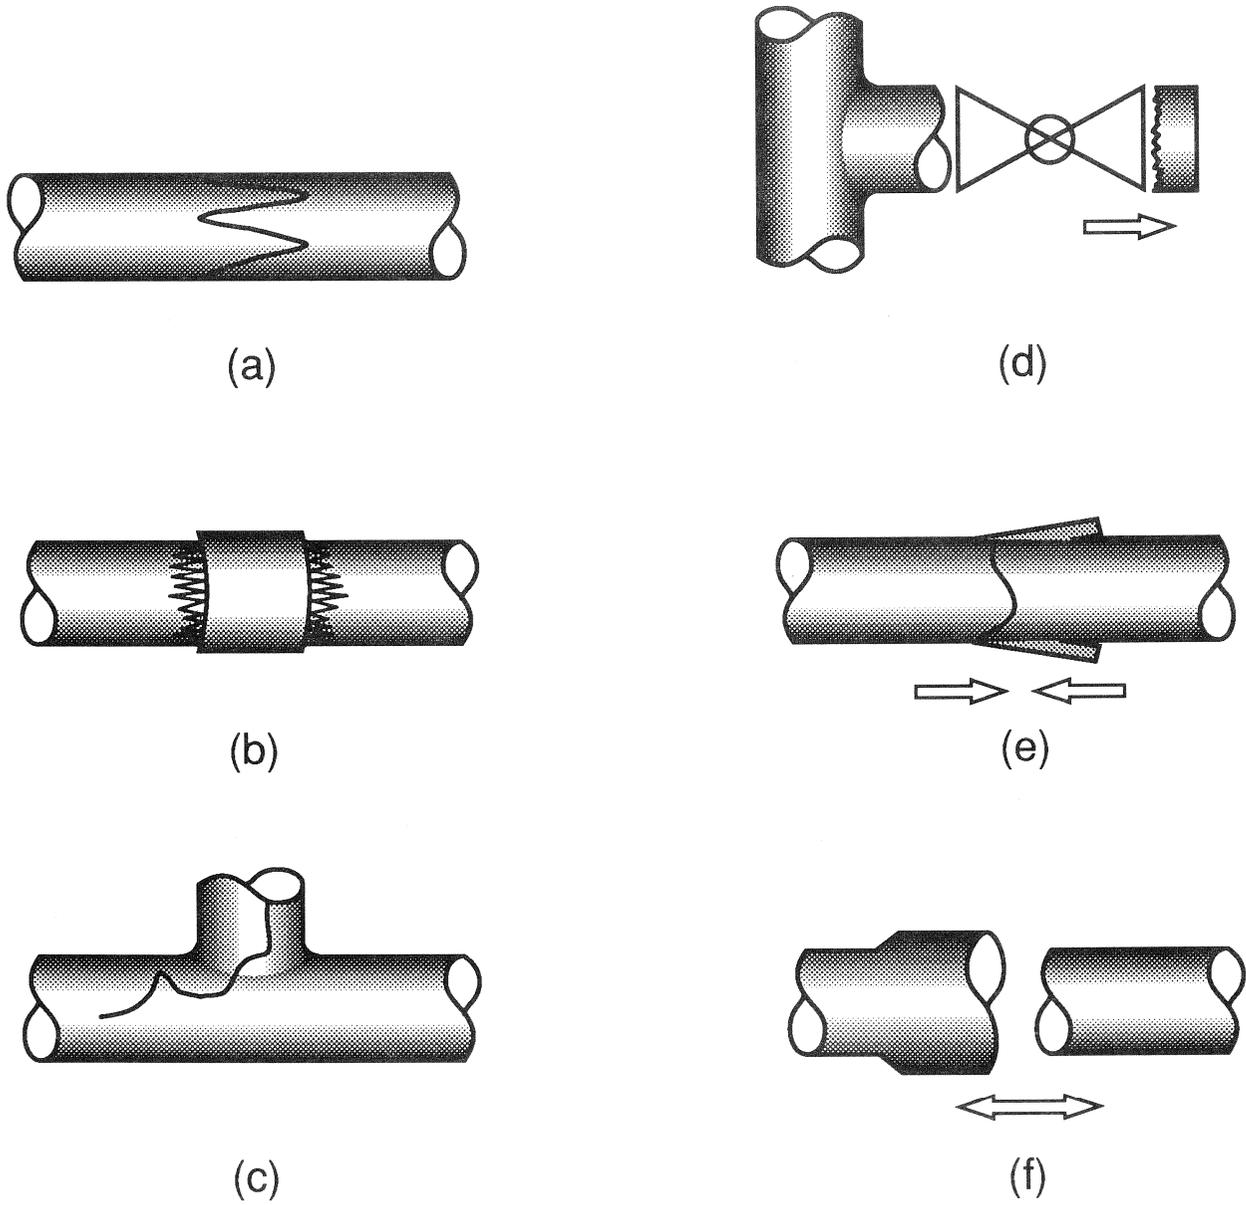
FIGURE 3-3 Damage Mechanisms; (a) pipe segment break, (b) break in union piece, (c) blowout at Tee, (d) disconnection at Tee, (e) compressive telescoping at joint, (f) tensile pull-out at joint

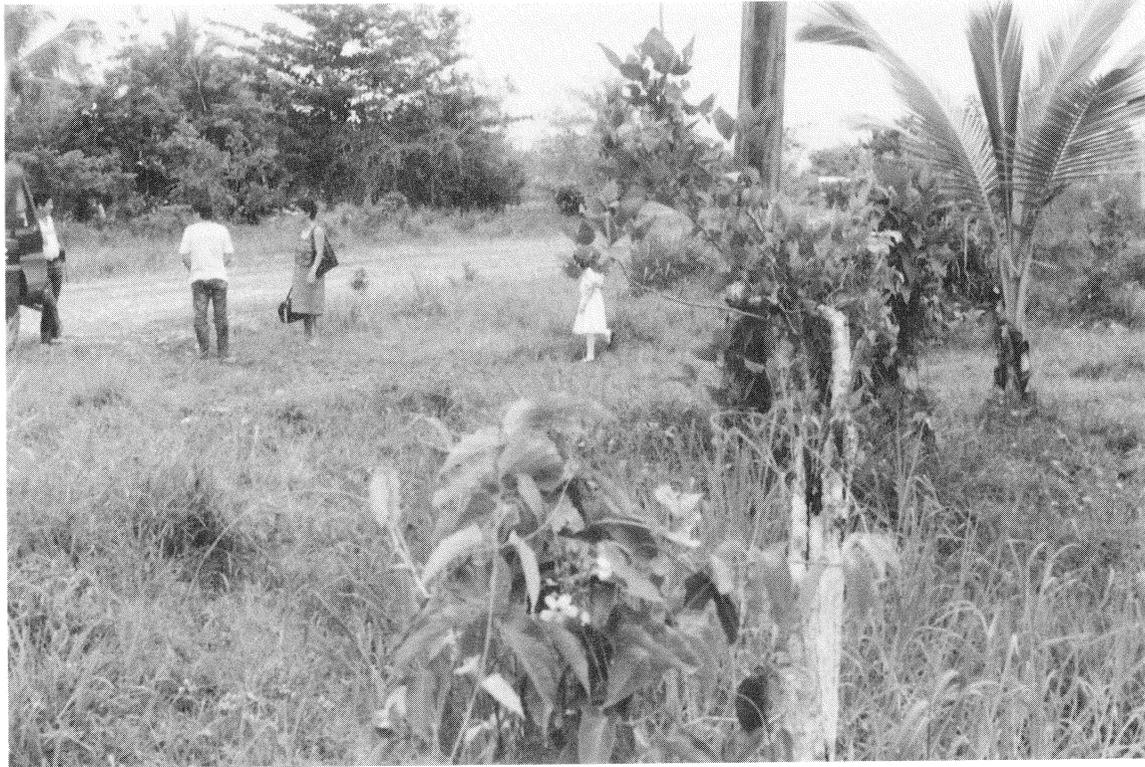
FIGURE 3-15 Reasonably Straight Fence Line Roughly 5 m (16 feet) to Right of Unrepaired Transmission Pipe Leak in Figure 3-14.

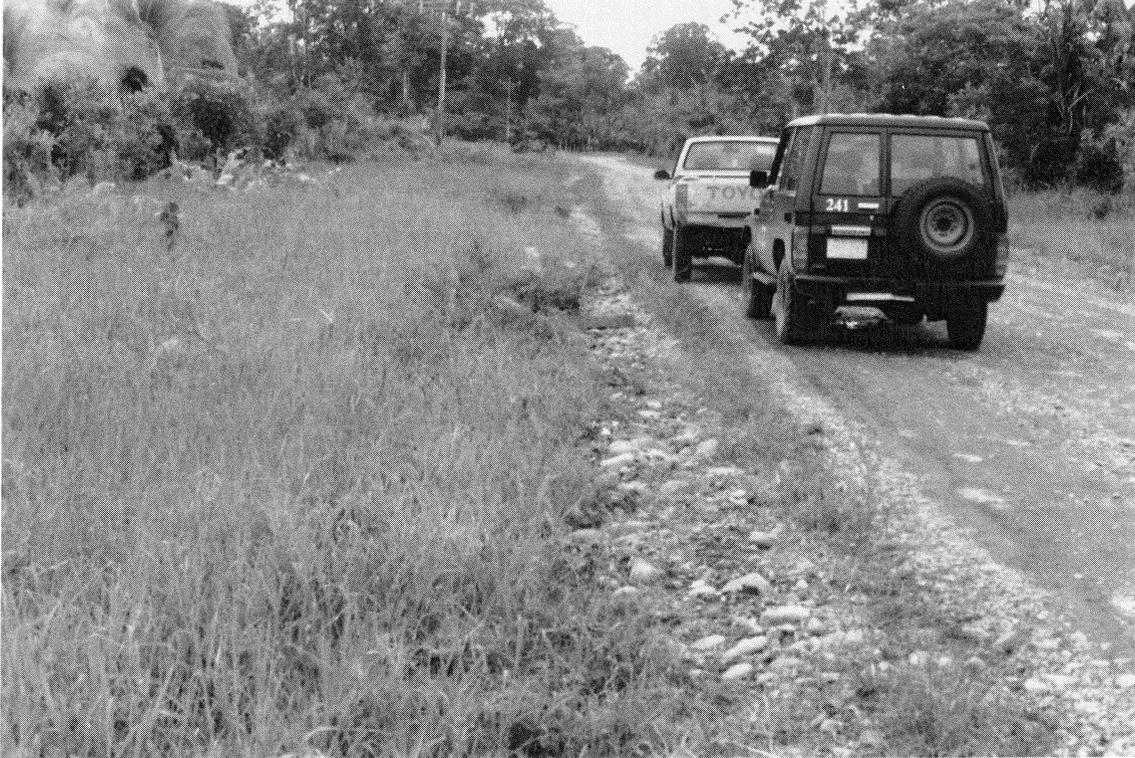
FIGURE 3-16 Dirt and Gravel Road Adjacent to Unrepaired Transmission Pipe Leak in Figure 3-14.

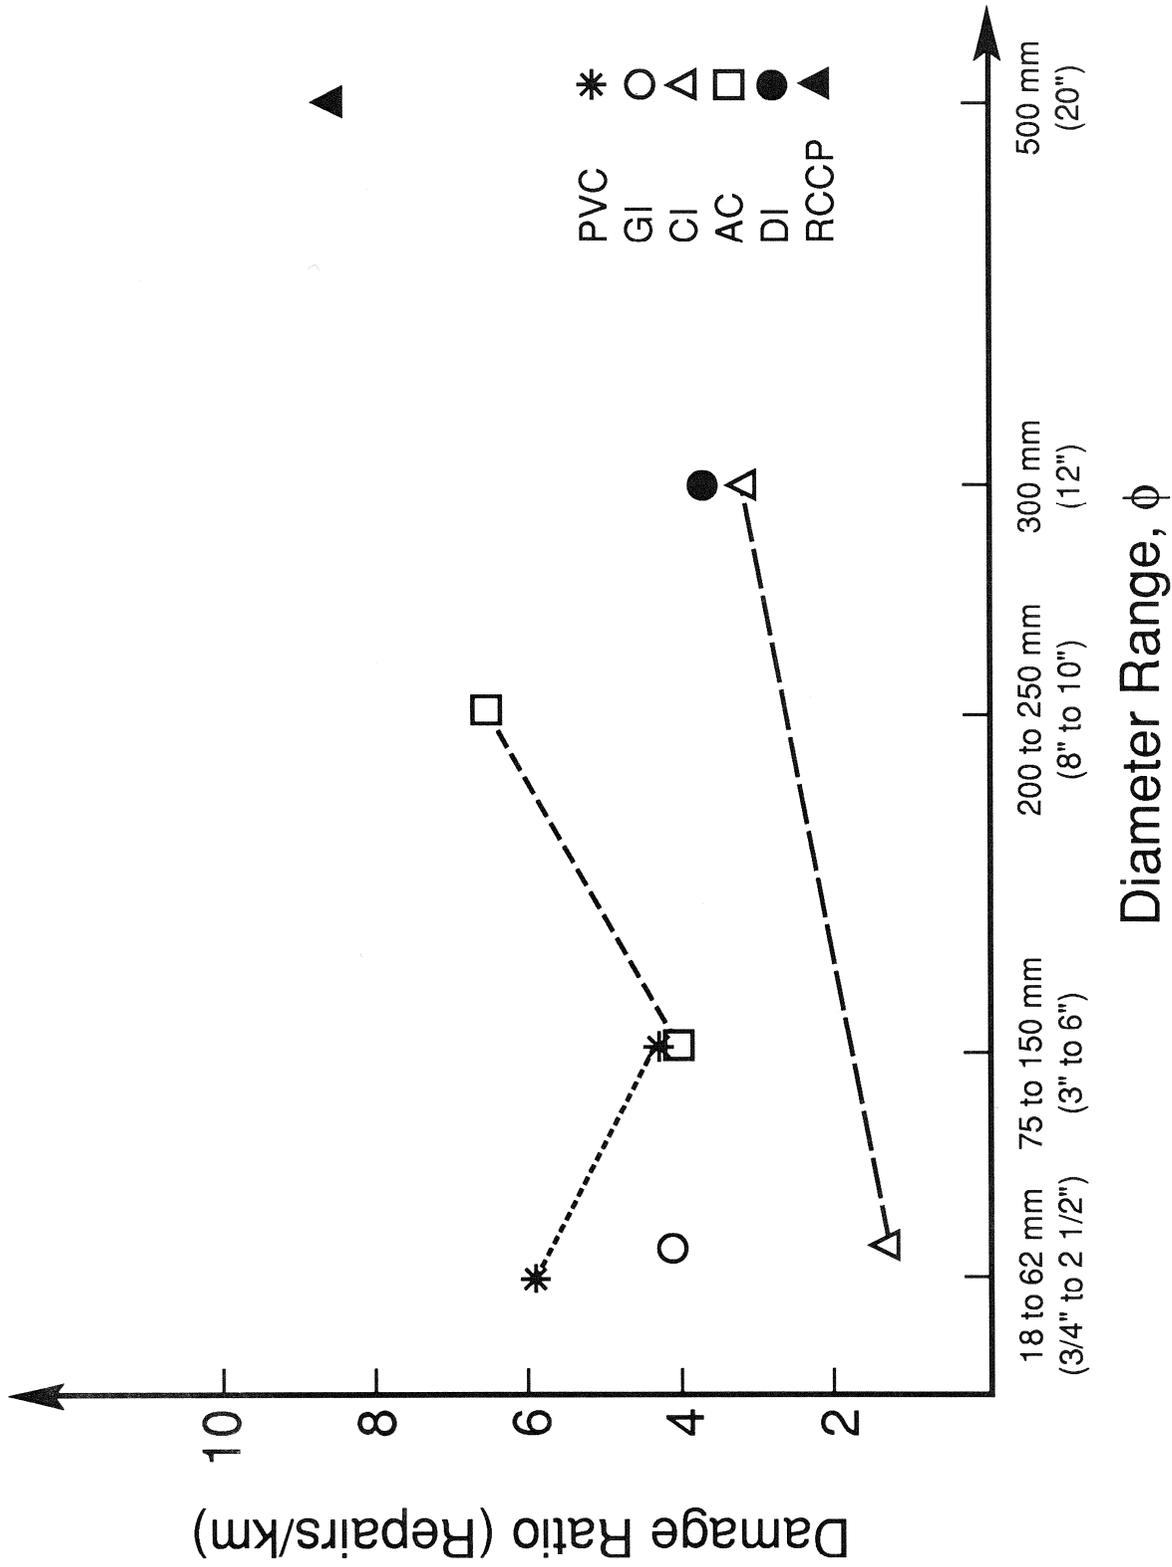
FIGURE 3-18 Damage Ratios for Distribution and Transmission Pipe Versus Diameter Range
