The Island of Guam Earthquake of August 8, 1993

S.W. Swan and S.K. Harris

Technical Report NCEER-93-0017

September 30, 1993

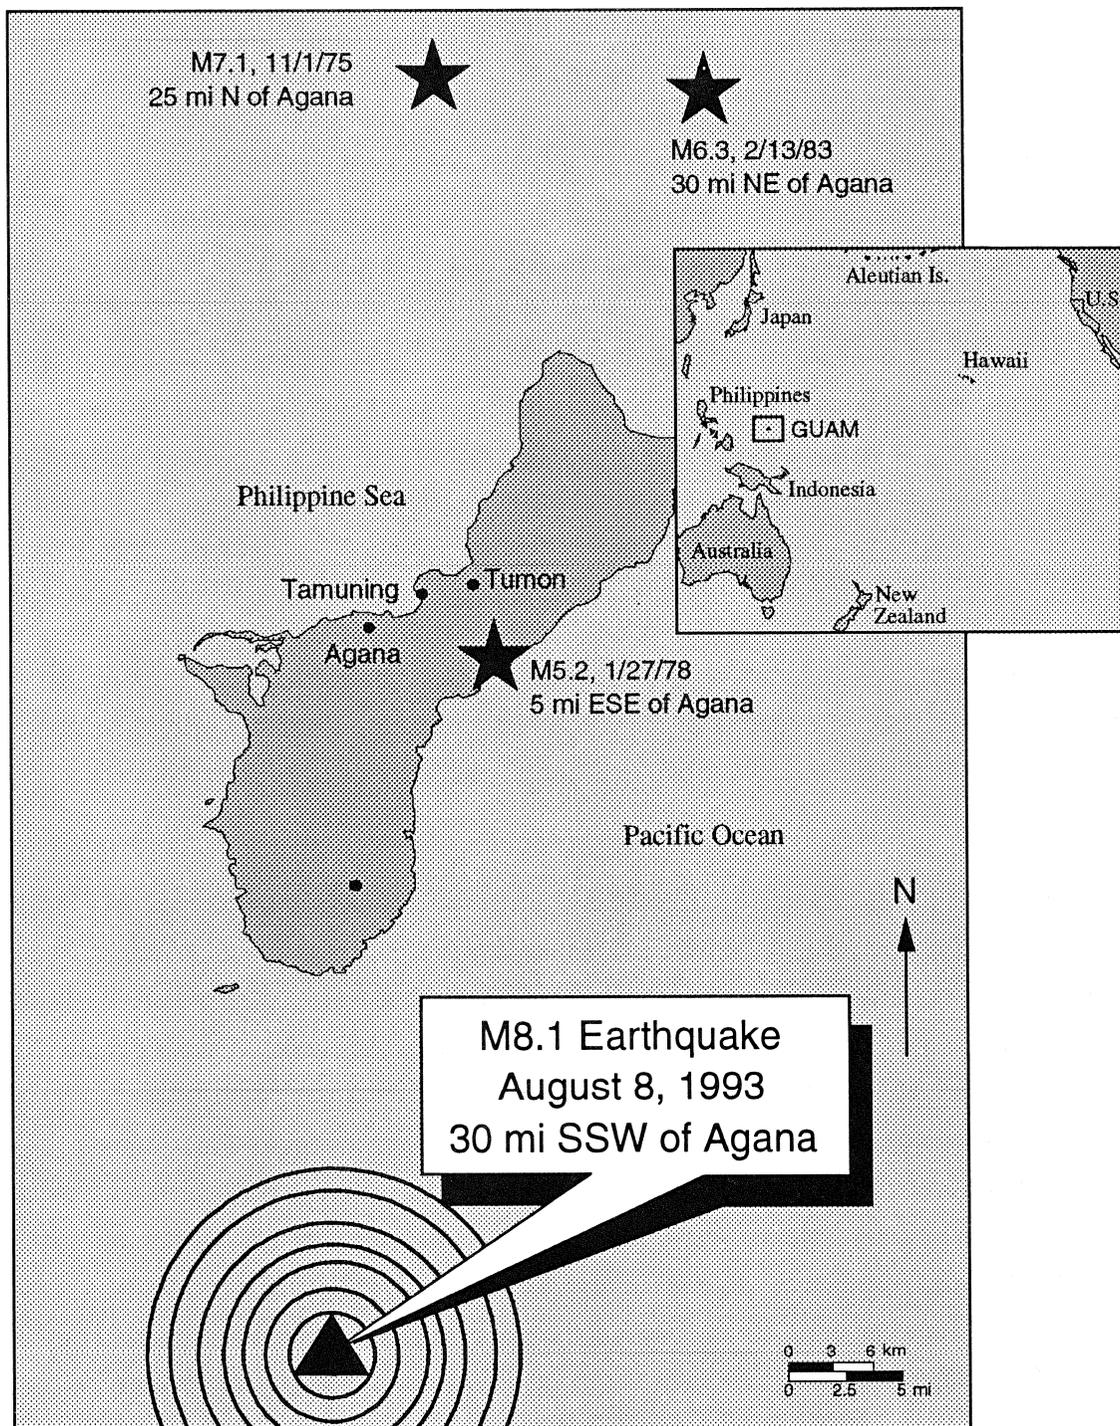
FIGURE1.DRW 71031-01 9/21/93

Estimates of the epicentral location initially placed it north of Guam toward the neighboring island of Rota. Further study indicated that the fault movement was in the Marianas trench about 50 km to the south of Guam (Figure 3-1). In this region the trench curves toward the southwest beneath the Marianas Island chain. The westward movement of the Pacific plate relative to the Philippine plate combines strike-slip sliding with subduction compression. Based on a moment-tensor solution of long distance seismic waves by the USGS, the August 8 earthquake appears to have been a shallow-dipping subduction thrust toward the northwest, combined with a limited amount of strike-slip movement along the trench. The orientation of the fault plane is more-or-less normal to Guam, so that the rupture did not approach the island. The fault plane was estimated to be centered some 60 km beneath the ocean floor. This relatively deep source (compared to California earthquakes for example) reduced the intensity of shaking on the island.

Figure 3-1: The map shows the best-estimate location of the August 8 epicenter relative to the island of Guam. Locations are also shown for other earthquakes occurring near the island within the last 20 years.

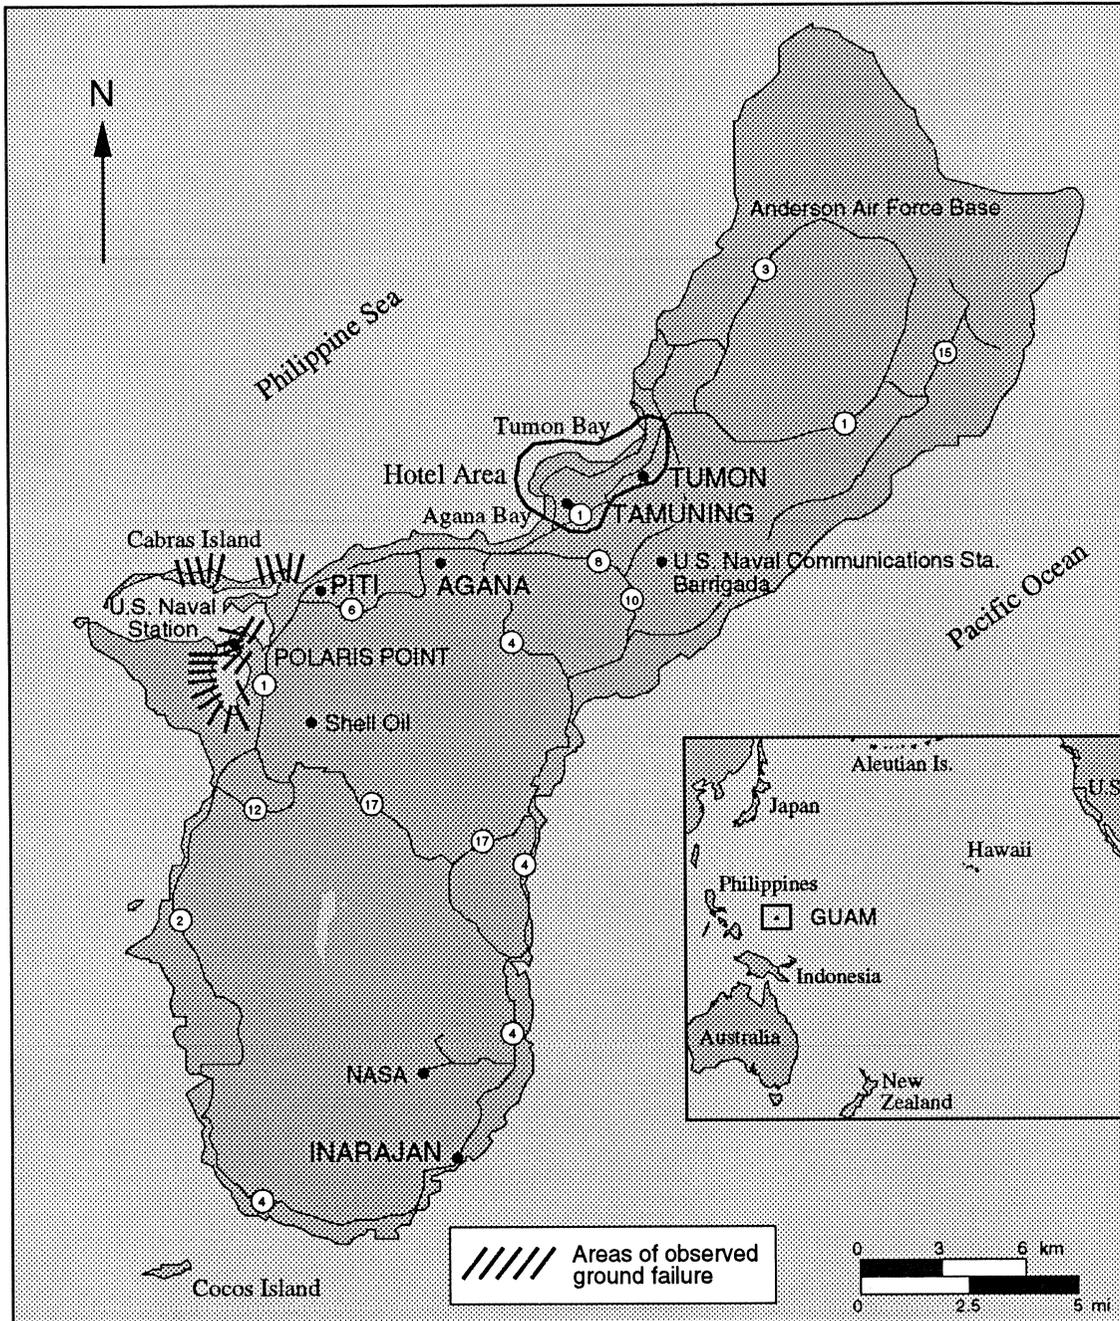
FIGURE2.DRW 71031-01 9/21/93

Nearly all of Guam's surface would be described as firm soil or rock (Figure 4-1). Permanent ground displacement from the earthquake, in the form of settlement or spreading, was therefore rare. The largest region of soft soil bounds Apra Harbor, location of the commercial port and the U.S. Navy port on the west side of the island. The harbor area is a combination of coral reef surrounded by natural alluvium and artificial fill.

Figure 4-1: Most of Guam is relatively firm soil or rock, with the exception of the port area of the western shore. The most intense ground shaking appeared to occur near the port, including areas of soil liquefaction. The tourist hotel district around Tumon Bay, sited on the coral reef, appears to have experienced moderate ground shaking.
