# Hokkaido Nansei-oki, Japan Earthquake of July 12, 1993

P.I. Yanev and C.R. Scawthorn

Technical Report NCEER-93-0023

December 23, 1993

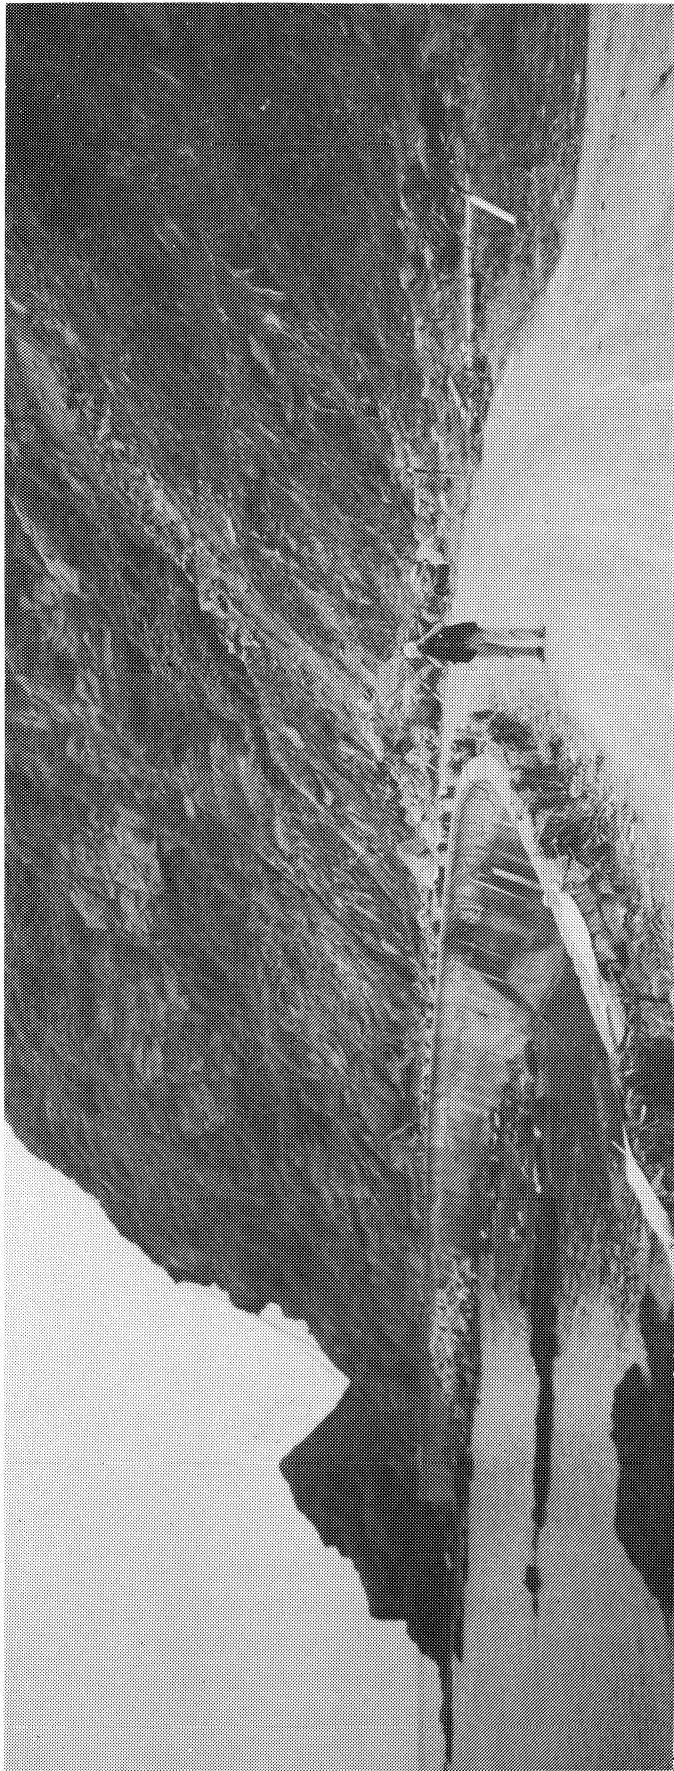
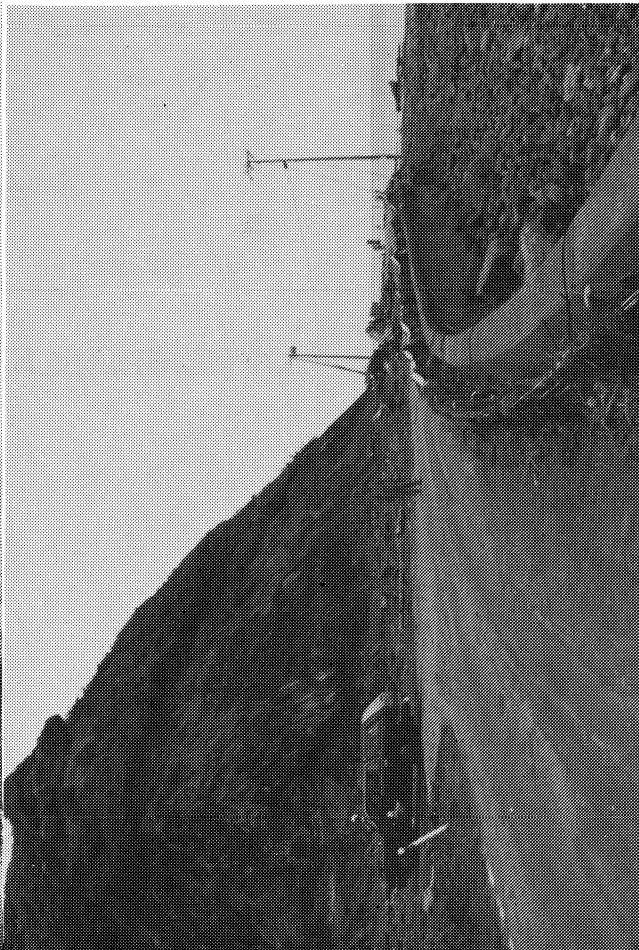
Figure 5-2: View of tsunami run-up at the mouth of a small canyon where the maximum run-up of about 30.5 m occurred. That is just to the left of the lower photo. The poles are new. Note how sea- and tsunami-borne debris backfilled along the base of the retaining wall/tsunami wall.

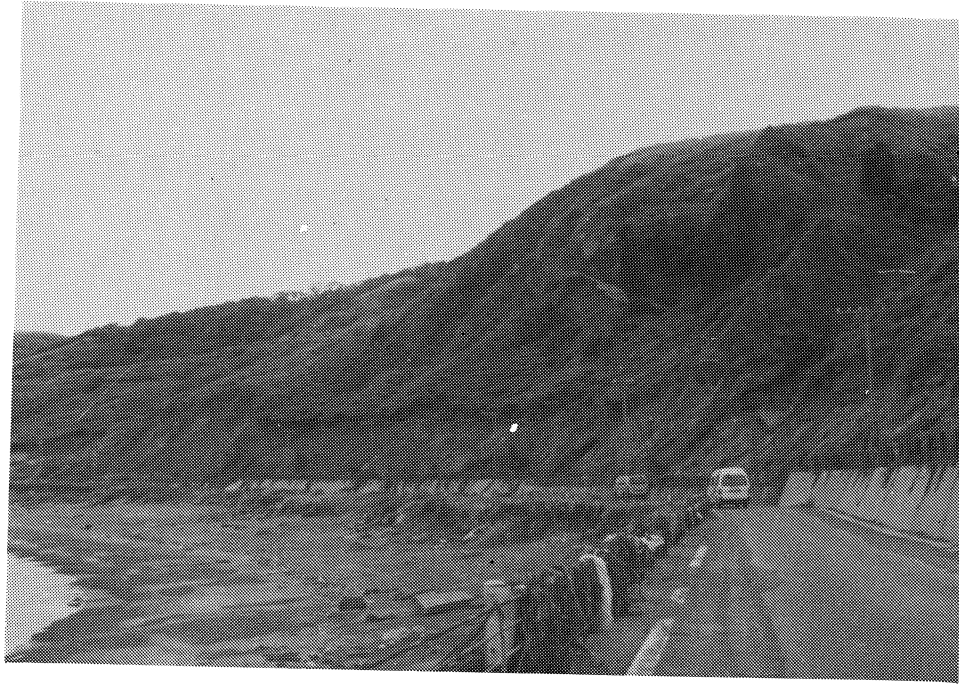
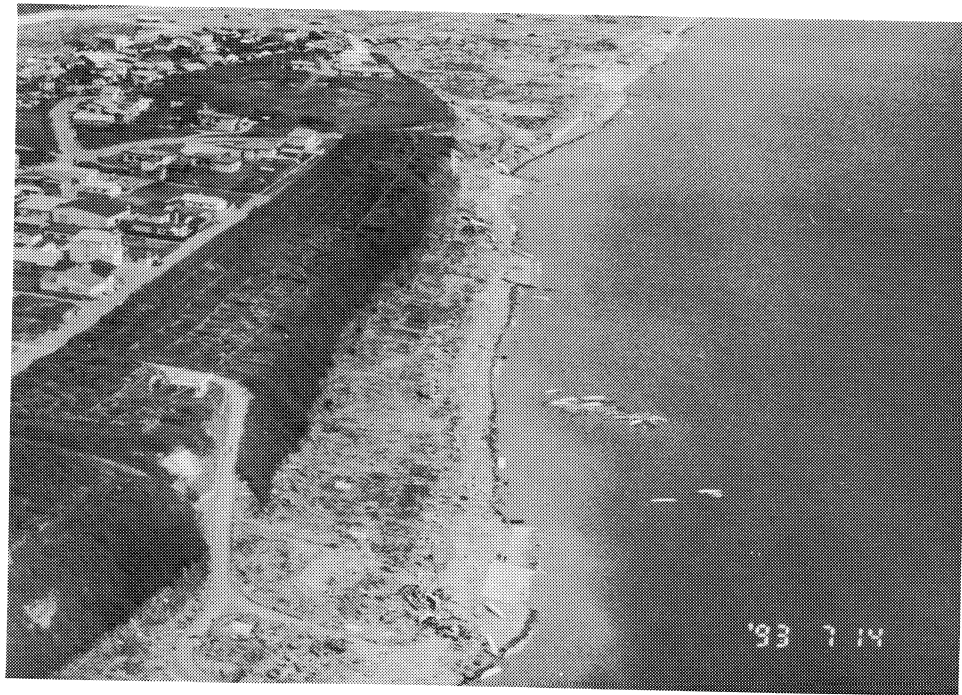
Figure 5-3: Evidence of tsunami inundation along the western shoreline of Okushiri Island just north of Aonae town. The run-up is about 15 m. All the telephone power lines are new; the old ones were destroyed. The vegetation remains along the road railing are from the tsunami. All buildings in this area along the coast at or near sea level were destroyed (lower photograph; courtesy of K. Kawashima).

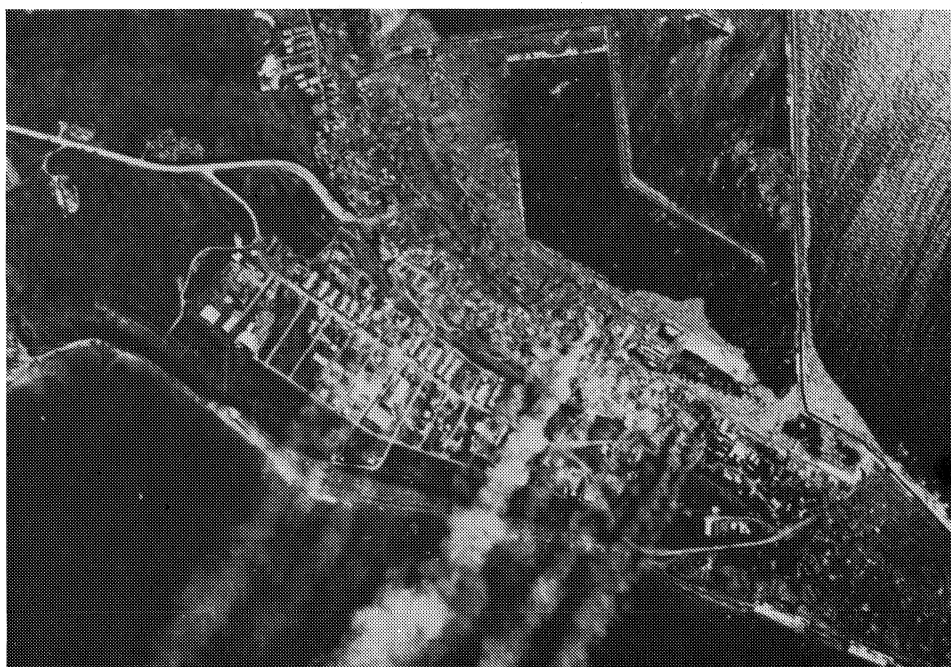
Figure 6-2: View of Aonae soon after the earthquake with smoke from the fire, debris of (primarily) wood-frame buildings in the port, total destruction in the low-lying area on the left, and heavy tsunami and fire destruction along and behind the port. The tsunami run-up here was on the order of 10 to 15 m high.

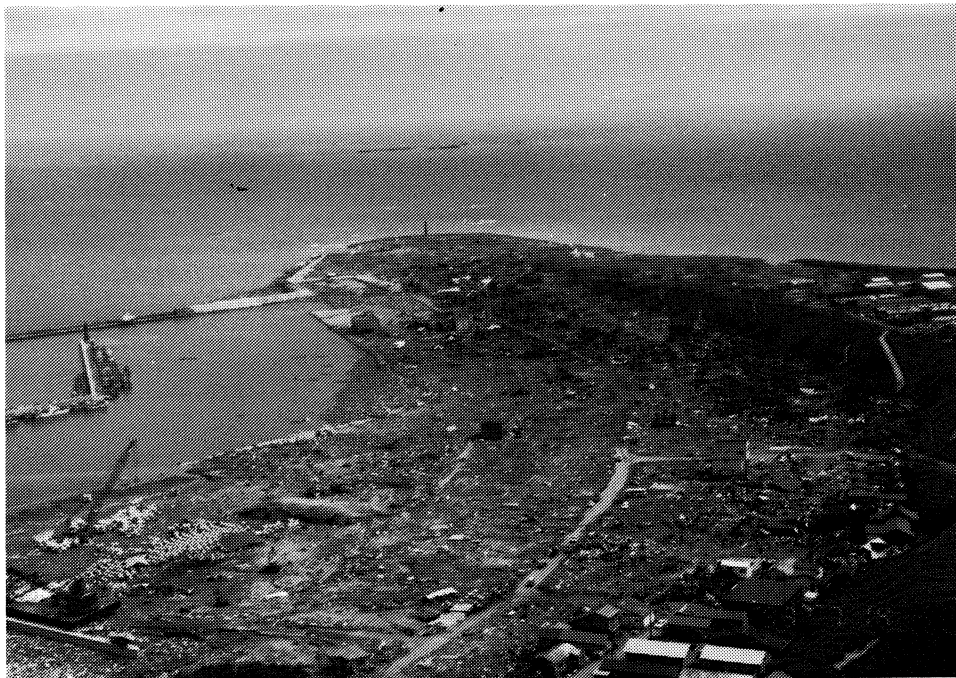
Figure 6-4: The sea-level southern tip of Aonae showing near total destruction of buildings. All destroyed buildings, mostly two-story, were wood frame. Note that the area is completely surrounded by protective, up to 4.5-m tsunami walls. They were ineffective in preventing the destruction, although they probably moderated the height of the run-up, which was 10 to 15 m high. The lower photograph shows much of Aonae, looking south. Photographs by K. Kawashima.

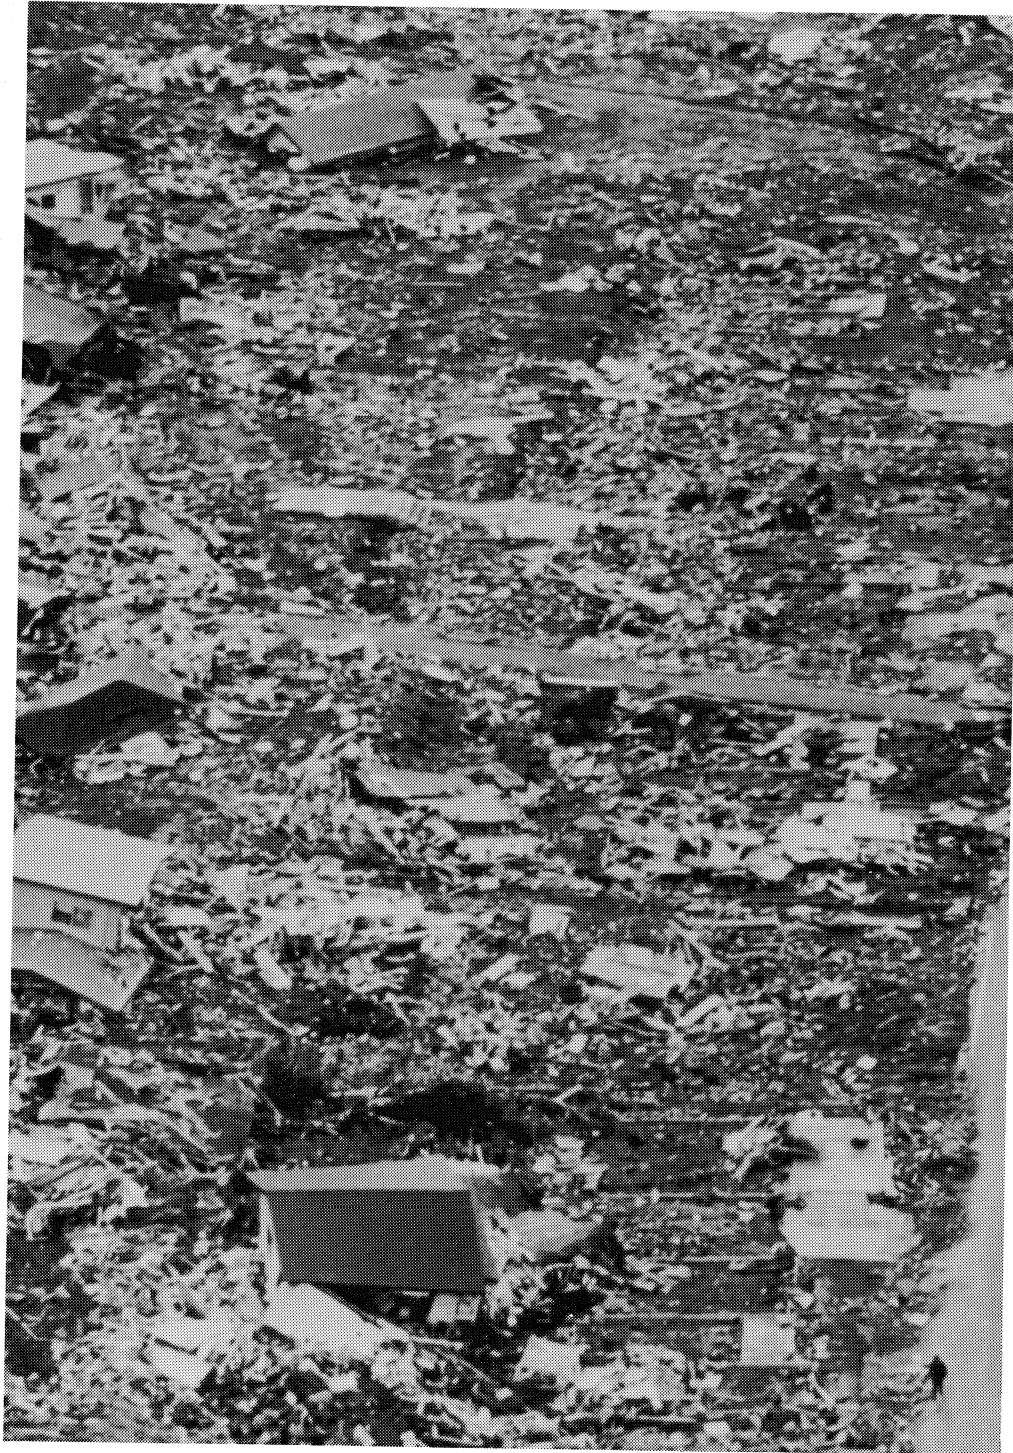
Figure 6-5: A partial view of the area in the previous photograph. The somewhat intact remains are roofs and the upper floors of two (or more) story buildings. These remains have been transported many meters away from their original locations.

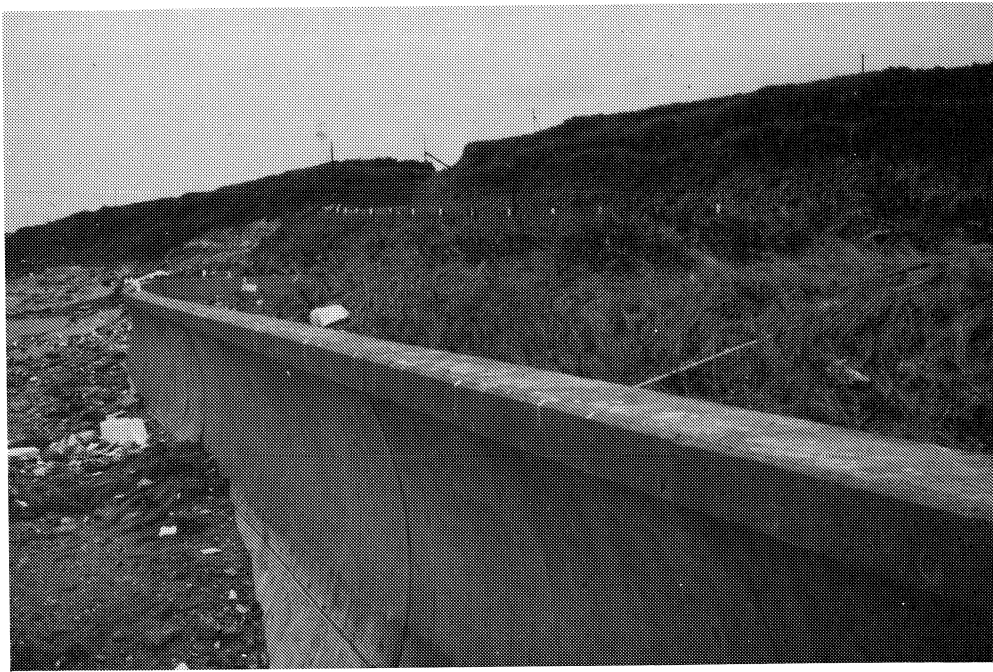
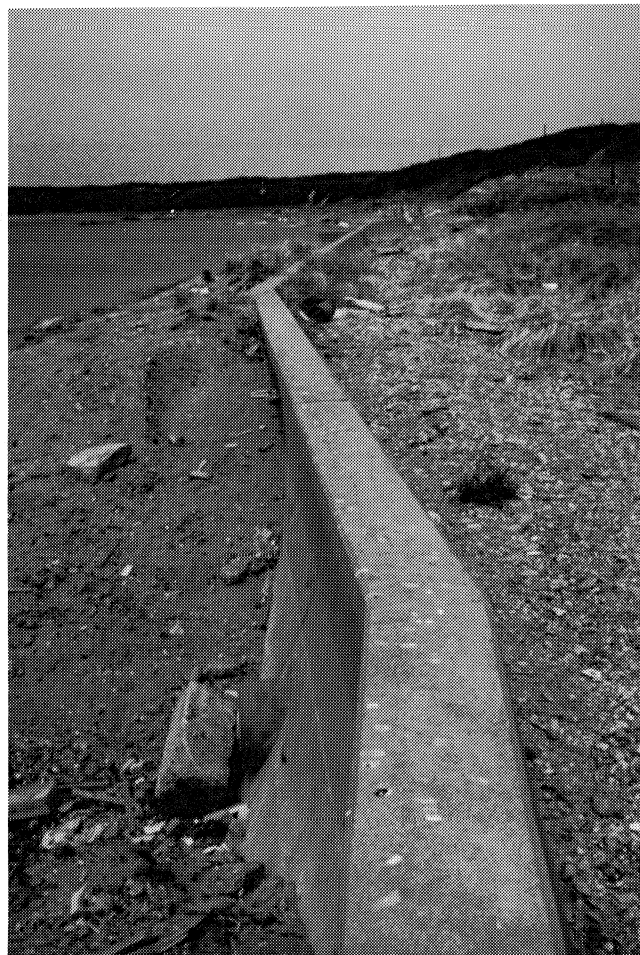
Figure 6-6: Two views of the tsunami walls surrounding the west side of the southern tip of Aonae. Note how the walls have been partially backfilled with sea-borne debris--much of it before the tsunami of the July 12, 1993, earthquake.

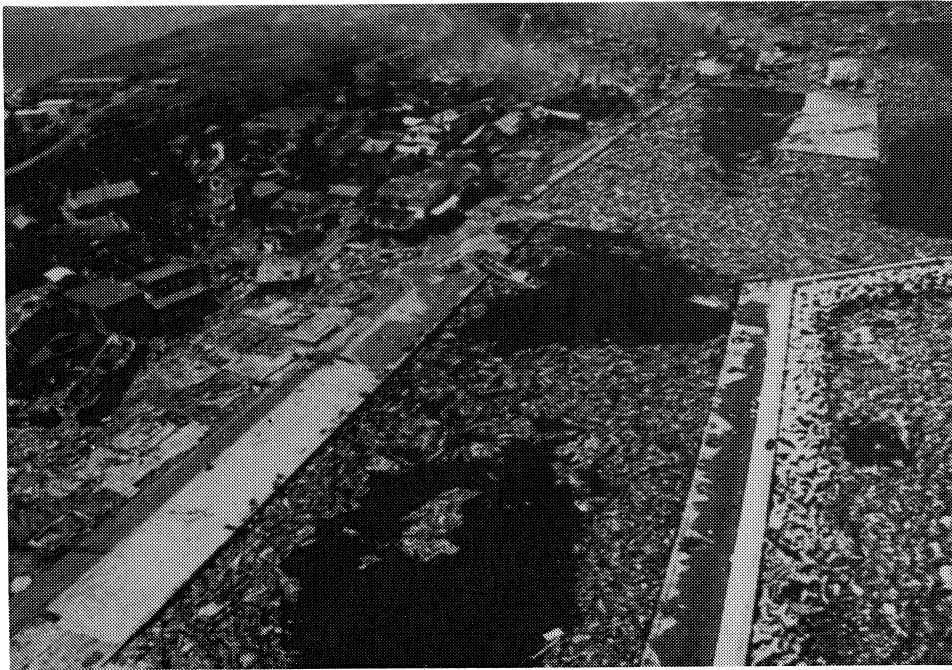
Figure 6-8: Wood-frame building and contents debris littered and choked the port of Okushiri on the morning after the earthquake.

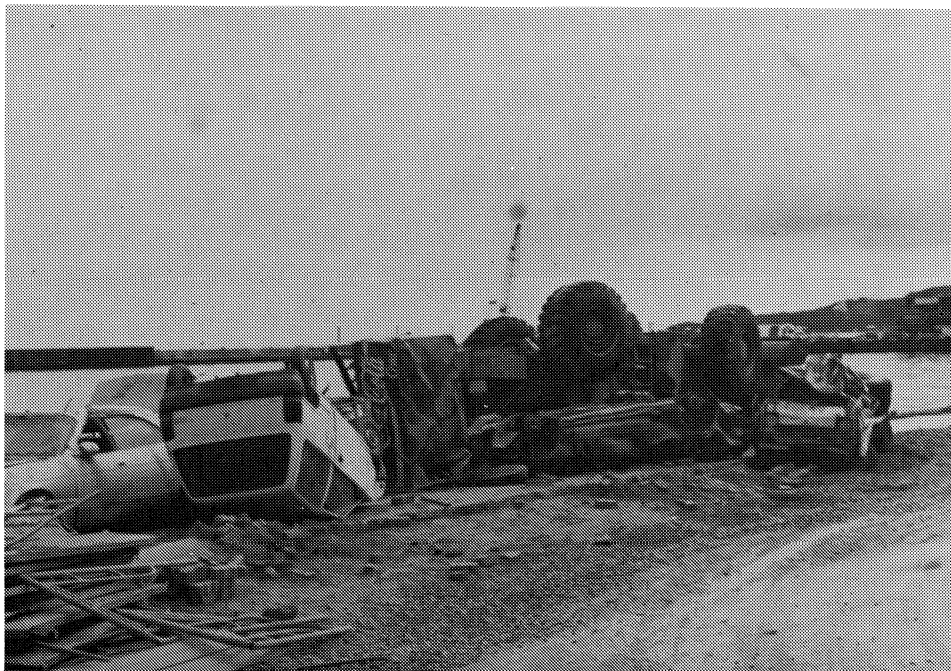
Figure 6-9: Overturned cars and a heavy bulldozer in the port area of Aonae.

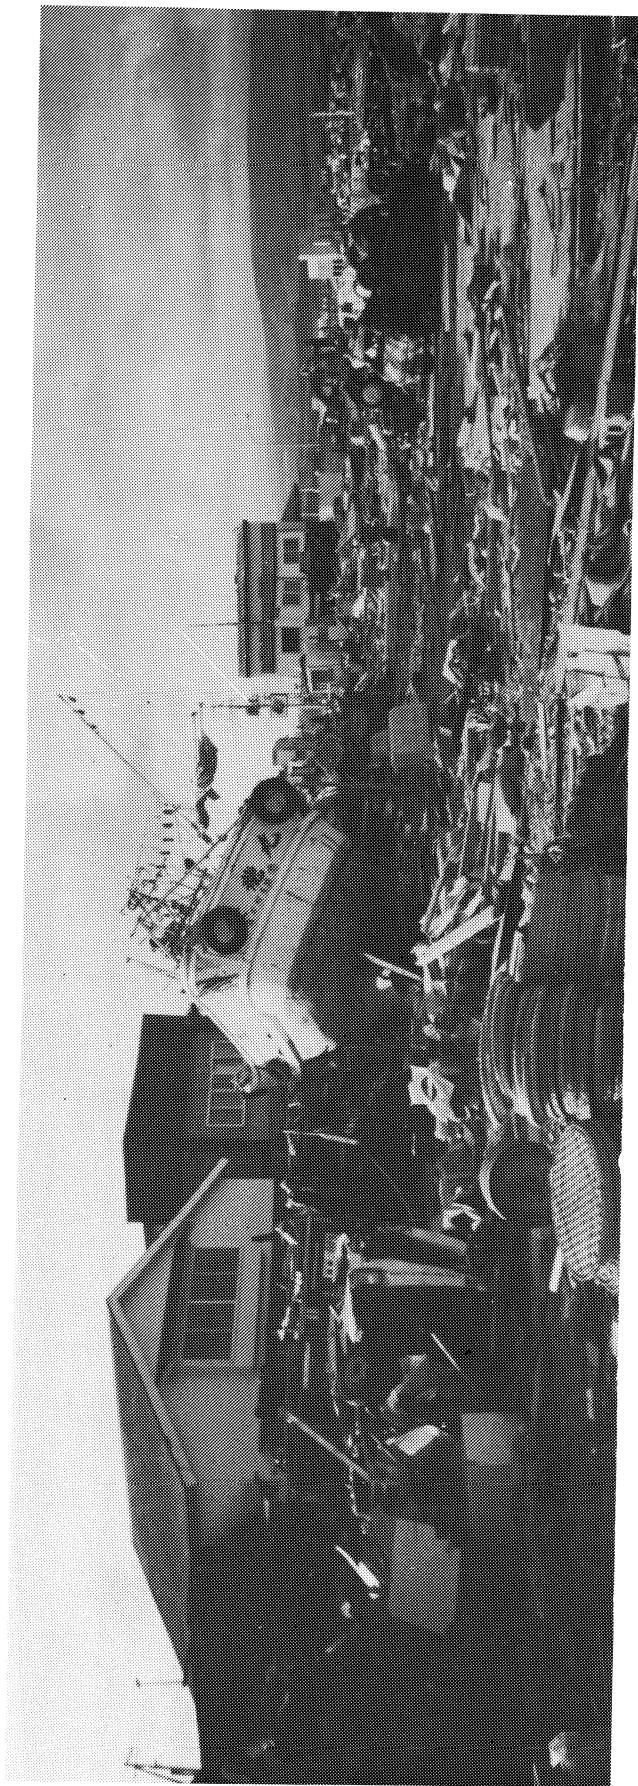
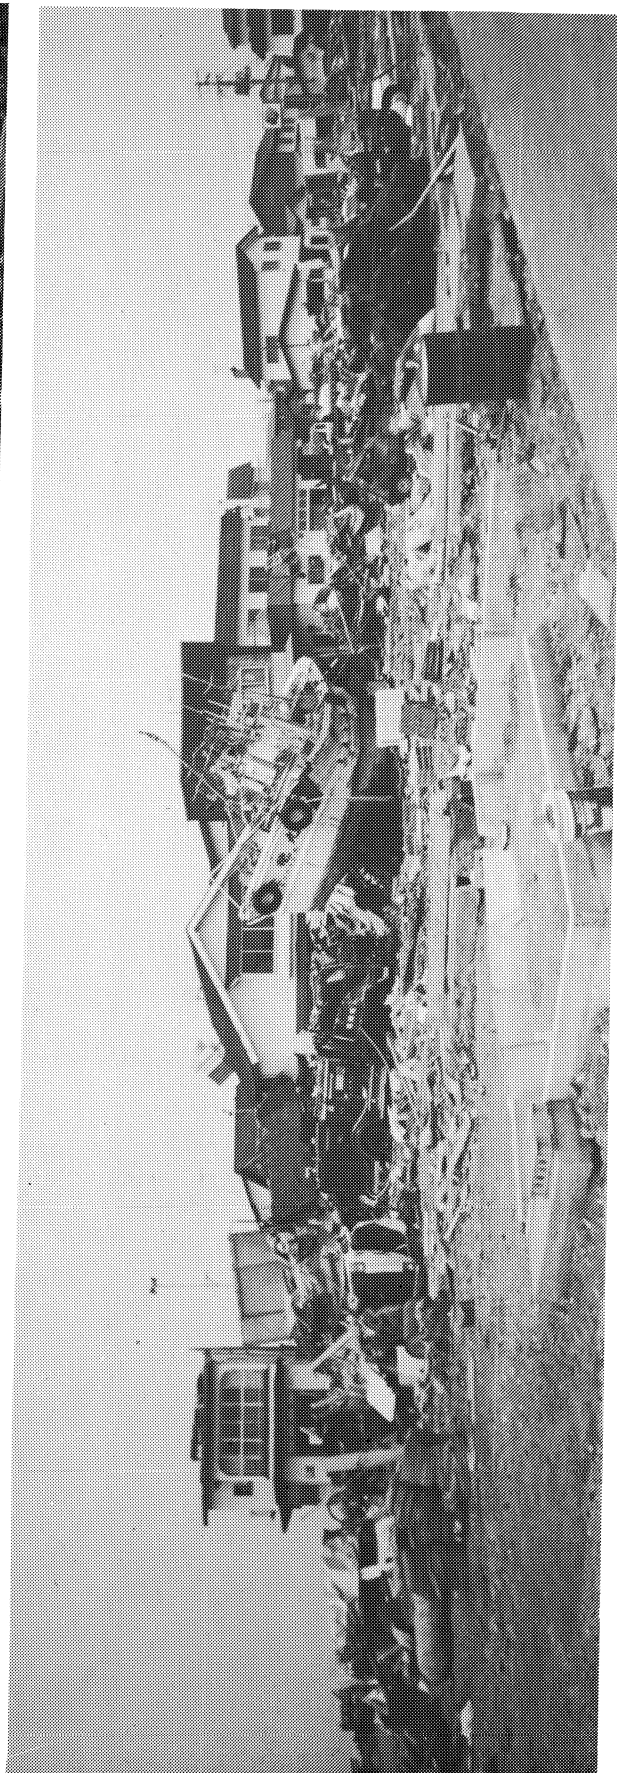
Figure 6-10: Tsunami effects and tsunami-borne debris at the edge of the port area of Aonae. The boat was transported about 100 m.

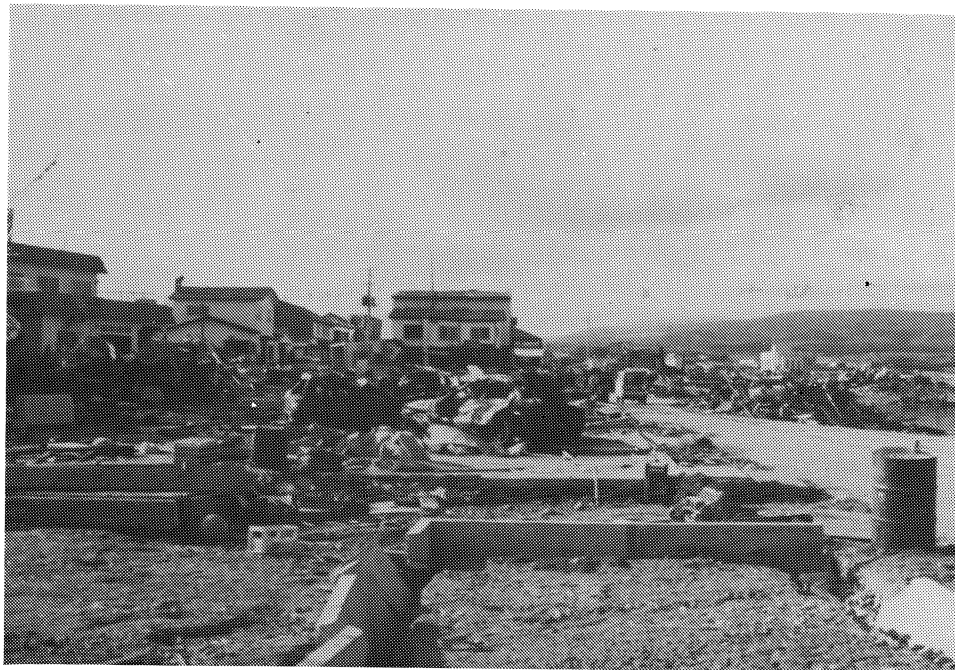
Figure 6-12: Tsunami devastation in the southeastern part of the port area of Aonae. The building foundations in the forefront have been stripped of any wood. Many foundation anchor bolts without any remaining wood-framing were observed throughout the devastated area. The cars (in center) have been rolled over several times. Several people were trapped and killed or drowned in their cars. About 10 days after the earthquake, search teams were still looking for vehicles and trapped victims along the shores of Okushiri Island.

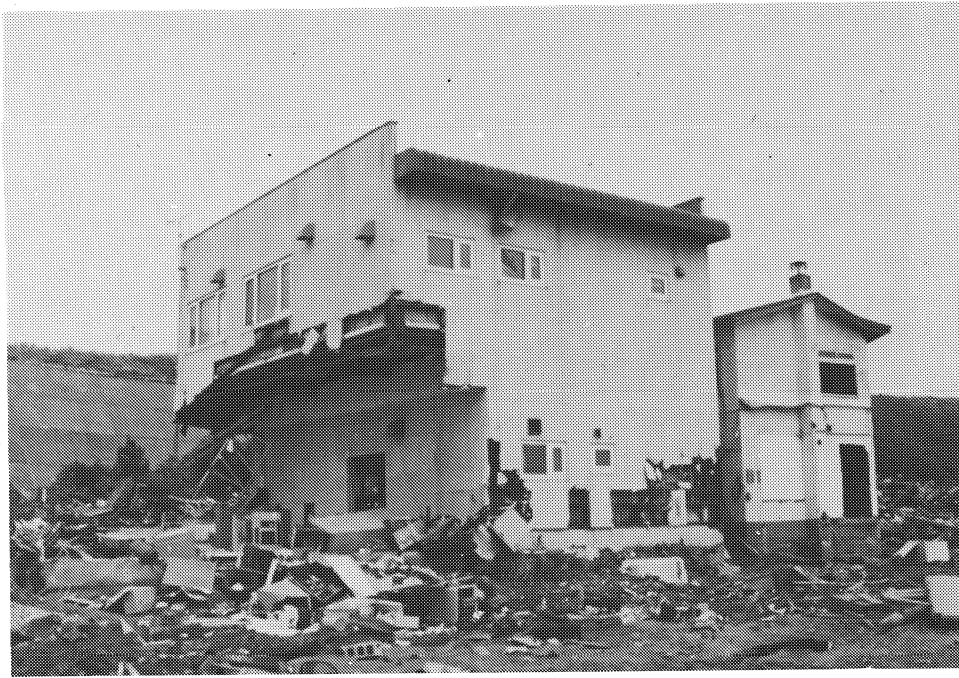
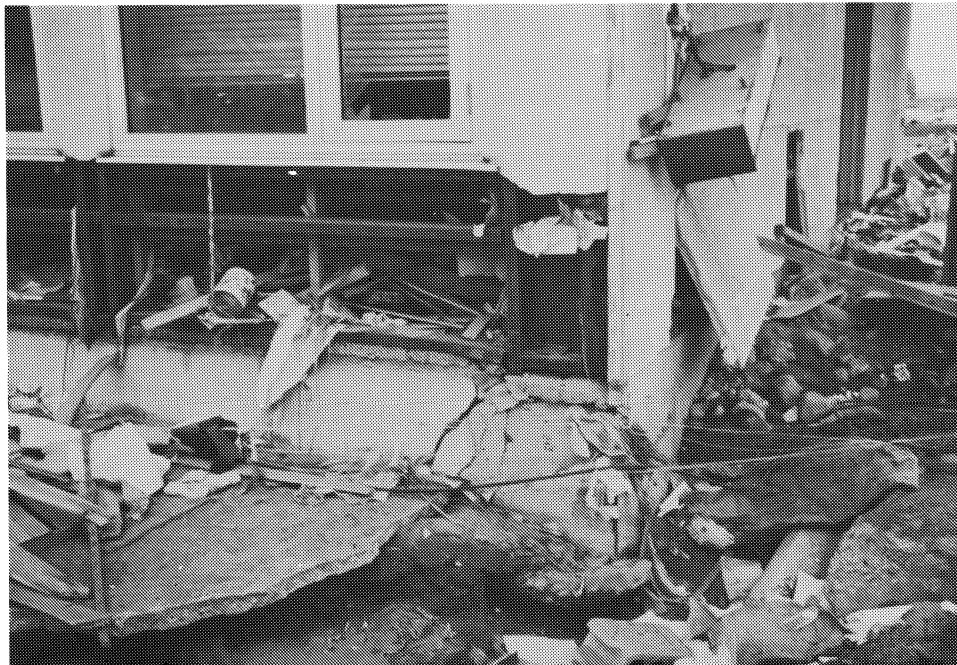
Figure 6-14: The only observed steel-frame building in the tsunami-devastated parts of Aonae. The building suffered some settlement damage (lower photograph), probably due to shaking. Its first-floor interior finishes were damaged extensively, and at least 15 cm of sand was deposited on the ground floor slab. The building is probably repairable, the estimated loss is less than 50% of value. Note the surviving wood-frame building, which was saved by its steel neighbor.

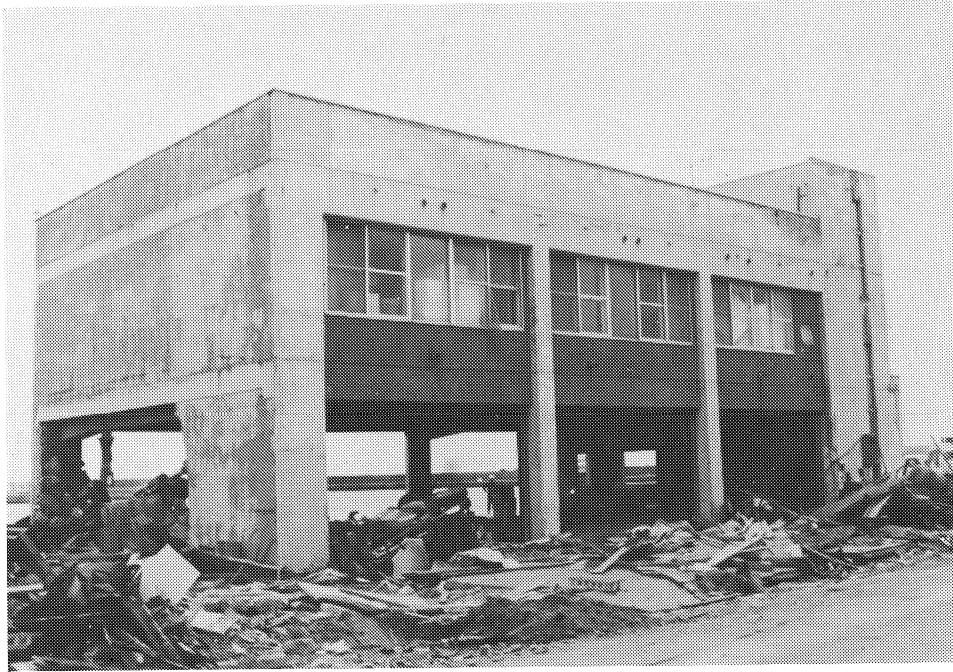
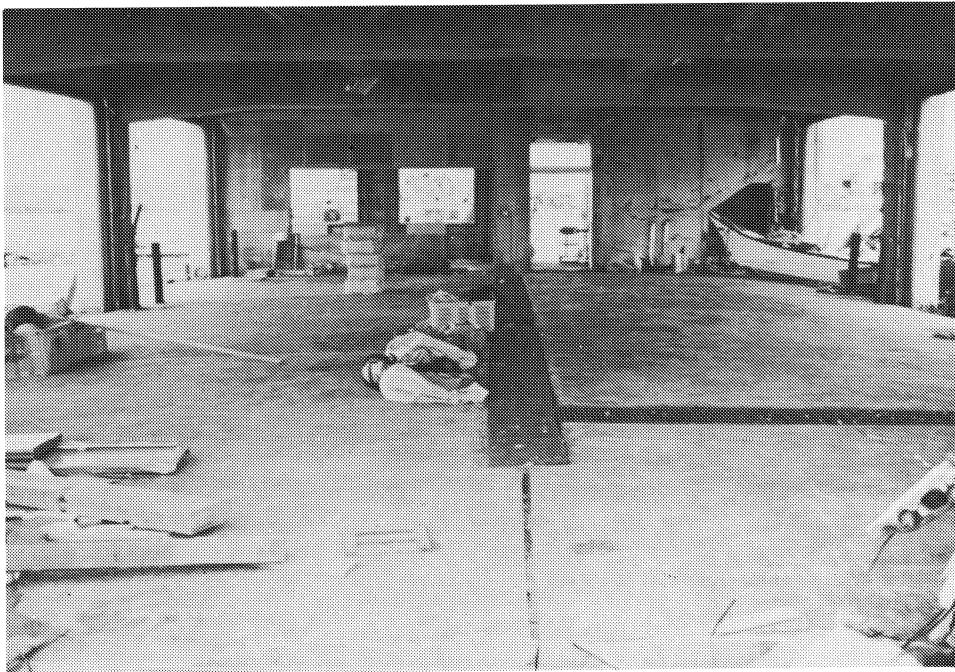
Figure 6-16: A two-story concrete-frame building survived the earthquake and tsunami with light structural damage. It is located at the front of the harbor. The ground floor finishes were completely destroyed. The damage to the left concrete wall is probably from tsunami-borne debris such as the overturned forklift in the center. The ground-floor concrete slab of the building was severely distorted from settlement, probably induced by the shaking--not by the tsunami. The structure appears to be repairable.

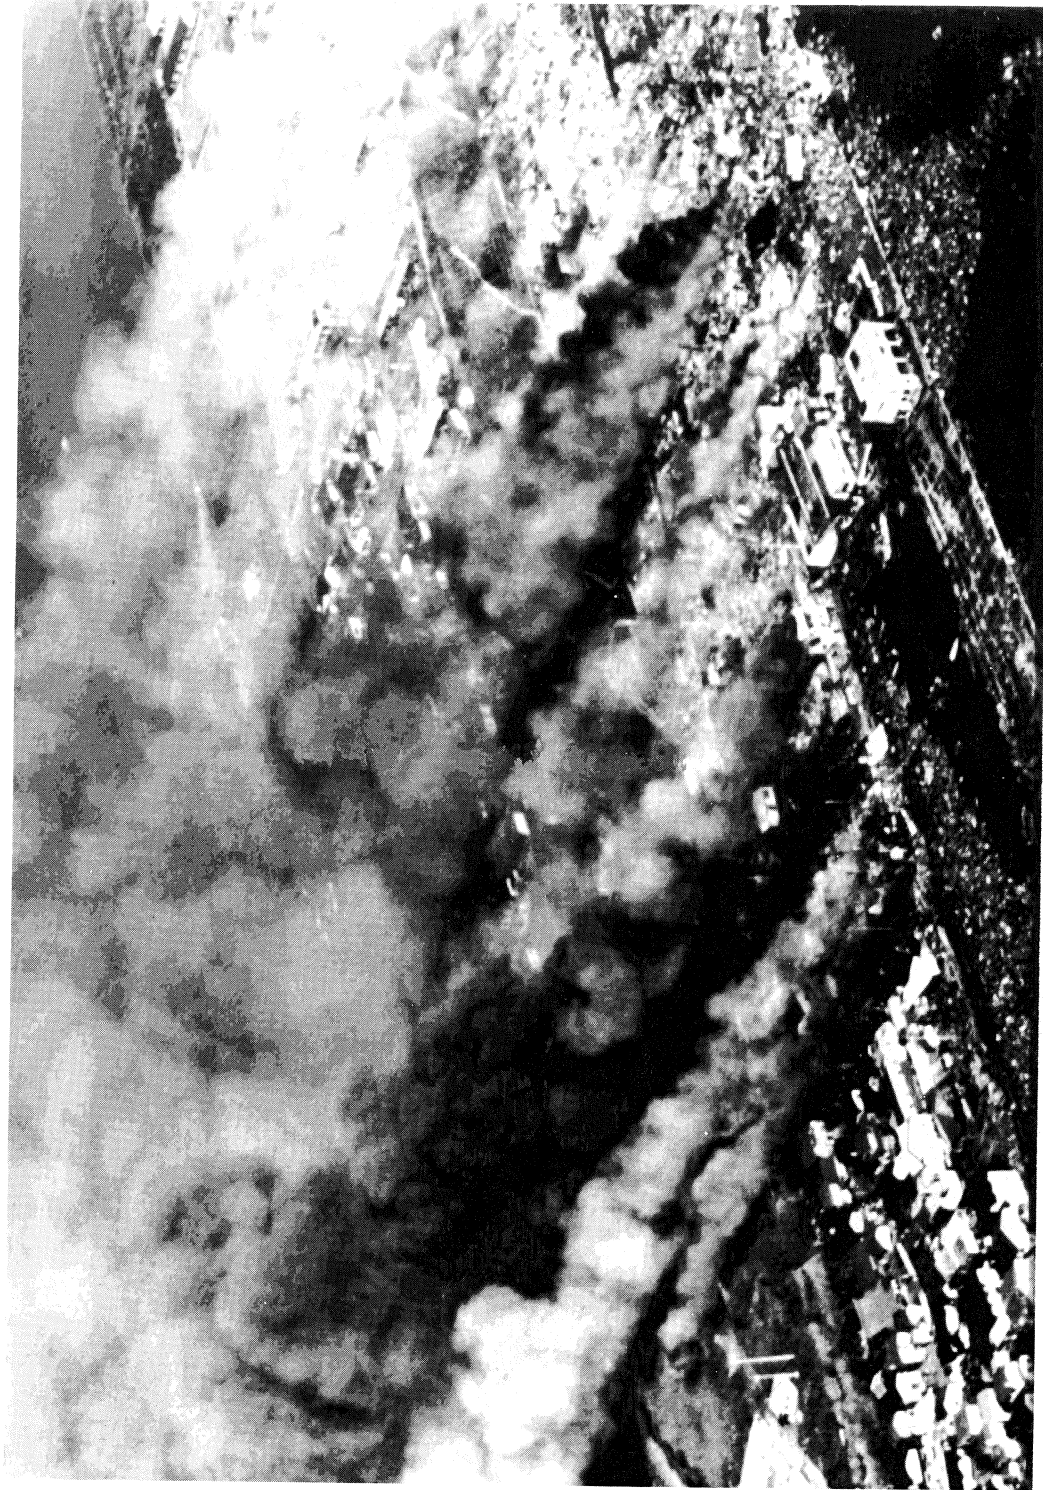
Figure 7-2: A view of Aonae and remains of the fire on the morning following the earthquake. The building from the previous photograph can be seen in the lower right corner.

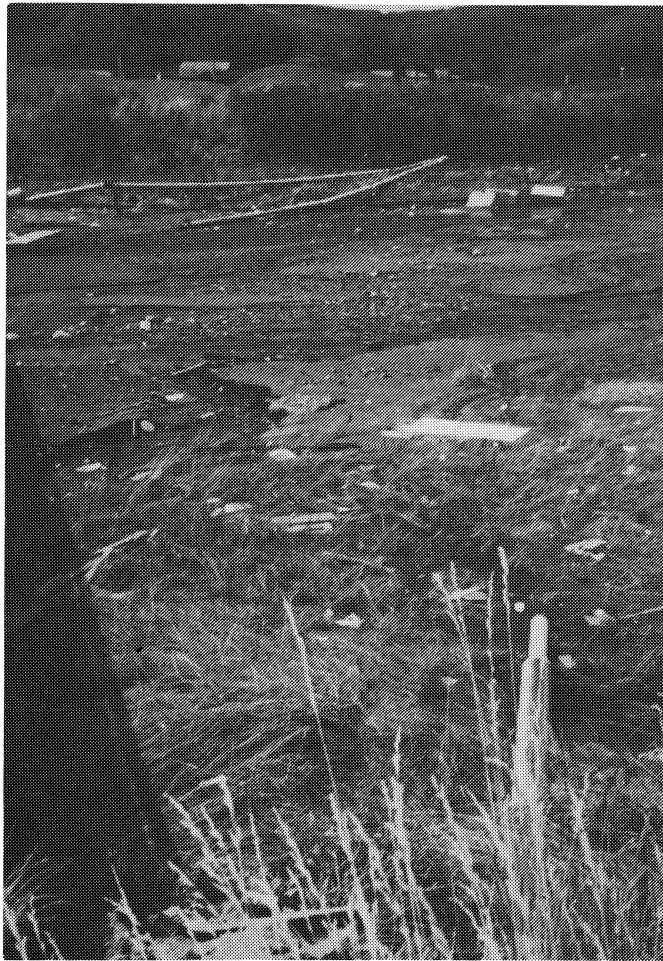
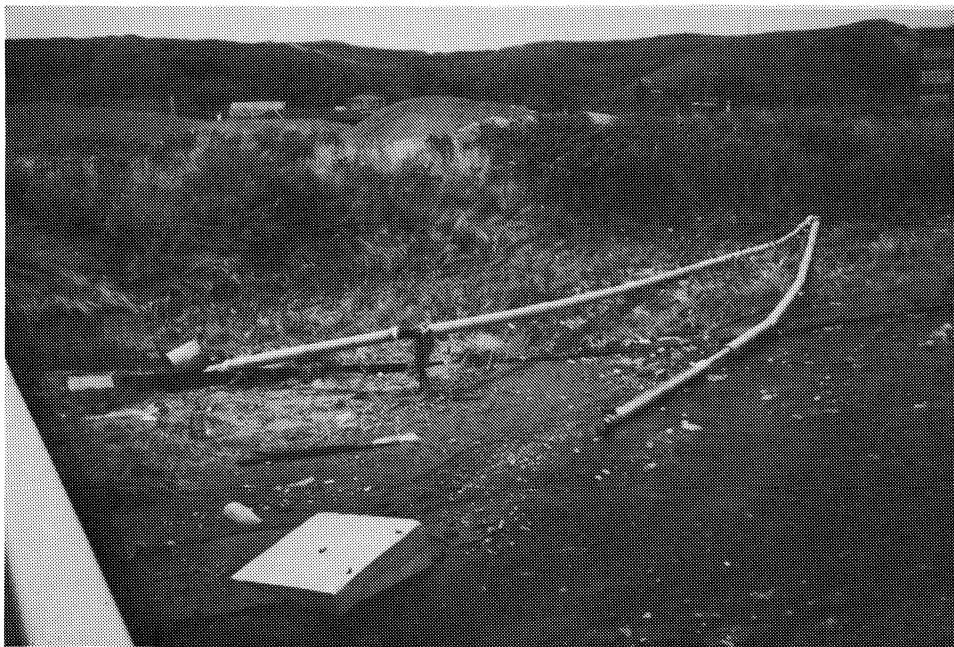
station. Within a few minutes following the earthquake, the tsunami swept through the lower area wrecking many buildings and scattering debris over a wide area. The tsunami also destroyed the main water line at its attachment point near a bridge (Figure 7-3). At approximately 10:40 P.M. the fire department received a citizen alarm of a fire in the lower area. A brigade of 10 men immediately responded and attempted to reach the fire by driving down the main street but found the street blocked by debris. They then returned to the top of the bluff and took a second route down the southern part of the bluff.

Figure 7-3: The main water line for Aonae was destroyed by the tsunami. This shows views from a bridge of portions of the approximately 20-cm line.

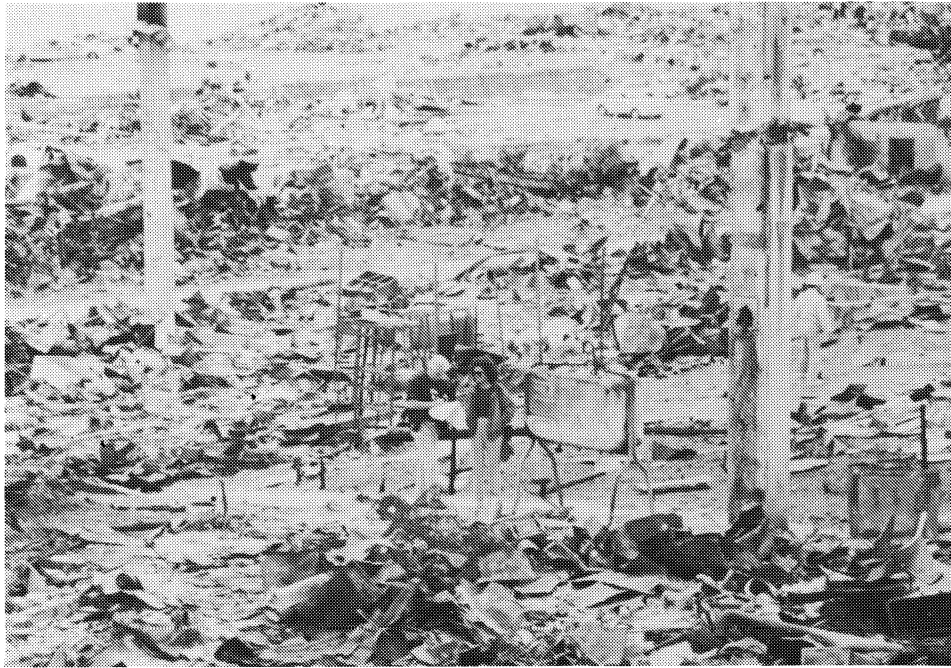
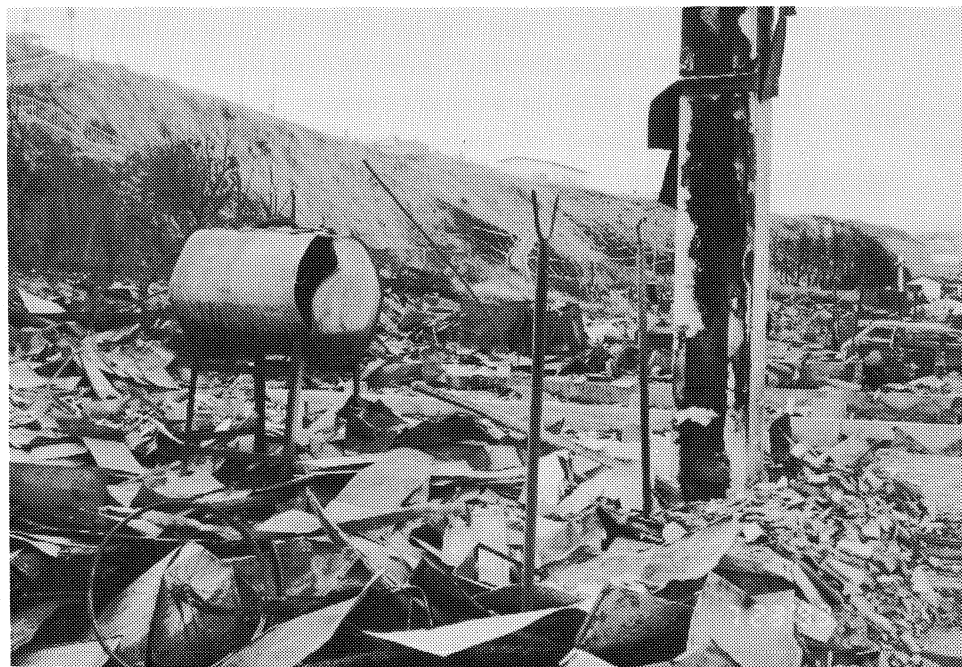
Figure 7-6: A view of a small part of the burned out area of Aonae (top photograph). Note the standing kerosene tank. These and other such tanks, containing fuels, added much fuel to the fire. The vertical columns are chimneys (of wood-frame buildings), which survived the earthquake, tsunami, and fire. Note that the roads have been cleared of debris. The lower photograph shows an exploded kerosene tank.

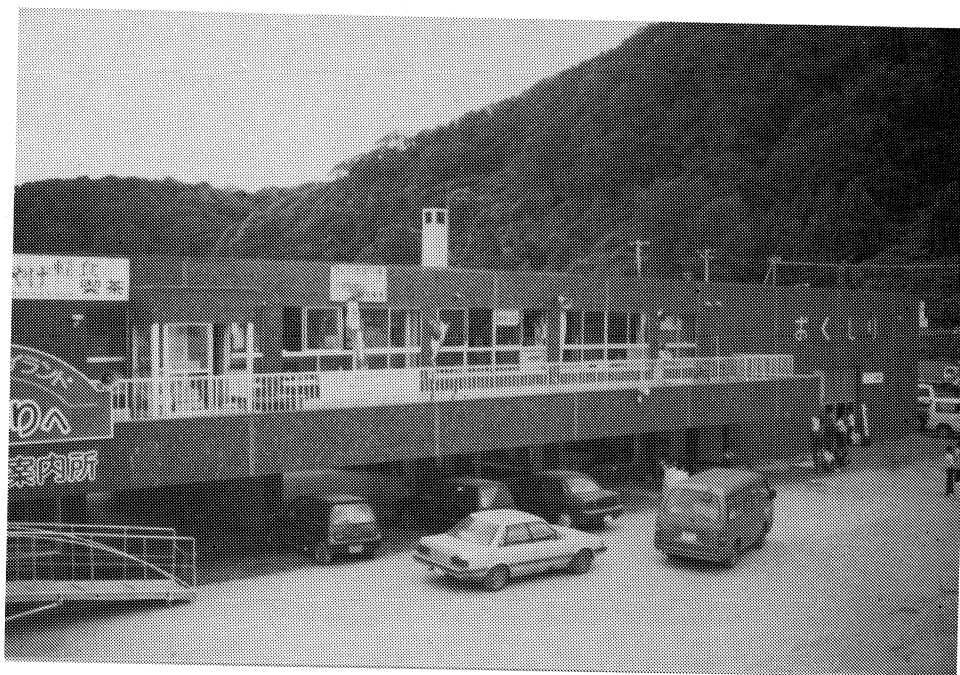
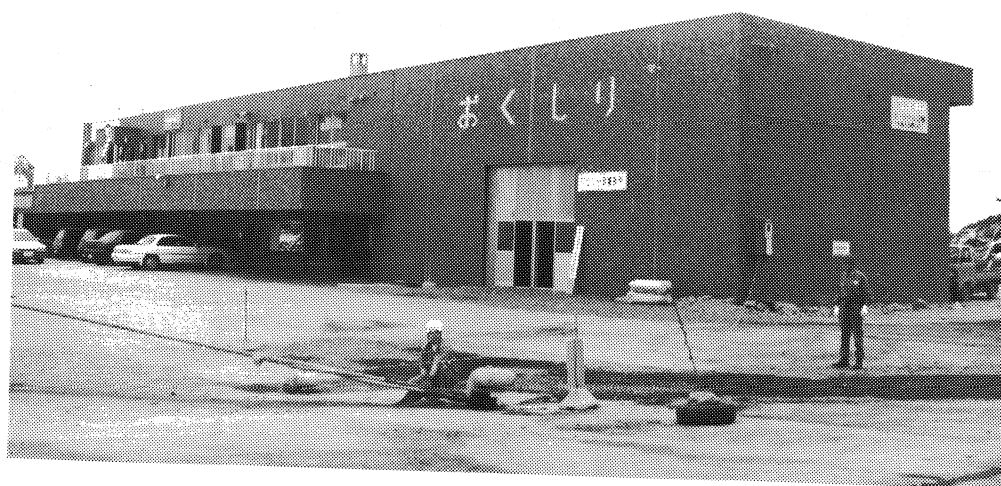
Specific buildings of note in Okushiri-cho included the Ferry Building, a two-story reinforced concrete frame with relatively large, approximately 40-cm columns. Located on the main pier, the building's first story was inundated by the tsunami (Figure 8-3), which swept away large glass windows and all interior furnishings. The building sustained settlement of one column on the south side, resulting in shear cracking of beams, but was otherwise structurally undamaged, with the second floor relatively undisturbed. The City Offices (Figure 8-4) are a two-story, stuccoed, wood-frame building, probably built in the 1950s and located approximately 1 km from the shore, up a river valley on apparently firm soils. There was no observable structural damage to

Figure 8-3: The reinforced concrete-frame Ferry Building in Okushiri. The ground-floor finishes were extensively damaged by the tsunami. The building had some damage due to local settlement in one corner.

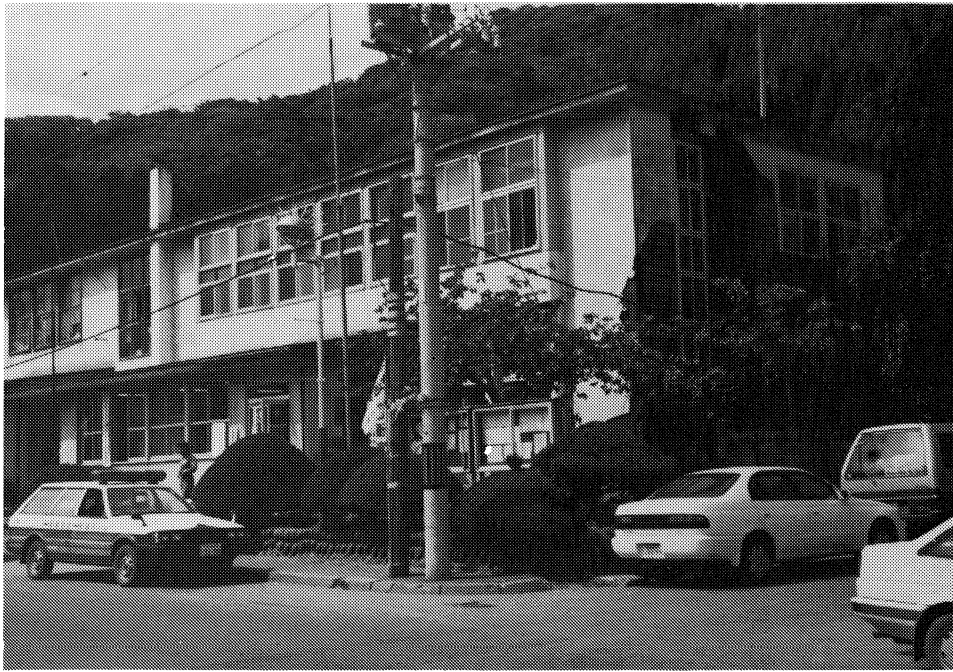
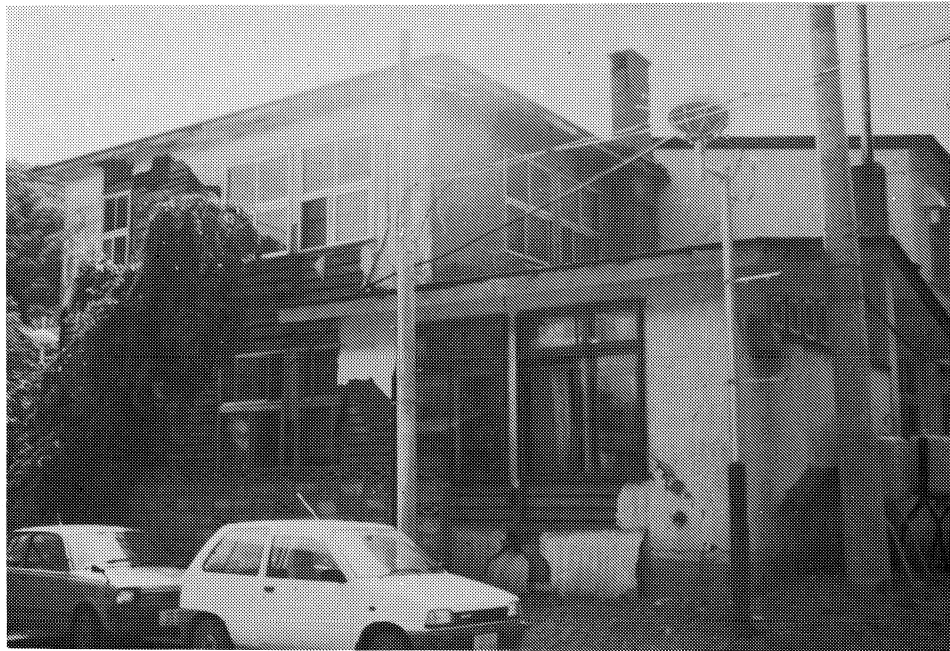
Figure 8-4: The light wood-frame and stucco City Offices Building in Okushiri-cho (upper photograph) and a smaller building (lower photograph) suffered extensive damage to their stucco facades but not major structural damage. These rather flimsily built structures suffered probably as much damage from shaking as any building observed in the town.

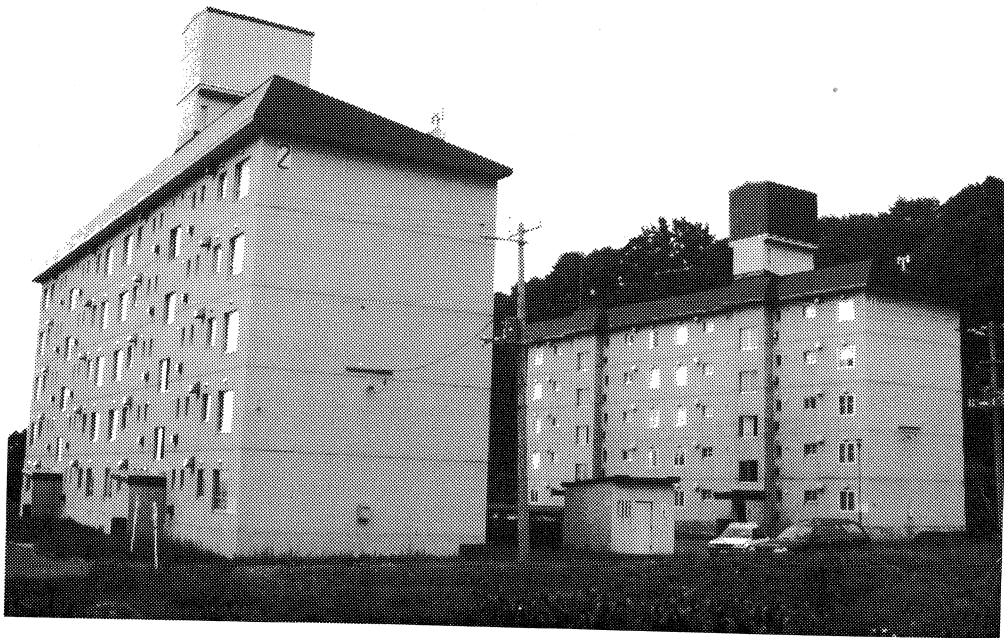
Figure 8-6: Undamaged five-story reinforced concrete shear wall apartment buildings in the outskirts of Okushiri-cho. Minor settlement of fill around the buildings was observed. Several large landslides in steep terrain were visible from the buildings.
