# Hokkaido Nansei-oki, Japan Earthquake of July 12, 1993

P.I. Yanev and C.R. Scawthorn

Technical Report NCEER-93-0023

December 23, 1993

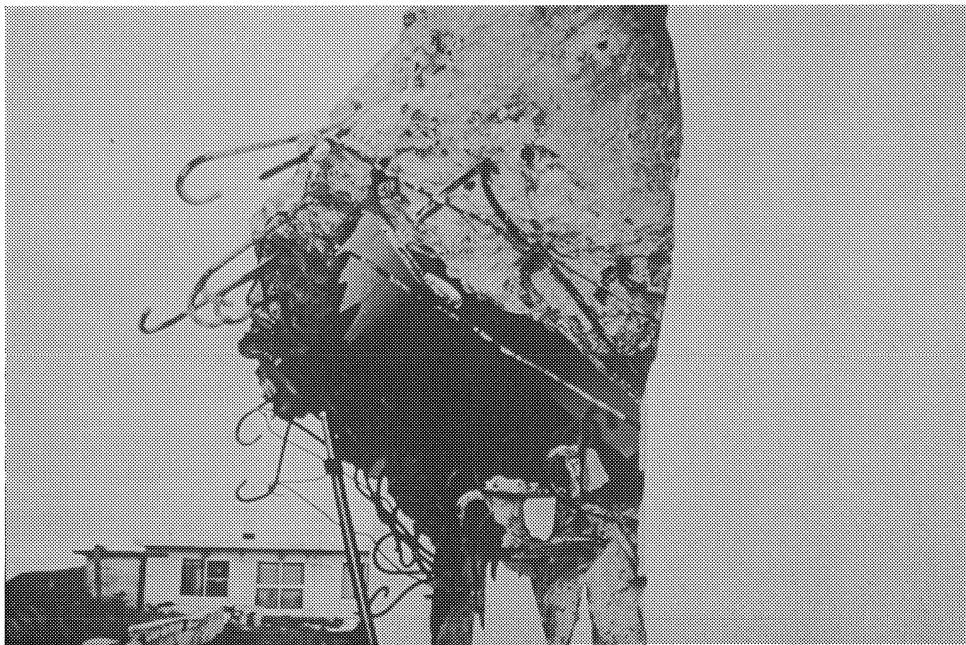
Figure 8-7: The Aonae lighthouse collapsed during the earthquake. The failure was caused by fracture of the tower structure at the base, along with pull-out of reinforcing steel dowels from the foundation. The inspection indicated an apparent bond failure of plain J anchorage bars (approximately 24 mm in diameter).

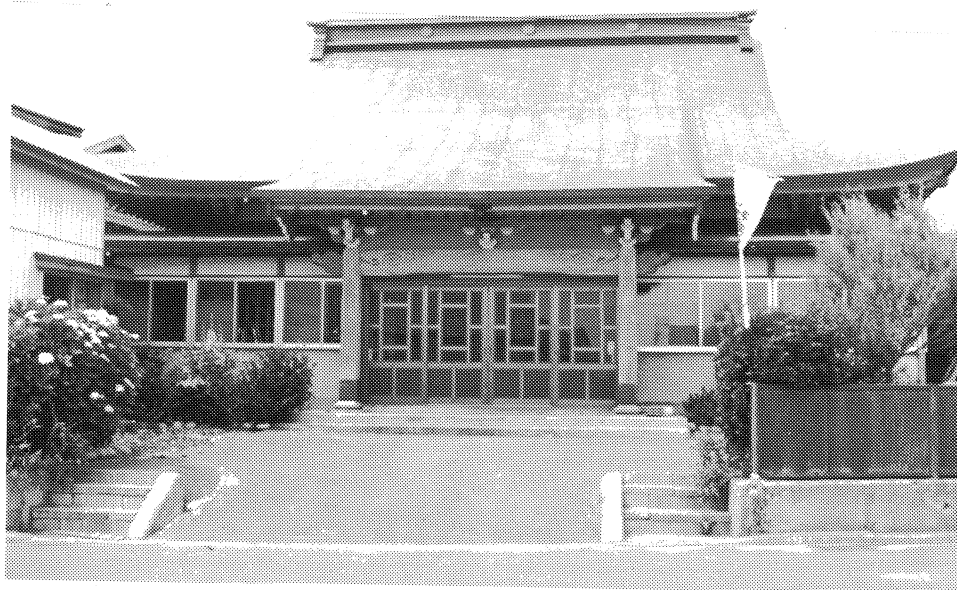
Figure 8-8: A practically undamaged temple building, which was not affected by the fire and the tsunami. This is probably structurally one of the weakest wood-frame buildings in Aonae, indicating that the intensity of the ground motion on rock or stiff soils was not high in the central port area. The temple is located below the Aonae lighthouse.

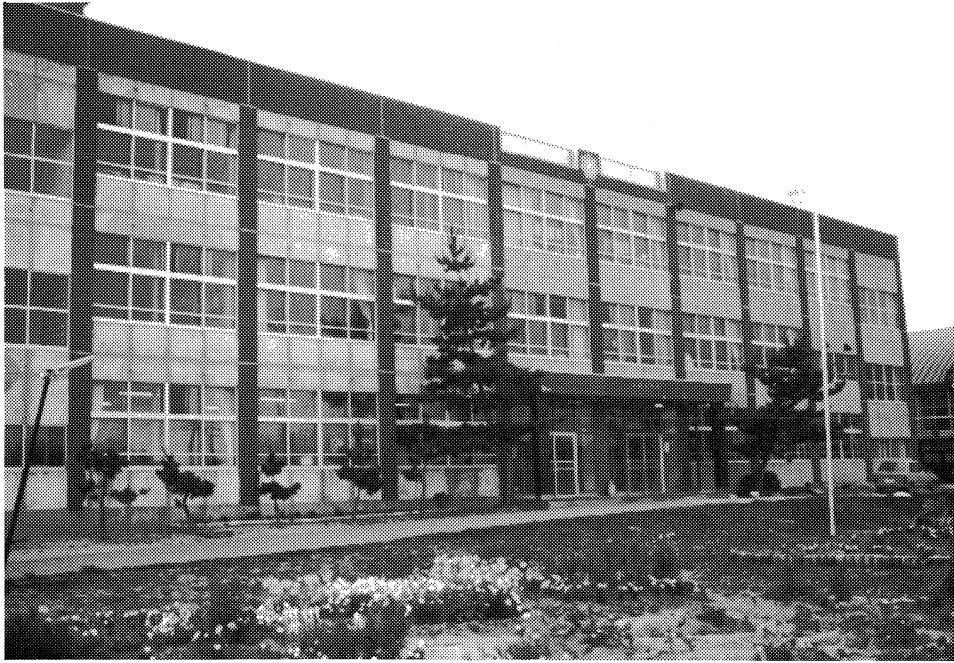
Figure 8-9: Aonae Elementary School, a typical 1950s through early 1970s nonductile concrete-frame building (preceding the lessons learned from the 1971 San Fernando, California, Earthquake). The school, on level ground at sea level, suffered extensive cracking of frame and concrete-block infill-wall elements. These types of buildings have historically suffered extensive damage in Japan (Sendai Earthquake of 1978) and California in 1971, 1979, 1989, etc.). Extensive strengthening of these kinds of buildings has been carried out for all California public schools of similar construction.

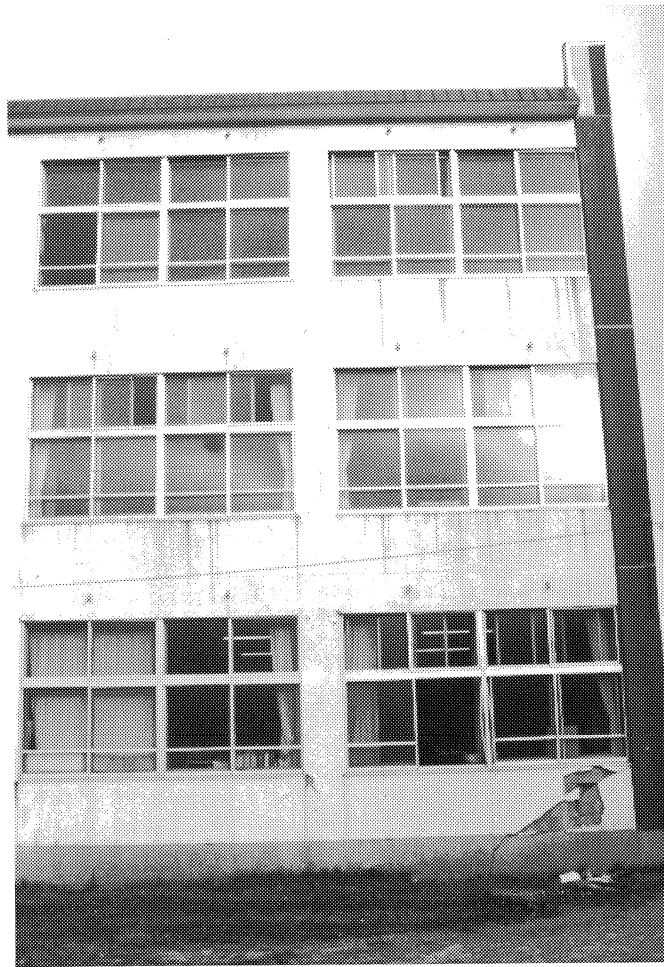
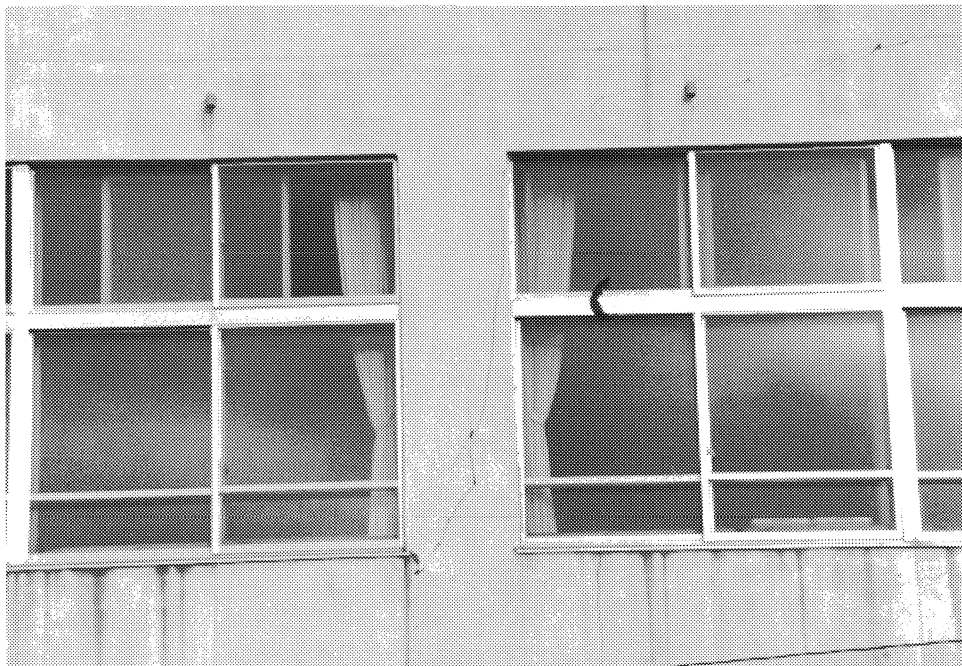
Figure 8-11: The damaged west facade of the Aonae Elementary School. Spandrel and other infill wall cracking has propagated into the columns.

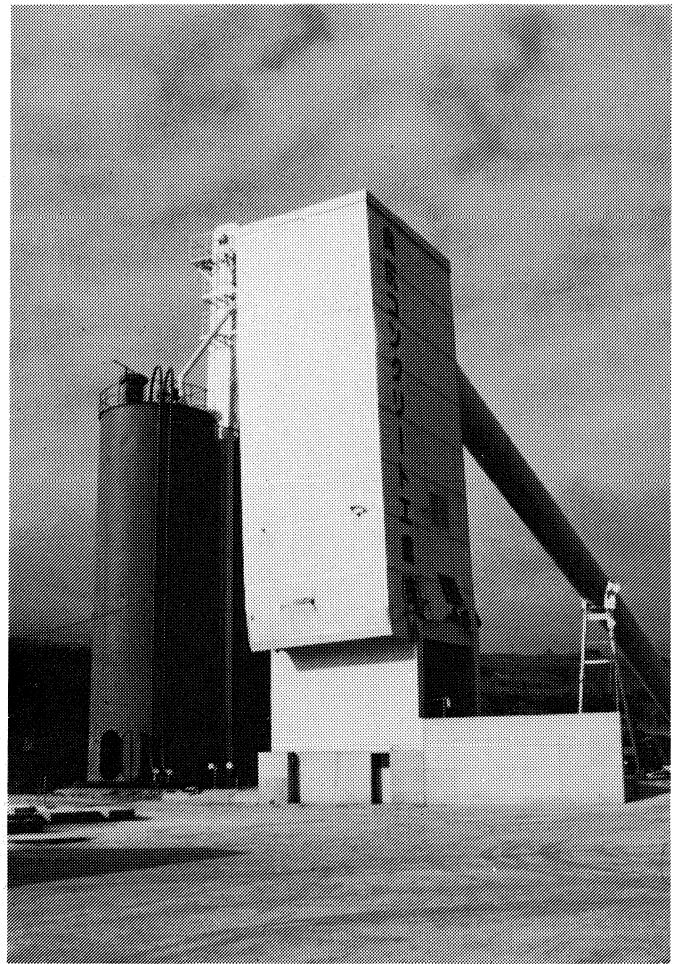
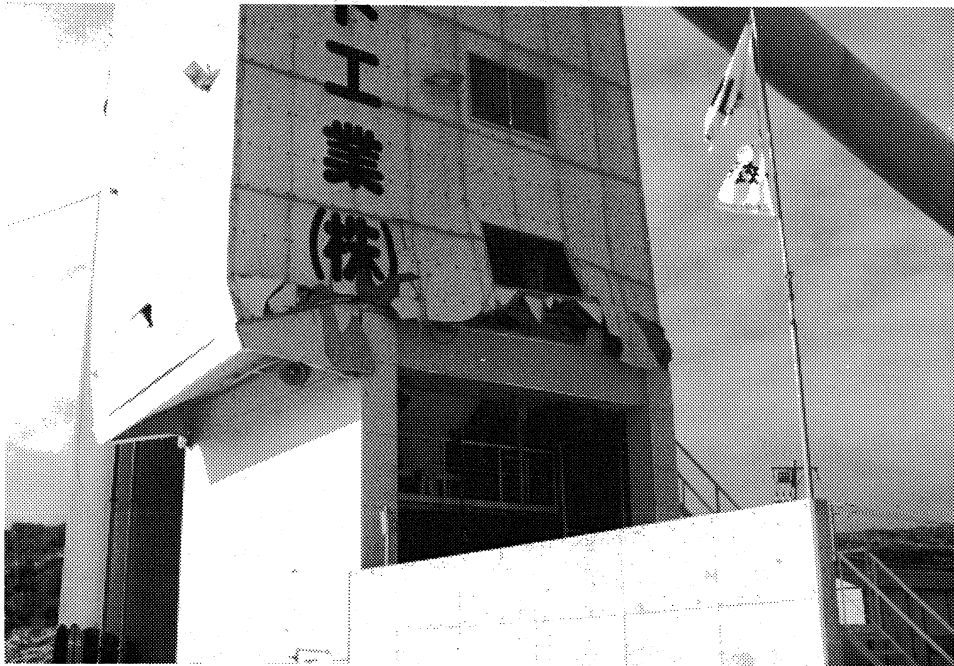
Figure 8-14: OCBP; close-up of the steel-frame hopper superstructure that buckled. The ground-level columns appeared undamaged. Note that the superstructure has dropped about 50 cm.

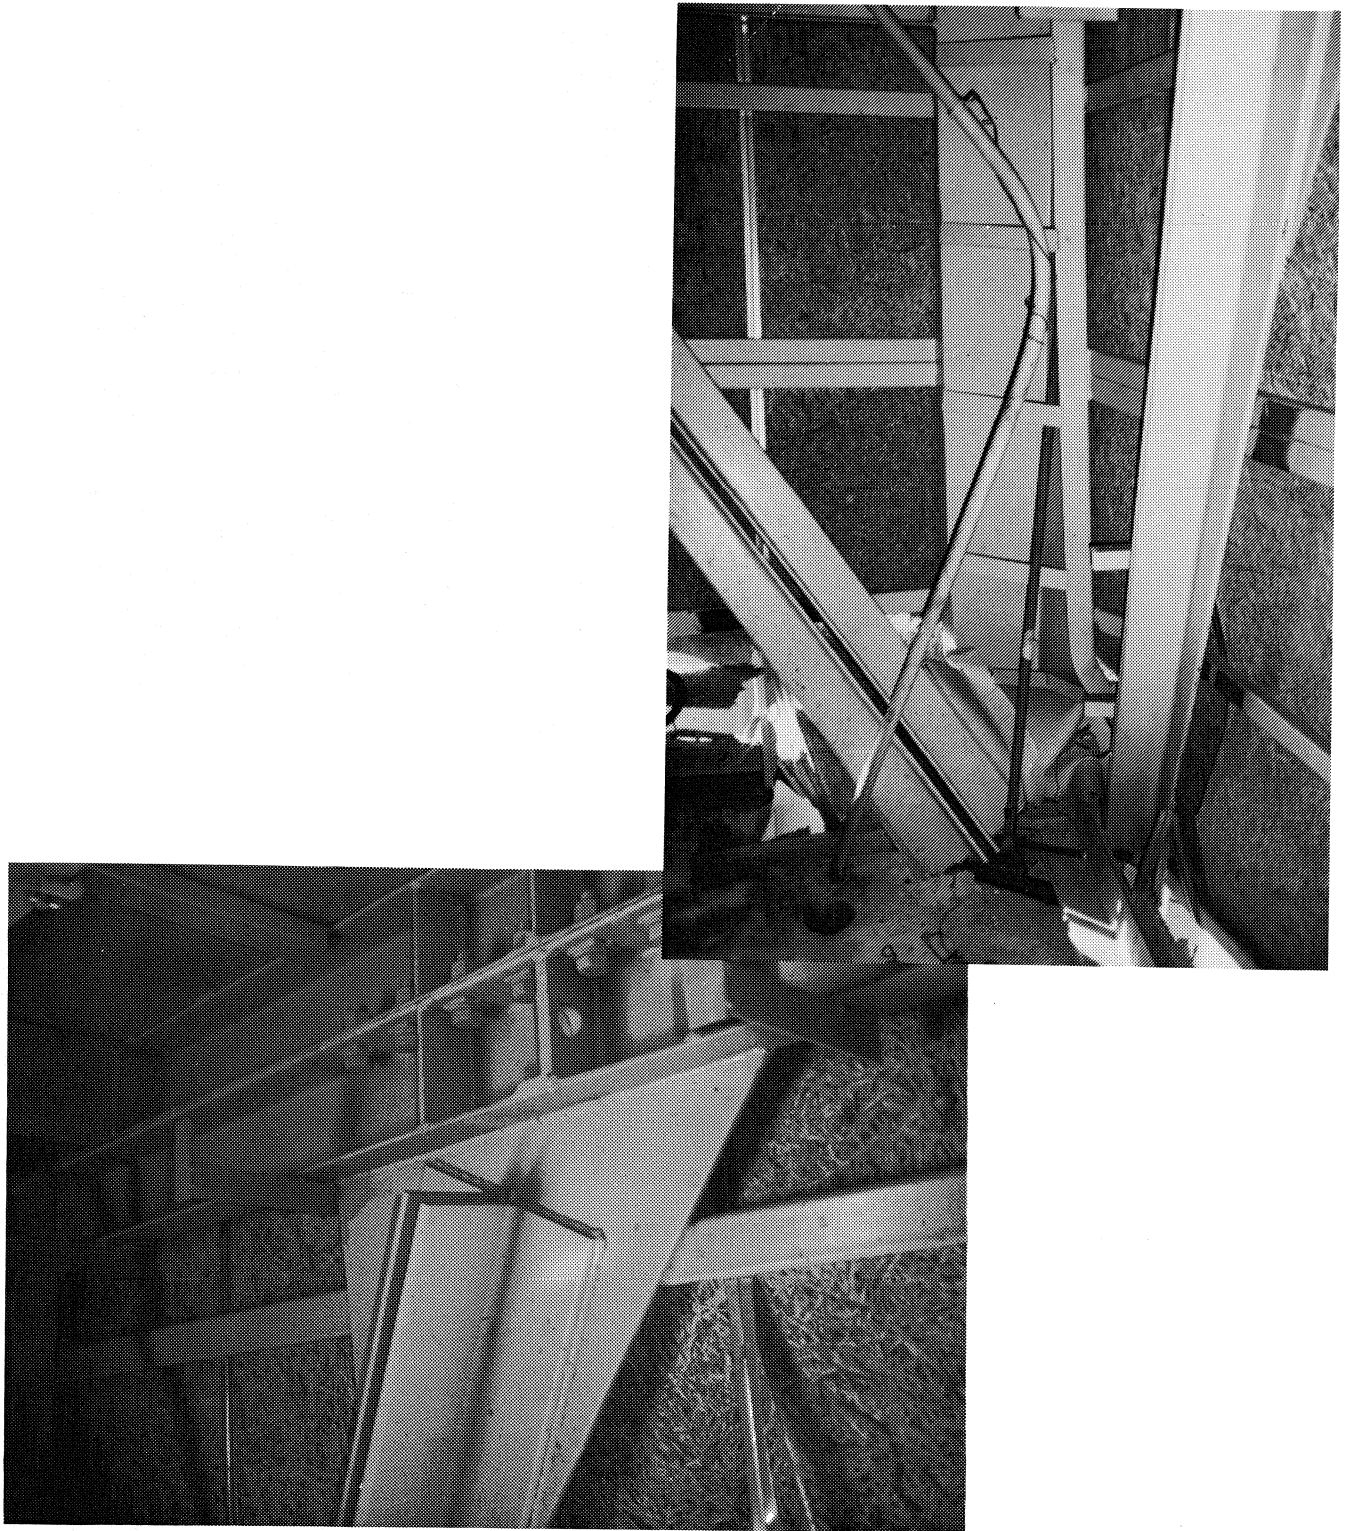
Figure 8-15: Interior view (upper photograph) of one of the four columns of the superstructure of the hopper at OCBP. The cold-formed corner thin-plate column has buckled and shortened by about 50 cm. Note that the seismic diagonal braces are undamaged. The hot-rolled angle diagonal steel braces are much heavier than the corner columns (about twice as thick). In effect, the designer designed against large earthquakes (lateral forces) but neglected to detail properly the vertical system. The lower photograph shows the well-detailed and undamaged brace connection.

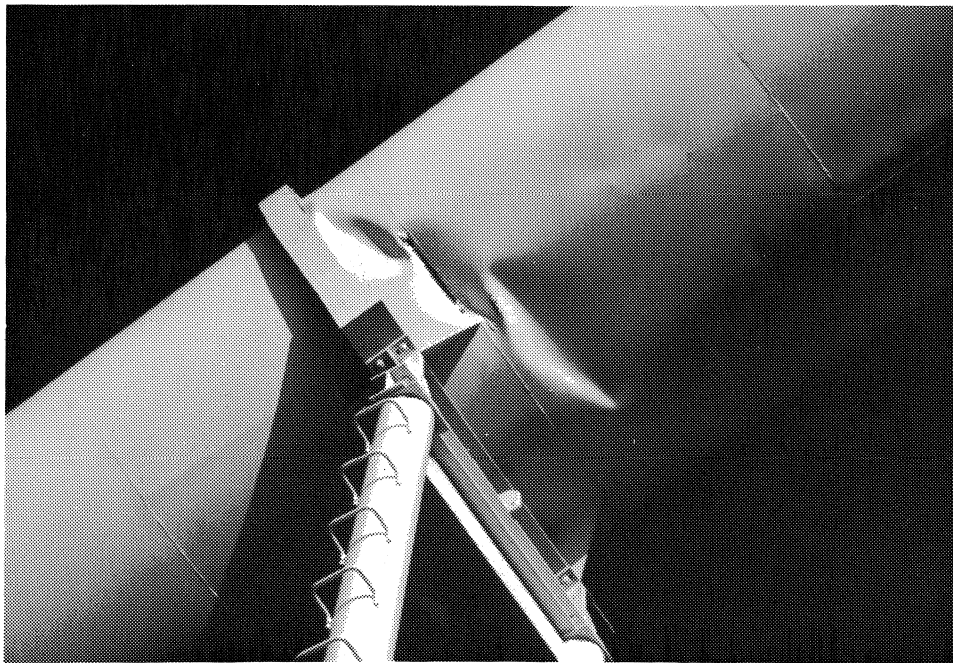
Figure 8-16: OCBP; damage to the large-bore hopper ducting due to differential displacements at its supports—caused by the buckling and shortening of the hopper structure.

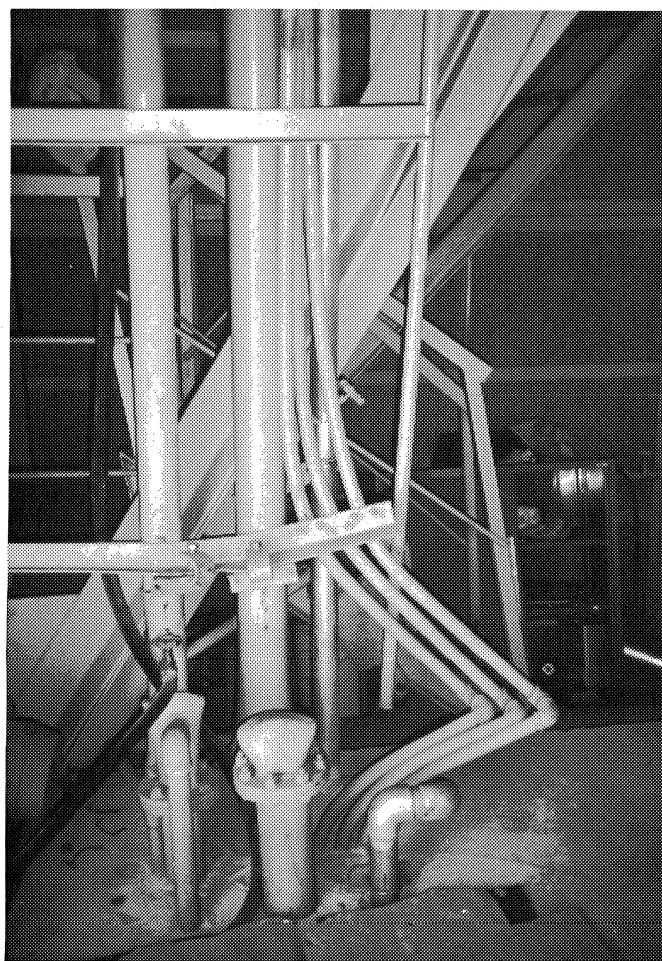
Figure 8-17: OCBP; buckled small-bore piping on the second floor of the partially collapsed hopper structure. The piping has been compressed on the order of 50 cm; some of this compression is taken through the piping floor penetration. Note the large ductility of threaded steel piping when the couplings do not pull apart.

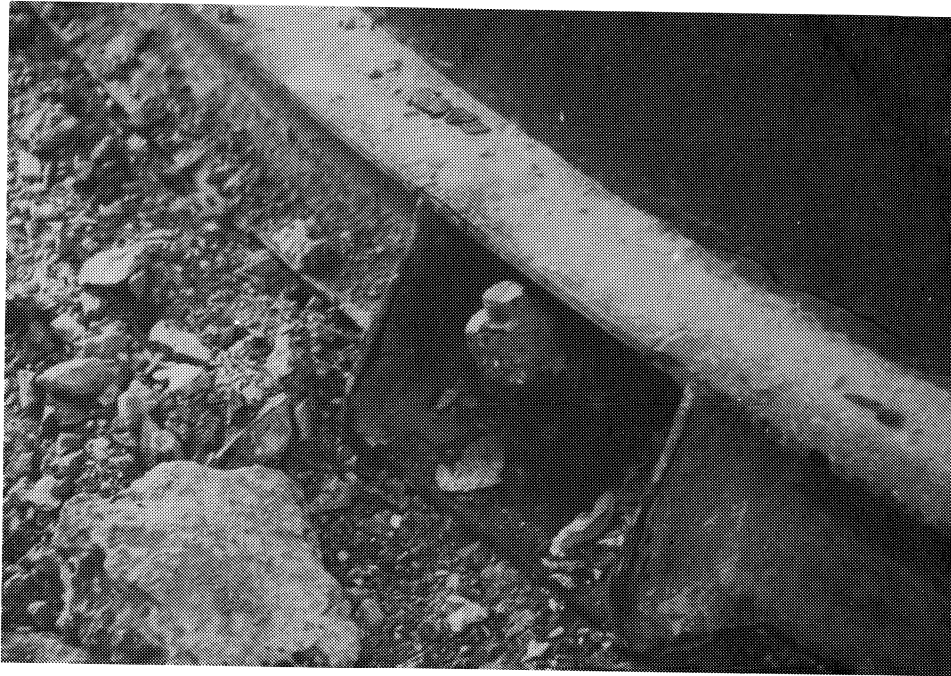
Figure 8-18: OCBP; typical anchorage damage to the two steel silos at the plant. The anchors are somewhat corroded.

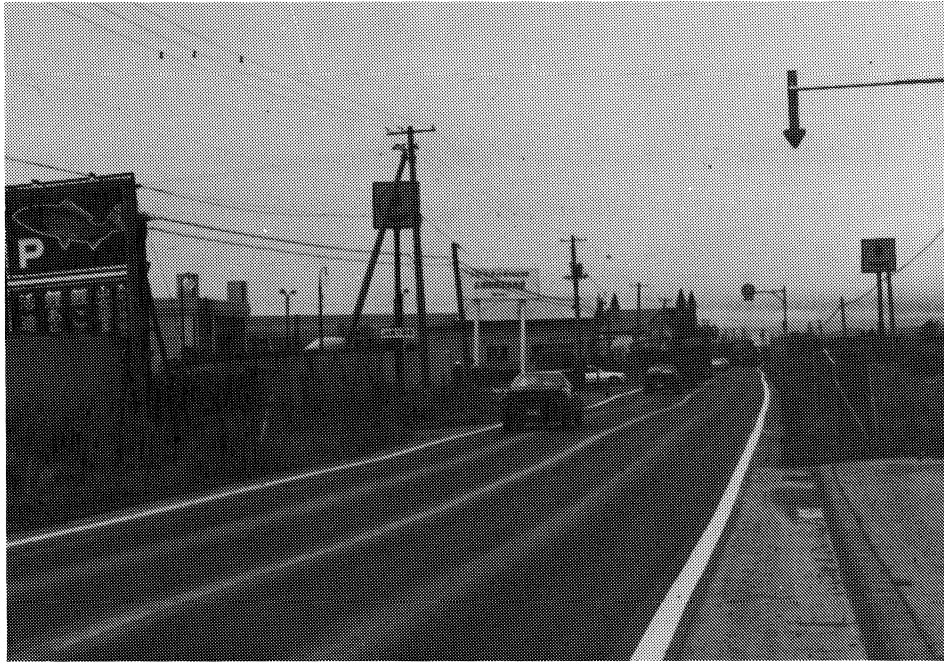
In general, highway performance was very good, with most damage to pavements due to general ground settlement, settlement at approaches to bridge abutments, etc. Repairs were ongoing 10 days after the earthquake, with a large number already accomplished. Lateral spreading and settlement affected many primary roads in Hokkaido, up to about 90 km from the faulting. Some of the many locations of more extensive damage are shown in Figure 3-3. The coastal stretch of National Highway 5 south of Oshamanbe, for example, was damaged at many locations, including long stretches of embankment near sea-level elevations (Figure 9-1). Typically, the fill of the embankment spread laterally, destroying the asphalt roadway. Most of these types of

Figure 9-1: Typical damage to roads, at Highway 5 south of Oshamanbe, from liquefaction and/or lateral spreading. Many of the coastal stretches of the road had a roller-coaster appearance following the earthquake.

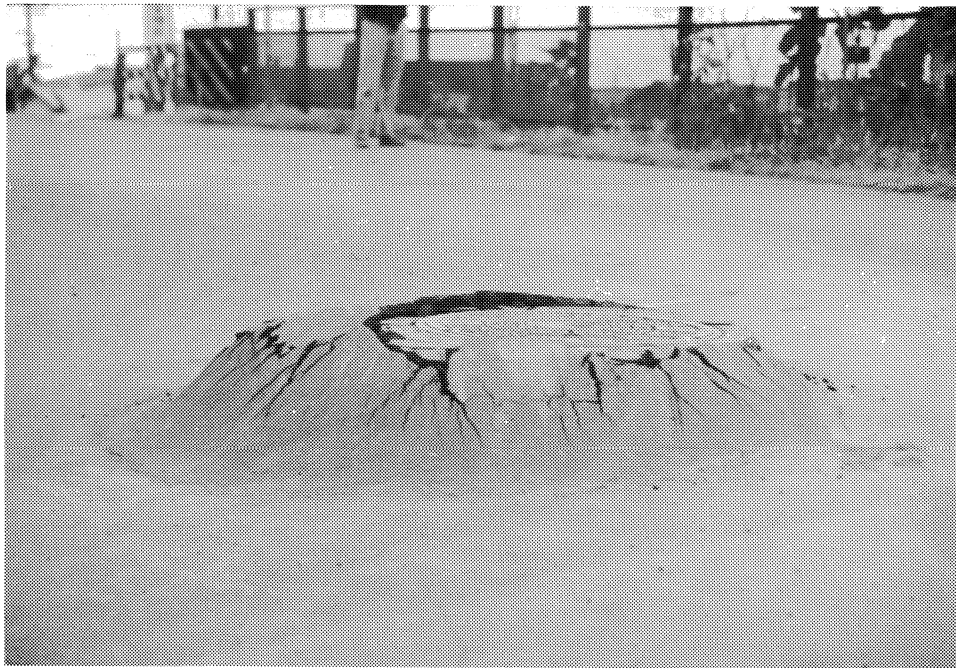
Damage from liquefaction was continuing to occur to roads in the area. Figure 9-6 shows an example of damage from buoyant underground structures that was occurring about 10 to 12 days after the earthquake as the softer soils continued to settle.

Figure 9-6: Manhole pushed up in Oshamanbe area from settlement. This 30+ cm settlement occurred mostly about 10 to 12 days after the earthquake and was continuing to increase.

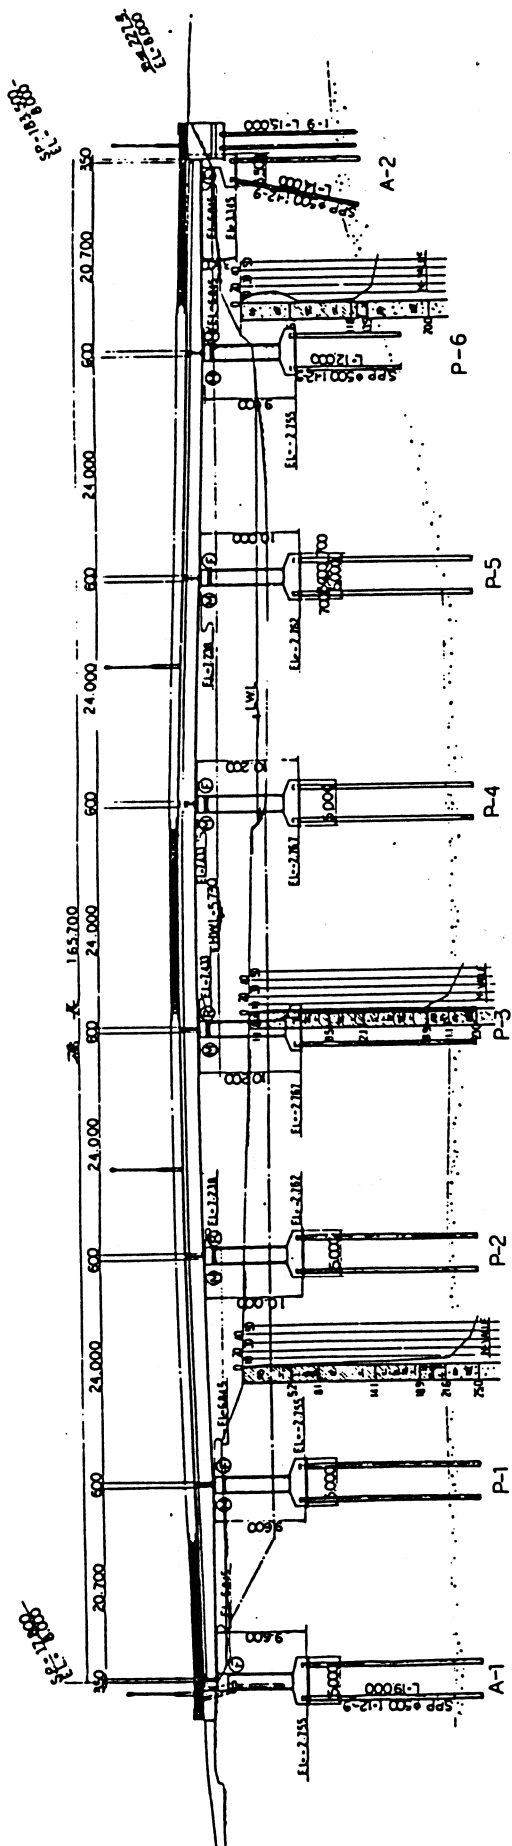
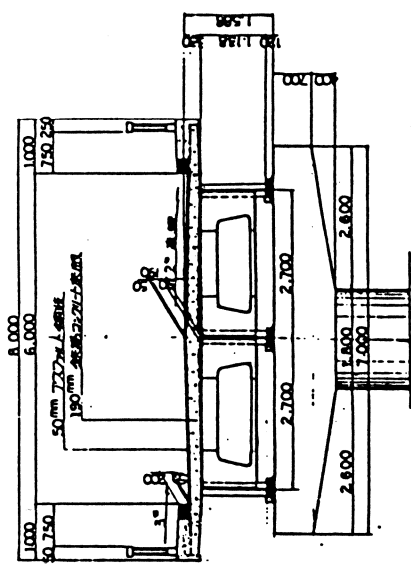
図-4.4 基梁橋の一般図

The most heavily damaged bridge observed was a six-span, two-lane, 1970-vintage steel plate girder highway bridge over the Azabu River, at Azabu-cho (length about 166 m, width 8.0 m), Figures 9-9 to 9-14. Lateral spreading was observed on the south bank of the bridge, which did not, however, appear to affect the superstructure. Significant cracking was observed just above the waterline at the 1.75-m-diameter reinforced concrete bridge piers founded in the river, with the northernmost in-river pier having significant spalling and broken hoop reinforcement.

Figure 9-9: A six span, two-lane, 156-m-long, 1970 steel plate girder bridge at Azabu on Highway 277. The bridge suffered severe shear damage to all visible columns, which are about 2 m in diameter. The bridge is located about 70 km from the eastern edge of the aftershock zone. No significant damage to the superstructure was observed. The following figure shows drawings of the bridge.

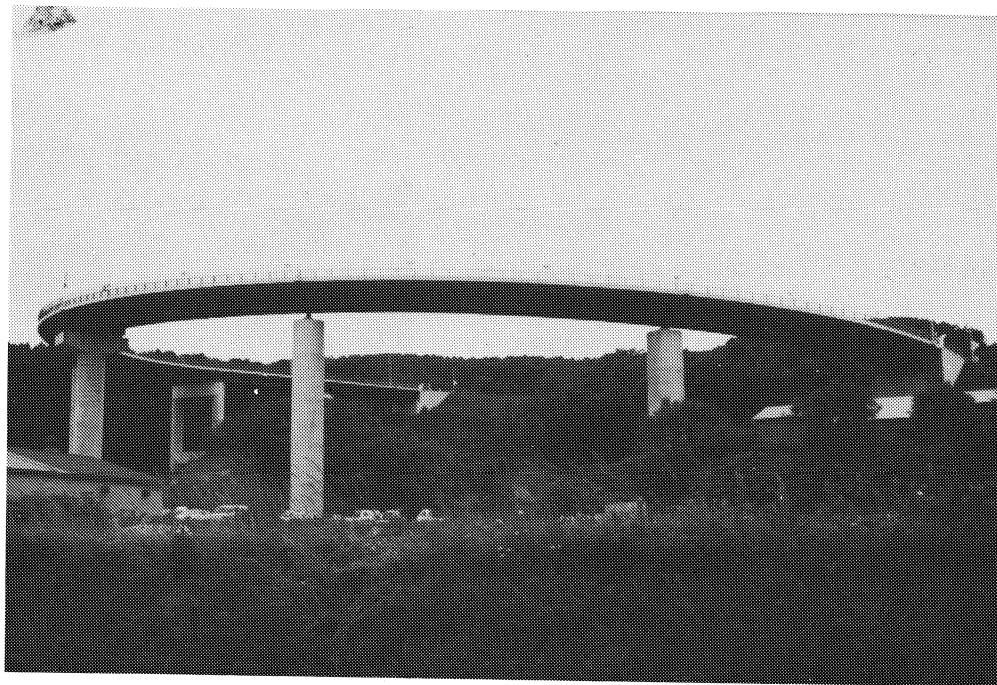
Figure 9-15: An undamaged curved bridge near Setana in Hokkaido, about 40 km from the eastern edge of the aftershock zone.

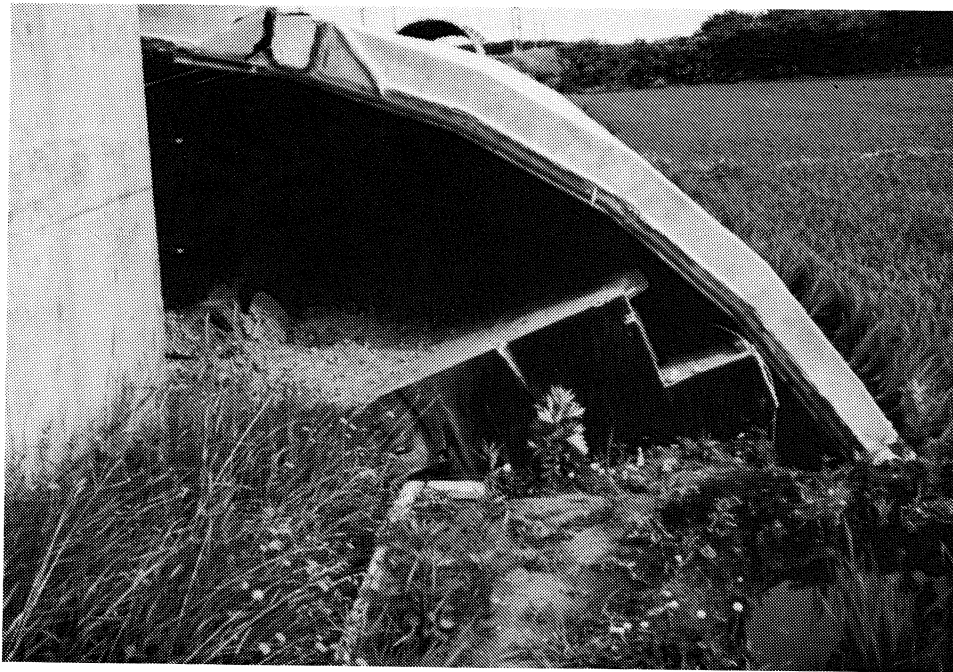
Figure 9-18: Failed east side of the snowshed. Lateral spreading of the fill and/or liquefaction caused spreading of the footings, rotation of the stem wall, and failure of the stem wall.

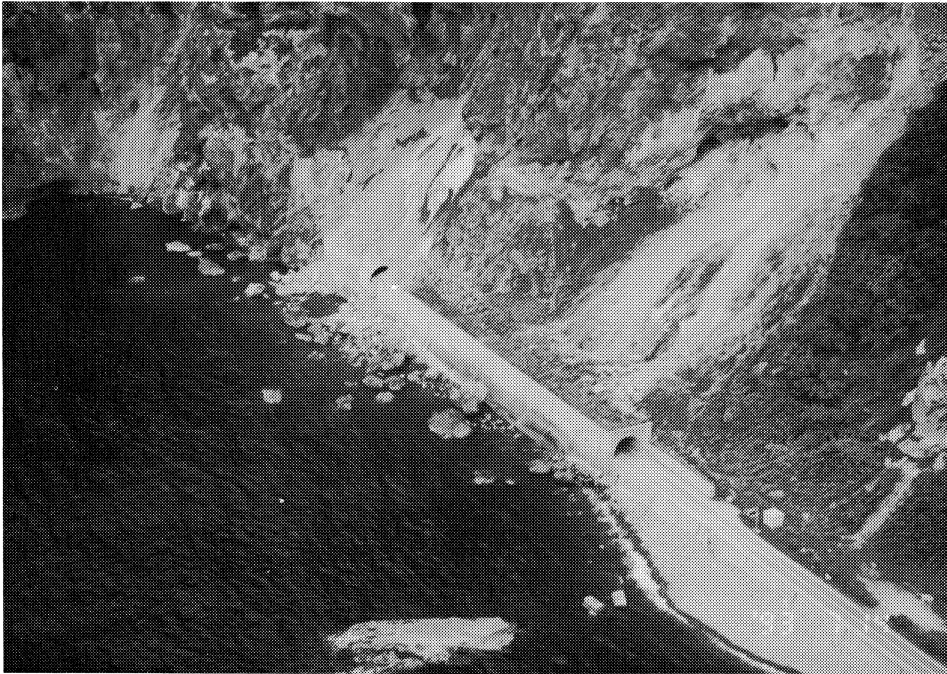
Figure 9-21: Collapsed Shiroito Tunnel north of Setana on Highway 229. Collapse was caused by a large rockfall from above. The tunnel was intended to protect the highway against rockfalls; this rockfall was bigger than designed for. Note that adjacent sections of the collapsed portion of the tunnel have been displaced. Photograph by K. Kawashima.

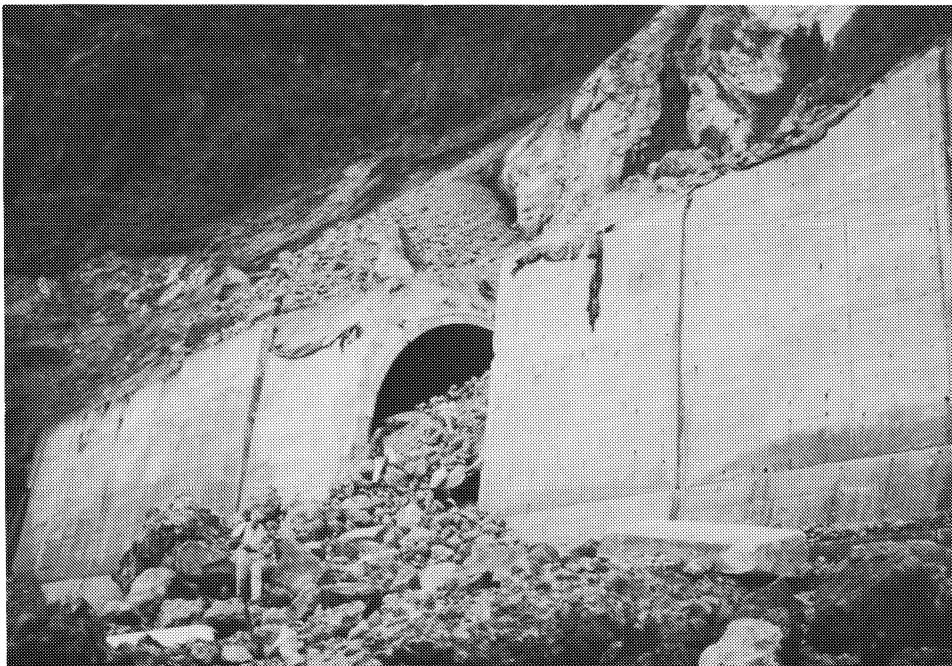
Figure 9-22: Close-up of the failed section of the Shiroito Tunnel.

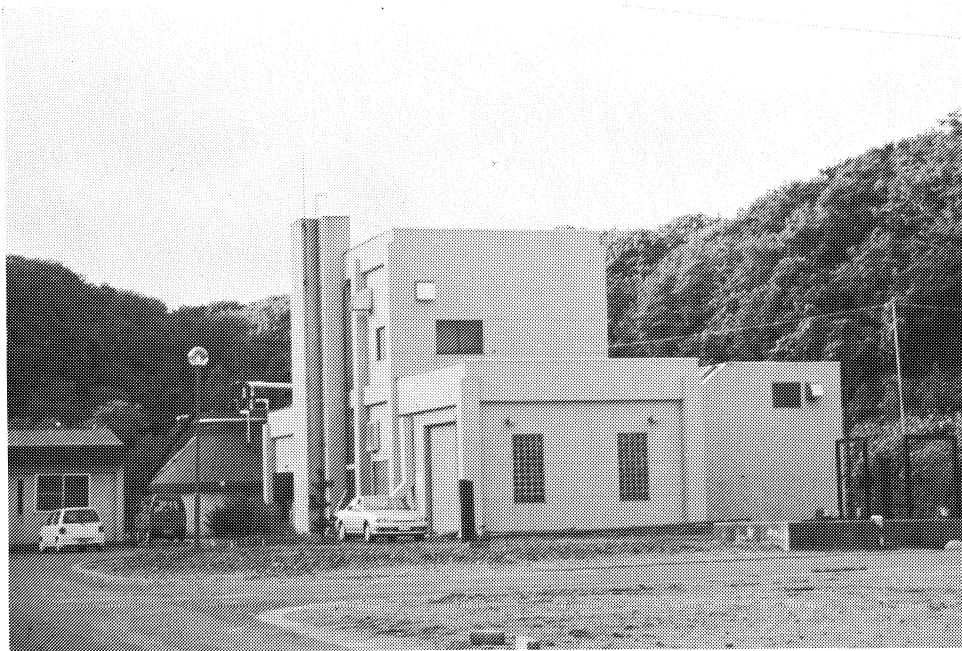
The plant is constructed on a level site, probably on sandy soils. Liquefaction was observed on the site and settlement of up to about 30 cm occurred around the structures. The settlement caused light structural damage and damage to surface paving and underground concrete pipeways or culverts (Figure 9-26). The buildings suffered moderate, repairable nonstructural damage from pounding between adjacent buildings and between buildings and the elevated digester tanks. The tanks and the stack were not damaged. Piping was not braced for seismic loads but appeared to have suffered no damage, with the exception of a large-diameter, short ducting pipe which spanned between two structures (a building and the tall stack) and buckled without rupturing. The buckling was caused by differential movements between the buildings, which compressed the pipe (Figure 9-27). Since it was not designed for such loads, it buckled. The main reported damage to equipment was the failure of a transformer, which was located on the second floor. The transformer, which was enclosed in a cabinet, toppled within the enclosure (Figure 9-28).

The sand dunes in front of the plant protected it from the tsunami. The run-up at the nearest buildings was only a few centimeters and caused no direct damage. However, the basement of the main structure, which contained pumps, piping, and some electrical panels, was flooded to a depth of about 1.25 m due to tsunami flooding via the outflow structure (piping) (Figure 9-29). That is, seawater entered the basement room by forcing its way through the outflow piping, a distance of more than 350 m. The flooding inundated pumps, motors, electrical control equipment, etc., incapacitating the plant for several weeks. Tsunami protection against such incidents can and should be provided for high-value facilities with outflow structures. That could be accomplished with one way valving or screens.

Figure 9-25: Aonae Sewage Treatment Plant (ASTP). The plant is located just north of the town, on soft soil and behind natural sand dunes, which prevented the tsunami from directly affecting the plant. The structures suffered light, easily repairable damage from settlement and pounding. Some unanchored equipment tipped over, but overall, the direct earthquake damage was small.

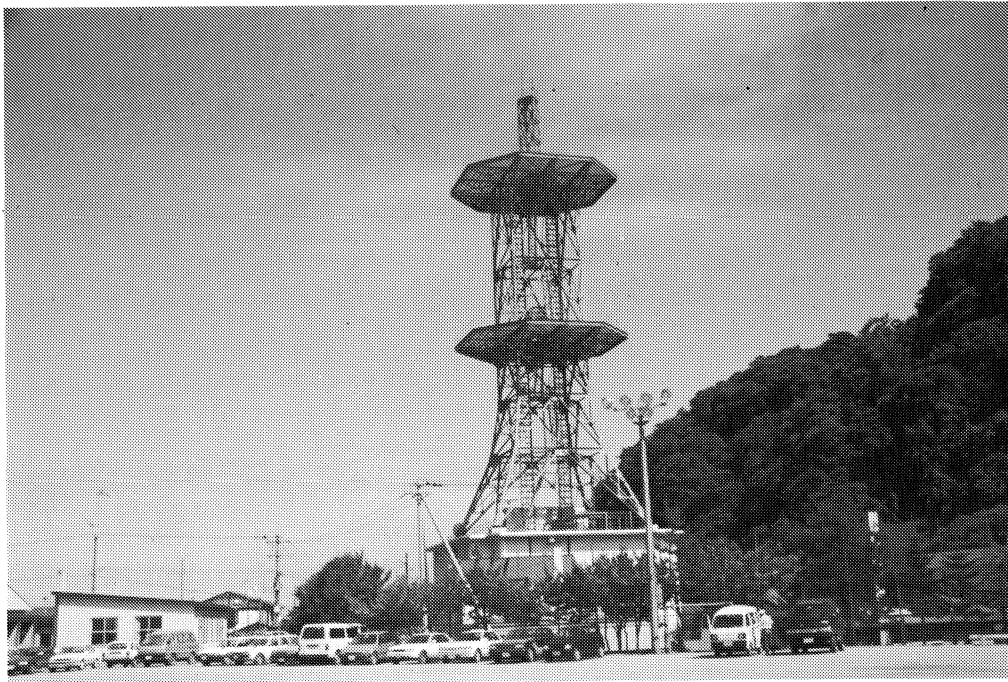
Figure 9-30: Okushiri-cho remote control switch building; this concrete shear wall building supports an approximately 40-m freestanding steel truss microwave tower.

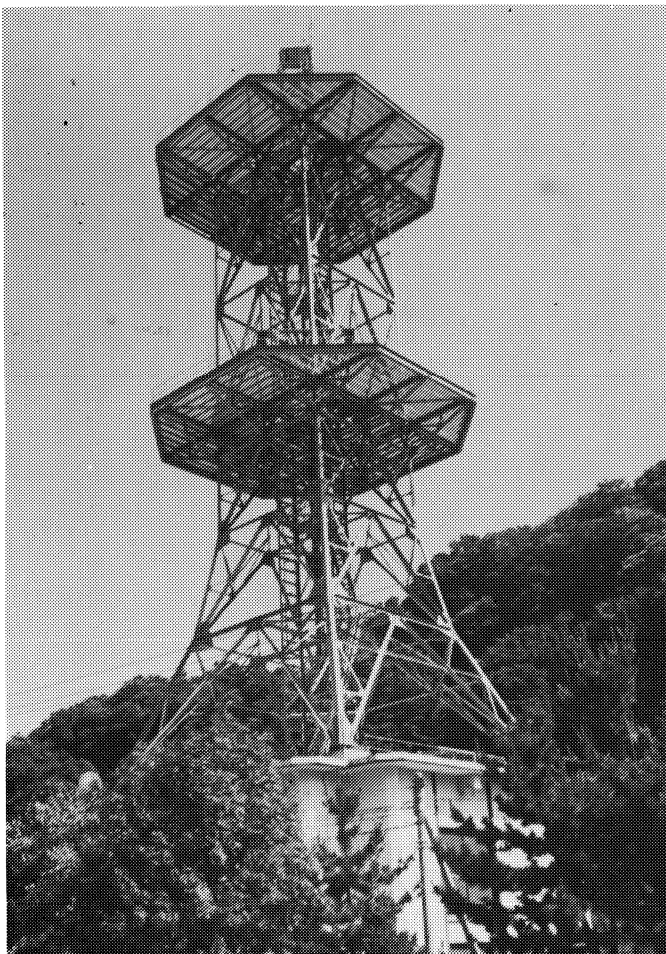
Figure 9-31: Okushiri-cho remote control switch building; close-up of the approximately 40-m freestanding steel truss microwave tower atop the building.

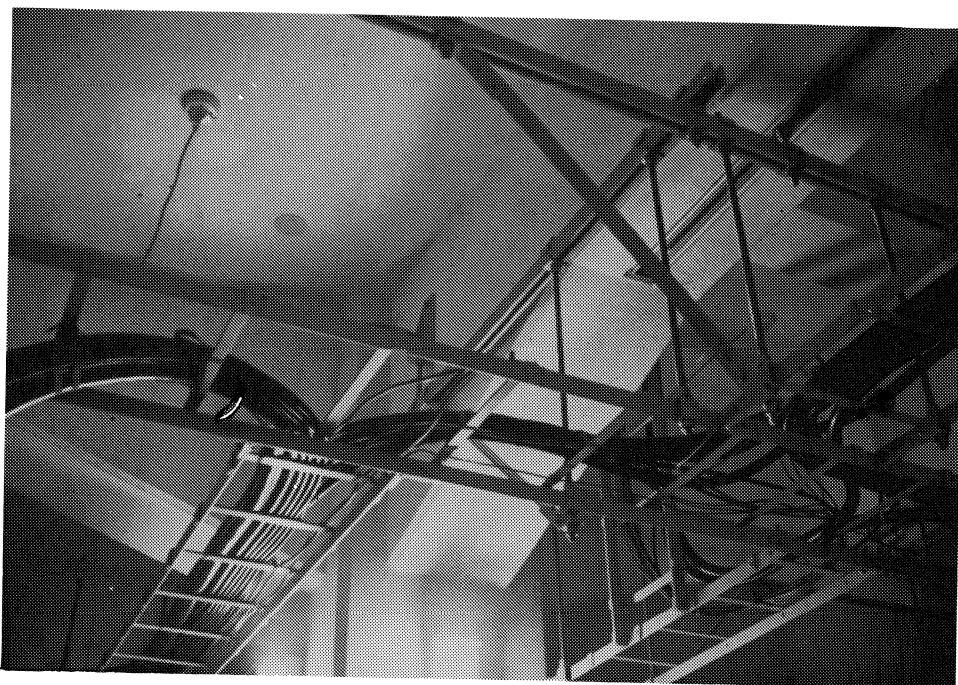
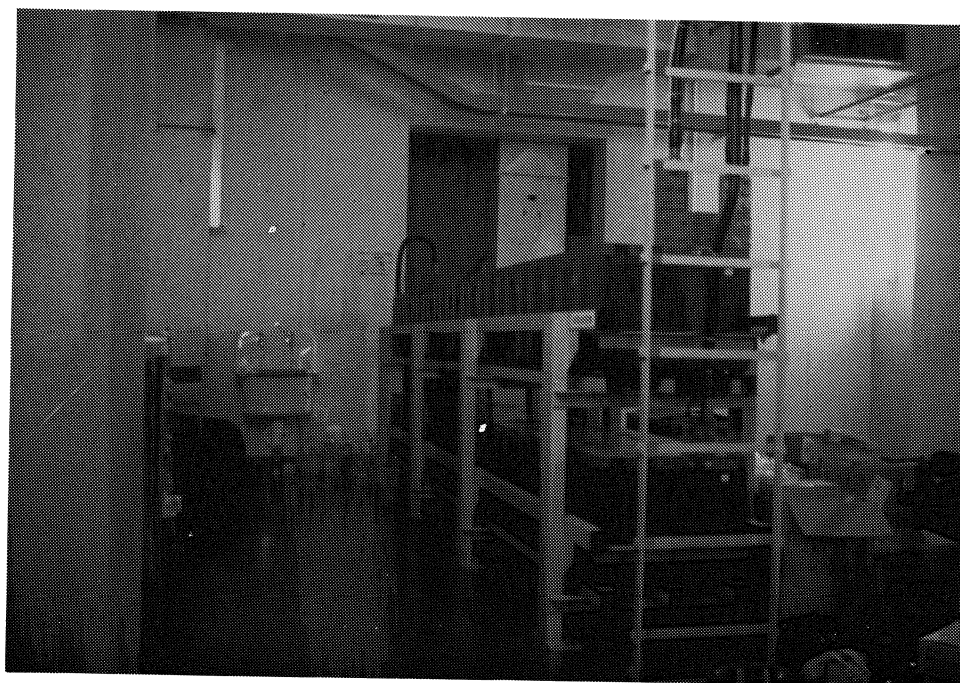
equipment and various support equipment such as emergency batteries, diesel generators, various other building support system equipment, piping, and well-braced overhead distribution systems such as cable trays. All the equipment was designed and/or anchored for earthquake loads (Figure 9-32). No damage or any problems were observed or reported with the building, the tower and the microwave, telecommunications, electrical, HVAC, or other equipment. In particular, the telecommunications equipment was well braced in both directions to floors and ceilings or walls. The backup diesel generators functioned properly following the earthquake.

Figure 9-32: Okushiri-cho remote control switch building; the telecommunications equipment in the building was well-braced in both directions, to floor and ceiling. No damage was observed or reported.

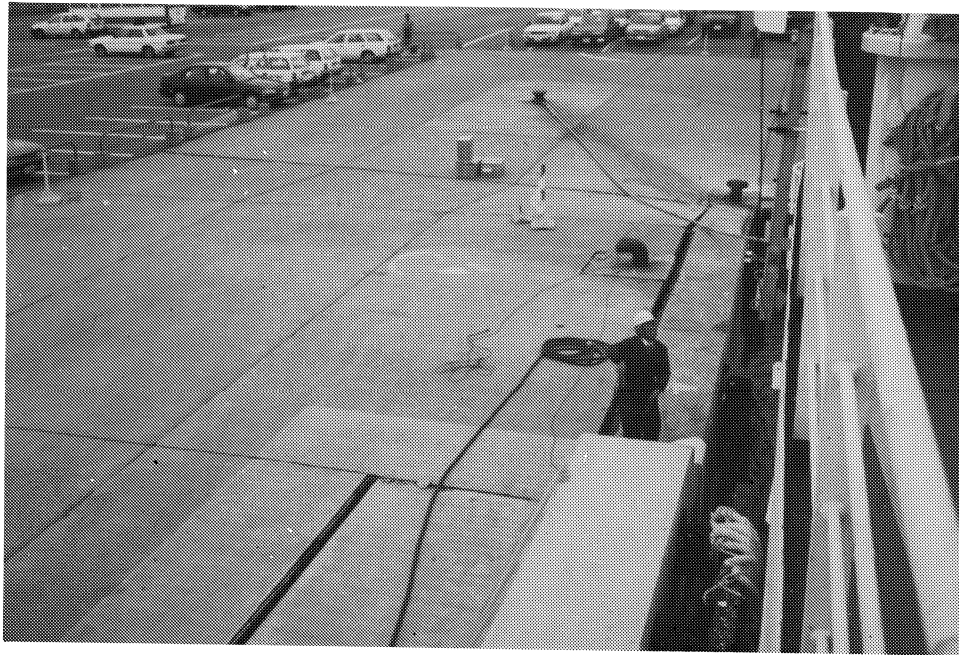
The port of Hakodate, in particular, experienced extensive damage (Figure 9-34). It is located at least 100 km from the boundaries of the aftershock zone and Okushiri Island. The peak horizontal accelerations in the port were 0.12g to 0.13g with strong duration of at least 35 seconds. The data from this earthquake show the very high vulnerabilities of typical, older and newer waterfront port structures to long-duration ground shaking. This was also the case for San Francisco's 1989 Loma Prieta Earthquake, except that

Figure 9-34: Examples of typical damage from the ports of Setana (upper photograph) and Hakodate (lower photograph; photo courtesy of T. Leslie Youd), where quay walls displaced or tilted seaward by as much as 3 m. A peak horizontal ground acceleration of 0.12g was recorded nearby.

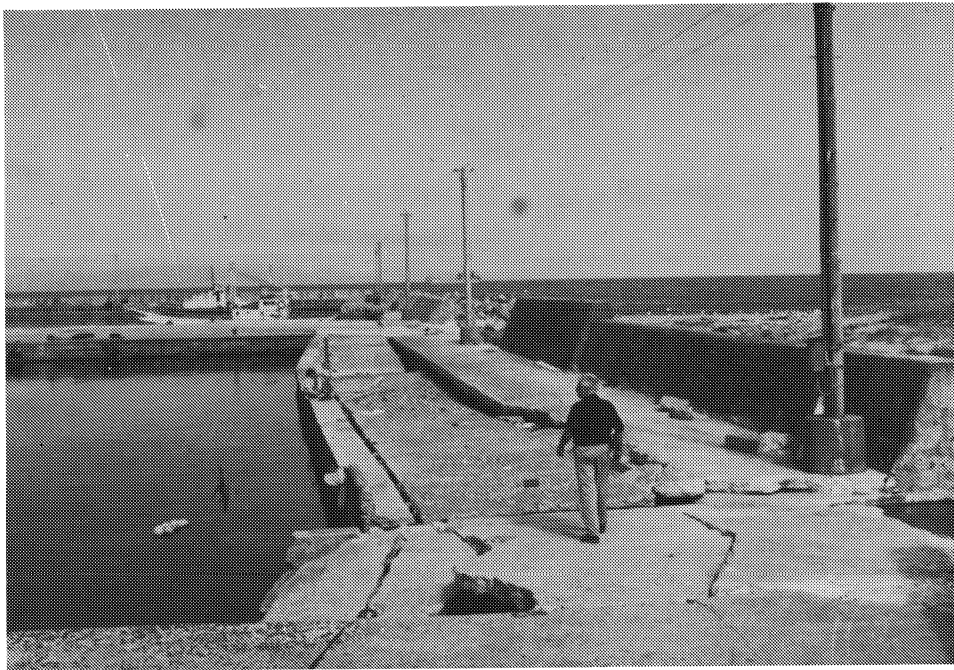
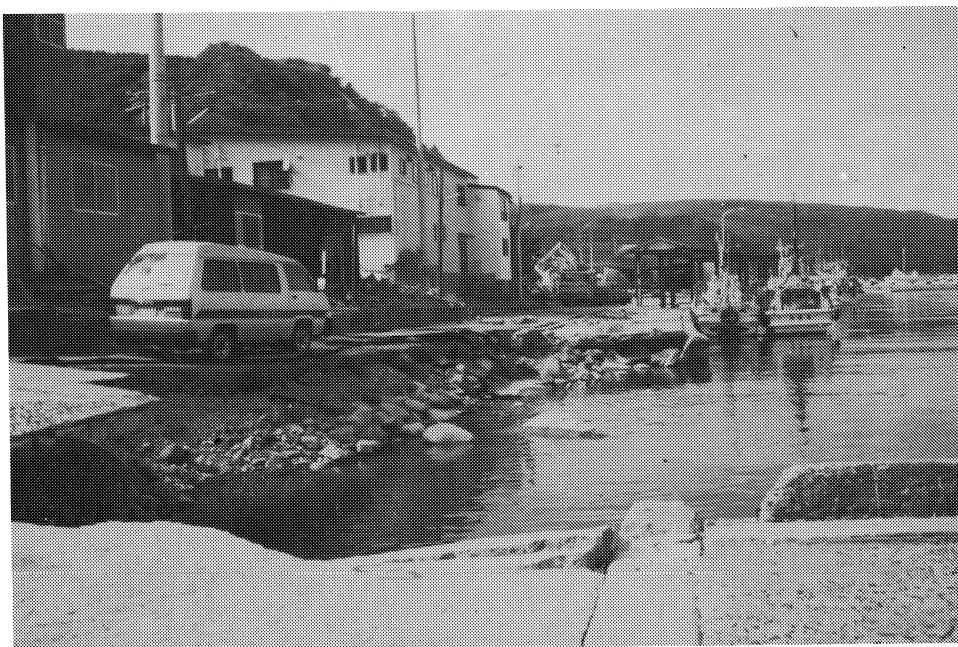
Figure 9-35: Typical damage from the earthquake to port facilities. These two examples are from Okushiri-cho Port.

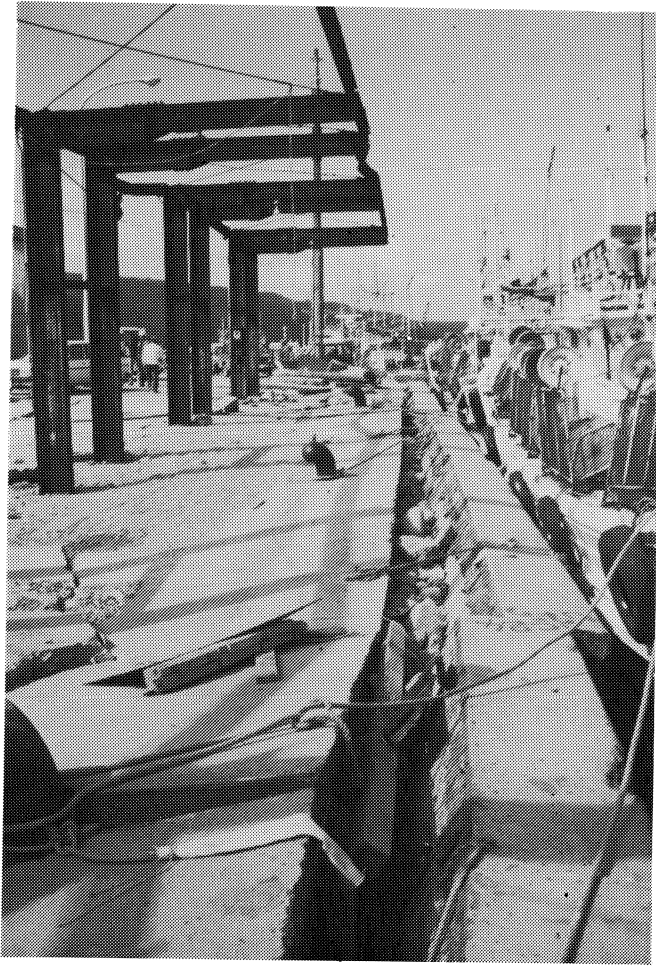
Figure 9-36: Damage to waterfront facilities at Okushiri-cho Port. The illustrated damage is due to soil failures from liquefaction, settlement, and lateral spreading of walls. Some of the damage is due to tsunami scour. Note that despite the severe damage to its foundations, the steel structure shown in both photographs has maintained its overall integrity, illustrating the large ductilities available in steel structures when properly designed and constructed.
