# Hokkaido Nansei-oki, Japan Earthquake of July 12, 1993

P.I. Yanev and C.R. Scawthorn

Technical Report NCEER-93-0023

December 23, 1993

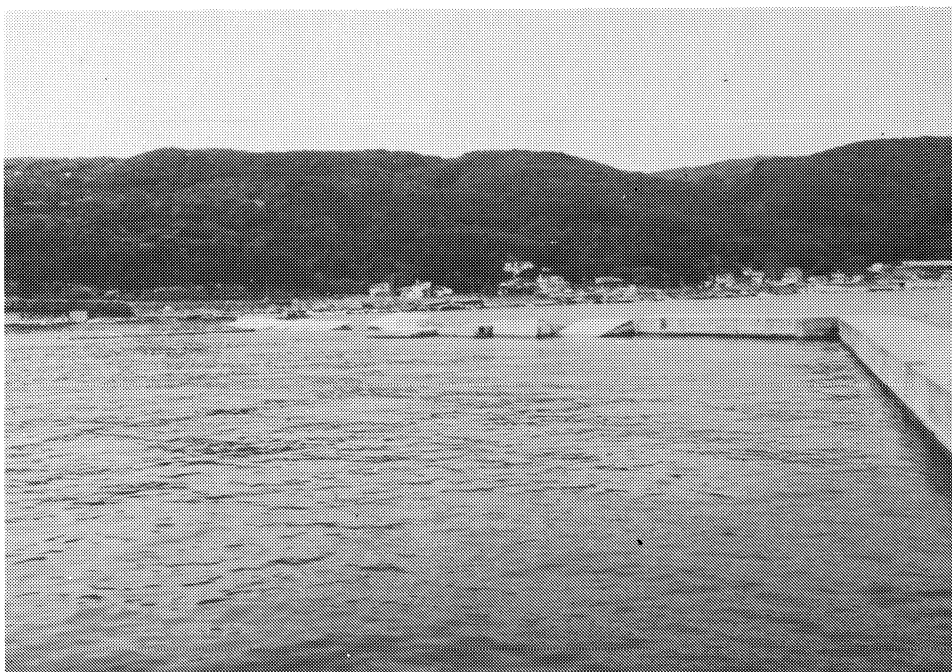
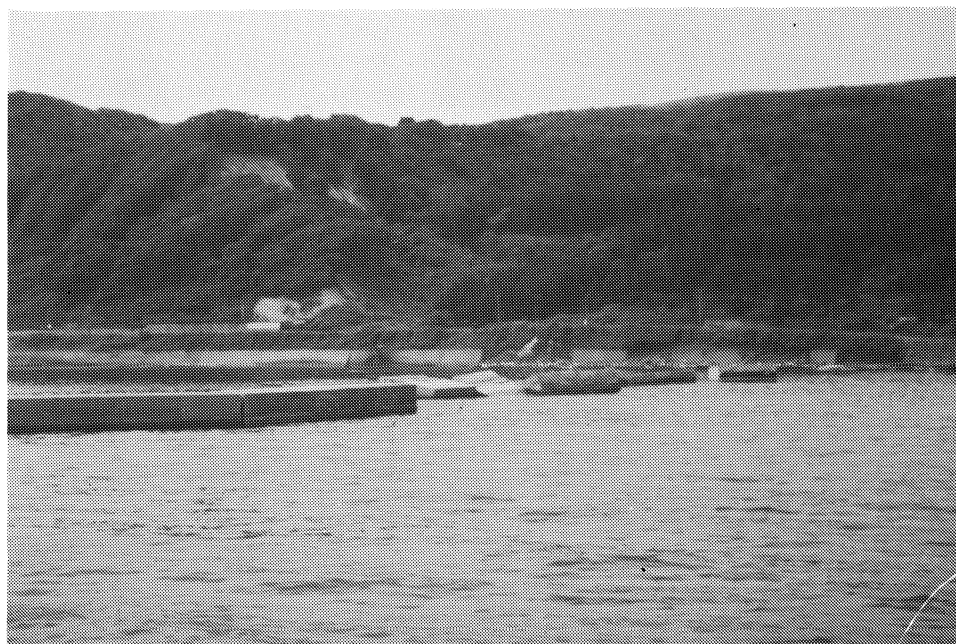
Figure 9-37: Damage to a breakwater at the Port of Okushiri-cho. These large concrete sections were probably displaced by lateral spreading of ocean-bottom deposits, although the tsunami may have caused the damage.

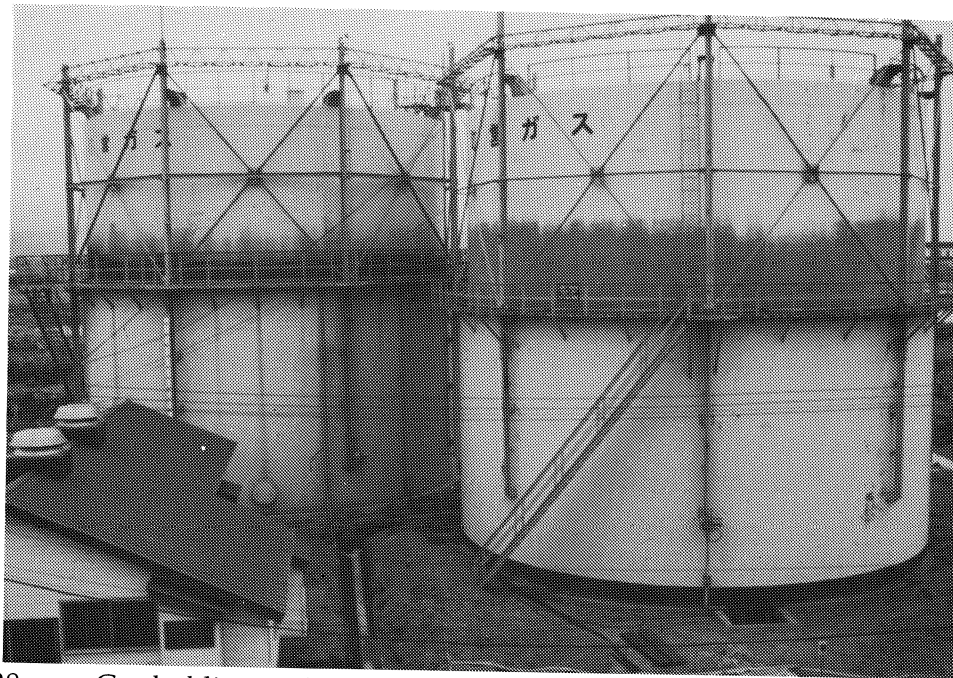
In general, few tank failures were observed. Figure 9-38 shows gas holding tanks in the Oshamanbe area on soft soils. The tanks were not damaged, but the underground piping had been damaged by ground settlement. Note the excavated piping. Similar damage was observed throughout the affected area.

Figure 9-38: Gas holding tanks in the Oshamanbe area on soft soils. The tanks are not damaged, but the underground piping has been damaged by ground settlement, which can lead to total loss of the tank contents. Note the excavated piping. Similar damage was observed throughout the affected area.

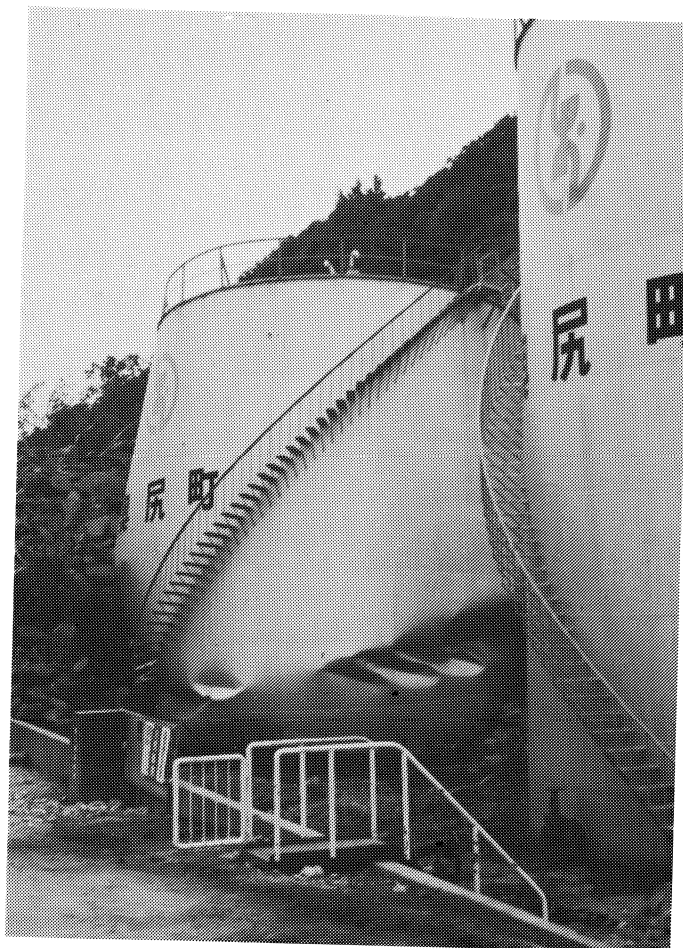
Figure 9-39 shows fuel oil tanks in the port of Okushiri. The tank on the left buckled due to landslide impact (the same landslide that caused the collapse of the Hotel Yo Yo)--note that the tank on the right is undamaged.

Figure 9-39: Fuel oil tanks in the port of Okushiri-cho; the tank on the left buckled due to landslide impact (the same landslide which caused the collapse of the Hotel Yo Yo)--note that the tank on the right is undamaged.

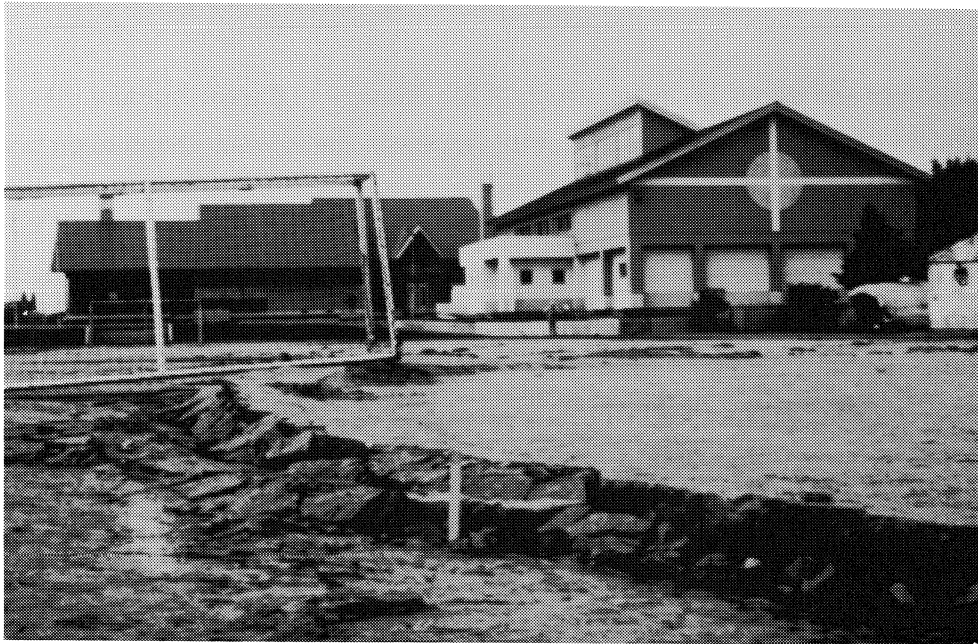
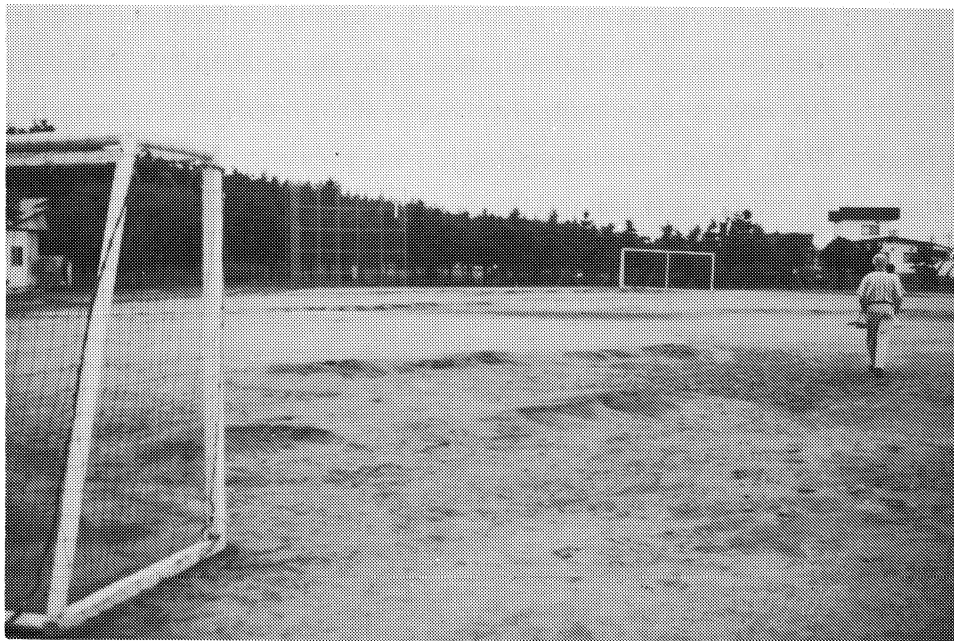
The site suffered extensive liquefaction, which induced lateral spreading and extensive settlement. Figure 10-1 shows the effects of liquefaction to some of the sports fields. Settlement of up to about 1 m occurred around the buildings, as shown in Figures 10-3, 10-4, and 10-5, causing damage to all underground piping and conduit. Minor cracking was observed to the reinforced concrete shear walls at the back of the gymnasium building (Figure 10-6). Where it was possible to view the concrete piles that were exposed from settlement, severe shear damage was observed (Figure 10-7). Absolutely no damage was observed to the interior finishes of the buildings, indicating that overall they performed well, especially given the severe ground damage all around them.

Figure 10-1: Oshamanbe Elementary School; damage to the sports fields from liquefaction, lateral spreading, and settlement.

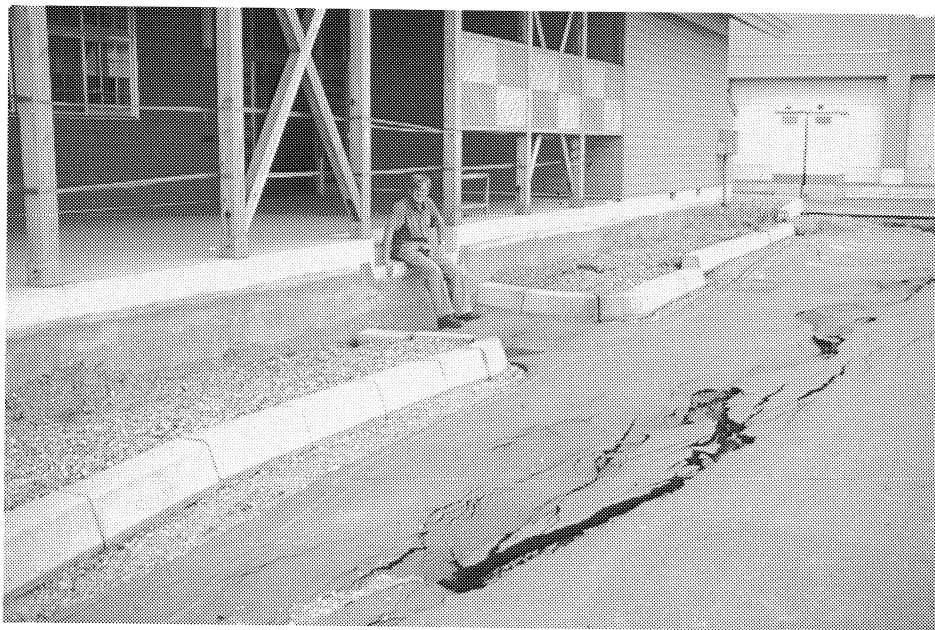
Figure 10-3: Oshamanbe Elementary School; settlement at the entrance of about 1 m.

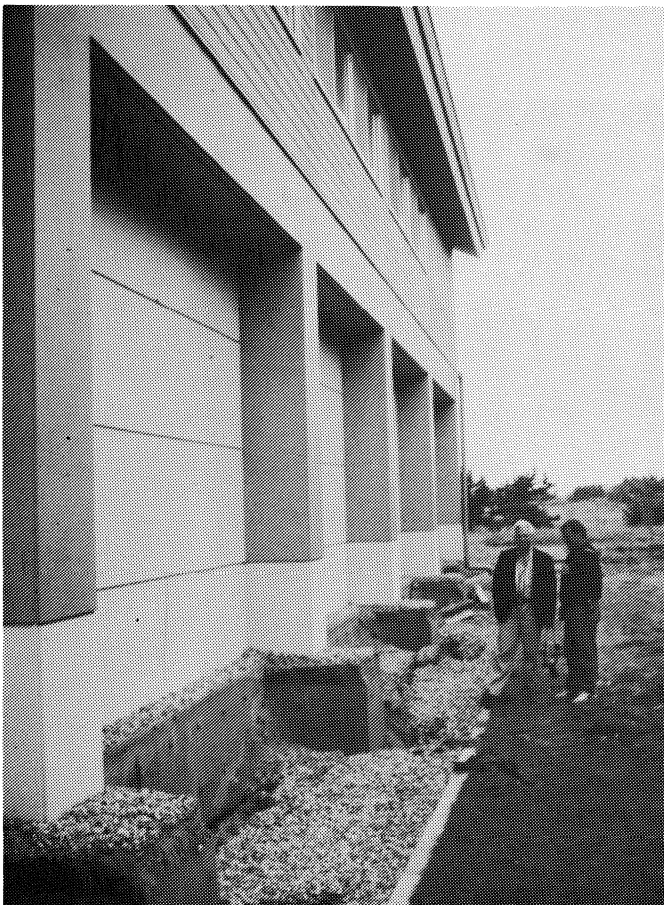
Figure 10-5: Oshamanbe Elementary School--note that the settlement exposed the pile caps.

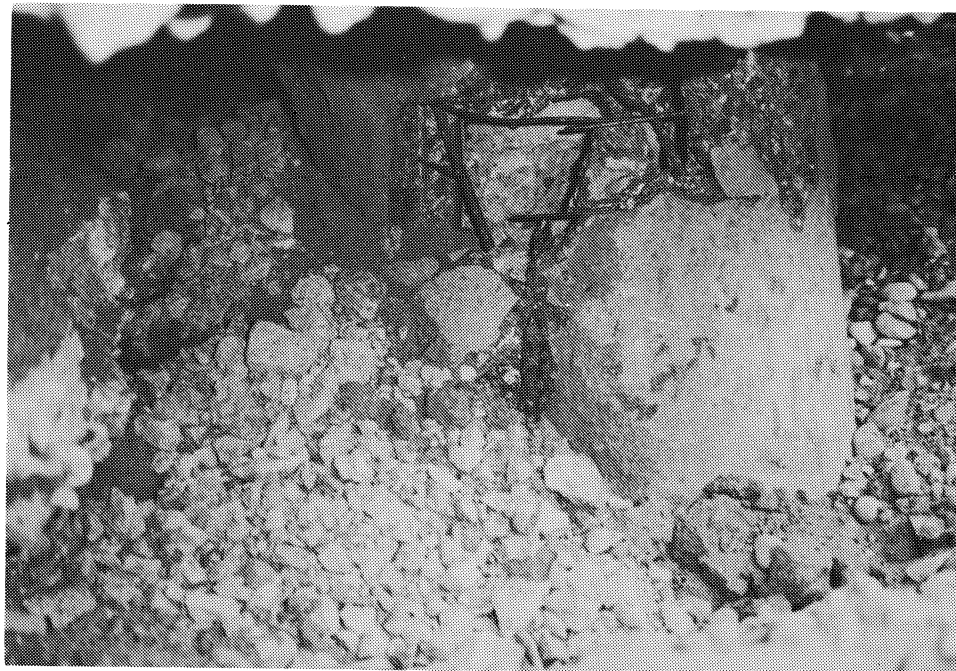
Figure 10-7: Oshamanbe Elementary School--sheared pile just below the cap.

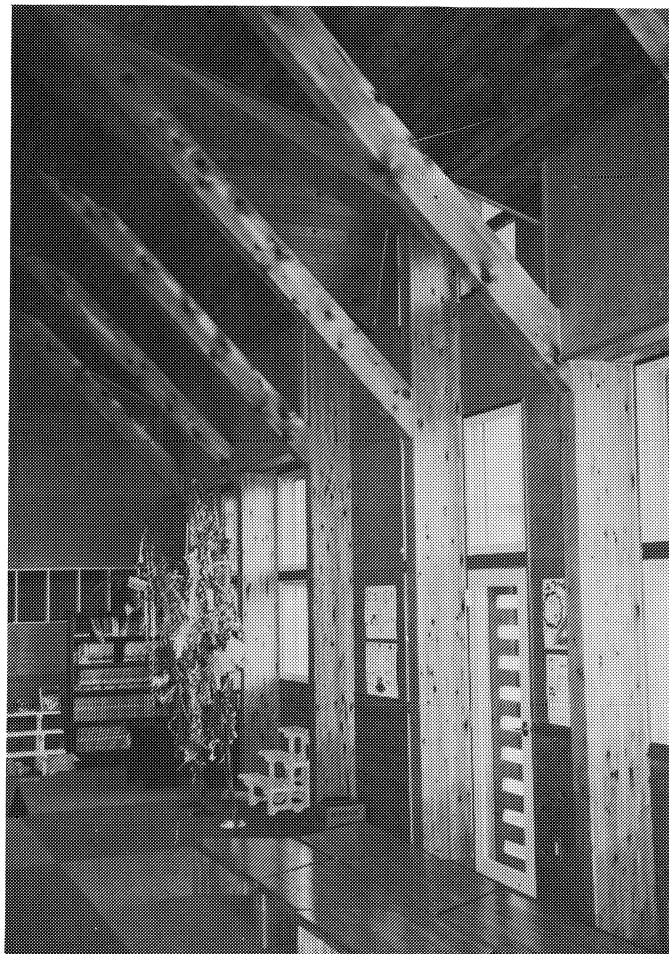
Figure 10-8: Oshamanbe Elementary School--undamaged interior in the classroom building.

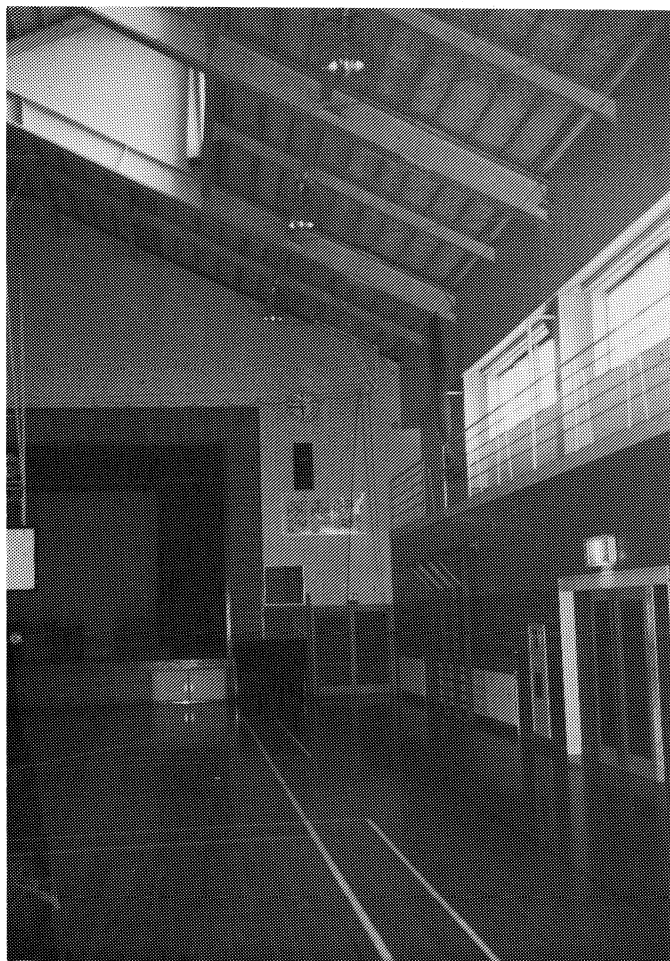
Figure 10-9: Oshamanbe Elementary School--the undamaged interior of the gymnasium.

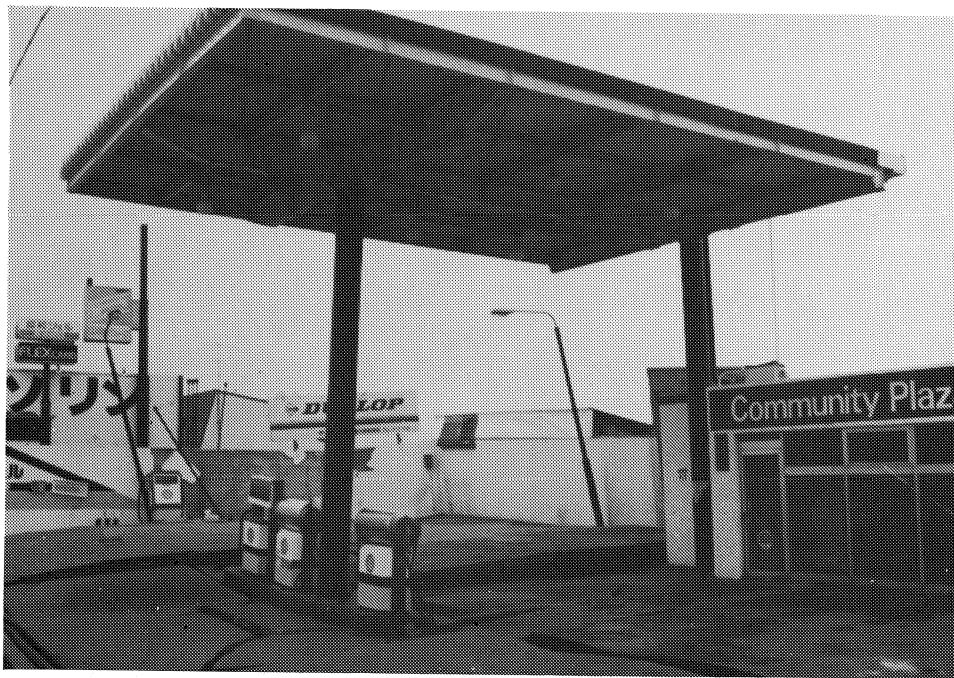
Figures 10-8 through 10-13 show other examples of ground failures. Note the contrast, in Figure 10-10, between the damage to the well-founded Oshamanbe Elementary School and the lighter gas station buildings on shallow foundations without piles.

Figure 10-10: Substantial damage in Oshamanbe occurred to light buildings on shallow foundations due to liquefaction. This photo shows near-total damage to a gas station from liquefaction and settlement about 80 km from the edge of the aftershock area. Note how the tank(s) below are pushing up because of buoyancy. None of the glass is broken, indicating a low level of shaking. This is also a fill site on old farm land very near the shoreline. Much similar damage on poor soils was observed throughout the affected area.

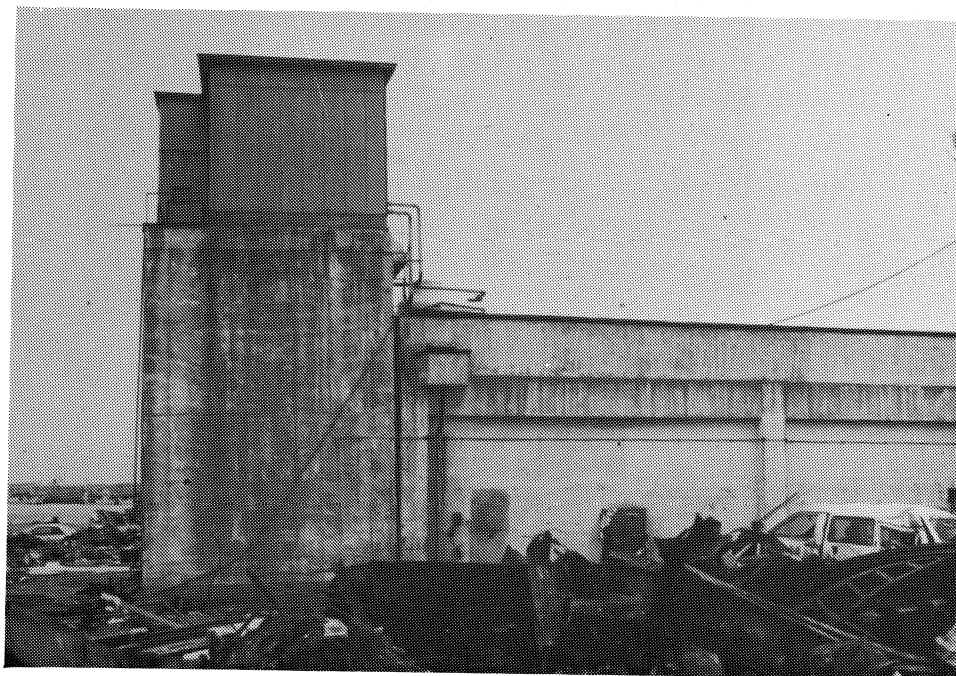
Figure 10-11: Differential settlement at these two reinforced concrete structures at the waterfront of the port of Aonae caused tilting of the taller structure on the left (and to the left). Note the gap between the higher and lower structures.

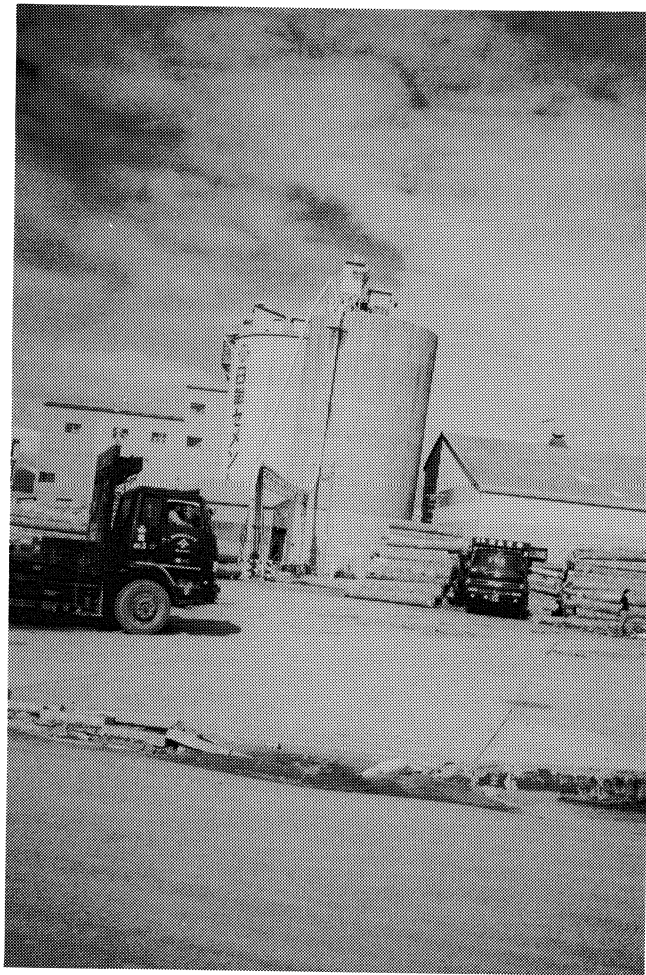
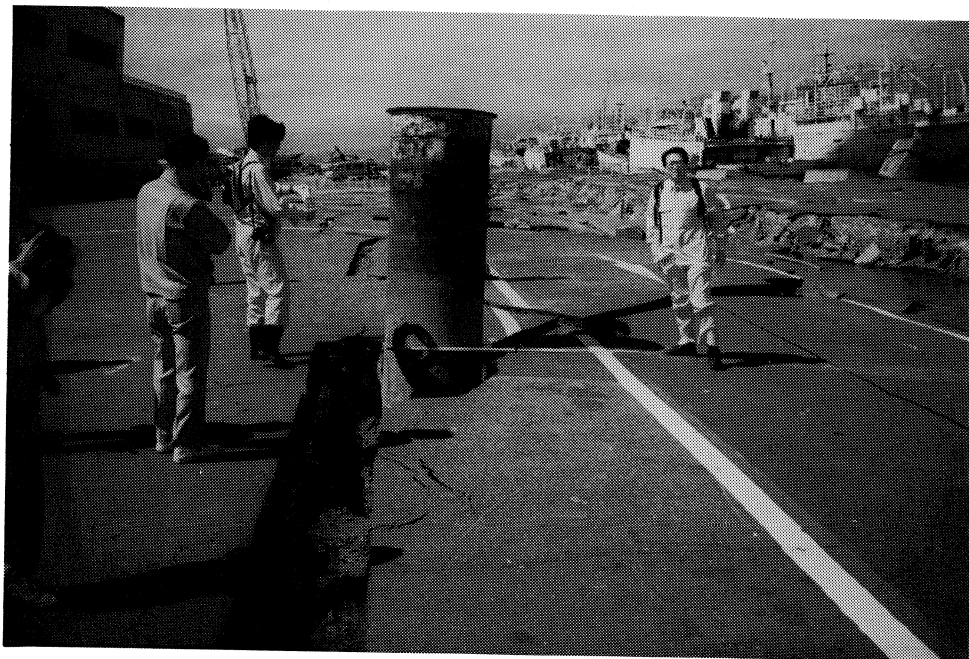
Figure 10-13: Liquefaction effects at the port of Hakodate--a tilted reinforced concrete silo and a buoyant manhole. Photographs courtesy of T. Leslie Youd.

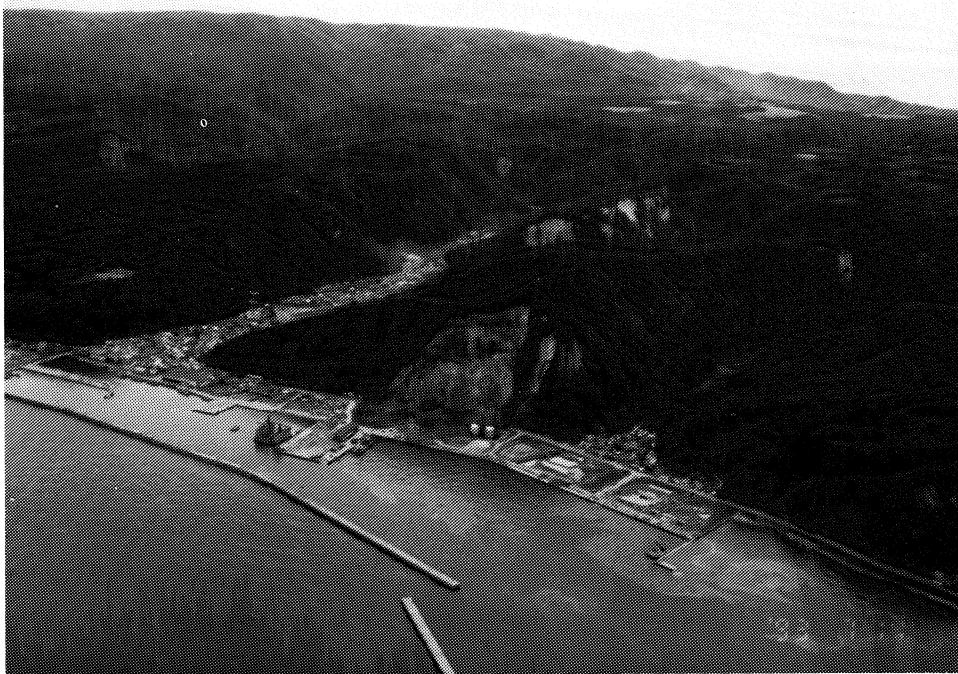
The largest single life loss from the earthquake other than from the tsunami, was caused by a landslide that buried the two-story Hotel Yo Yo (where 35 to 40 guests were killed) and several vehicles in Okushiri-cho. The slide occurred across the ferry landing in Okushiri-cho Port in steep terrain. The slide had a volume of about 800,000 m<sup>2</sup> and consisted of Pliocene tuff, tuffaceous sandstone, and conglomerate rock (References 1 and 2). The pre-earthquake slope was about 60° parallel to the slide surface. The height of the slide was about 100 m, its width was about 170 m, and its thickness ranges from 20 to 40 m. That, and other large landslides, are illustrated in Figures 11-1 and 11-2. Other landslides and their effects are illustrated throughout the report.

Figure 11-1: The port area of the town of Okushiri. Note the extensive tsunami damage. A large landslide about 100 m high and 170 m wide high buried the Hotel Yo Yo, killing 35 to 40 people and damaging the tanks (on the right side). This was the most destructive landslide of the many hundreds of landslides caused by the earthquake. Photographs by K. Kawashima.
