# The Northridge, California Earthquake of January 17, 1994: Performance of Highway Bridges

Technical Report NCEER-94-0008

March 24, 1994

This reconnaissance report provides an analysis of major bridge damage which occurred during the earthquake. Eight highway bridges are described in terms of their geometry, site ground motions, observed damage and likely failure modes.

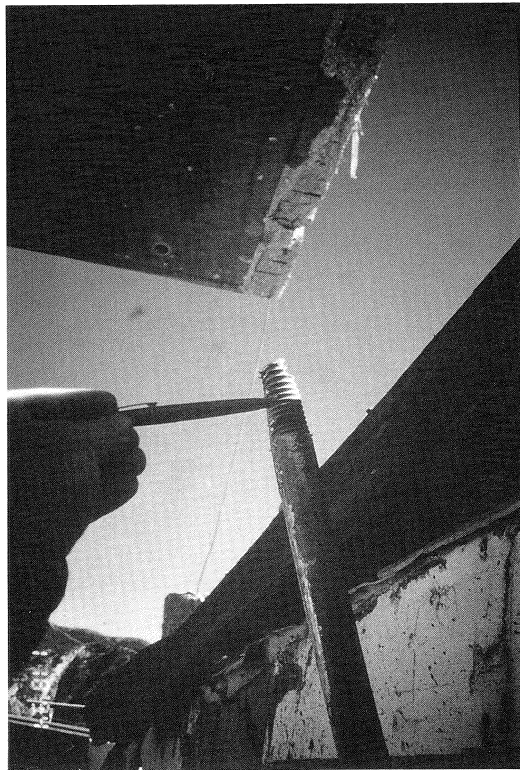
**FIGURE 4-9 SR14/I-5 Separation and Overhead (Southbound) -  
Equalizing Bolt at Hinge in Span 3**

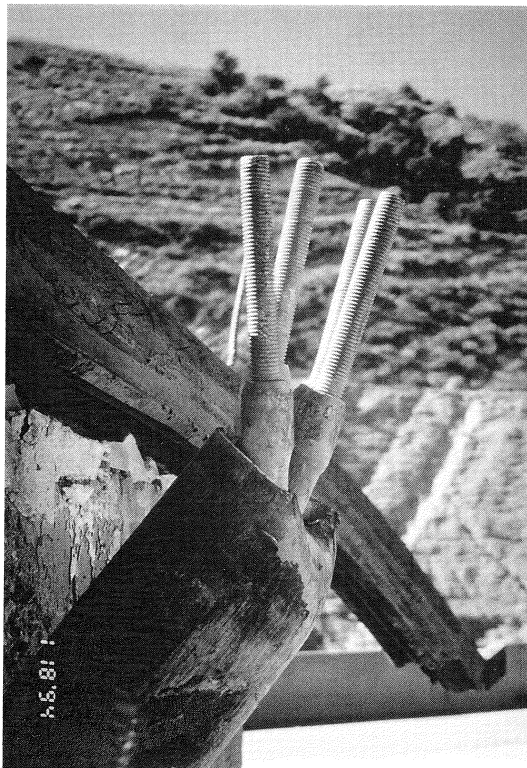
**FIGURE 4-11 SR14/I-5 Separation and Overhead (Southbound) - Restrainer Studs at Hinge in Span 3**

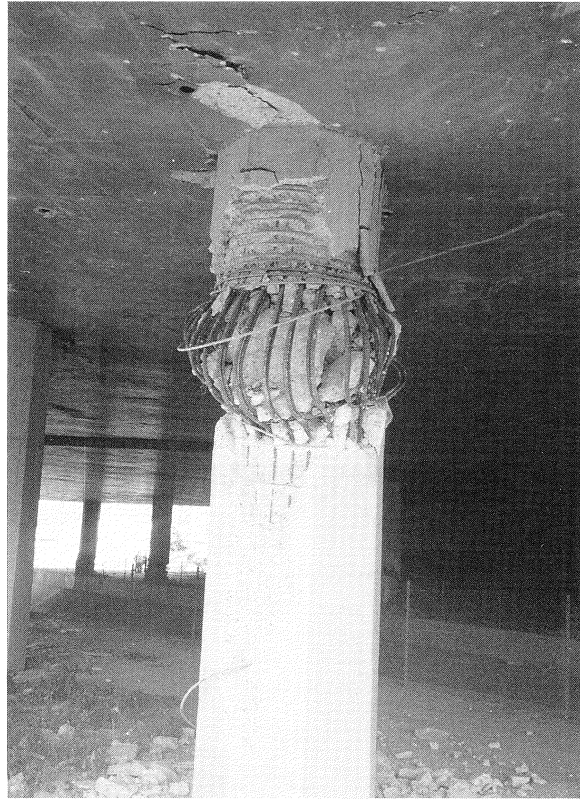
**FIGURE 6-4 Bull Creek Canyon Channel Bridge -  
Hinge Formation Below Well Confined Section in Column of Bent 2 (Eastbound Bridge)**

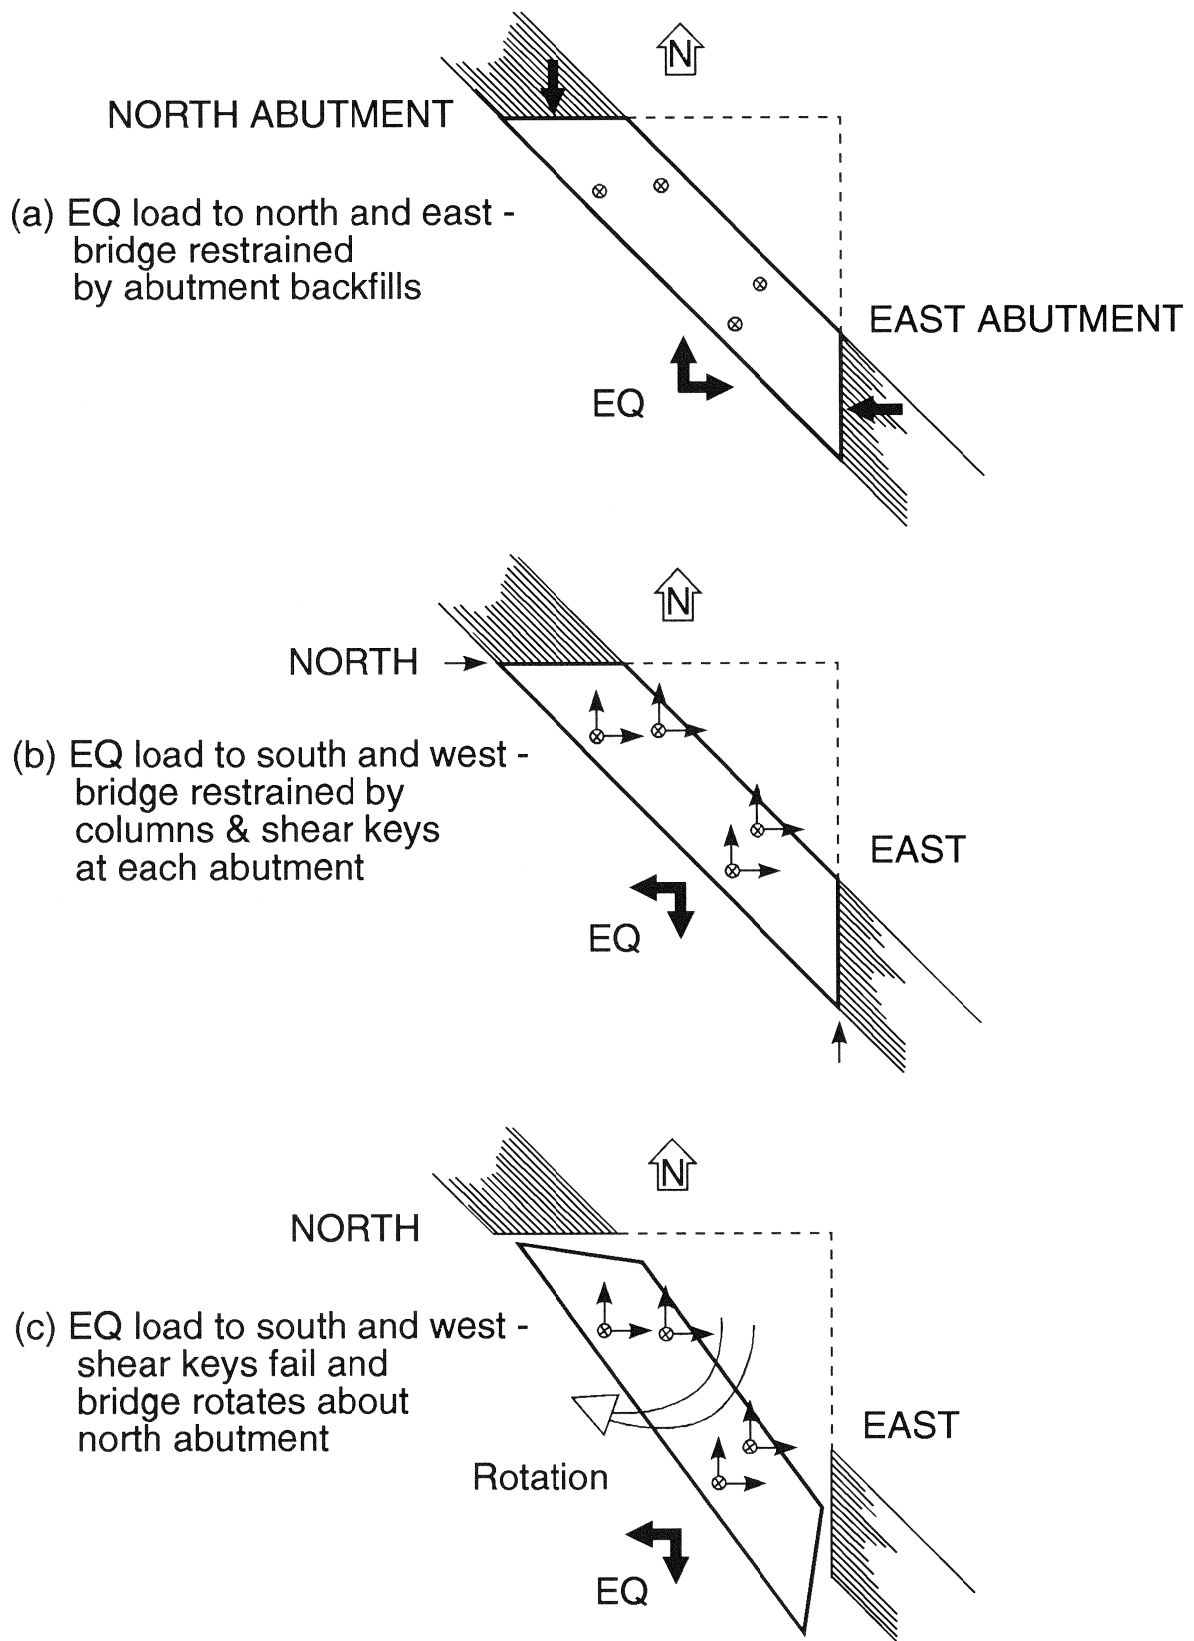
This is illustrated in Figure 7-11 which shows the eastbound bridge of the Mission-Gothic undercrossing. For shaking predominantly in the north-south and/or east-west direction, the bridge was “locked” in one direction but “free” in the other. For loading towards the north and east (Figure 7-11a), the bridge was restrained by the backwalls and fills behind the north and east abutments. In this locked position, the columns and shear keys were protected by the resistance provided by the backfills. For loading towards the south and west (Figure 7-11b), the bridge was not restrained by either abutment and the full lateral loads were resisted by the columns until the transverse restraints at the abutments engaged.

Under these loads, the columns began to develop plastic hinges. But because of their flared geometry and the accidental strength that these provide to the upperhalf of the column, these hinges formed near mid-height. The corresponding shear forces were then almost 83% larger than if the hinges had formed just under the soffit (as assumed in design) leading to excessive shear demands in the plastic hinge zones. Degradation of the columns transferred more load to the abutment restraints which subsequently failed leaving the bridge free to translate and rotate about a vertical axis. If the north-south component dominated the ground motion, then the east abutment restraints would likely fail before those at the north abutment leading to a clockwise rotation about the north abutment, as shown in Figure 7-11c.

In fact, the damage patterns and residual displacements at the west end suggest that the center of torsion was probably nearer bent 2 than abutment 1. The corresponding rotation imposed large horizontal deformations in the bents that increased with distance from the west end (Figures 7-11c and 7-5) and culminated in the unseating at the east abutment and the large permanent offsets in the columns of bent 4. Partial collapse of the eastbound bridge followed. The westbound bridge was not as extensively damaged probably because it is shorter in length and the shears in the columns and at the abutments were not sufficient to trigger collapse.

While it is recognized that this may not have been the exact sequence of events, it is almost certain that three factors played a contributing role in the collapse of the bridge. In summary these are:

1. The unusual geometry and in particular the effect of orthogonal skew, and variations in skew from one substructure to the next;
2. The unintended actions of architectural elements such as the flares on the columns which may have inadvertently enhanced the flexural strength of the columns leading to premature shear failures, particularly in these short columns; and
3. The inadequate capacity of shear keys and other transverse restraints at the abutments.

**FIGURE 7-11 Mission-Gothic Undercrossing ( Eastbound Bridge) - Possible Load Distribution and Failure Sequence**

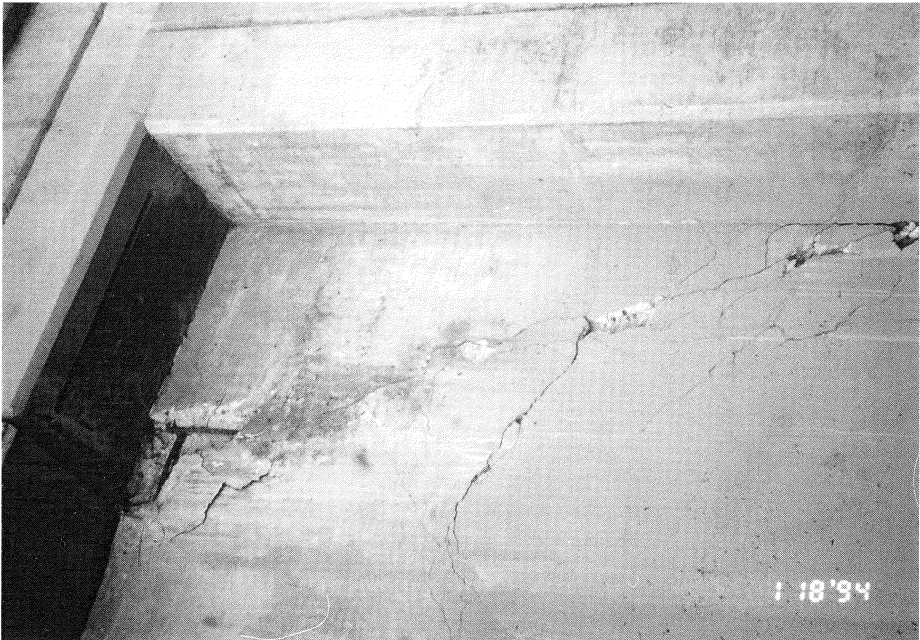
**FIGURE 8-4 Balboa Boulevard Overcrossing -  
Wall and Expansion Joint at Abutment 2**

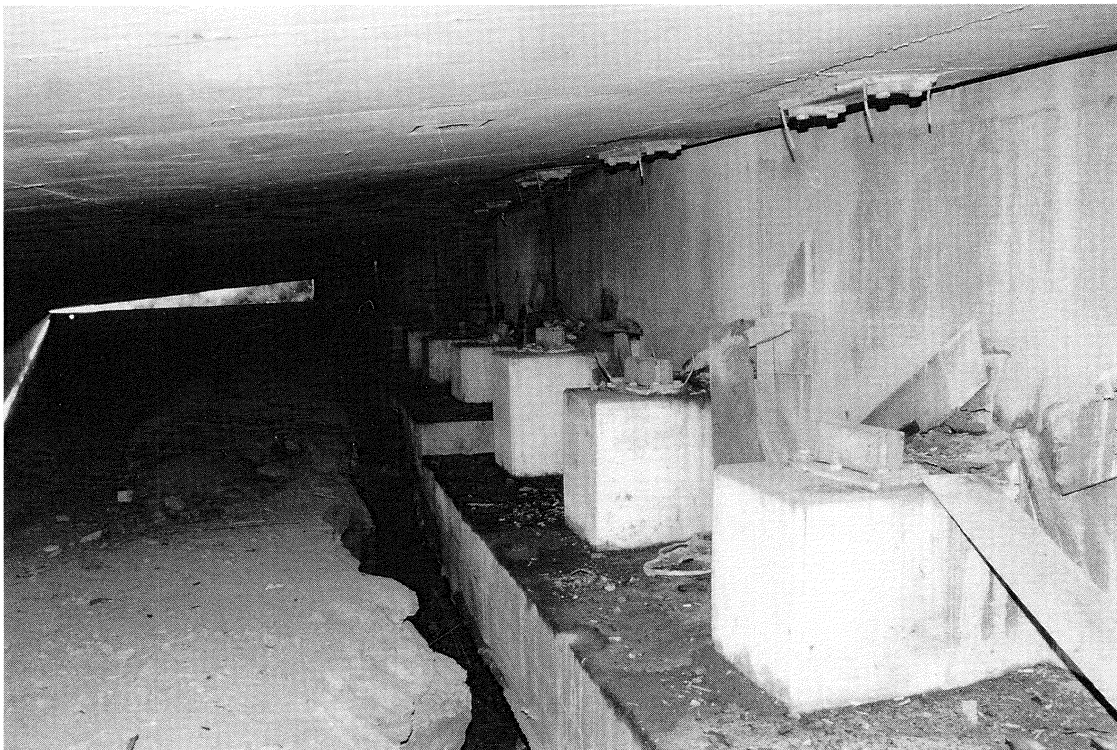
**FIGURE 9-4 Fairfax-Washington Undercrossing - Uplift from Seat at Abutment 1**

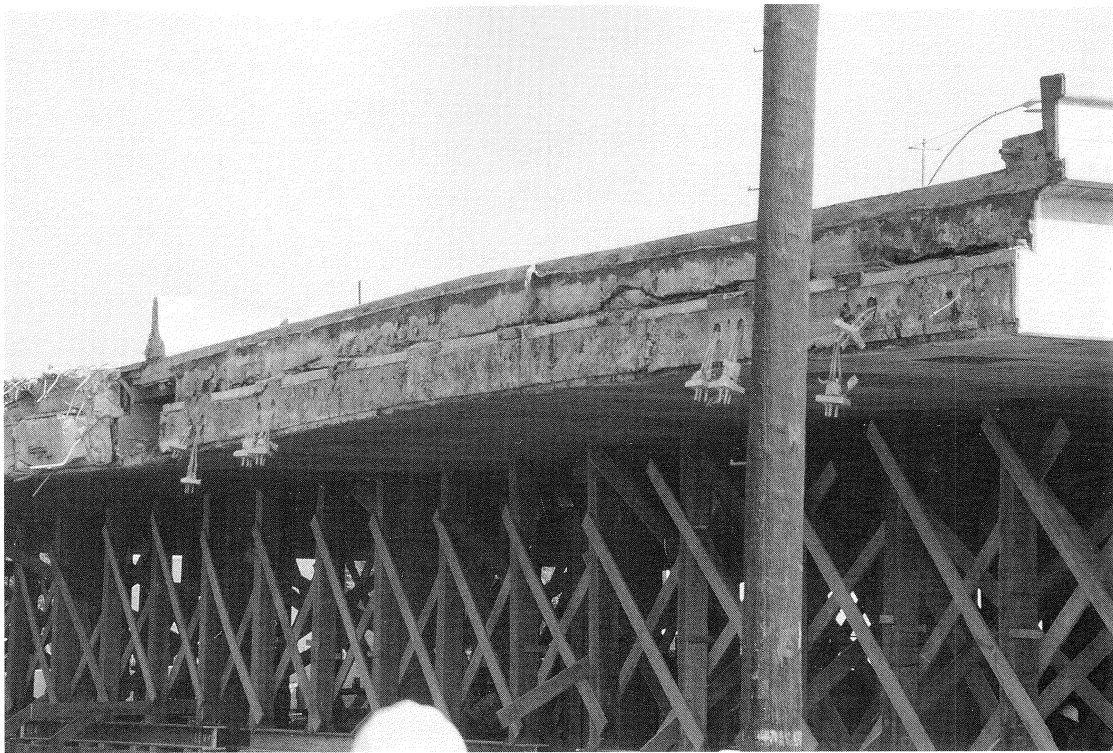
**FIGURE 9-6 Fairfax-Washington Undercrossing -  
Hinge Seat and Restrainers in Span 3 after Demolition**

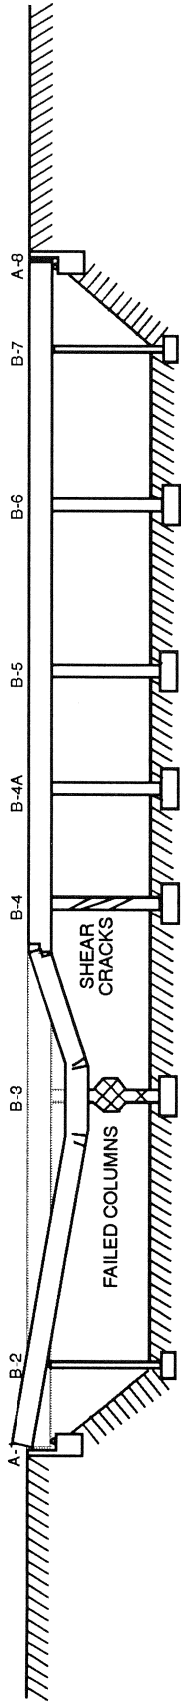
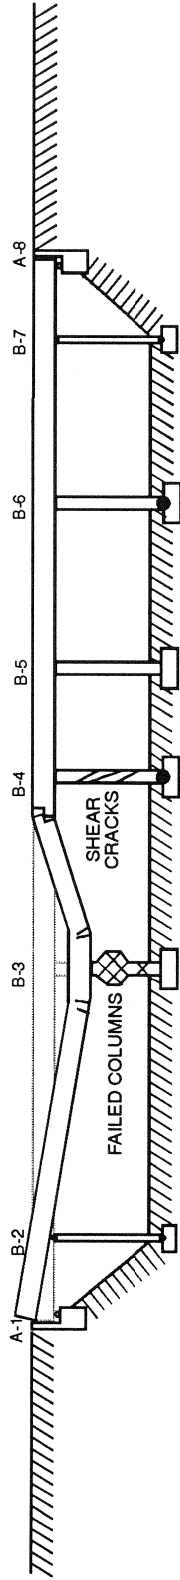
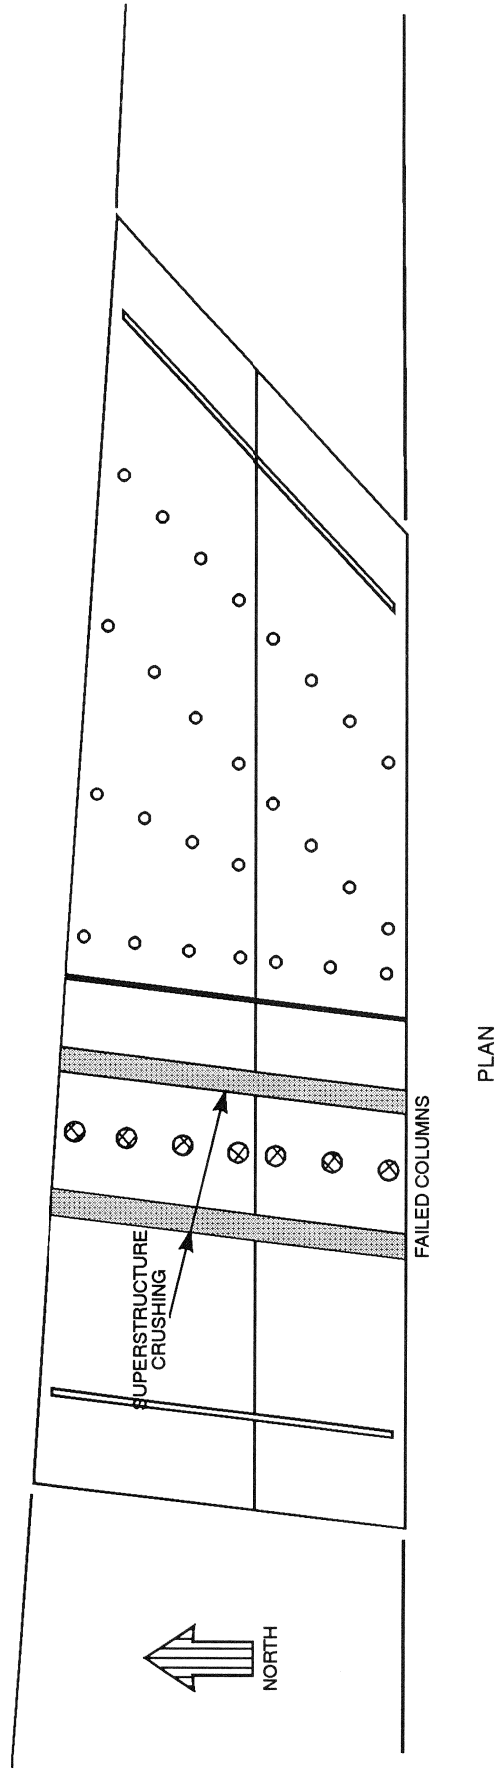
**FIGURE 9-10 Fairfax-Washington Undercrossing - Distribution of Column Damage**

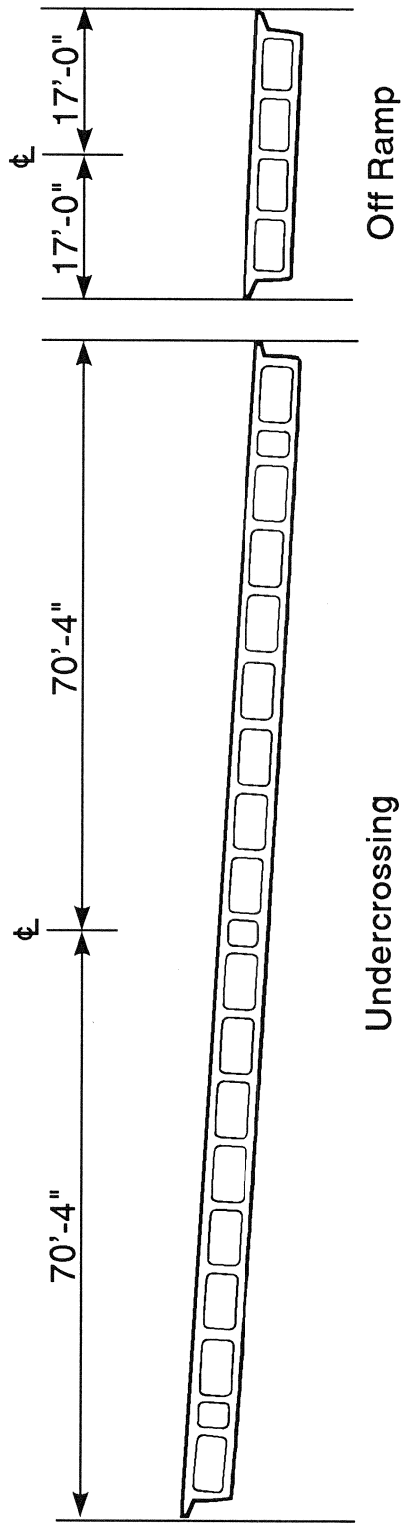
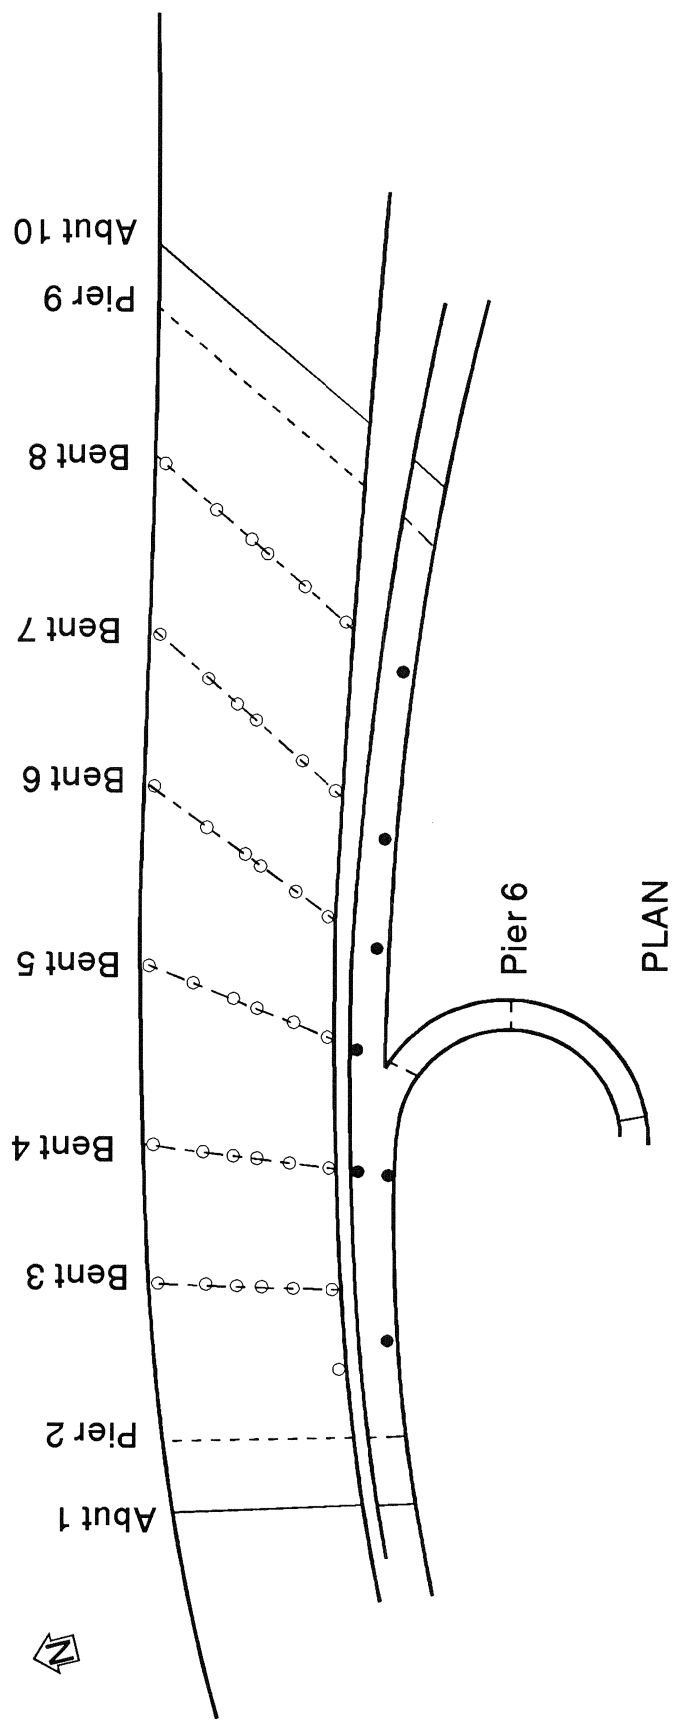
FIGURE 10-1 La Cienega-Venice Undercrossing -  
General Plan and Elevation

The bridge superstructure, between piers 2 and 9, consists of two nine-cell cast-in-place, reinforced-concrete box girders, varying from 70 feet to 94 feet in width. A general plan and typical section is given in Figure 10-1. Damage sustained during the earthquake is illustrated in Figures 10-2 through 10-7. Detailed plans, sections and elevations are presented in Figures 10-8 to 10-16. These details are generally representative of Caltrans' design and construction practice in the mid-sixties.

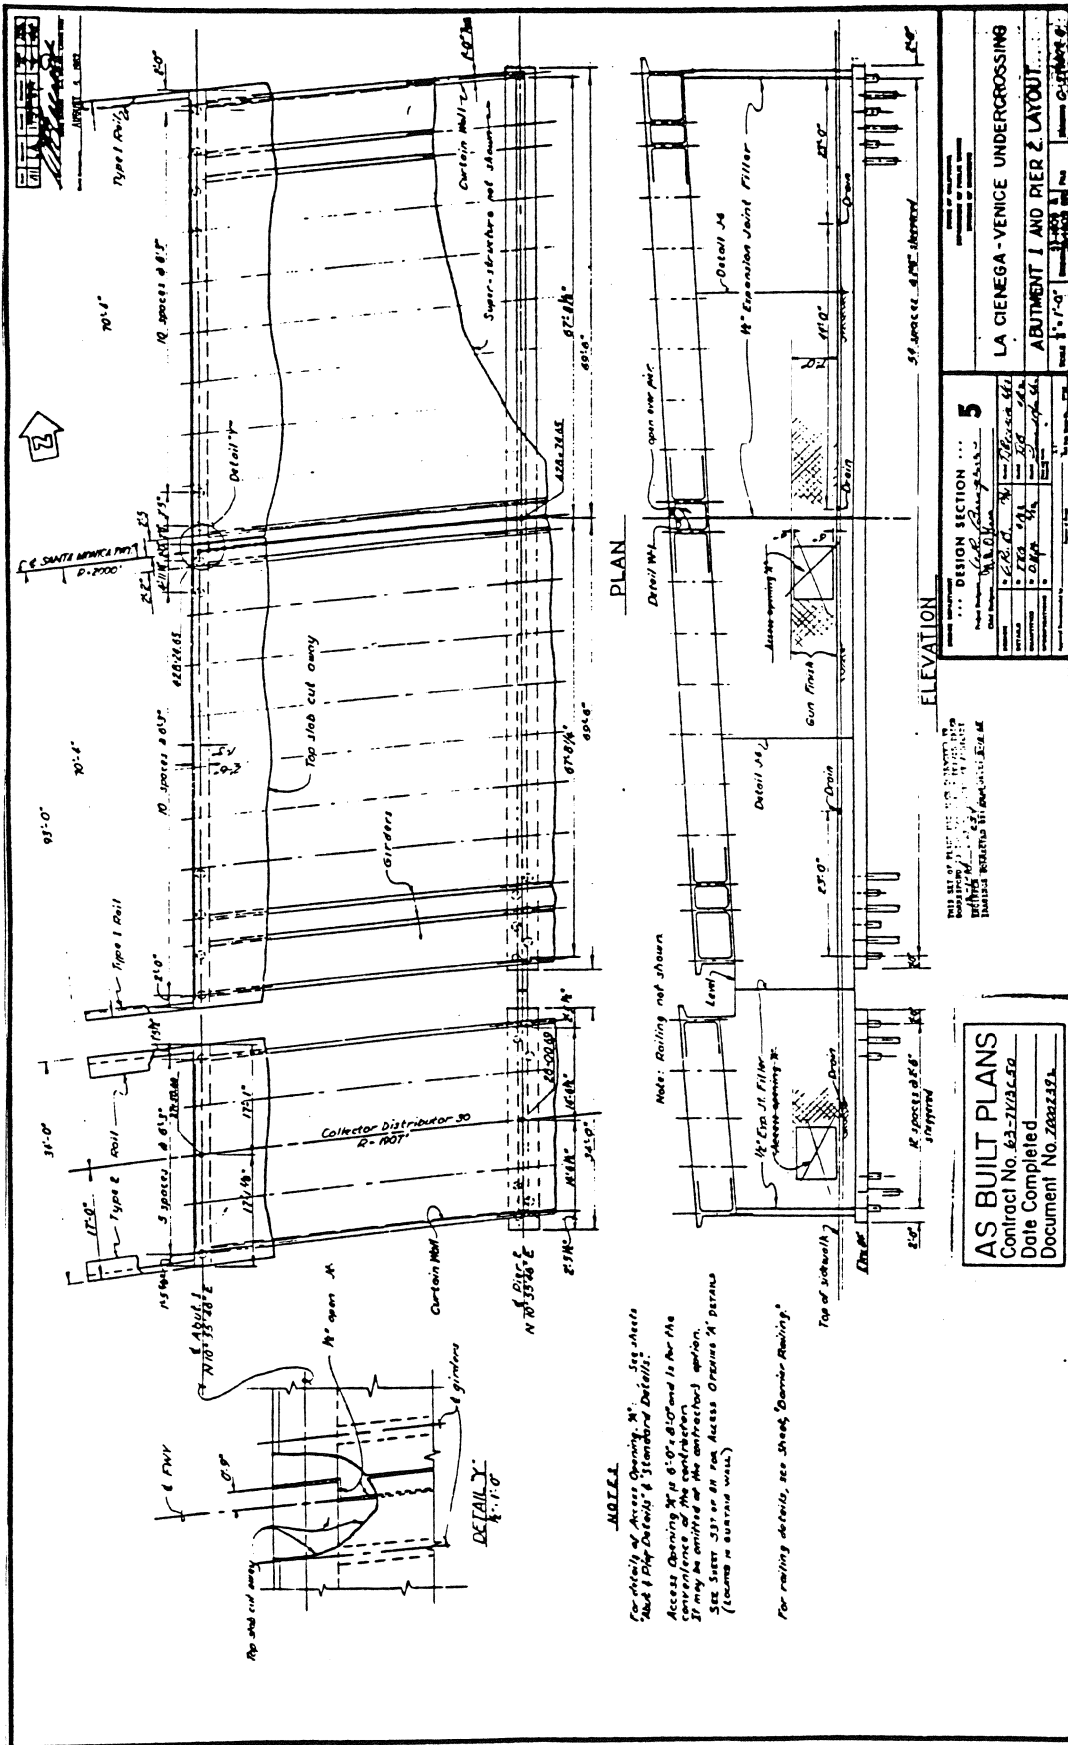
FIGURE 10-9 La Cienega-Venice Undercrossing -  
 Layout of Abutment 1 and Pier 2

The east- and west-bound bridges are separated by a longitudinal expansion joint that runs down the median of the freeway. Both end spans consist of slab and girder construction with a span length of approximately 51 feet (Figure 10-9). Abutment 1, pier 2 and bent 3 are nearly normal to the center line of the bridge, whereas from bent 4 to abutment 10 there is an increasing skew that is approximately 45° at abutment 10 (Figure 10-10). There is an off-ramp adjacent but structurally separate from the undercrossing on the south side. There are two expansion hinges, one between bents 3 and 4, and the other between bents 6 and 7 (Figure 10-10). From bents 3 to 7 there are storage facilities located underneath most of the superstructure, and the concrete block walls enclosing these facilities prevented the total collapse of the superstructure. The total length of the bridge was 870 feet, with span lengths of 51, 116, 93, 111, 112, 105, 116, 115, and 51 feet, measured from abutment 1.

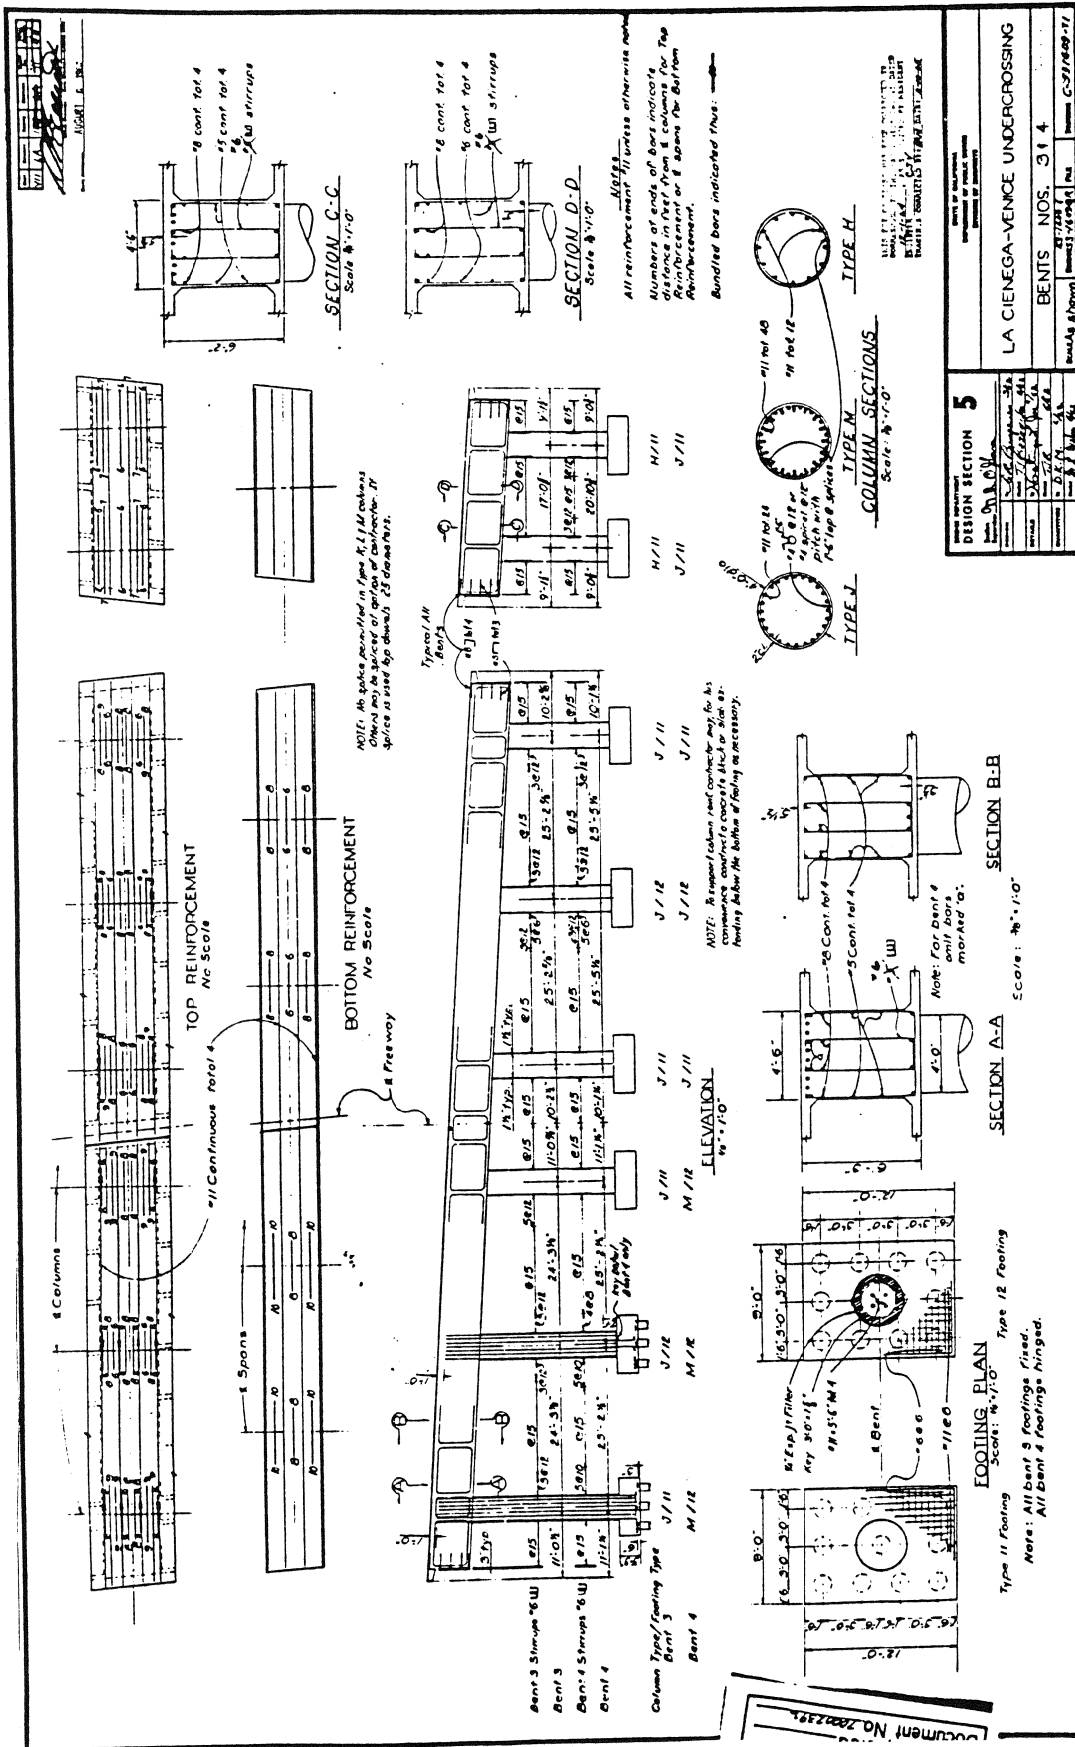
FIGURE 10-11 La Cienega-Venice Undercrossing - Bents 3 and 4 Details

Bents 3 to 7 have three columns of support for each 70 feet to 90 feet width of superstructure, and bent 8 has four columns of support (Figures 10-11 through 10-16). All columns are four ft. in diameter, but with significant variations in the longitudinal steel. Confinement/shear reinforcement is a No. 4 bar at 12 inches or a No. 4 spiral with a 12 inch pitch at each column location. All columns are supported on piled foundations of approximately 35 ft. depth.

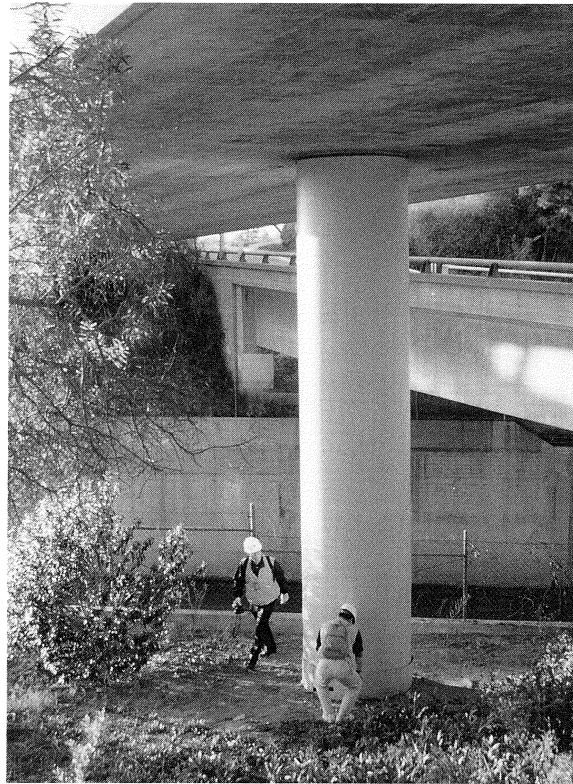
All of the columns with steel jackets appeared to perform without distress. Some were on bridges close to other structures which did partially collapse. One example is shown in Figure 11-2 which is a view of a jacketed single column under an off-ramp across Ballona Creek on I-10. It is located between the La Cienega-Venice and Fairfax-Washington structures. Close examination found no sign of damage.

**FIGURE 11-2 Ballona Creek Undercrossing on I-10 -  
Single Column Bent Retrofitted with Steel Jacket**
