The Quindío, Colombia Earthquake of January 25, 1999: Reconnaissance Report

Technical Report MCEER-99-0017
October 4, 1999

Quindío, Colombia Earthquake of January 25, 1999: Reconnaissance Report

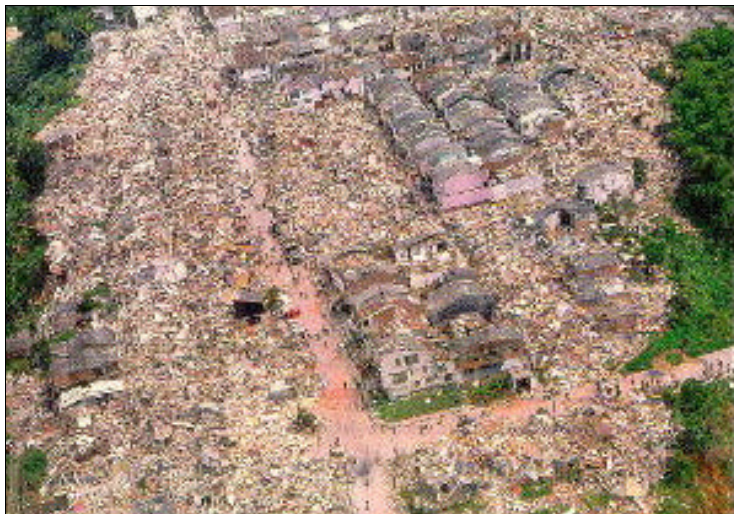
Figure 5-1 Debris Blocking Streets in Brasilia, Armenia

The debris on the streets of Armenia was so extensive that during the first few days after the earthquake, the only way for emergency personnel to get around was by using motor scooters. Even though the debris began to be removed almost immediately after the earthquake, the streets remained heavily congested (see figure 5-1). For security reasons, traffic into the city's downtown area was restricted, further adding to the congestion. At the time of the team's visit, debris was being removed and temporarily stored in several

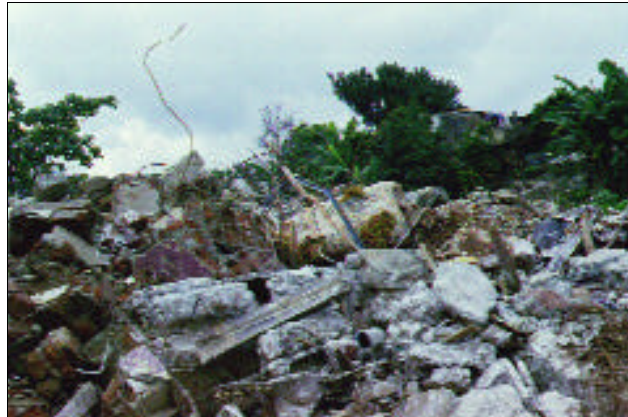
Figure 5-2 Debris Storage Area in Armenia

of the many ravines that transect the city (see figure 5-2). The earthquake produced over 1 million cubic meters of debris. According to city officials, the debris will eventually be removed from these ravines and recycled.

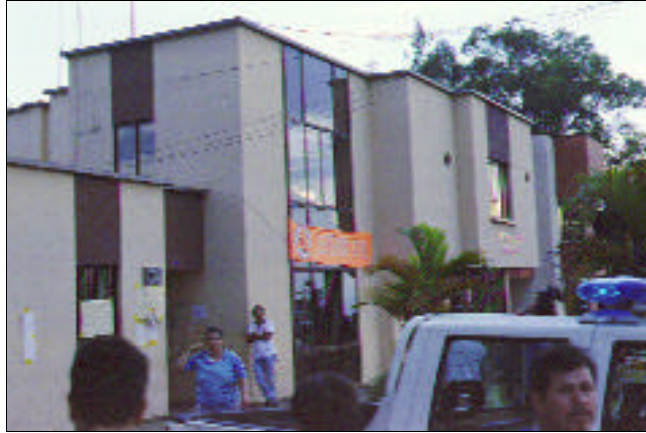
Figure 5-3 The Civil Defense Building in Armenia Temporarily Housed Key City Agencies

Further adding to these problems, the city's municipal government building ("city hall") was evacuated due to uncertainty about its structural safety. This is the building that housed the COLPAD. Not until the third day following the earthquake was a temporary Emergency Operations Center (EOC) established at the Civil Defense headquarters to better coordinate emergency operations (see figure 5-3).

Even though the Civil Defense facility was small and space was very limited, it provided a centralized point of coordination for government operations. Most key agencies were forced to operate temporarily from buildings that were not seriously damaged. At the time of the team's visit to the temporary EOC, plans were underway to centralize emergency and "normal" government operations at a museum located in the northern part of the city, which suffered relatively little damage.

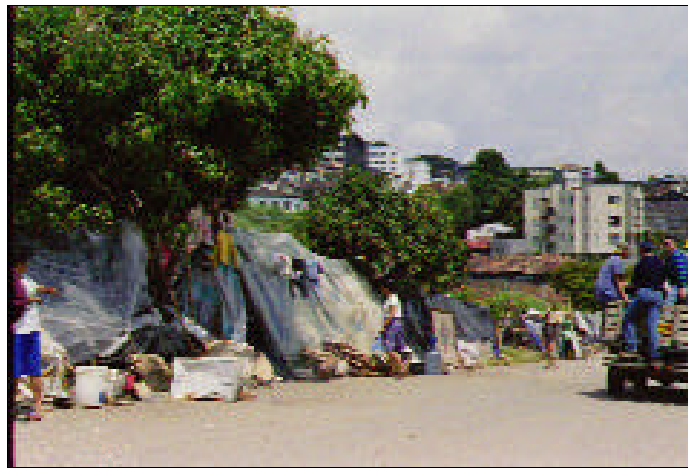
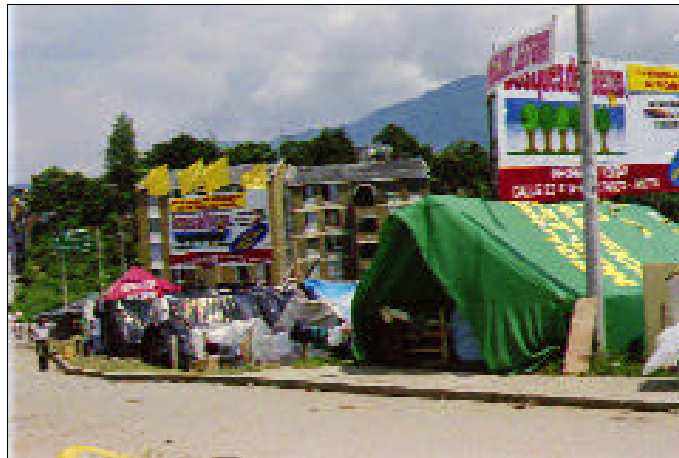
Figure 5-5 Spontaneous Shelters, Downtown Armenia

The provision of emergency shelter to those displaced by the earthquake damage, is perhaps the most critical issue currently facing the city. Approximately 90,000 families were displaced by the earthquake. In the City of Armenia alone, the number of displaced persons is conservatively estimated to be over 100,000. While many of the displaced have found shelter with unaffected family members or friends, many had no place to seek shelter or refused to leave their damaged property. This led to the creation of spontaneous emergency shelters (see figure 5-5). Most of these shelters are tents or lean-tos that displaced persons have constructed on sidewalks, roadsides or parks in the vicinity of their destroyed homes, using plastic sheeting and materials recovered from the debris.
