# MCEER RESPONSE

## PRELIMINARY REPORTS FROM THE KOCAELI (IZMIT) EARTHQUAKE OF AUGUST 17, 1999

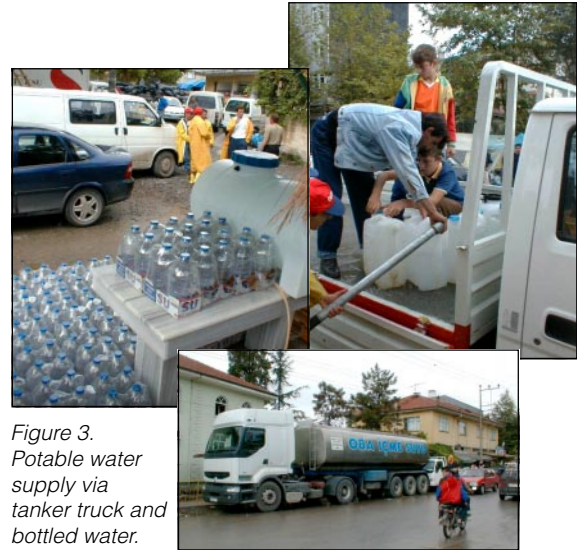
Figure 3. Potable water supply via tanker truck and bottled water.

Izmit water treatment plant and from several naval vessels in the Bay, and by bottled water, Figure 3.
