Numerical Investigation of the Failures Observed in Eccentrically-Braced Frames in the Aftermath of the Christchurch Earthquake Series (2010–2011)

Reza Imani, A.M.ASCE¹; and Michel Bruneau, F.ASCE²

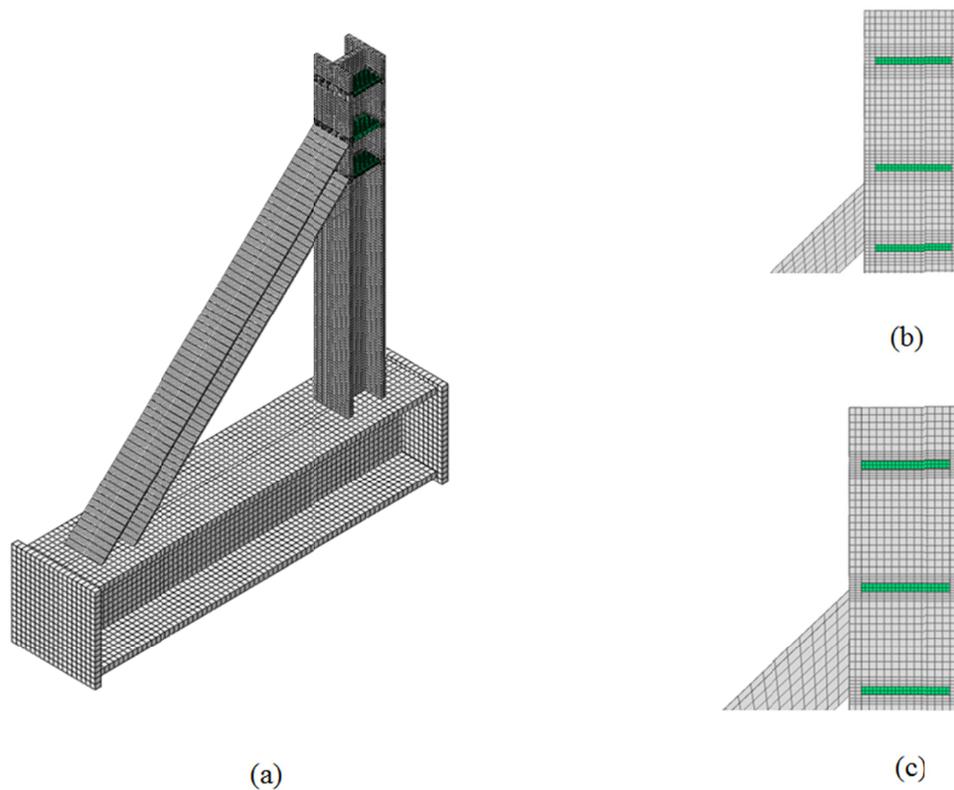
Fig. 3. Finite Element Modeling of The EBF System: (a) Complete Model; (b) Case 1 connection detail; (c) Case 2 connection detail.

Case 1 is similar to the configuration used in the reported fractured EBFs in that the stiffener is placed at the intersection of the brace and beam centerlines but doesn't vertically line up with the edge of the brace flange; Case 2 represents the ideal configuration; The third case, EBF-3, is similar to EBF-1, except that the link end-stiffener has been moved to align vertically with the point where the flange of the brace is welded to the beam. Note that all four configurations are allowed per AISC 341-10.

General finite element software, ABAQUS, was used to study the behavior of the EBF frames with different connection details. The analysis model was built with 8-node 3D brick elements (C3D8R) and a non-uniform mesh pattern that was designed to be finer around the area of interest. Due to symmetry, only half of a typical EBF frame was modeled. To eliminate unnecessary complexities, the column and the brace were set to remain elastic throughout the analysis. The beam (including the link) and the stiffeners were modeled with a simple bilinear steel material with von-Mises yield criteria. Post-yield behavior was modeled with a linear strain hardening branch going to the strain value of 0.15 (hardening slope was defined to be 3% of the initial stiffness). The material was modeled to linearly lose strength from strain of 0.15 to 0.2 to crudely model damage in the elements at high strains. Assuming a simple connection at the base of the column, a cyclic lateral displacement was applied to the frame by pushing and pulling top of the column while its other end was simply supported. Fig. 3 shows different views of the finite element model.
