Performance of structures during the 1992 Erzincan earthquake

MURAT SAATCIOGLU AND MICHEL BRUNEAU

Can. J. Civ. Eng. 20, 305-325 (1993)

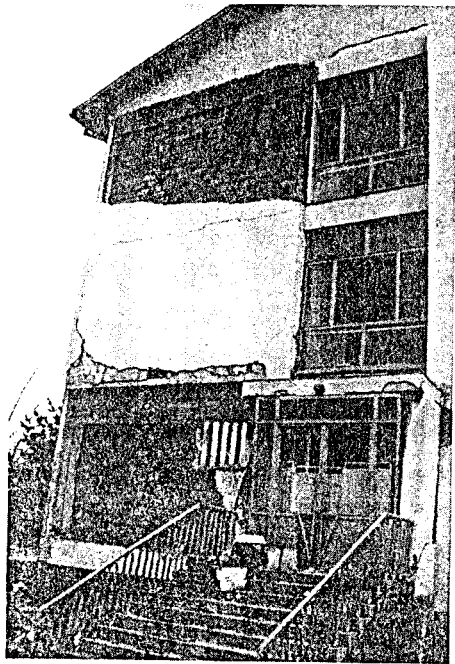
Unreinforced concrete masonry infills were used in some of the commercial buildings as well as the State Hospital. Their performance appeared to be slightly better than those of the brick masonry. Figure 30 shows the concrete infills used in the State Hospital.

FIG. 30. Concrete block masonry infills used in the State Hospital.

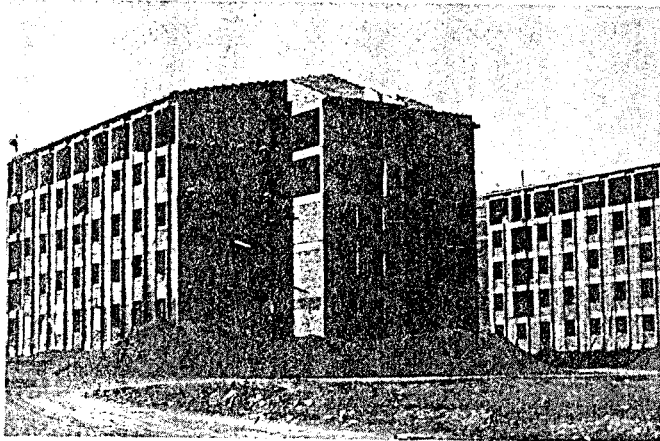
Only a limited number of reinforced concrete shear wall-frame interactive systems were found in Erzincan. A new condominium complex in the northeast had a number of buildings with shear walls placed in two orthogonal directions. These buildings, shown in Fig. 31, were under construction at the time of the earthquake, and did not suffer any damage. Another building that contained reinforced concrete shear wall-frame interactive system was the north wing of the new Police Headquarters. Ironically, the south wing of the same building, separated by a construction joints, did not contain any shear walls. As a result, the north wing showed a far superior response with no appreciable damage, while the south wing experienced extensive failure of unreinforced brick infills. Figure 32 illustrates the two

FIG. 31. Condominium complex in the northeast, utilizing frame-shear wall interactive systems.

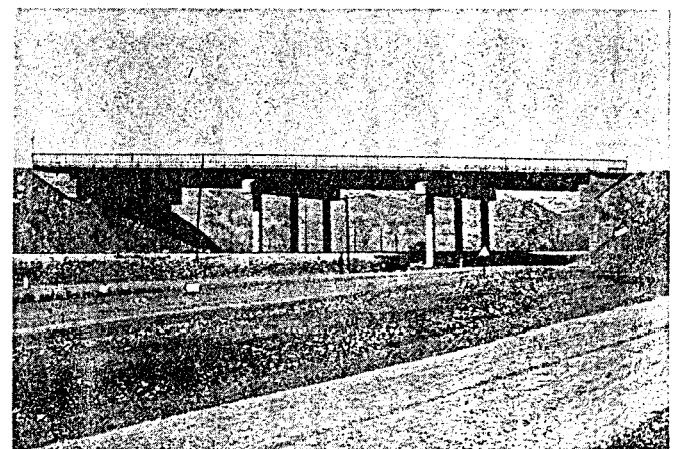
Only one of the bridges in the area suffered damage during the earthquake. This was a three-span reinforced concrete railroad overpass located on the southwest highway, leading to Kemah, just outside the city limits (Fig. 36). Each span was supported by three main girders that were resting on transverse beams monolithically built with three supporting piers. The middle span was 12 m long and the middle piers were 6 m tall. The piers had an 800 mm diameter circular cross section. The settlement of the abutments at both ends left separations that caused the bridge to be closed to traffic (Fig. 37a). The settlement at the north abutment led to the sliding and tilting of the retaining wall, which accidentally beared against the north piers, applying a horizontal force in the longitudinal direction (Fig. 37b). This resulted in flexural cracking of the piers at the ends, wide enough to signify yielding.

FIG. 36. Three-span reinforced concrete bridge on the southwest highway leading to Kemah.

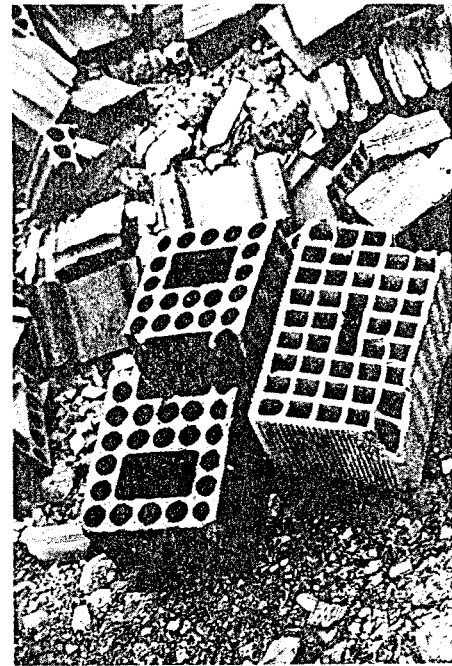
Two types of non-bearing masonry were commonly encountered: multi-cell clay blocks with large rectangular holes and with smaller circular holes, manufactured in Erzincan and Tokat, Turkey, respectively (Fig. 39).

FIG. 39. Examples of types of non-bearing masonry brick commonly encountered.

Although the usage of both types is improper in a bearing wall application, even such a slight variation in shape had repercussions on seismic behaviour. This was most forcefully illustrated in the neighbouring town of Uzumlu, 30 km east of Erzincan, where an entire residential complex of URM buildings was under construction at the time of the earthquake. Although the seismic intensity in this town was already less than in Erzincan, being attenuated by distance, a number of those new URM buildings collapsed. While others have alleged that a local soil effect was solely responsible for the damage sustained by the buildings built on the valley side of the Uzumlu complex, the authors believe that, in light of the severe difference in seismic performance observed over only a few hundred feet and a subjective evaluation of the local topography, such a soil effect can only be, at best, partly accountable for this damage. A closer observation revealed that, invariably, the walls built of the rectangular-cell URM blocks were severely damaged. This can be attributed to the poor resistance of these URM walls

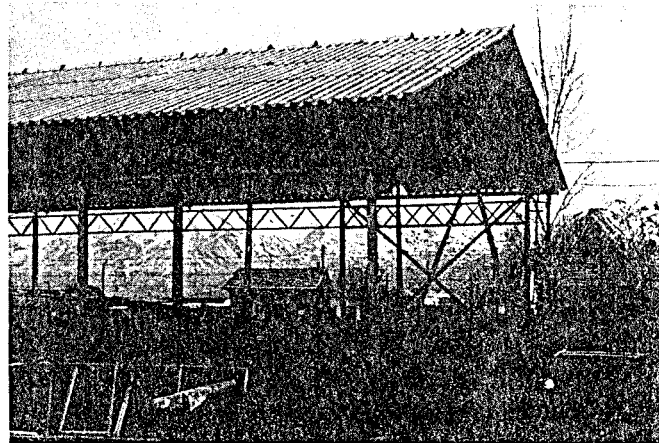
FIG. 45. Open-air steel warehouse of light corrugated steel roofing supported by steel trusses and columns which survived the earthquake (belonged to Rural Services Affairs).

One such survivor, of particular interest, belonged to Rural Services Affairs (Fig. 45). It had a light corrugated steel roofing supported by steel trusses and columns. Four equally spaced inverted-chevron braced frames and two X-braced frames were used in the N-S and E-W directions respectively. As all bays on the north side of the warehouse were used as loading docks, no X-braced frames were located on that side. Braces of the inverted-chevron and X-braced frames had slenderness ratios (KL/r) of 246 and 207 respectively. It is noteworthy that the maximum slenderness ratio for ordinary compression members allowed by the Turkish steel code (TS-498) is 250, slightly more liberal than the 200 limit specified by the CSA-S16.1-M89. Eccentricities of up to 125 mm were observed between member axes at the gusset plates connecting the diagonal members to the other structural components. Welded connections were used throughout, and the very poor quality of workmanship in the executions of those welds could be easily appraised from simple visual inspection.
