Performance of bridges in the 1994 Northridge earthquake

Denis Mitchell, Michel Bruneau, Martin Williams, Donald Anderson, Murat Saatcioglu, and Robert Sexsmith

Key words: Northridge, earthquake, seismic, bridges, damage, performance.

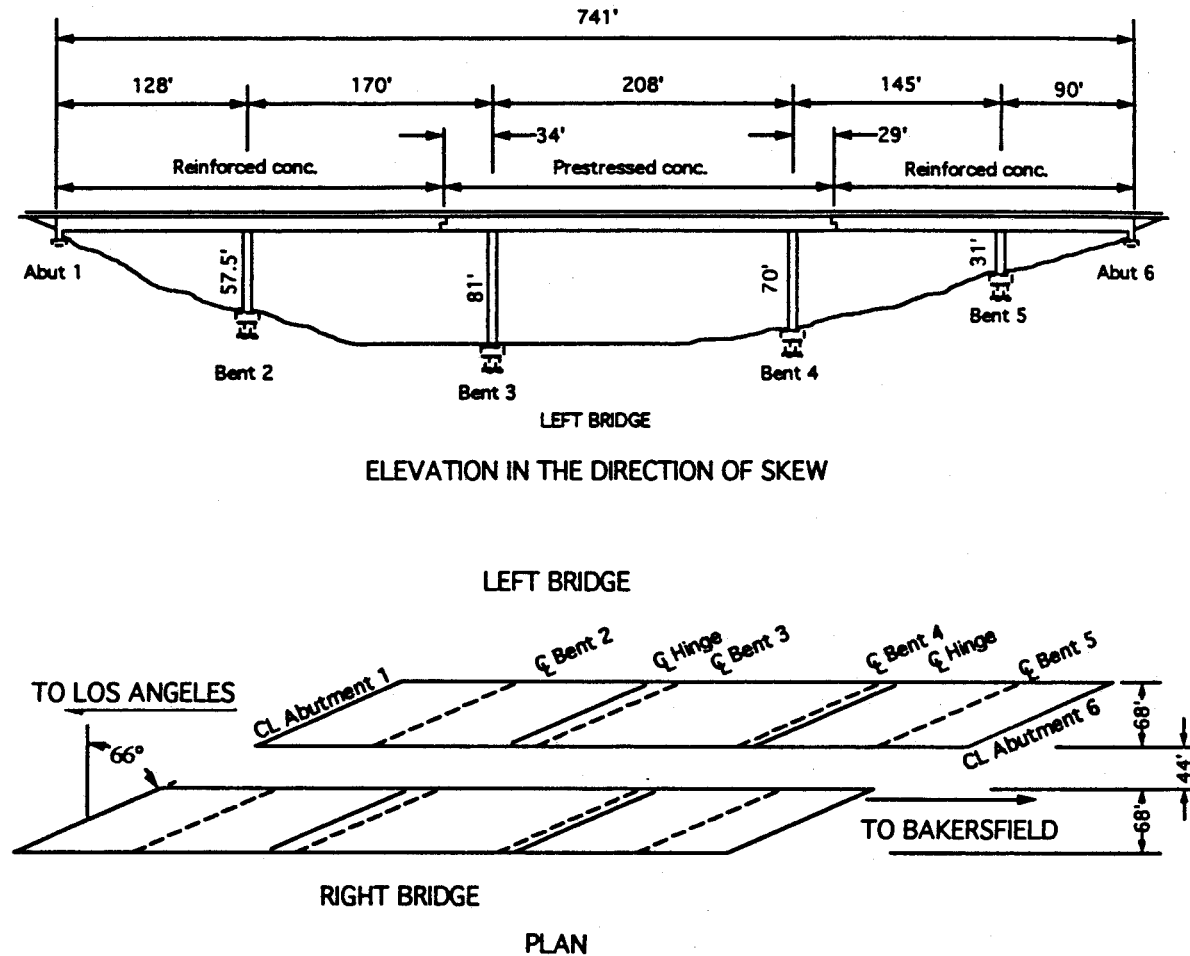
Fig. 17. General layout of Gavin Canyon Bridge (after Priestley et al. 1994).

The value of restrainers was again evident in the Northridge earthquake, although there were some failures. The collapse of the Gavin Canyon bridge was attributable to unseating even though it had been retrofitted with restrainers, while a small number of minor problems caused by faulty restrainer design was also noted at other bridges. These are discussed below. Apart from these few cases, all of which related to very early restrainer designs, joint restrainers performed satisfactorily, and again proved to be an inexpensive but effective retrofit measure in preventing loss of span failures.

This bridge, constructed in 1964, carried Interstate 5 across a canyon approximately 15 km north of the epicentre. The peak ground acceleration in this area, estimated from early attenuation relations, is thought to have been around 0.44g (Priestley et al. 1994), although there were higher recorded peak ground accelerations further to the north at Newhall. Initial estimates from CALTRANS were 0.6g (Yashinsky 1994). The bridge consisted of two nearly identical structures, carrying northbound and southbound traffic, oriented at a very high skew angle of 66°. Each structure consisted of a five-span box girder deck, continuous over flared twin-column bents and built in at the abutments (Fig. 17). Movement joints were located in the second and fourth spans, thus splitting the deck into three separate sections. The central
