Performance of steel structures during the 1994 Northridge earthquake

Robert Tremblay, Peter Timler, Michel Bruneau, and André Filiatrault

Abstract: The performance of concentrically braced steel frames and moment resisting steel frames during the January 17, 1994, Northridge, California, earthquake is examined. Most of the observations made during the reconnaissance visits confirmed the current knowledge on the inelastic response of these structural systems. This permits the anticipation of proper seismic behavior for buildings designed according to the seismic provisions that have been recently introduced in the Canadian building code and standard for steel structures. In some cases, however, the observed damage raised concerns that should be addressed in future investigations or next editions of these codes. Preventing potentially hazardous nonstructural damage, avoiding premature nonductile failures anywhere along the lateral load paths, limiting structural and nonstructural damage due to brace buckling, and accounting for the vertical ground motion are among those issues.

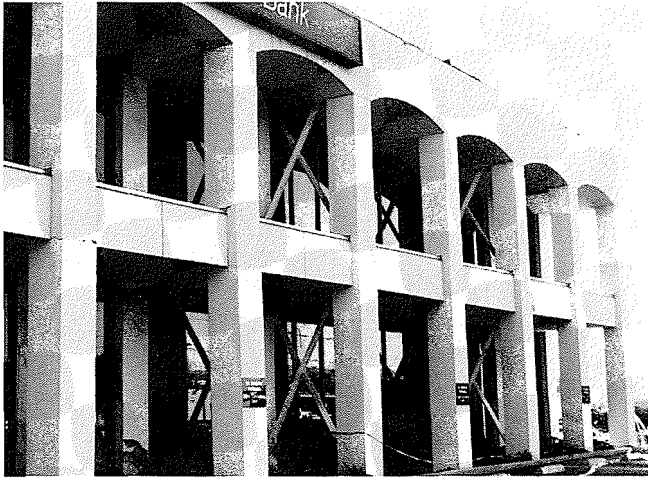
bracing members (Fig. 5). At the base of the columns of the X-braced bays, evidence of uplift could be observed, as the tiles on the ground and the stucco covering the columns were damaged (Fig. 6). This suggests that neither the anchorage nor the brace connecting plates could sustain the load that developed in the braces.

Fig. 5. First Interstate Bank Building in Northridge: buckling of connecting plate at brace intersection.

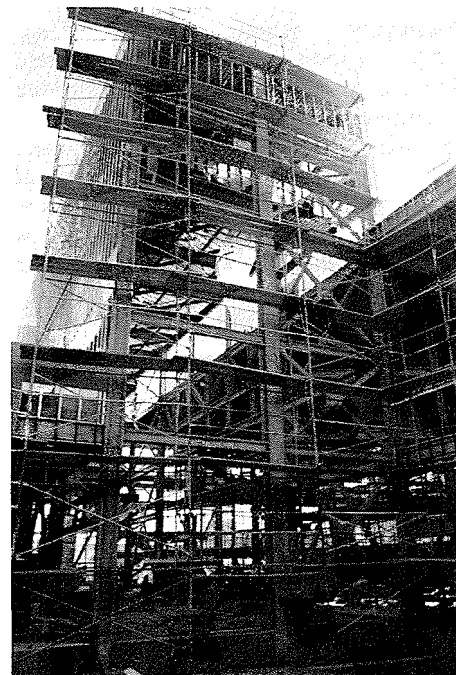
Fig. 7. Student Union Building at the California State University at Northridge: exterior view of building bracing system.

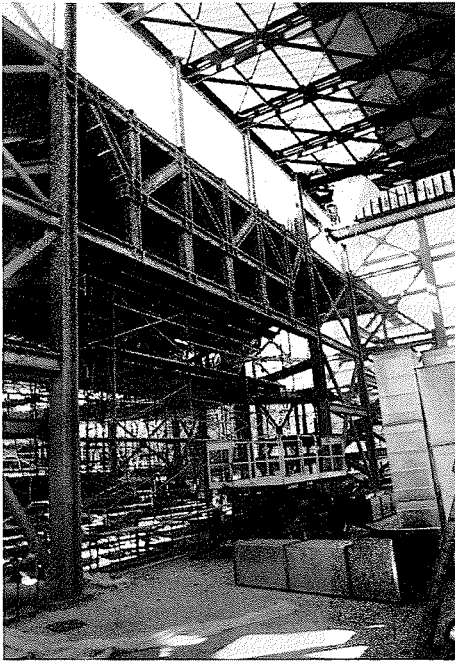
Fig. 8. Student Union Building at the California State University at Northridge: interior view of building bracing and details.

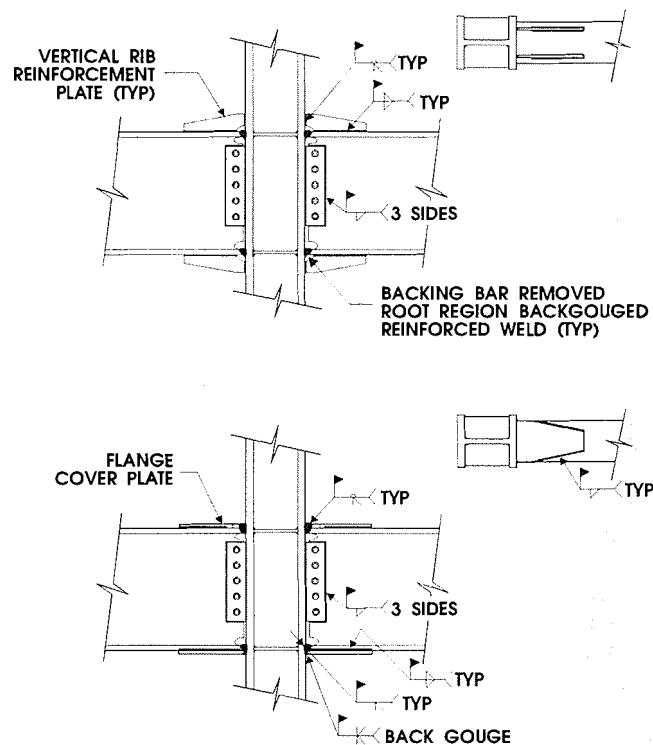
Fig. 45. Proposed reinforced beam-column joints for retrofit and new constructions: (a) vertical ribs; (b) cover plates (adapted from Engelhardt and Sabol 1994).

In March 1994, a special task committee of the American Iron Steel Construction (AISC) proposed interim recommendations for the repair of damaged connections and the design of new moment resisting frames (AISC 1994a). For repair, it was suggested that any cracked material or weld be removed and replaced by new steel material or welding. Of course, fabrication and welding practices were to strictly meet applicable code requirements. In addition, based on the current state of knowledge at that time, three options were proposed to enhance the performance of the joint. These are illustrated in Fig. 45 for the connection shown in Fig. 43.

Firstly, it was suggested that the backing bars of the beam flange welds be removed, the weld root region backgouged and rewelded, and, subsequently, a reinforcing fillet weld be applied. Second, the beam web was to be welded directly to the column or, alternatively, to the vertical shear connectors as shown in Fig. 45. The third correction consisted in adding flange reinforcement plates, either vertical ribs or cover plates, to help transferring to the column the axial loads acting in the beam flanges. The decision of using only one or more of those three schemes was left to the engineer. Examples of these repair procedures are presented by Sabol (1994) and by Tide (1994). For the design of new structures, AISC recommended to implement these repair provisions when
