Performance of masonry structures during the 1994 Northridge (Los Angeles) earthquake

Michel Bruneau

Abstract: The surface magnitude 6.8 Northridge earthquake which struck the Los Angeles area on January 17, 1994, damaged a large number of engineered buildings, of nearly all construction types. As earthquakes of at least similar strength are expected to occur in most of eastern and western Canada, the study of the effects of this earthquake is of particular significance to Canada. This paper, as part of a concerted multi-paper reporting effort, concentrates on the damage suffered by masonry buildings during this earthquake, and explains why the various types of observed failures occurred. The seismic performance of all masonry construction similar to that commonly found in Canada is reviewed, but a particular emphasis is placed on providing an overview of damage to unreinforced masonry structures which had been rehabilitated before this earthquake. To provide a better appreciation of the impact of this earthquake on masonry buildings, and a better assessment of the engineering significance of their damage in a Canadian perspective, this paper first reviews the evolution of buildi

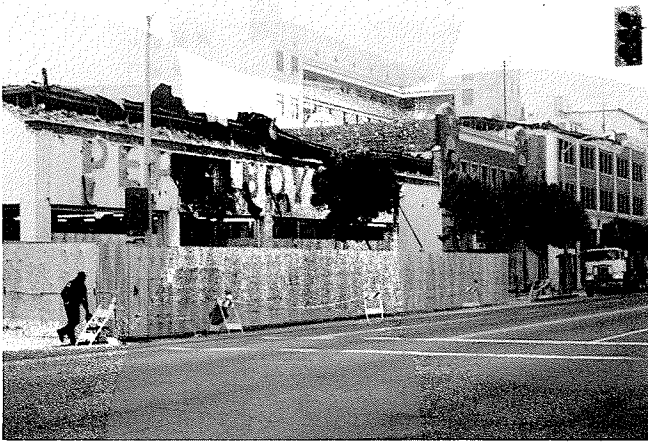
survived undamaged. For example, in Fig. 13, which effectively illustrates this satisfactory performance, an undamaged retrofitted building is adjacent to (although separated by an alley-way on one side) two nonretrofitted unreinforced masonry buildings which suffered considerable damage during this earthquake.

Fig. 13. Undamaged retrofitted unreinforced masonry building located between two severely damaged unreinforced ones, Santa Monica Boulevard, Santa Monica.

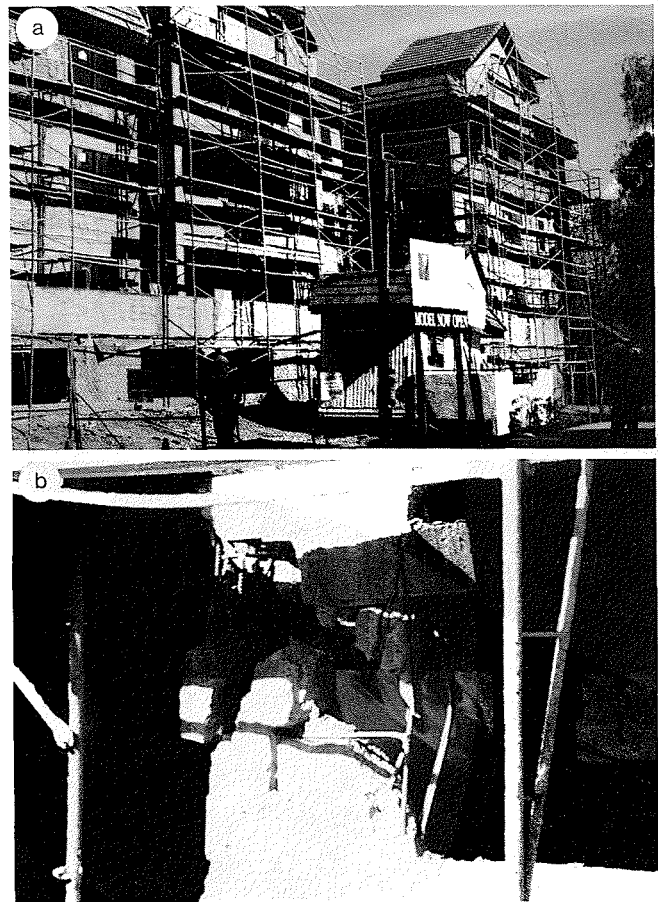
Nonductile shear failure of reinforced masonry piers occurred at the first story of the Kinzey at Northridge Condominiums. This very large residential building was still under construction at the time of the earthquake. Damage concentrated at the first story which had a significantly larger number of architectural openings (doors, windows, and garage access) due to the presence of a parking garage, making for a relatively softer story. Moreover, at that level, the aspect ratio of most reinforced masonry elements ensured that failure would be of the nonductile shear type (Fig. 33).

Fig. 33. Damaged reinforced masonry building, Kinzey at Northridge condominiums: (a) global view of building during construction; (b) closeup view of severe shear failure of first-story reinforced masonry pier.

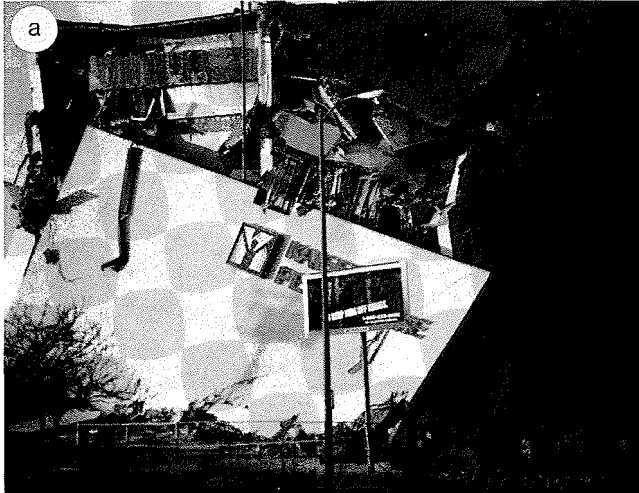
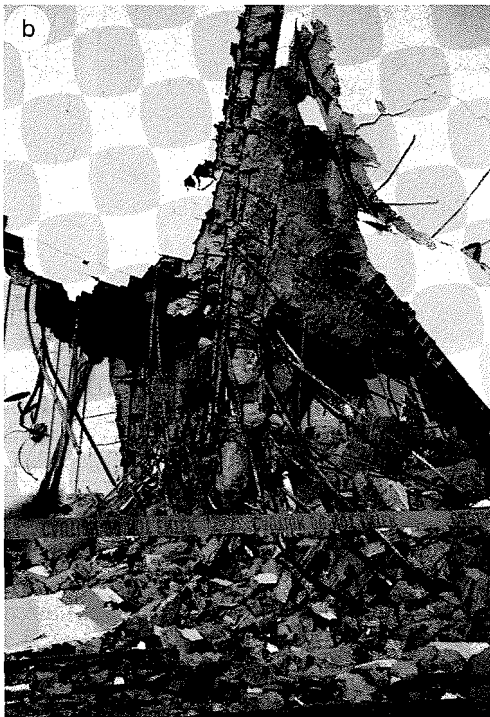
Finally, it is noteworthy that the Northridge Kaiser Permanente Medical Center, a five-story reinforced concrete building which collapsed, had a very large and stiff reinforced brick masonry wall spanning the entire 20 m (65 ft) width of the building in the east–west direction. Damage to this building was considerable, as a soft-story failure of the second floor occurred further to excessive damage to the nonductile reinforced concrete frame, which formed a collapse mechanism and swayed in the north–south direction, pushing the stiff reinforced masonry walls outward (Fig. 34a). Walls thus collapsed at both ends of the building. Numerous casualties would have occurred there had the earthquake struck during working hours.

Observation of the walls' reinforcement details, also made visible by the collapse (Fig. 34b), confirms that concrete edge-columns were embedded in the reinforced brick masonry end-walls designed to behave structurally if excited in the east–west direction. These heavily reinforced and stiff walls unfortunately provided little contribution to structural response in the north–south failure direction. Plans for the seismic retrofit of this building were ready; a construction permit had been obtained two months earlier, and the contractor was about to begin the seismic rehabilitation work when the earthquake struck. Four new 300 mm (12 in.) thick reinforced concrete walls were to be shotcreted, each wall spanning 14.6 m (48 ft) in the north–south direction. No retrofit

Fig. 34. Collapse of the Northridge Kaiser Permanente Medical Center, a five-story reinforced concrete building having solid stiff reinforced brick masonry wall spanning the short direction: (a) global view of collapse in the north-south direction; (b) closeup view of reinforcement details of end walls.
