Damage to masonry buildings caused by the 1995 Hyogo-ken Nanbu (Kobe, Japan) earthquake

Michel Bruneau and Koji Yoshimura

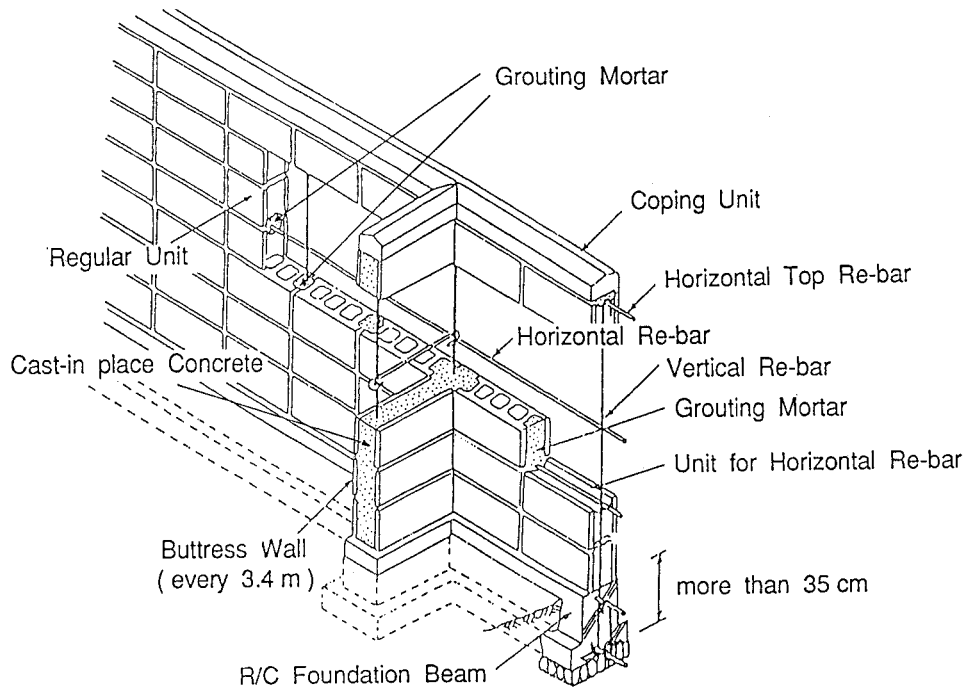
and AIJ Design Standard (AIJ 1994), which call for horizontal and vertical wall reinforcing bars spaced at 800 mm or less in both directions, deep anchorage of the vertical bars in the reinforced concrete foundation, a maximum wall height of 2.2 m, and other requirements as illustrated in Fig. 14. The current AIJ standard specifically aims at preventing this type of out-of-plane flexural failure as well as foundation rotation failure, even for walls without buttresses.

Fig. 14. Example of standard reinforcement specified by Japanese standards for concrete block masonry garden walls.
