Seismic design of steel buildings: lessons from the 1995 Hyogo-ken Nanbu earthquake

Robert Tremblay, Michel Bruneau, Masayoshi Nakashima, Helmut G.L. Prion, Andre Filiatrault, and Ron DeVall

Key words: earthquake, seismic design, steel structures.

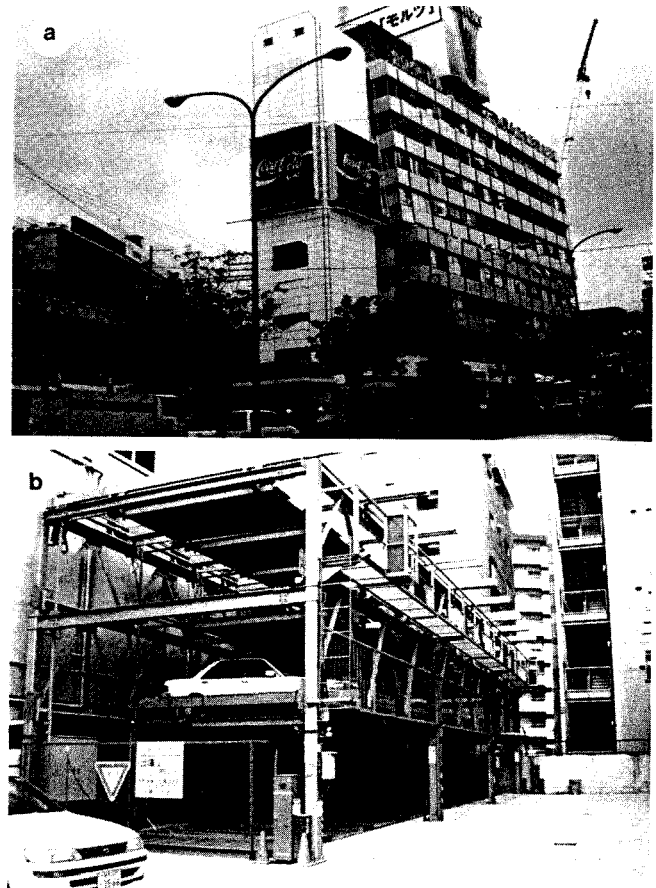
Fig. 16. Small parking facilities: (a) slender multistorey structure (to the left of the building with the collapsed 5th storey); (b) light two-storey parking structure.

Fig. 34. Shedding of the exterior cladding of the slender parking structure shown in Fig. 16a as a result of the out-of-plane buckling of chevron braces.

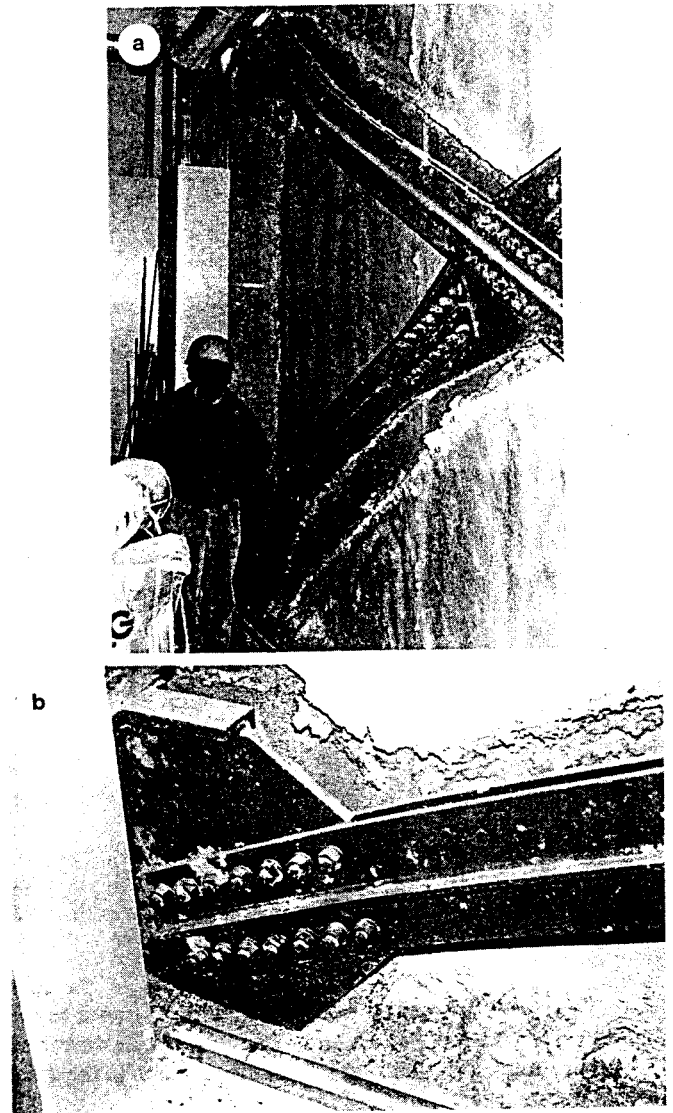
Fig. 29. Properly detailed slender tension-only bracing in a modern structure: (a) overview; (b) close-up of the end connection.

The Kobe experience also demonstrated (surprisingly perhaps) that tension-only braced frames with well-designed brace connections (Fig. 29) can behave in a satisfactory manner during strong ground shaking. Although this system generally exhibits lower energy dissipation capability due to a severely pinched hysteretic behaviour, it can represent a reliable solution for resisting earthquake-induced forces. Slender braces buckle in a nearly elastic mode, and hence are less vulnerable to low cycle fatigue than stockier compression acting braces, which experience intense inelastic action within plastic hinge regions. In addition, gusset plates in tension-only braced frames are exposed to lower compression loads than in tension-compression systems. Incidentally, in the 1994 NEHRP seismic provisions, the maximum slenderness ratio for bracing members in special concentrically braced frame systems (the equivalent in the United States of the Canadian ductile braced frame category) has been eliminated, as a result of the longer post-buckling life exhibited by more slender braces. A similar relaxation should be examined for ductile braced frames in Canada.

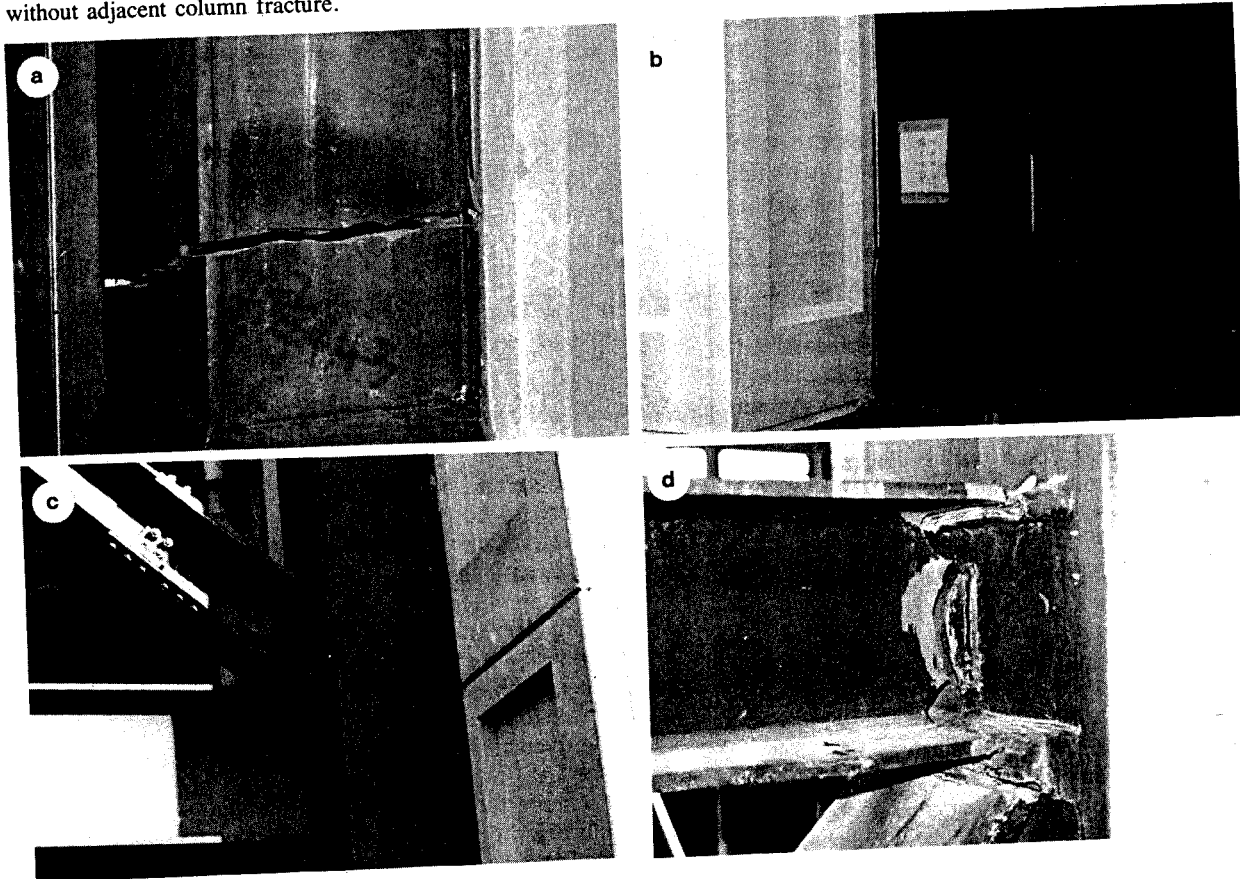
Fig. 40. Structural failures in the Ashiyahama Residential Complex: (a) fracture of the boxed columns away from the column splice; (b) failure of the boxed columns at the welded column splice; (c) fracture of the boxed columns at the column to brace connection, with extension into the brace; (d) failure of the web member to column welded connection, without adjacent column fracture.
