Preliminary report of structural damage from the Loma Prieta (San Francisco) earthquake of 1989 and pertinence to Canadian structural engineering practice

MICHEL BRUNEAU

Can. J. Civ. Eng. 17, 198-208 (1990)

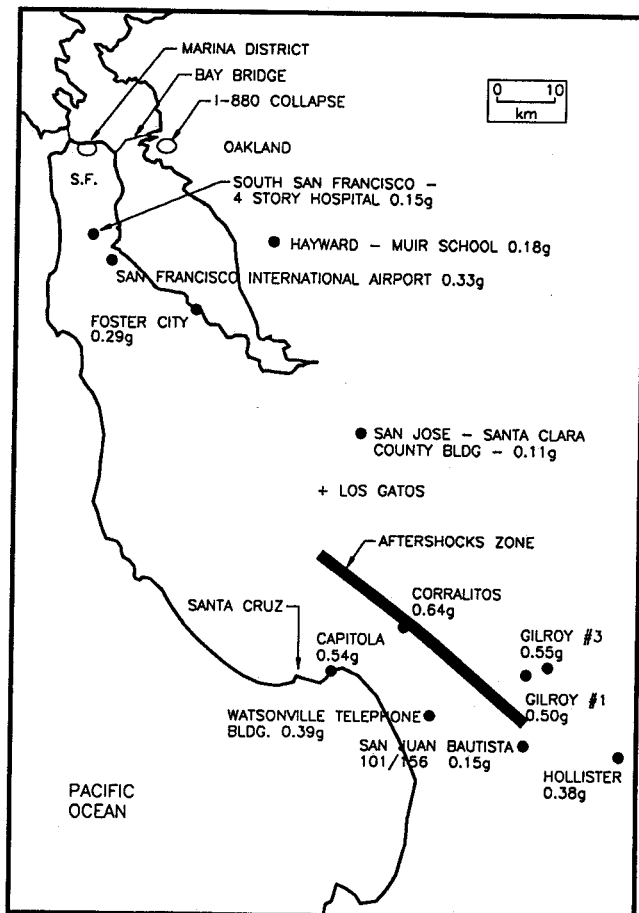
FIG. 1. Location of seismograph stations, damage areas, and aftershocks zone (adapted from CSMIP 1989).

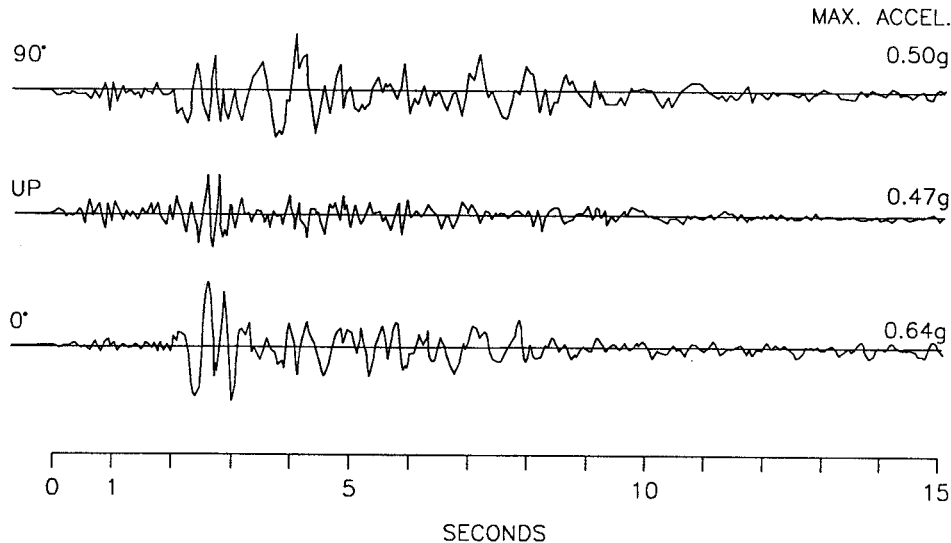
the Corralitos station (CSMIP station 57007) is presented in Fig. 2. Strong motion can be seen to last approximately 10 s, with some relatively long frequency oscillations. In a separate communication, the University of California, Berkeley, indicated that its seismograph station recorded a PGA of 0.09g.

FIG. 2. Ground accelerations seismograph records — Corralitos, CSMIP Station 57007, Record 57007-S4809-89291.00 (adapted from CSMIP 1989).

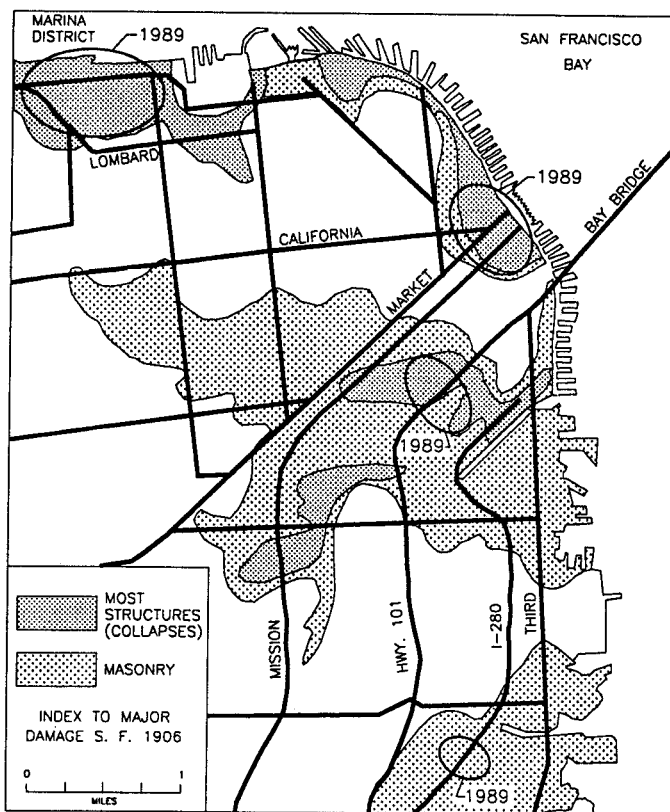
Generally, structural damage has not been uniformly widespread, but has rather been localized to areas where structures were built on soft soils. A comparison of locations where severe structural damage occurred in San Francisco due to both the 1906 and 1989 earthquakes (Fig. 3) emphasizes this observation; in both cases, damage was concentrated where land has been reclaimed from the bay. Consequently, most of the Bay Area survived the earthquake unaffected.

FIG. 3. Location of structural damage in San Francisco from the 1906 (adapted from Iacopi 1981) and 1989 earthquakes.
