DAMAGE TO ENGINEERED BUILDINGS FROM THE 1995 HYGOKEN-NAMBU EARTHQUAKE

ABSTRACT

A large number of engineered structures suffered damage due to the Hyogoken-nambu earthquake of January 17, 1995. Visual evidence of this damage to reinforced concrete and steel buildings together with preliminary descriptions of the possible reasons for this damage is given.

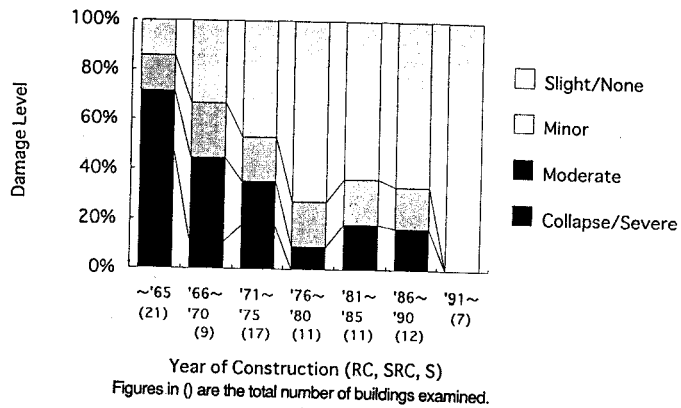
Fig. 1 Correlation between damage level and year of construction

limited the spacing to 150mm, further reducing it to 100 mm at the ends of structural members, thus providing more appropriate shear resistance and concrete confinement. Furthermore, the latest building code changes (1980) introduced other stringent ductile-design requirements as well as a two-level design procedure which effectively requires that the *ultimate* seismic-resistance of buildings be verified. As a result of this evolution of design requirements, striking contrasts in the life-safety protection afforded by adjacent buildings of different eras were readily observable following the earthquake (Photo 3). Although newer buildings sometimes suffered internal structural damage, they did not totally or partially collapse. This observation is supported quantitatively by data collected in a portion of downtown Kobe where damage was particularly severe (Fig.1).
