RECONNAISSANCE AND PRELIMINARY ASSESSMENT OF A DAMAGED HIGH-RISE BUILDING NEAR GROUND ZERO

GORDON WARN, JEFFREY BERMAN, ANDREW WHITTAKER* AND MICHEL BRUNEAU

SUMMARY

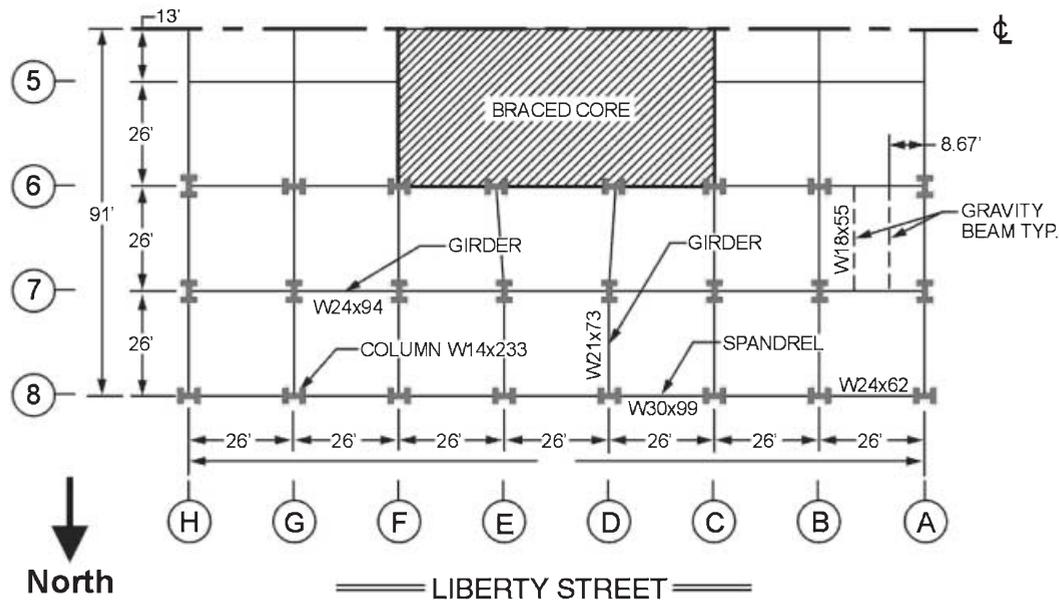
Figure 2. Part plan view of a typical floor

Both structural and non-structural components in the building suffered significant damage but all of the non-dust and non-mildew-related damage above the sixth floor appeared to be substantially confined to a two-bay by two-bay zone contained by Lines 6 and 8 and C and E. See Figure 2 for details. Non-structural damage did extend a short distance to the west of Line C and the east of Line E.

To facilitate three-dimensional finite element analysis of the building, sections sizes along frame Lines 6 and 7, including intermediate perpendicular framing, were determined based on: (1) information from the September 23, 2001, reconnaissance visit; and (2) gravity load considerations. The resulting column and beam sections at Tenant Level 25 are shown in Figure 2 for one half of a typical floor plan.

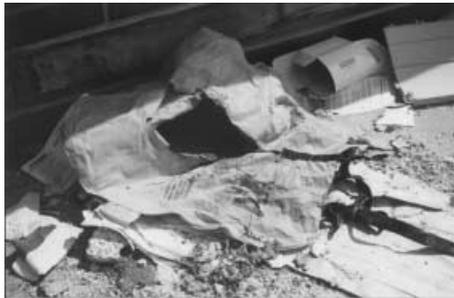
Figure 6 presents photographs taken at the roof level of the building. Part (a) of the figure is a photograph looking east across the roof. Silver U-shaped aluminum panels from Tower 2 can be seen in the figure together with life vests from American Airlines (AA) Flight 11 that struck the north face of Tower 1 (approximately 120 m from 130 Liberty Plaza). Part (b) of the figure is a photograph looking west across the roof. Aluminum panels and AA life vests are also visible in this figure. Parts (c) and (d) of the figure are close-up photographs of an AA life vest and a seat from the AA Flight 11.

c. American Airlines life vest

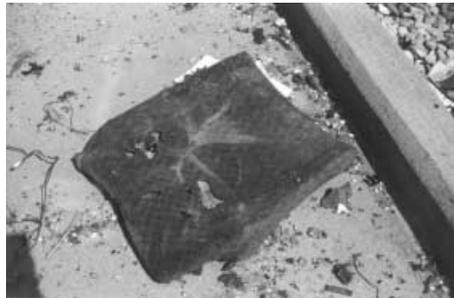
d. seat from American Airlines plane

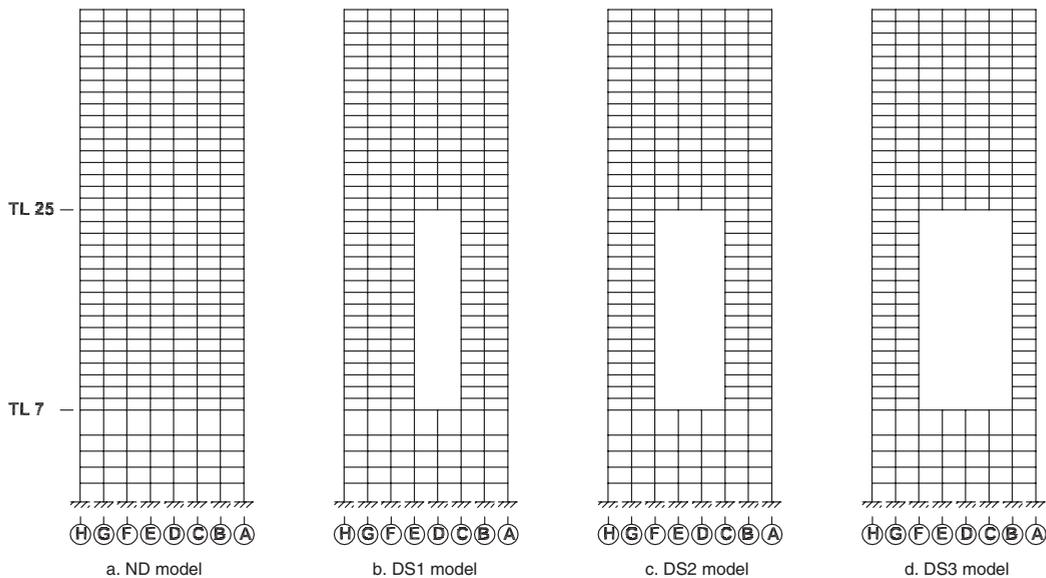
Figure 15. Two-dimensional mathematical models of framing on Line 8

Two- and three-dimensional finite element models were constructed using SAP2000 (CSI, 2000). First, a two-dimensional model (Figure 15a) was prepared that considered structural framing over all 39 stories along Line 8 (Figure 2). This model was constructed to study the response of a single frame with varying degrees of damage (or damage states). Second, a three-dimensional model was prepared that considered structural framing over all 39 stories along Lines 6, 7, and 8, including intermediate perpendicular framing (Figure 16). This model was prepared to better understand the response of the building for the observed damage state and to compare the results of two- and three-dimensional analysis. The light dashed line in Figure 16 identifies the zone of observed damage per Figure 15(b).

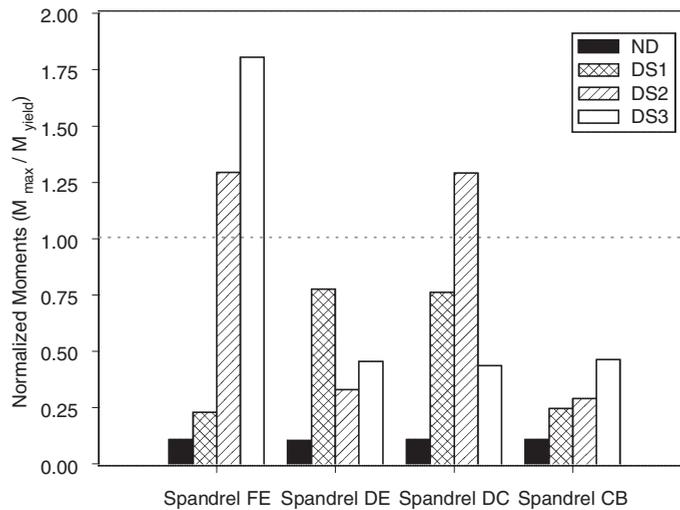
Figure 17. Demand-to-capacity ratios for two-dimensional linear elastic analysis

Figures 17 and 18 present some of the results of the two- and three-dimensional analyses, respectively. Shown in these figures are moments normalized by the yield moment for the assumed beam section sizes at Tenant Level 25, the floor level immediately above the observed damage. The spandrel beam designation (e.g., DE) refers to the grid lines between which the beam spans (e.g., Lines D and E). The girder designation (e.g., E87) refers to the grid line along which the girder is aligned (e.g., Line E) and the grid lines between which the girder spans (e.g., Lines 8 and 7). Such normalized moments represent demand-to-capacity (D/C) ratios for these elements, albeit not exactly, because M_y is used in lieu of $\phi \cdot M_{nx}$ and each beam is assumed to be fully braced.

Consider first damage state DS1 (the observed damage) and the two-dimensional analysis. All D/C ratios are substantially less than 1. The three-dimensional analysis shows similar results. These results provide an explanation for the observed behavior of the framing along Line 8 following the impact of debris from Tower 2 and the loss of a column on Line D, namely, that the moment-resisting framing above Tenant Level 25 provided an alternate (redundant) path for gravity loads around Line D and to the foundation without distress of the structural framing. As observed from DS1, models with increasing levels of damage (i.e., DS2 and DS3) showed that the moment-resisting framing above the damage provided an alternate path for gravity loads. However, for DS2 and DS3, Vierendeel truss action became more apparent.

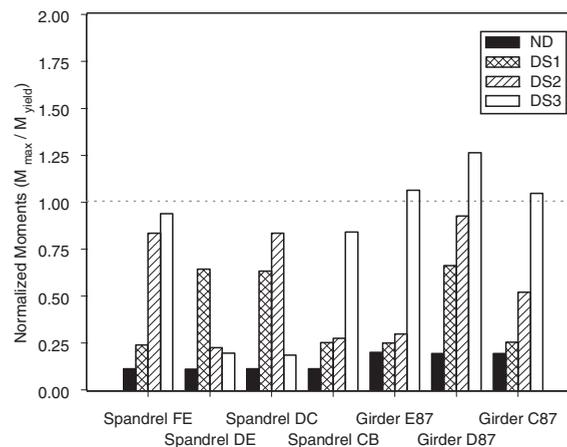
Figure 18. Demand-to-capacity ratios for three-dimensional linear elastic analysis

Review of the three-dimensional analysis results of Figure 18, however, shows that the use of the results of the two-dimensional analysis leads to conservative conclusions and that moment-resisting framing perpendicular to Line 8 also participated in the redistribution of load around the lost columns on Lines D and E. Analyses for both the two- and three-dimensional models of DS3 (the loss of columns on Lines C, D, and E) show modest overloads in both instances. For the three-dimensional analysis, the D/C ratios are greatest in the framing perpendicular to Line 8, namely, Girders C87, D87, and E87.

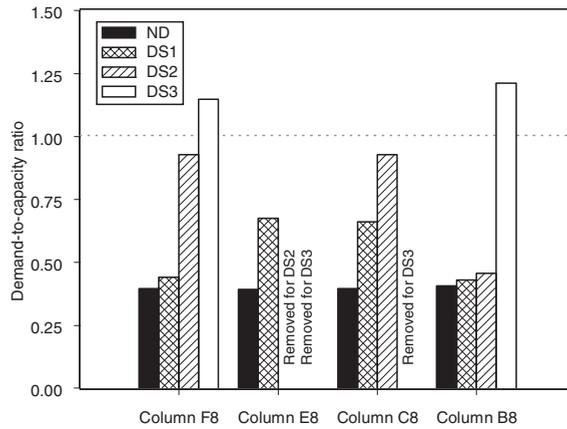
Figure 19. Demand-to-capacity ratios for two-dimensional linear elastic analysis

The results of the two-dimensional analyses shown in Figure 19 indicate D/C ratios less than unity for the undamaged state ND and the damage states, DS1 and DS2. For damage state DS3, the D/C ratios for columns F8 and B8 exceed unity. Ratios greater than unity can be attributed to an increase in both axial forces and moments due to the removal of columns C8, D8 and E8. This observed increase in bending moment for the two-dimensional analyses ranged from essentially zero for ND to approxi-

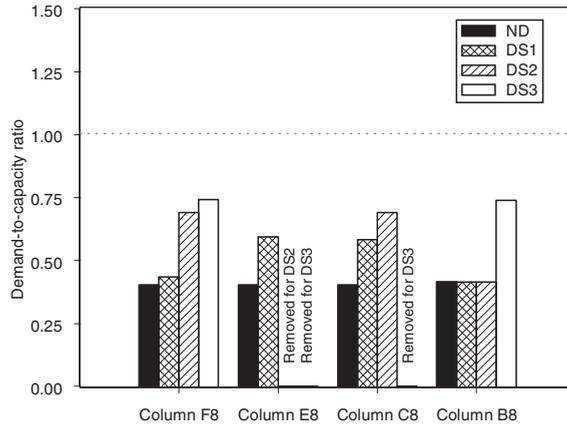
Figure 20. Demand-to-capacity ratios for three-dimensional linear elastic analysis

mately $0.25M_p$ (plastic moment of section) for DS3. Noting that the span between adjacent columns for DS3 is four times the span in the undamaged state ND an increase in moment demand is expected. The D/C ratios for the three-dimensional model (Figure 20) are less than unity for ND and DS1, DS2, and DS3. Again, the results of the three-dimensional analyses indicate that the use of two-dimensional analysis leads to conservative conclusions and that the presence of perpendicular framing provides additional redundancy and capability for gravity loads to be redistributed to adjacent framing.

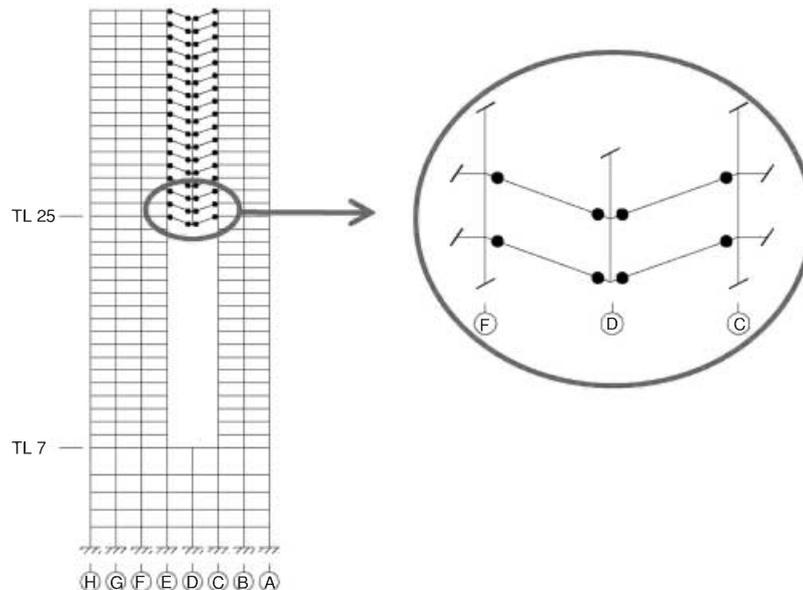
Figure 21. Two-dimensional collapse mechanism for DS1

Simple two- and three-dimensional plastic analyses were performed to determine an upper bound on the load-carrying capacity of the framing system for each of the three damage states identified previously. In both the two- and three-dimensional analyses, beam plastic moments were calculated assuming a yield stress of 36ksi and the section sizes determined in the preliminary design (Figure 2). All sections were assumed to be compact. Further, all beam-to-column connections were assumed to have unlimited rotation capacity. For the two-dimensional analyses, vertical 'panel' mechanisms were assumed to form for each damage state. Figure 21 shows the assumed mechanism for DS1. The assumed mechanisms for the three-dimensional analyses were similar, with the addition of hinges in the girders of the perpendicular framing where appropriate. Curtain wall loads and beam plastic moments were taken as known quantities, and the maximum corresponding floor load that could be sustained by the framing was determined for each case.

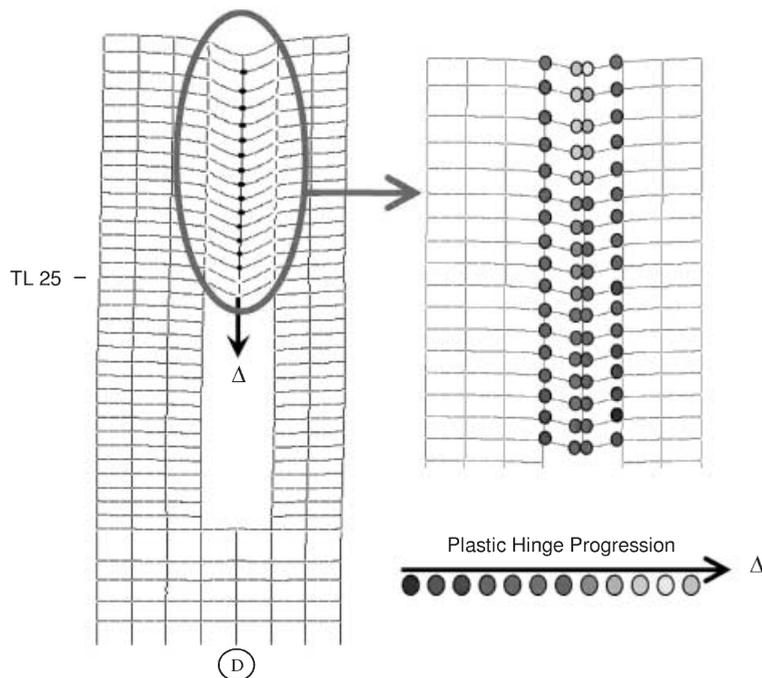
Figure 22. Progression of plastic hinge formation in DS1

Two-dimensional non-linear static or ‘pushdown’ analysis of the framing along Line 8 was performed for the three damage states to obtain insight as to the displacements that could be expected at the maximum floor loads predicted by simple plastic analysis. Elastic–perfectly plastic moment–rotation relationships were assumed for all beams. Connections were assumed to have infinite rotation capacity. The analyses were run using SAP2000 under displacement control and used the node at Frame Line D and Tenant Level 25 as the control node. The loading pattern was a series of equal-valued point loads at the locations where the floor beams and perpendicular girders frame into the spandrel elements on Line 8. Prior to running the displacement-controlled non-linear static analysis, the curtain wall load was applied as a single force controlled step because it had been accounted for in the plastic analyses. Figure 22 shows the observed progression of plastic hinging for DS1. The hinging patterns for DS2 and DS3 were similar to DS1. Hinging started at the beam-to-column connections on Lines E and C near Tenant Level 25, progressed to the connections on Frame Line D, and then vertically up through the framing on Line 8.

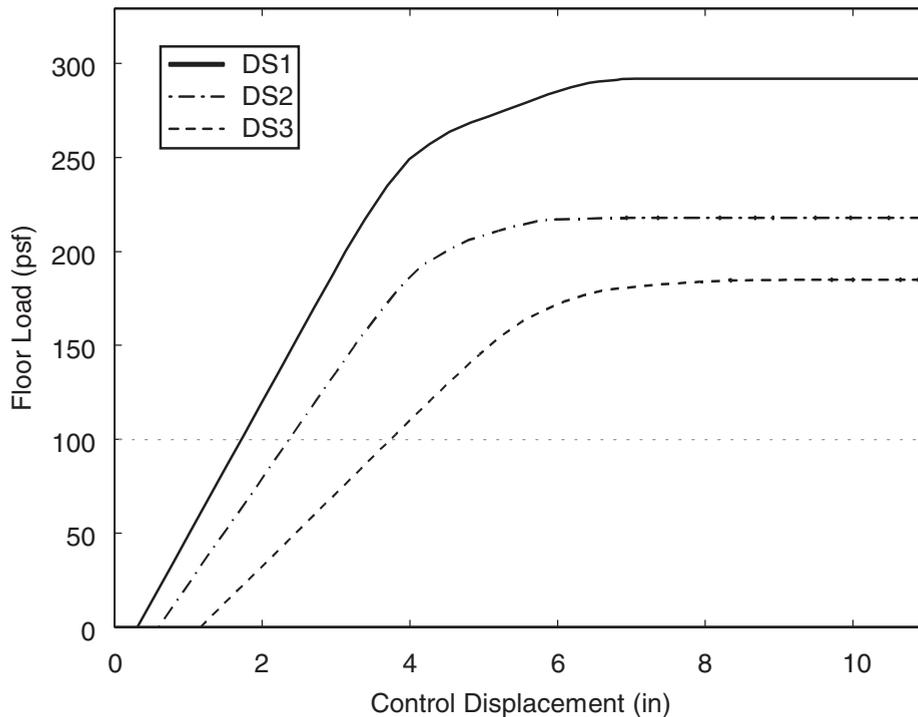
Figure 23. Two-dimensional pushdown curves for DS1, DS2, and DS3

Figure 23 shows the resulting relationships between floor load (psf) and the deflection of Line D at Tenant Level 25 for the three damage states, where the floor load is assumed to be present over the entire width of the damaged zone (i.e., between Lines C and E for DS1, Lines C and F for DS2, and Lines B and F for DS3). The initial displacements seen in the figure correspond to the deflection due to the prior application of the curtain wall load. Also shown in this figure is the research team’s estimate of the likely maximum floor loading at the time of the attacks of September 11, 2001, of 100psf. As expected, an increase in damage led to increased structural flexibility and reduced the maximum permissible floor load. The results of the non-linear static analysis and those of the simple plastic analysis are in good agreement for all damage states.
