Behavior of Unreinforced Masonry Structures During the 1992 Erzincan, Turkey, Earthquake

by Michel Bruneau¹ and Murat Saatcioglu²

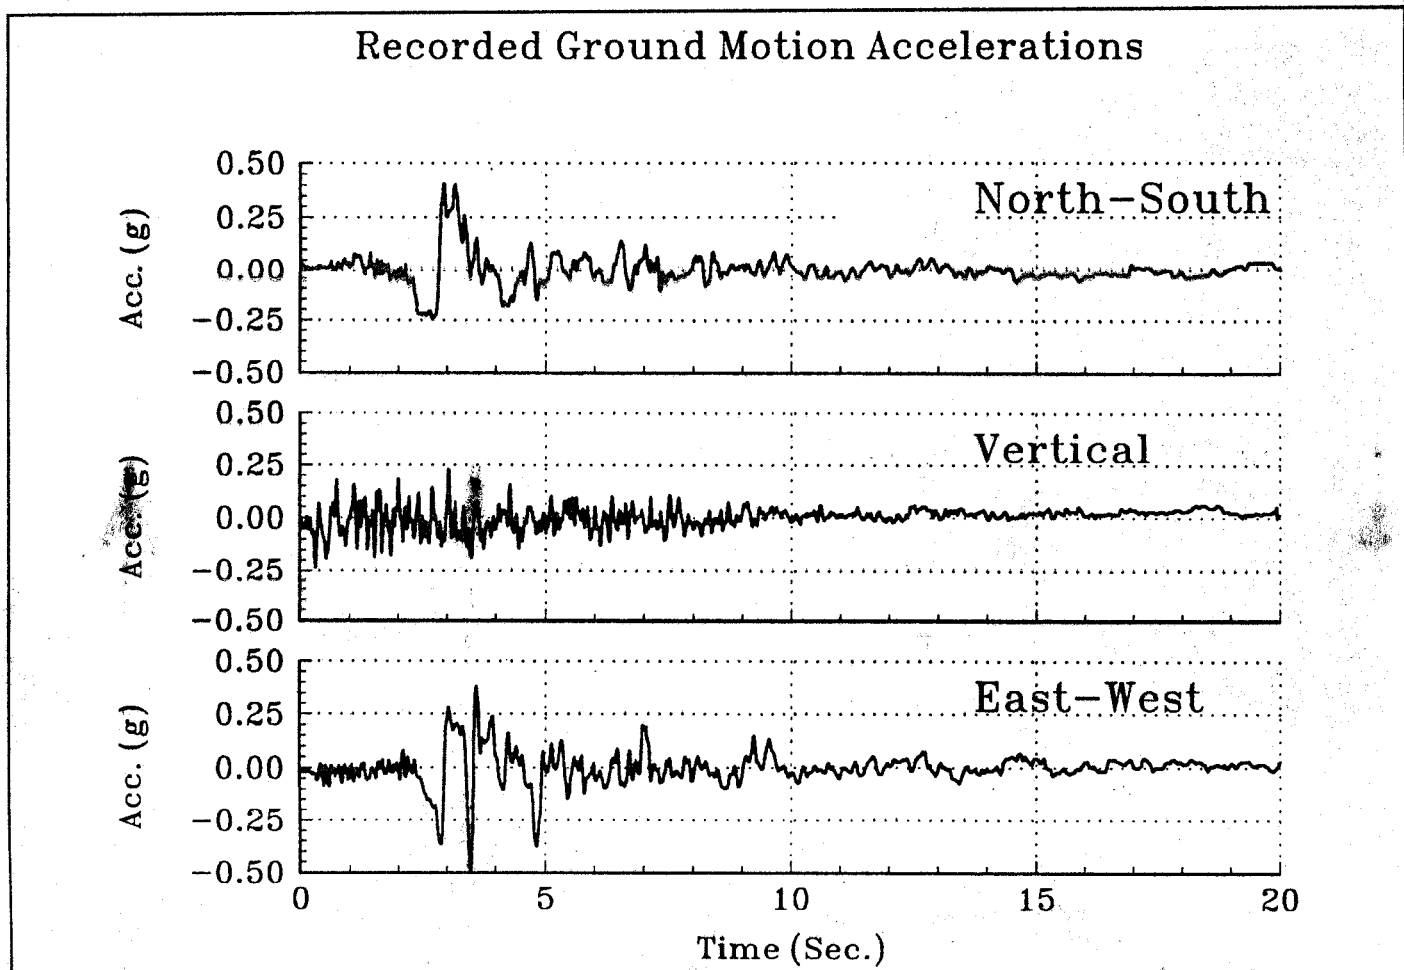
FIGURE 1. Strong motion accelerograms

A single strong motion instrument was present in Erzurum at the time of the main shock. It was located in the Meteorological Services Building, approximately in the center of the town, situated above a deep soil deposit. The three digitized acceleration time histories recorded by this instrument along its orthogonal axes were obtained by the writers, and are plotted in Figure 1. The values of horizontal PGA recorded, 0.39g and 0.49g in the N-S and E-W directions respectively, are compatible with those anticipated at such a close epicentral distance for an earthquake of this magnitude as per the existing applicable attenuation relationships (4).

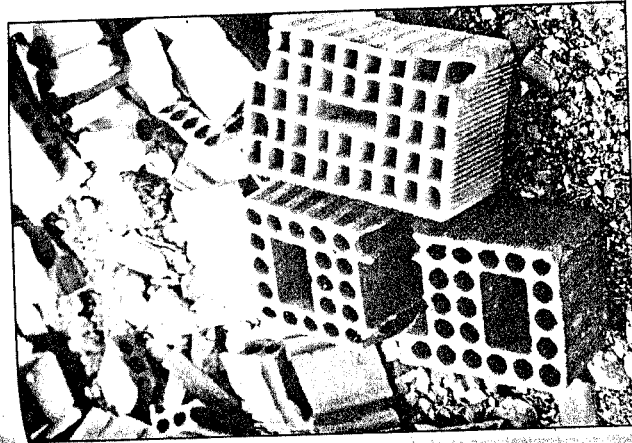
FIGURE 3. Examples of types of non-bearing masonry brick commonly encountered

Two types of non-bearing masonry were commonly encountered: multi-cell clay blocks with large rectangular holes or smaller circular holes, manufactured in Erzurum and Tokat (Turkey) respectively (Figure 3). Although the usage of both types is improper in a bearing wall application, even such a slight variation in shape had repercussions on seismic behavior. This was most forcefully illustrated in the neighboring town of Uzumlu, 30 kilometers east of Erzurum, where an entire residential complex of URM buildings was under construction at the time of the earthquake. Although the seismic intensity in this town already was less than in Erzurum, buildings collapsed. While a number of those new URM buildings collapsed. While others have alleged that a local soil effect was solely responsible for the damage sustained by the buildings built on the valley side of the Uzumlu complex, the writers believe that, in light of the
