## PERFORMANCE OF CHURCHES DURING THE DARFIELD EARTHQUAKE OF SEPTEMBER 4, 2010

Myrto Anagnostopoulou<sup>1</sup>, Michel Bruneau<sup>2</sup> and  
Henri P. Gavin<sup>3</sup>

### SUMMARY

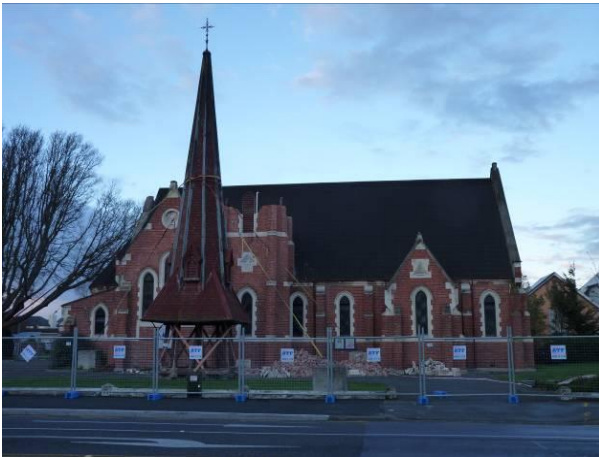
The Christchurch Chinese Methodist Church in Merivale (165 Papanui Rd, 43030'49"S-172°37'19"E) is an unreinforced masonry building with a square tower on top of which rests a pyramidal spire. The building suffered out-of-plane wall failures of its gables, as shown in Figure 1, and was characterized as unsafe to access. In order to facilitate the reconstruction and strengthening of the damaged building, the spire was lifted off its supporting tower with a crane and placed on the ground as illustrated in Figure 2 and Figure 3.

**Figure 2:** General view of Christchurch Chinese Methodist Church with tower and spire [Photo by M. Anagnostopoulou].

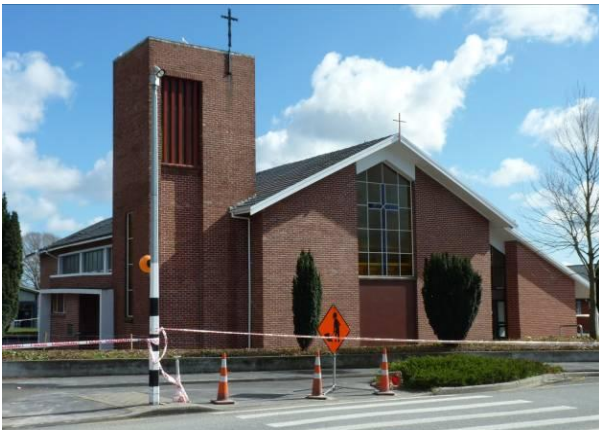
St Paul's Catholic Church in Dallington (17 Gayhurst Rd,  $43^{\circ}31'10''\text{S}$ - $172^{\circ}40'21''\text{E}$ ) was built in 1957 (Figure 8). The building has a rectangular shaped plan view and its structural system consists of concrete portal frames and masonry infill walls [2]. The 2010 earthquake caused an extensive amount of liquefaction and ground deformation in the church's surrounding area (Figure 9). As a result, significant settlement and vertical cracking were observed in the body of the building (Figure 10). Differential settlement across the length of the church separated the lower part of the structure, leaving a wide gap in the roof (Figure 11). The church was determined to be unsafe for occupancy and is to be demolished [2].

**Figure 8:** Front view of St Paul's Catholic Church [Photo by M. Anagnostopoulou].

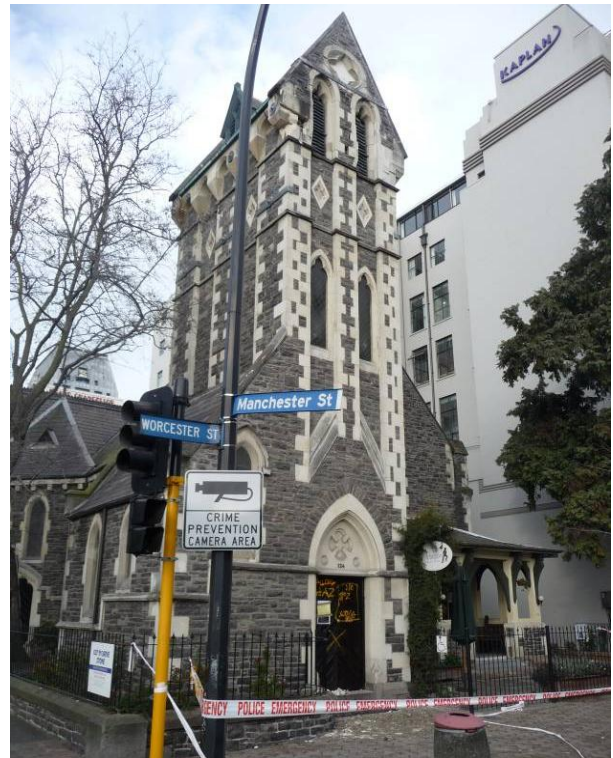
The Trinity Congregational Church in central Christchurch (124 Worcester St, 43°31'52"S-172°38'22"E) was built in 1874 and has a Gothic style [6] (Figure 19 and Figure 20). Recent retrofitting and strengthening of the building, including several anchor ties (Figure 21), appears to have reduced the damage from the 2010 earthquake. Minor cracking, spalling of the building's thick stone walls, and damage in the tower were observed (Figure 22). The building will reopen as soon as repairs are completed [7].

**Figure 19:** General view of Trinity Congregational Church [Photo by M. Bruneau].

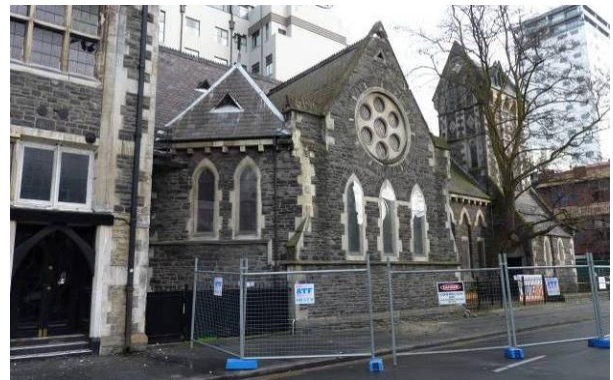
**Figure 20:** Side view of Trinity Congregational Church [Photo by M. Anagnostopoulou].

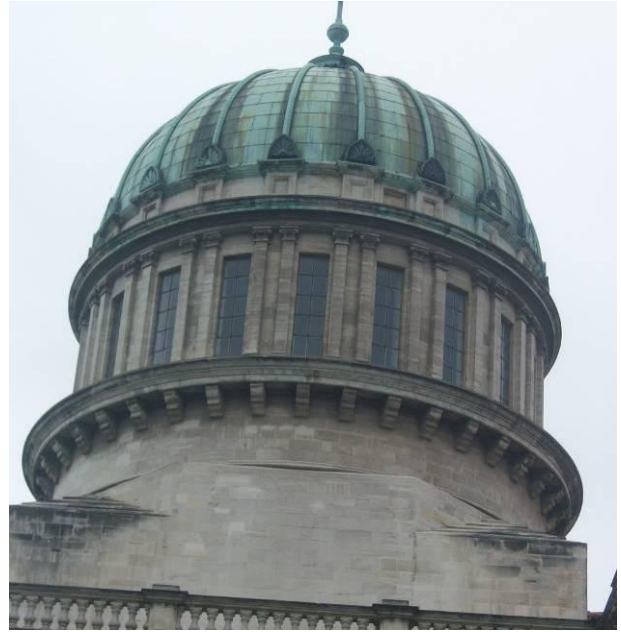
The Cathedral of the Blessed Sacrament in central Christchurch (122 Barbados St,  $43^{\circ}32'17''\text{S}$ – $172^{\circ}38'46''\text{E}$ ) has a basilica form and is constructed of poured concrete between walls of large limestone blocks [9]. The wall thickness is 1.2 meters. “The Basilica” was built over four years and opened in 1905. Seismic upgrades in 2004 included strengthening of the drum below the dome (Figure 24), the bell tower, the mezzanine floor, and the roof above the mezzanine. The drum was strengthened with cast concrete ring beams above and below the windows which were joined by pilaster columns. Spandrel beams and cross bracing were added inside the bell towers. The 2010 earthquake caused little in the way of horizontal shear cracks at construction joints in the walls or in the retrofitted portions. Repairs to cracks around the keystone of window arches and in the mezzanine floor above the sanctuary require that “the Basilica” remains closed for at least a year (Figure 25).

**Figure 24:** *Dome and drum of the Cathedral of the Blessed Sacrament [Photo by H. Gavin].*

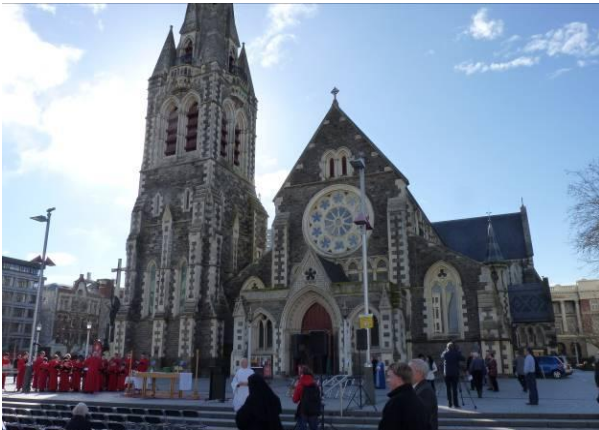
Because of these renovations, the structure suffered insignificant damage during the 2010 earthquake (Figure 27). The only damage was to ornamental stone details. The Cathedral remained closed until September 22 due to the risk of falling debris during aftershocks. Careful and repeated inspections of the Cathedral revealed no significant structural damage.

**Figure 27:** General view of Christchurch Cathedral [Photo by M. Anagnostopoulou].

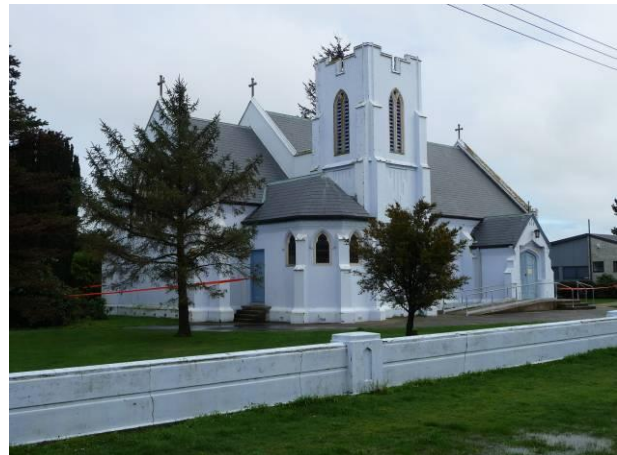
St Joseph's Catholic Church in Darfield (Telegraph Rd,  $43^{\circ}29'32''\text{S}$ - $171^{\circ}06'32''\text{E}$ ) is a masonry structure located only a few kilometres away from the epicentre (Figure 30). During the 2010 earthquake, the church suffered cosmetic wall cracks as illustrated in Figure 31.

**Figure 30:** General view of St Joseph's Catholic Church [Photo by M. Bruneau].
