PRELIMINARY FINDINGS ON PERFORMANCE OF BRIDGES IN THE 2010 DARFIELD EARTHQUAKE

SUMMARY

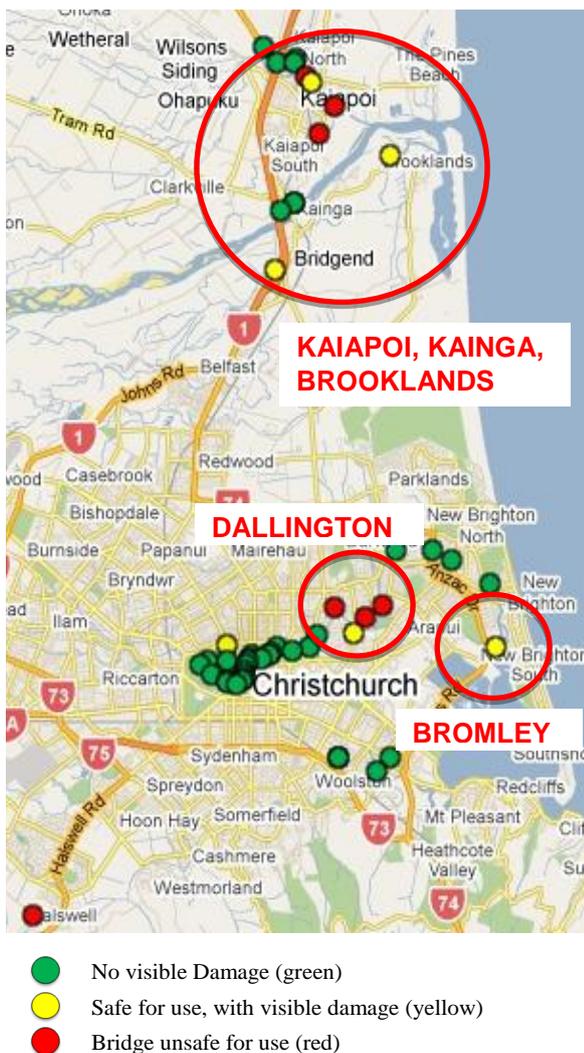
Bridges were graded similarly to buildings. A green label/tag meant no visible damage, a yellow label stands for safe for use with visible damage, while red label/tags were given to bridges prone to collapse (unsafe for use). Location of red and yellow bridges can be seen in Figure 1.

Figure 1: Map showing inspected bridges approximate areas of high levels of liquefaction.

A strong correlation was observed between areas where bridge damage was observed, and areas where liquefaction occurred. This correlation is shown in Figure 1. The areas enclosed in circles are the areas where extensive liquefaction occurred.

Fourteen of the fifteen damaged bridges were inside the areas that experienced extensive liquefaction. The detailed liquefaction assessment map developed by Environment Canterbury [3] prior to the earthquake confirms that the major bridge damage occurred in the high sensitive liquefaction areas.

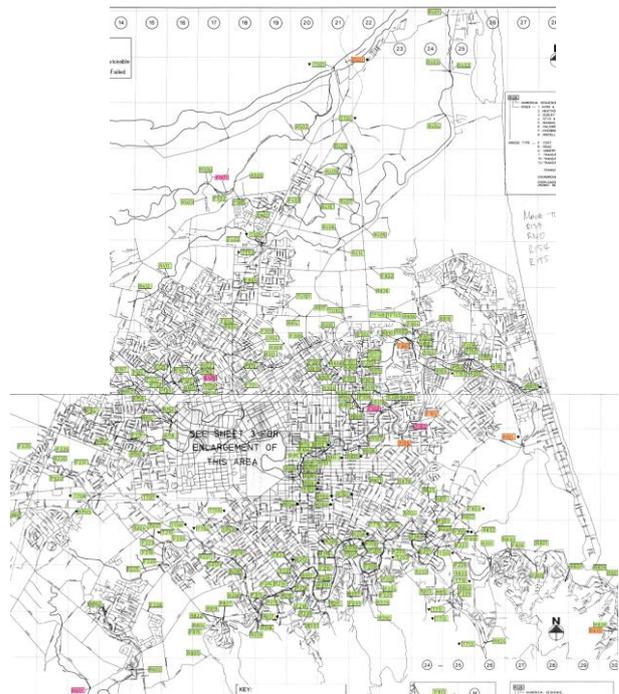
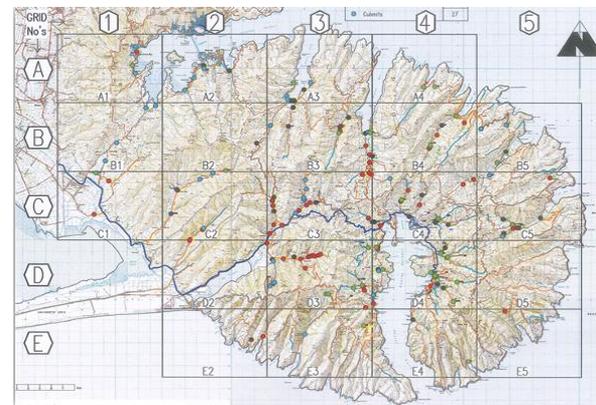
Figure 2: Christchurch City Council and Banks Peninsula bridges inspected by Opus [Courtesy of M. Cowan, Opus International].

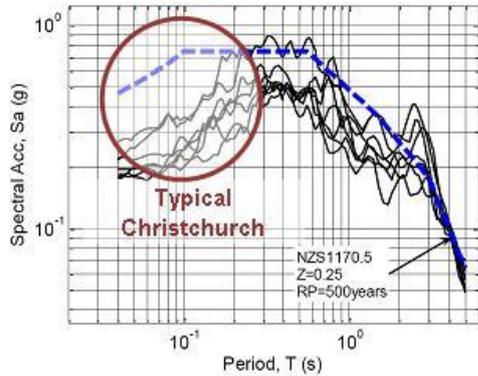
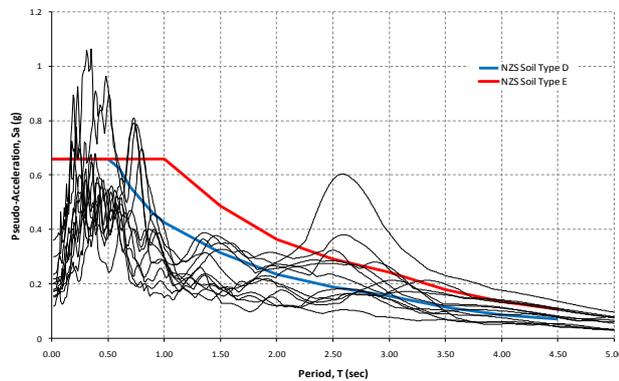
The overall lack of damage to the structural systems of the short to mid-span bridges can be explained by closely inspecting the acceleration response spectra of typical sites in Christchurch and Kaiapoi areas. Figure 3 compares the NZS1170 Design Spectra for site soil classes D and E [2] against the horizontal acceleration response spectra of six strong motion stations within the Christchurch and Kaiapoi areas. For periods in the range of 1.50 seconds and less, the response spectral acceleration is on in average below the design spectral acceleration; whereas for periods above 1.5-2.0 seconds the spectral acceleration exceeds the design spectrum level. The approximate period range of a Christchurch short to mid-span road bridge is indicated by a circle in Figure 3.

Within this period range, it is quickly seen that the actual spectral acceleration is considerably less than the values that a bridge should have been be designed for.

Figure 3: Horizontal Acceleration Response Spectra (ARS) of six seismometer stations in the Christchurch and Kaiapoi areas against the NZS1170 Design Response Spectra (DRS) for Soil Classes D and E [2] (Generated by M. Anagnostopoulou based on Geonet data).

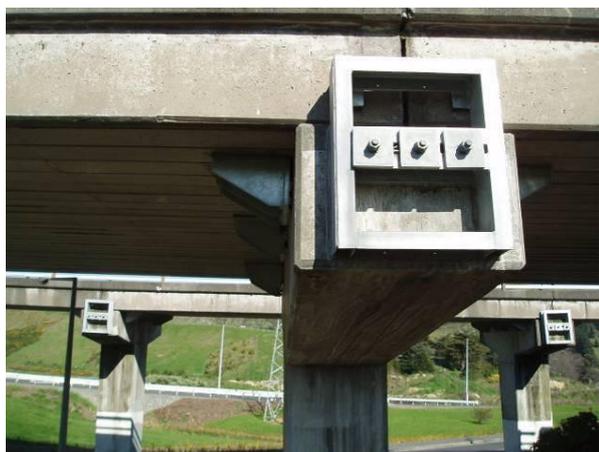
One of the most widespread retrofit programs was undertaken by Transfund New Zealand (now incorporated into NZTA) [7], which saw the installation of tie-rods and devices such as the transverse shear key shown in Figure 14. Similar devices were installed on bridges on most of the regions highways.

The post-earthquake investigations have not been in depth enough to ascertain if these devices were activated during the seismic shaking. However, it is positive that no bridges that were retrofitted under this program were structurally damaged. Lateral spreading had been identified as an issue on some key life-line bridges. The Ferrymead Road Bridge is one such case, where the concerns due to liquefaction were so great that the entire bridge was replaced. The abutments of the new bridge were specifically designed to accommodate lateral spreading. The bridge was not damaged during the earthquake, and although this was not a design level event, the strong performance of the bridge, helped to validate New Zealand governing bodies' commitment to life-line projects.

Figure 14: Transverse shear key and tie-rod retrofit of SH74 port hills overpass [Photo courtesy of Anthony Rooke, OPUS].
