LESSONS LEARNT FROM 2011 CHRISTCHURCH EARTHQUAKES: ANALYSIS AND ASSESSMENT OF BRIDGES

SUMMARY

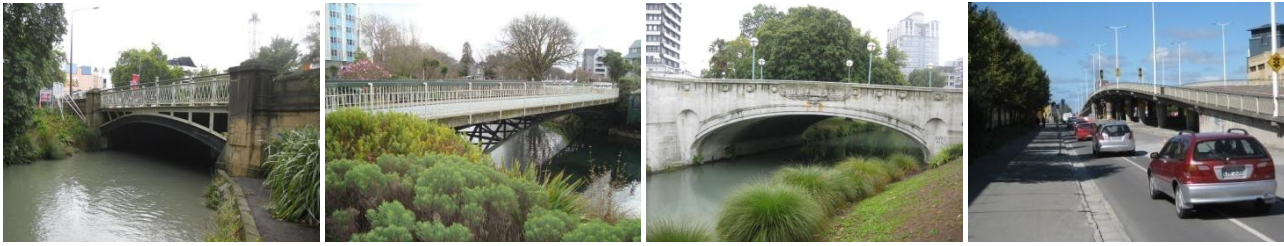
Figure 4: Selection of damaged bridges in the CBD area. From left to right: Colombo Street Bridge; Bridge of Remembrance; Antigua Street Footbridge; Moorhouse Avenue Overpass.

Most of bridges located in the Christchurch central business district (CBD) are historic structures that marked an important stage in the economic and social development of an effective transport network laid out in 1850 by the Canterbury Association survey of Christchurch. Initially simple structures and originally made of timber, many had been replaced by the 1880s with massive single span concrete bridges. The good performance of the main spans of these bridges was mainly due to their monolithic structure, acting as a stiff strut between river banks affected by lateral spreading. No collapses were registered and bridges maintained their vertical load carrying capacity after the earthquake. Nevertheless, for this same reason the majority of damage was registered at the abutments (flexural cracking) and at the approaches (settlement and spreading). Some of the most severely damaged bridges in the CBD are shown in Figure 4, with details of the damage suffered by each bridge summarized in the following sections.

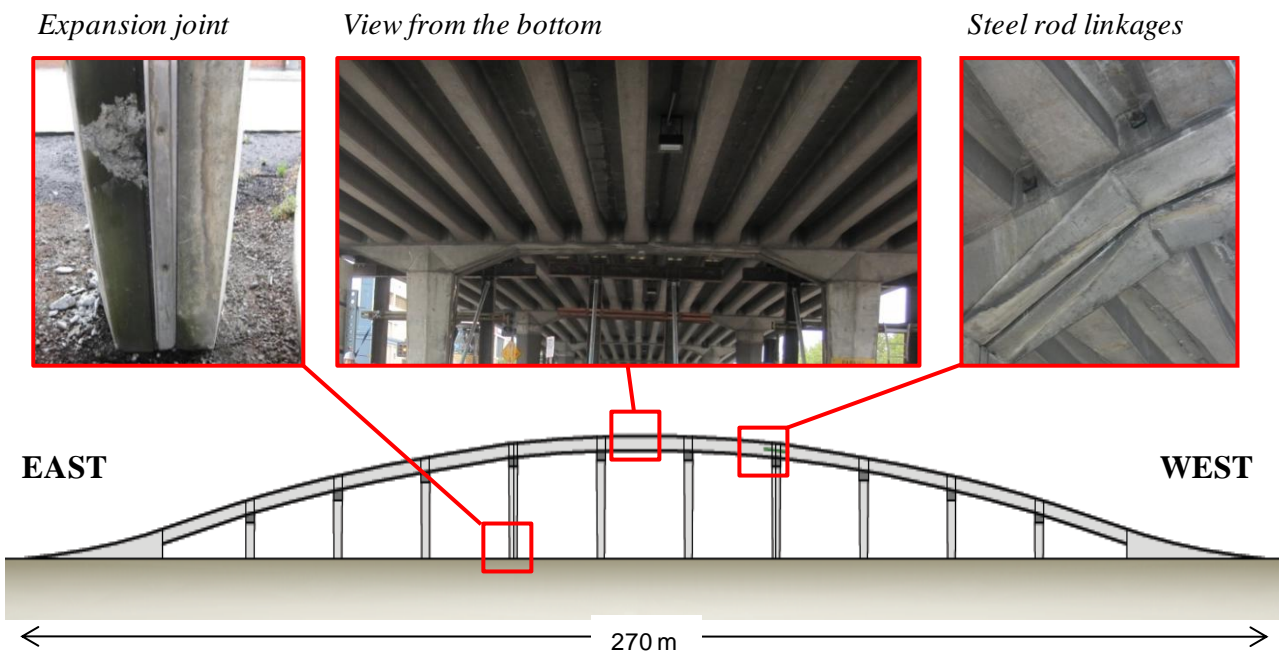
This bridge was designed prior to current design philosophies, which has resulted in regions where the seismic performance of the structure is deficient through the presence of brittle failure mechanisms. Significant pier damage developed during the 2011 Christchurch earthquake due to transverse ground shaking. The overall performance of the structure was unsatisfactory, with significant shear cracking and buckling of the piers. This damage affected the vertical load carrying capacity of the structure along with the lateral capacity. As a result of this damage, the bridge was closed for over five weeks following the February 2011 earthquake while strengthening works were undertaken.

The bridge sustained damage to one column near the north-east approach where a deck expansion joint was located. The insertion of steel rod linkages in the deck at the expansion joint at only one side of the bridge induced irregularity in the structures transverse response. In fact, with the west and central part of the bridge linked, the bridge pier at the eastern expansion joint suffered extensive displacement demand. The slenderness of the pier affected the vertical load carrying capacity of the structure along with its lateral capacity. The columns also had widely spaced transverse reinforcement, making the structure susceptible to shear failure, a brittle failure mechanism (Figure 10a). Observations after the 2011 Christchurch earthquake indicated that the damaged columns had started to buckle (Figure 10b) putting the central span at risk of collapse. In this instance, damage was induced by extensive ground shaking; large transverse horizontal accelerations may have caused a flexural-buckling failure mechanism in the columns.

Figure 9: *Moorhouse Avenue Overpass. Sketch of the bridge elevation with locations of the expansion joints and steel rod linkages (Taken from [5]).*

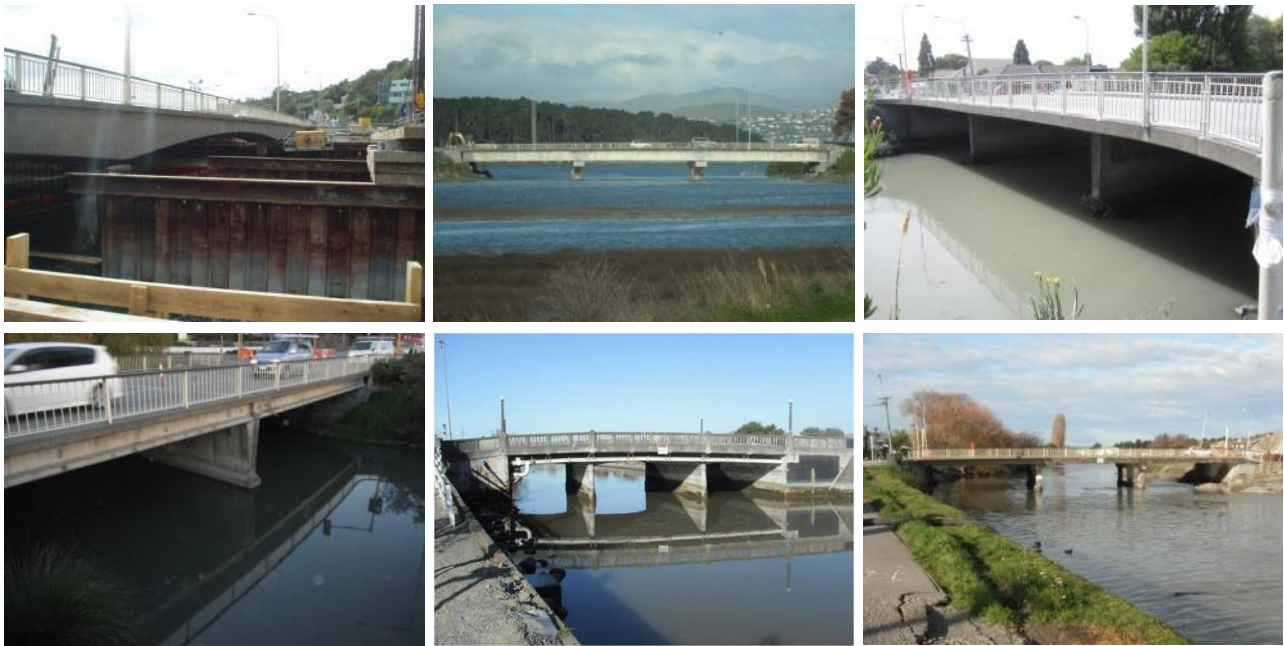
The following sections summarise a selection of Christchurch City Council road bridges (Figure 12) in the east and southern suburbs that sustained the most significant damage.

Figure 12: Selection of damaged road bridges. Clockwise from top left: Ferrymead Bridge; Bridge Street Bridge; Gayhurst Road Bridge; Avondale Road Bridge; Pages Road Bridge; Fitzgerald Avenue Bridge.

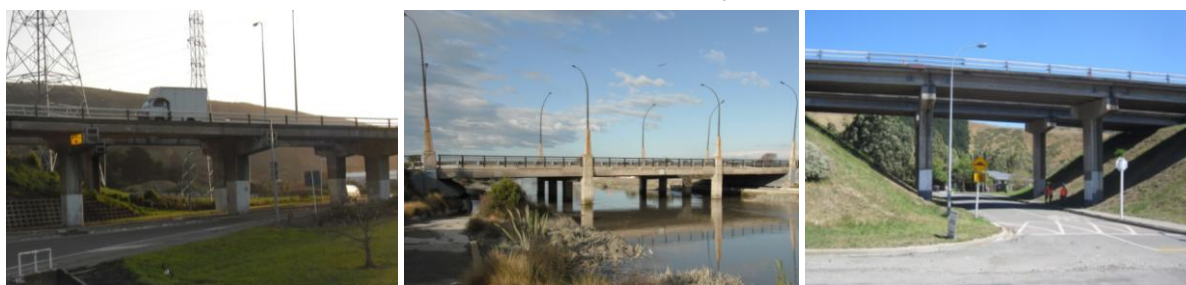
Thirty State Highway (SH) bridges were located within 20 km of the 2011 Christchurch earthquake and the 13 June 2011 aftershocks. Eighteen of these were inspected as part of a preliminary study of their earthquake performance. Included in this total were four groups of twin bridges with each pair in three of the sets having similar but not identical details. The fourth pair of twin bridges (Styx Overbridges) were constructed at different times and differed significantly in structural form and detail. Most of these bridges had also been inspected after the 2010 Darfield Earthquake. (A further nine bridges more distant from the 2011 epicentres were inspected following the 2010 Darfield Earthquake). Inspection and analysis details of the three bridges shown in Figure 18 are summarised here.

Figure 18: Selection of damaged State Highway bridges after February 22, 2011. From left to right: Anzac Drive Bridge [Photo by E. Camnasio]; Horotane Overbridge [Courtesy of Opus]; Port Hills Overbridge [Courtesy of Opus].

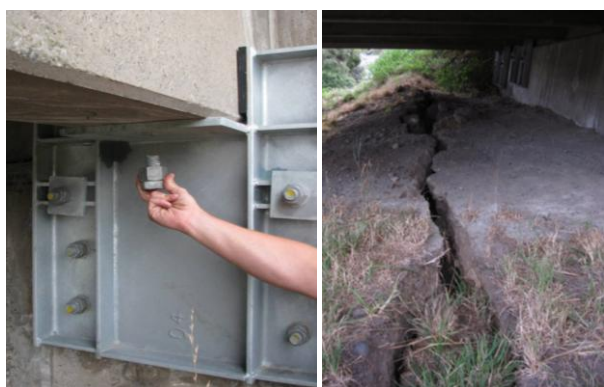
There was significant differential settlement between the approach pavements and the abutments of both bridges as evidenced by repairs to the asphaltic concrete pavement near the abutments. The approach roadway kerbs were damaged in several locations by compression against the abutments resulting from forward movement of the backfill. Buckling of the guardrails and shearing of their connection bolts occurred at several of the joints between the approach guardrails and the bridge end posts.

Minor structural damage to the bridges had been observed following the 2010 Darfield Earthquake. The most significant damage was the loosening of all the abutment linkage rods on both bridges with the slackness under the washers varying between 5 and 10 mm.
