Multistorey steel framed building damage from the Christchurch earthquake series of 2010/2011

ABSTRACT: This paper presents preliminary field observations on the performance of selected steel structures in Christchurch during the earthquake series of 2010 to 2011. The Christchurch earthquake series comprised 6 damaging earthquakes, on 4 September and 26 December 2010, February 22, June 6 and two on June 13, 2011. Most notable of these was the 4 September event, at M7.1 and MM7 (MM as observed in the Christchurch CBD) and most intense was the 22 February event at M6.3 and MM9-10 within the CBD. The earthquakes impacted on a range of steel framed buildings, from single storey to the tallest building in Christchurch at 22 storeys. Many of the multi-storey buildings used eccentrically braced framed seismic-resisting systems (EBFs) and this earthquake series was the first time these systems have been pushed into the inelastic range. This paper gives an overview of the performance of selected buildings, with an emphasis on EBFs. Their performance in particular was very good and possible reasons for this are presented.

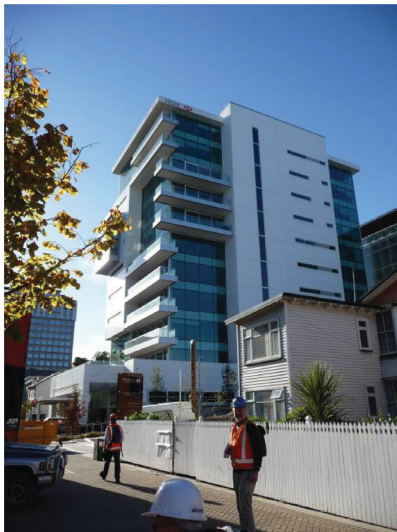
The Club Tower Building (Figure 2a), also known as the HSBC building, has eccentrically braced frames located on three sides of an elevator core eccentrically located closer to the west side of

the building, and a ductile moment resisting frame (DMRF) along the east façade. The steel frame is supported on a concrete pedestal from the basement to the 1st story, and foundations consist of a 1.6 m thick raft slab. Initially, only the EBFs on the east side of that core could be visually inspected without removal of the architectural finishes (Figure 2d), however, more detailed investigation was made of the South side active links through removal of ceiling tiles to ascertain the most significantly yielded braces. Figure 2c shows a link at level 3 on the South side which has the greatest observed inelastic demand. Estimates of the peak inelastic demand in that brace were made by two independent means. First was

(a) Global view

through assessment of the visible state of the metal in the yielded web of the active link and secondly through estimate of the peak interstorey drift. Both methods gave a peak shear strain of between 3% and 4%. The links were free of visible residual distortions. Assessment of damage accumulation in the steel at a peak shear strain of 4% over an estimated two complete cycles of loading using the damage criterion developed by Seal, (2009) and change in transition temperature based on the work of Hyland, (2006) showed that the yielded active links have sufficiently robust metallurgical properties to be left in place. Previously reported slab cracking (Bruneau et al., 2010) could not be detected as the concrete floor slab was covered by floor carpeting, except at one location at the fixed end of a segment of the floor cantilevering on one side of the building (a feature present only over two stories for architectural effect). Crack widths after February 22, 2011 appeared similar to what had been observed after September 4, 2010, being localised only. Substantial shear cracking of the gypsum plaster board (sheetrock) finish on the exterior wall of that cantilevering part of the floor was also observed (Figure 2b); only hairline cracking of gypsum plaster board finishes was observed elsewhere throughout the building, supporting post-earthquake survey measurements showing that the building has a post-earthquake residual drift of only 0.1%. One non-structural masonry block wall installed for sound proofing purposes adjacent to mechanical units on the pedestal roof suffered minor shear cracking, where it had been placed hard against a cantilevering floor beam.

Given the magnitude of the earthquake excitations, with demands above the ULS design level, substantial yielding of the EBF links would have been expected. EBFs designed in compliance with the NZS 3404 (SNZ, 1997/2001/2007) provisions are typically sized considering a ductility factor (μ , equivalent to R in US practice) of up to 4, corresponding to a level of link deformations that would correspond to significant shear distortions of the links. Yet, yielding was below that determined necessary in subsequent detailed assessment to require structural replacement of the EBF active links. Beyond the usual factors contributing to overstrength in steel frames (e.g., expected yield strength exceeding nominal values, modelling assumptions, etc.), a number of additional factors can explain behaviour in this particular case, including strength of the composite floor slab action (neglected in design), mobilization of the solid non-structural wall concrete cladding adjacent to the staircase, elastic stiffness of the gravity frame especially the columns and the relatively short duration of earthquake excitation.

The ductile MRF along the east wall did not show any evidence of yielding. Its design had been governed by the need to limit drift, particularly under torsional response due to the eccentricity of the core, and its corresponding effective design ductility factor (μ) was low at 1.25. Because the building strength and stiffness was over 2 times that designed for (based on observed lateral drift versus design lateral drift), this frame did not visibly yield.

Overall, the building was designed for a slightly lower level of structural ductility demand than is typical for an EBF, due to its height and plan dimensions, and performed well during the earthquake. No structural repairs were required; non-structural remedial work consisted of minor dry wall crack repair and realignment of the lift guide rails. The building was open and fully reoccupied in July 2011, becoming the first normal importance high rise building in Christchurch to be returned to use following the earthquake series.

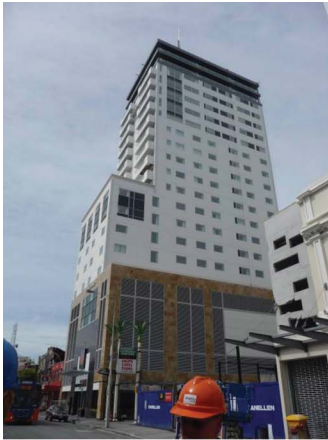
around the elevator core above those levels., with transfer slabs designed to horizontally distribute the seismic loads at those transition points. Several sections of the EBFs at levels below the level 6 transfer slab were visible, apart from at the top of the perimeter system, as these levels housed a mechanical multilevel parking elevator system. The separate bracing system of that mechanical device consisted of flat plates connected with turnbuckles and hooks. Some of those details failed as the bars un-hooked when returning into compression after tension yielding excursions that elongated the braces. The EBFs at intermediate locations (on the NW frame) were not integral with the floor slab and so did not benefit from the strength increase provided by that integral action throughout the rest of the building. A range of views for this structure are given in Figure 4.

Paint flaking and residual link shear deformations were observed in the EBF links at those levels. Design of the EBFs in that building was governed by the need to limit drift, with a corresponding resulting design ductility factor (μ) of 1.5 (even though up to 4.0 is permitted for EBF systems, as mentioned earlier). This is typical of EBFs in tall buildings in New Zealand's moderate to low seismic zones; Christchurch is moderate in accordance with the earthquake loadings standard, NZS 1170.5. When the initial internal inspections were undertaken, there was an absence of significant damage to architectural and other non-structural finishings except at level 6 where a few of the hotel room doors along the corridor could not be closed, suggesting greater residual deformations at that level. This level was the first in which a detailed evaluation was undertaken. One fractured EBF active link was discovered (Figure 4d) in the top level (underside of Level 6) of the EBF system at the North-Western corner of the building in August 2011, 6 months after the February event. When the fracture was caused is not known, however slightly concentrated non-structural damage at that level following the February event may indicate that it happened then. The frame sits behind the louvre system nearest the camera in Figure 4a. This link had undergone at least one full cycle of web panel yielding, as evidenced by the diagonal pattern of Luders' lines in the web panel, prior to a fracture propagating from one top corner across the active link region and resulting in significant residual deformation. Temporary strap cross-bracing was welded to the active link frame to provide lateral load resistance while a repair strategy was implemented, which comprised cutting out the damaged link, welding on an endplate system to each collector beam/brace face and replacing with a replaceable site bolted endplate active link. The replacement is scheduled for early October 2011 and is the only repair to the structural frame required for this building. A detailed evaluation was undertaken of all active links in the adjacent storeys and throughout the building, with no further links requiring replacement being found and discussion ongoing about replacing the link shown in Figure 4b. This inspection required removal of architectural finishes.

This type of failure has not been reported in either EBFs tested in the laboratory or from damage reports from other earthquakes; the reasons for this link fracture are not currently clear and it is to be the subject of a detailed metallurgical and structural evaluation once removed.

(a) Global view

As with Club Tower, some repair of dry-wall cracking and realignment of lift shaft guide rails is the only other work required and the intention is

to have this completed in time for the building to be fully opened when public access is restored into this area. It is also worth noting that this may be the only one of the six high-rise buildings in Christchurch that will be returned to service and requires much less repair than the others.
