# STEEL BUILDING DAMAGE FROM THE CHRISTCHURCH EARTHQUAKE SERIES OF 2010/2011

By: Charles CLIFTON<sup>1</sup>, Michael BRUNEAU<sup>2</sup>, Greg MACRAE<sup>3</sup>, Roberto LEON<sup>4</sup> and Alistair FUSSELL<sup>5</sup>

## Summary

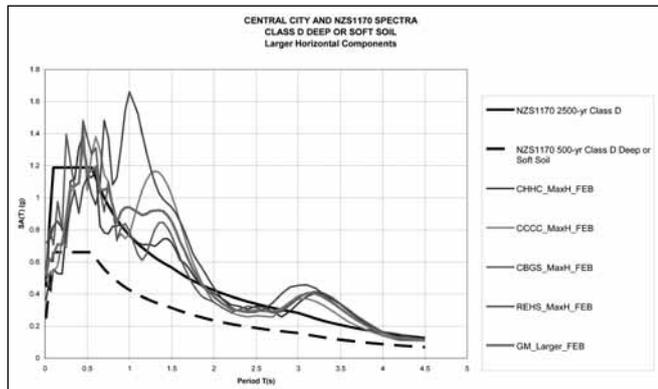
**Figure 1: NZS 1170.5 Spectra and Largest Horizontal Direction Recorded from the CBD Strong Motion Records of 22 February**

Contrary to the 2010 Darfield earthquake, seismic demands from the February 22nd earthquake were substantially more than those corresponding to the design level in the Central Business District (CBD) of Christchurch. Figure 1 shows the CBD ultimate limit state (ULS) design spectrum and maximum considered event (MCE) spectrum for buildings of normal importance, the larger horizontal components from the four strong motion recorders in the CBD and the average of these components. The average is above the MCE for periods of 0.3 seconds and above except for the period range of 1.8 to 2.7 seconds, where it still remains substantially above the ULS level.

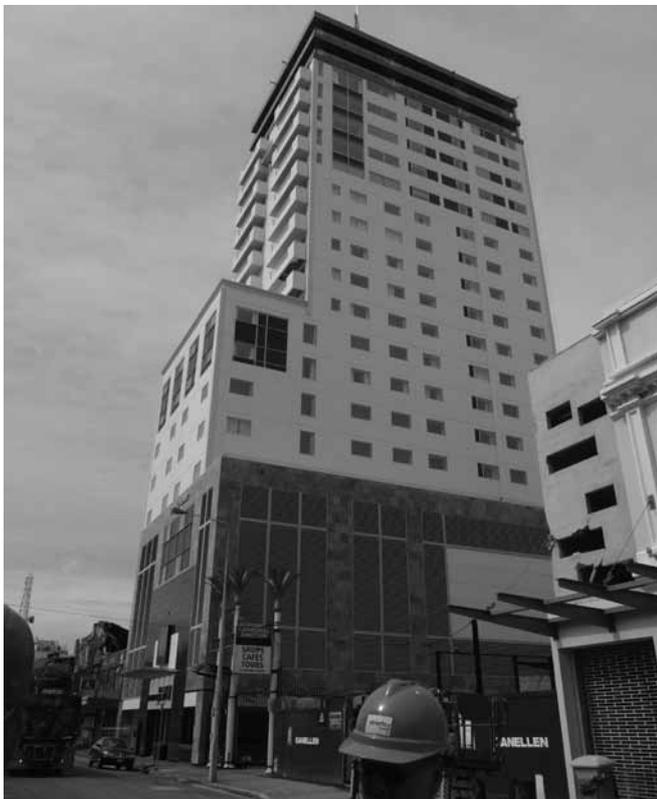
(a) Global view

into compression after tension yielding excursions that elongated the braces. The EBFs at intermediate locations were not integral with the floor slab and so did not benefit from the strength increase provided at lower stories. A range of views for this structure are given in Figure 3.

Paint flaking and residual link shear deformations were observed in the EBF links at those levels. Design of the EBFs in Pacific Residential Tower building was governed by the need to limit drift, with a corresponding resulting design ductility factor ( $\mu$ ) of 1.5 (even though up to 4.0 is permitted for EBF, as mentioned earlier). This is typical of EBFs in tall buildings in New Zealand's moderate to low seismic zones; Christchurch is moderate in accordance with the earthquake loadings standard, NZS 1170.5, at the time of writing. The EBF at all other levels were hidden in architectural finishes, and absence of damage to those finishes suggested limited inelastic deformation, which has been confirmed by subsequent detailed evaluation. Initial concern that inelastic demand was higher in level 6 which is the level of a horizontal transfer diaphragm between the podium and tower was found not to be the case in this detailed evaluation.

Figure 3. Pacific Tower [Photos by M. Bruneau]

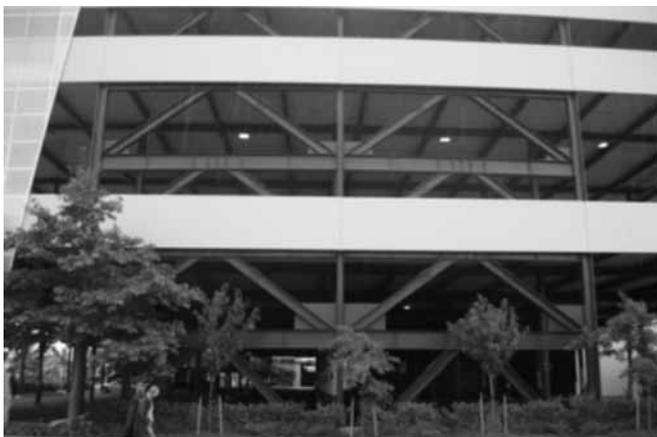
(a) View from the east

The EBFs in a three level parking garage of a shopping mall west of the CBD did not exhibit inelastic deformations (Figure 4(a)). However, there was some evidence of minor movement of the bolted splice connections in the braces. The basically elastic response of the EBFs is not surprising in this case, given that these frames had been designed to accommodate three additional parking levels to be added at a later time and the intensity of shaking was lower than in the CBD. Live load present at the time of the earthquake may also have been less than considered in design, although it was higher than in the September earthquake when the shopping mall was not occupied. Movement of precast units previously reported was observed to have intensified in the February earthquake but stable since. This resulted in fracture of the spandrel panels beside the epoxy mastic connection between panels presumably indicating that the epoxy mastic was stronger than the precast panels in tension (Figure 4(b)). These fractures occurred in all panels over the height of the structure. These spandrel panels were also designed to carry gravity loads in the parking structure so their fracture compromised the serviceability of the building.

**Figure 4: Shopping mall on Dilworth St and Clarence St, Christchurch**  
[Photos by G. MacRae]

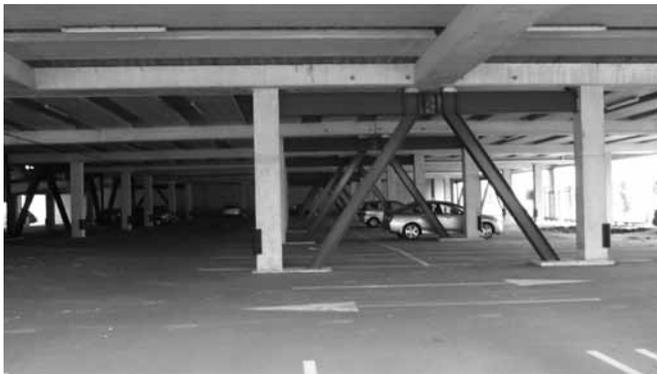
(a) Redundancy provided by multiple EBF bays

The EBFs in a hospital parking garage closer to the epicenter (Bruneau et al. 2010) also performed well, although some link fractures were observed in two braced bays (Figure 5). Note that at least six EBF frames were used at each level in each of the buildings' principal directions, and that this significant redundancy contributed to maintain satisfactory seismic performance of the building in spite of those significant failures. Residual drifts of the parking structure were not visually noticeable, which suggests that these fractures would not have been discovered if hidden by non-structural finishes.

Figure 5: Parking garage on St Asaph St and Antigua St, Christchurch [Photos by M. Bruneau]

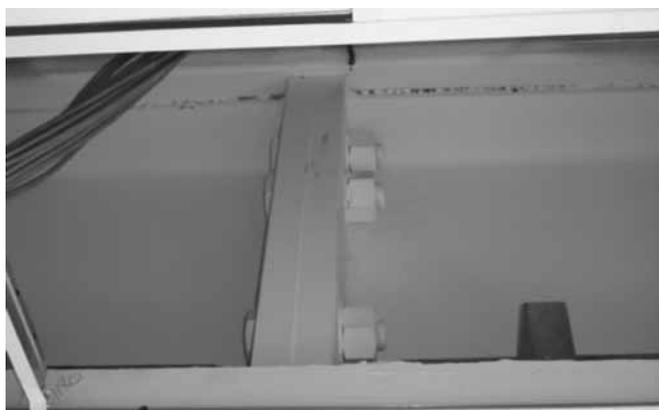
Connections in modern steel frames performed very well and as expected. Figure 6(a) shows a brace/beam/column connection in which the gusset plate is welded to the beam and bolted to the column with a flexible end-plate connection. This was designed and detailed to be rigid for vertical load transfer and flexible in the horizontal direction, to accommodate change in the angle between beam and column during the earthquake. This flexible endplate has undergone limited out-of-plane yielding, protecting the gusset plate from inelastic demand. Figure 6(b) shows a flush endplate splice in a MRF beam that has performed well.

*(b) Flush moment endplate splice connection*

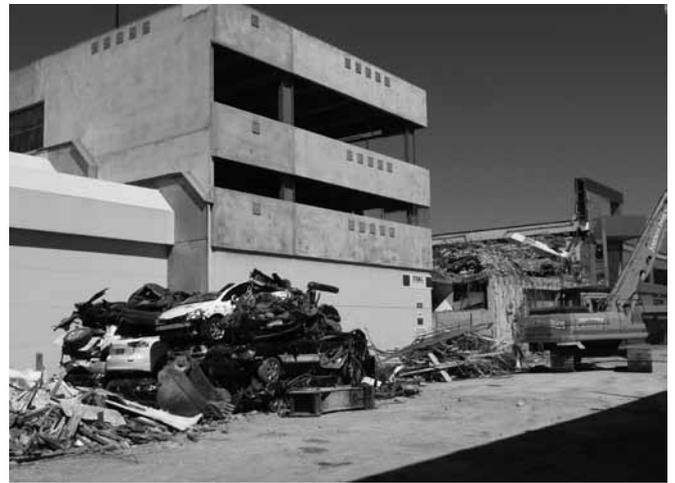
*(a) Global view*

A new parking garage (construction completed after the September 2010 earthquake) appeared to have performed very well, with no visible sign of inelastic deformation at the beam-to-column connections (Figure 8) or in any other part of the structure. However, this assessment could only be done from a distance as a pre-existing post-tensioned concrete section of that garage (together with the spans between the older and newer part of that parking garage) collapsed onto its access ramp.

*Figure 8: Low-rise MRF parking garage [Photos by M. Bruneau]*

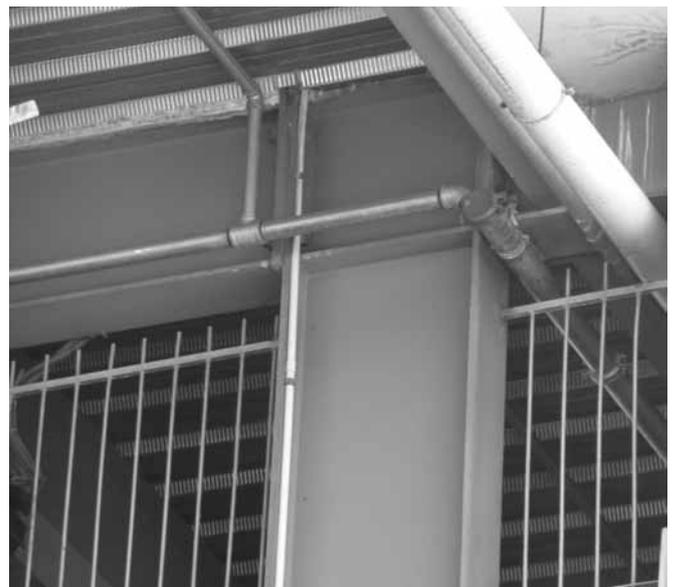
*(b) Typical moment connections*

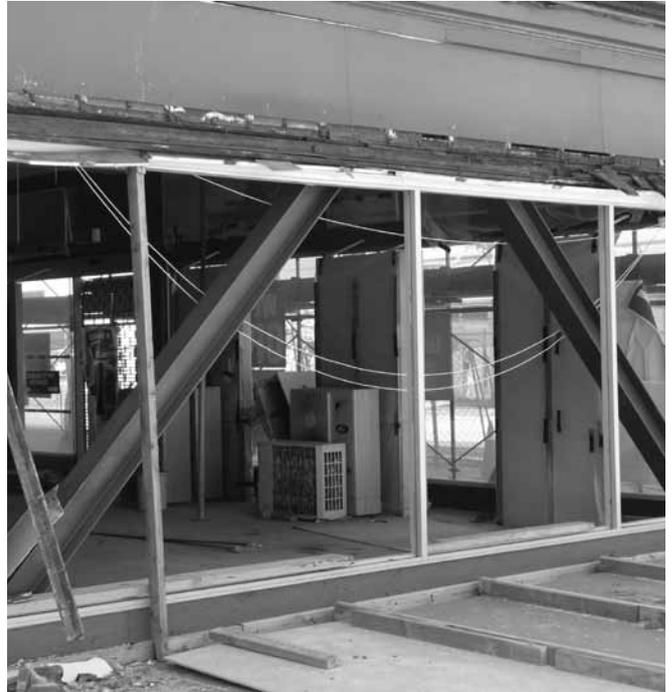
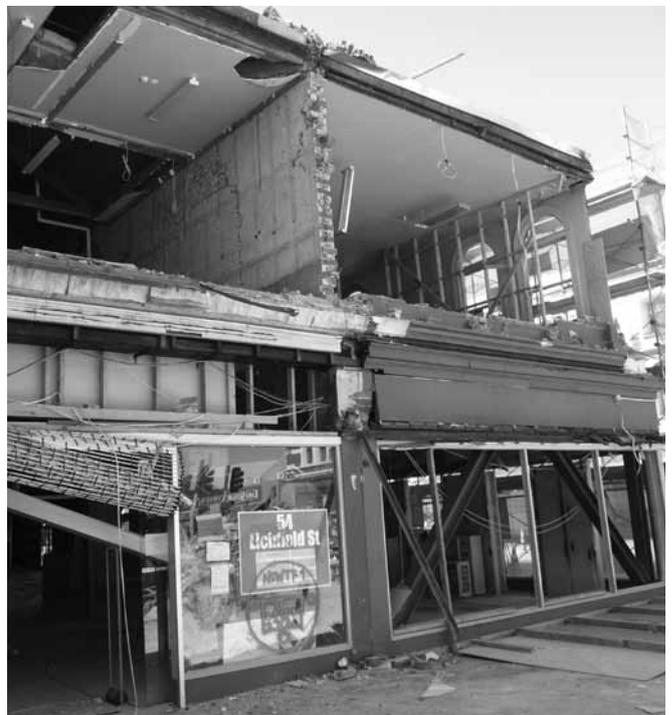
Steel braced frames were sometimes used to retrofit unreinforced masonry structures (e.g. Figure 10). Drift limits to prevent failure of the unreinforced masonry typically govern design in those instances, which explain the significant member sizes of these frames proportional to the reactive mass, and their elastic response.

*Figure 10: Braced frame as a retrofit to unreinforced masonry building [Photos by M. Bruneau]*

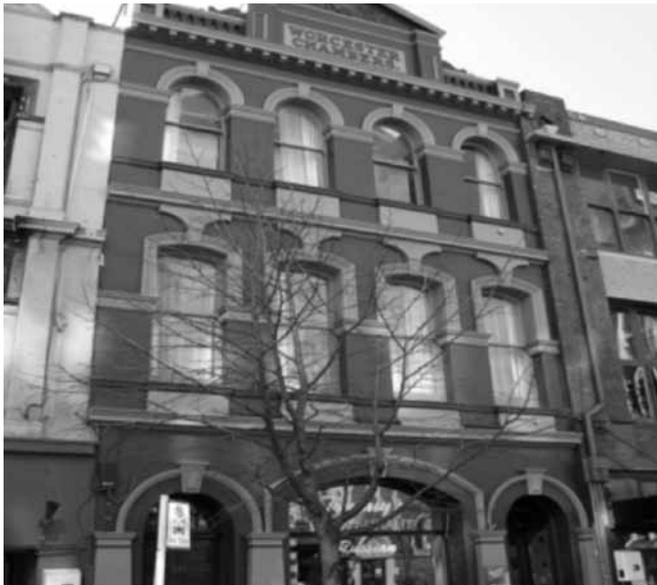
Buildings in the CBD that had been strengthened prior to the September 2010 earthquake typically suffered minimal to no damage in that event. They were not so fortunate in the much stronger February 2011 event. In part this is likely because the acceptable strengthening requirements were less than full design levels demanded of modern buildings. Figure 11 shows one group of three buildings, with (a) showing these following the September 2010 event and (b) showing (from a different vantage point) the three following the February 2011 event. Note especially the strengthened building on the corner has collapsed.

(a) is following the September 2010 event

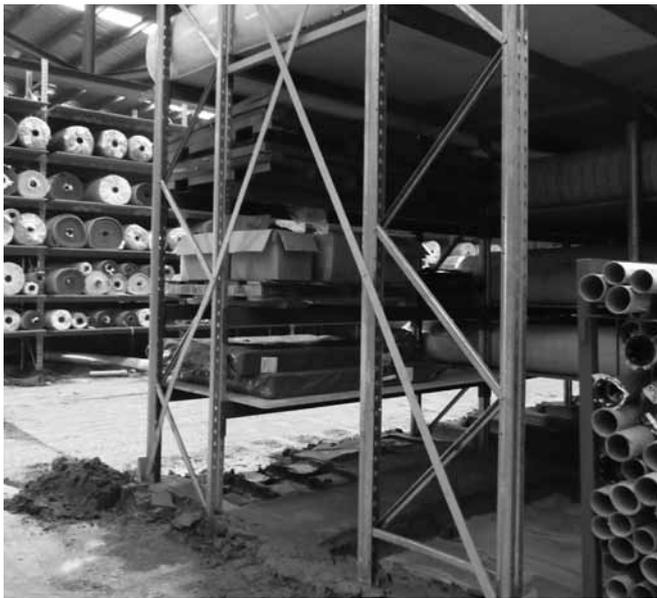
(a) Global view

Anecdotally, in another facility, existing racks had been retrofitted by coupling two racks back-to-back with flat bar braces (Figure 14). These bars showed evidence of elongation and residual buckling, but did not collapse, in spite of floor movements due to liquefaction, whereas the only rack that was not retrofitted (for it was not adjacent to a second rack to which it could have been tied) collapsed.

Figure 14: Industrial storage racks that survived, with evidence of soil liquefaction [Photos by M. Bruneau]

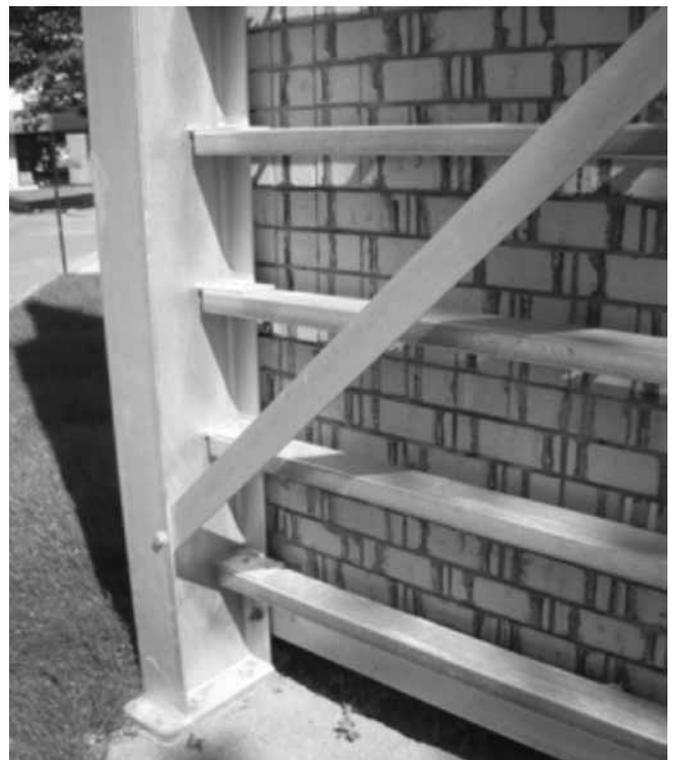
A steel framed wall with a brick façade was erected in a small park as shown in Figure 19, in a part of town where significant overall structural damage occurred. The wall was placed there after the September 2010 earthquake as states "Rebuild, Brick by Brick". The bricks were fixed to the steel frame with conventional brick ties as used in framing construction. The wall suffered no damage in the subsequent 5 earthquakes of the series.

(b) Back view of wall

**Figure 19. September 2010 rebuilding stand consisting of bricks supported by steel frame (Photos: MacRae)**

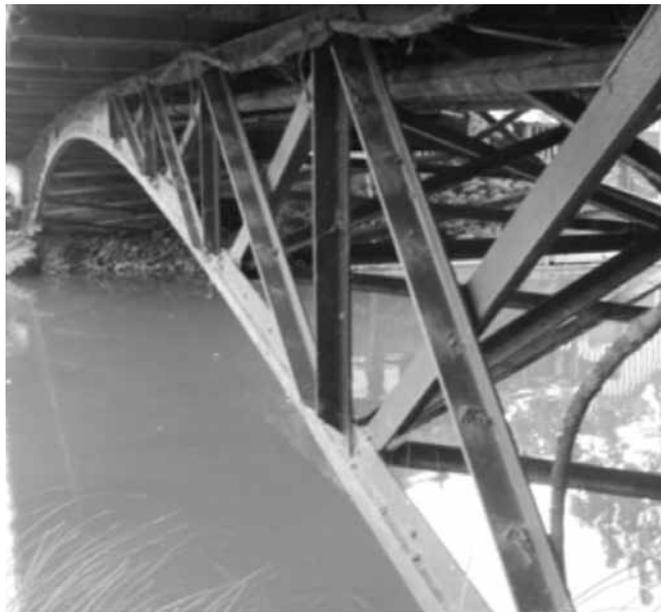
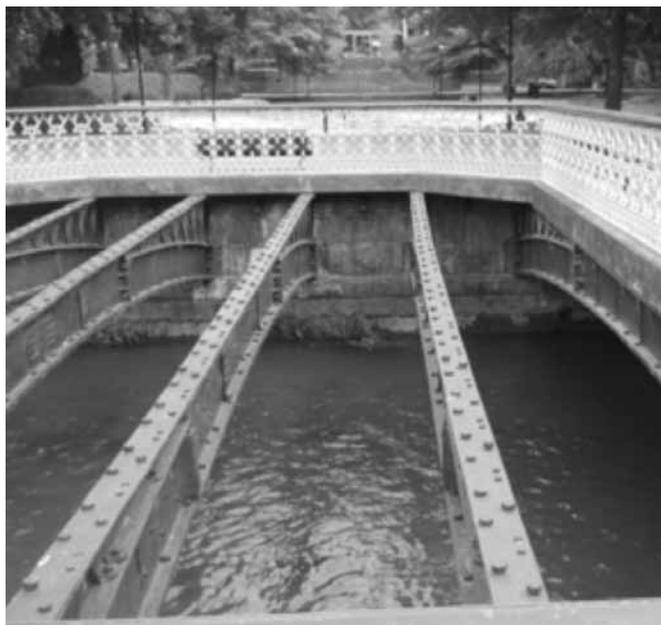
There are relatively few steel bridges in the Christchurch area. A pedestrian arch bridge at the Antigua Boatsheds and one at Victoria Square showed no visible damage (Figure 20).

*Figure 20 – Undamaged older steel pedestrian bridges on the Avon River near the CBD (Leon)*

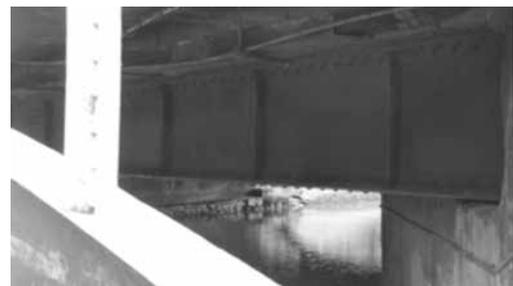
Although substantial liquefaction occurred along the Avon River near the CBD, the only older steel bridge in this area did show spectacular buckling of its fascia arches; the actual bridge, supported on straight riveted girders appeared undamaged even though large settlements had occurred at the abutments (Figure 21). The old rail bridge over the Waimakariri river behaved well even though it was clear that the pier had moved over 100 mm toward the river and back during this shake (Figure 22(a)). The old road bridge suffered some longitudinal buckling of the lower flange of one beam (Figure 22(b)) as well as some spalling of concrete on the west side of the abutment. The only major modern steel bridge at the Port of Lyttleton, a three-span continuous plate girder, had only minor damage at the abutment (Figure 23).

*(d) Undamaged straight riveted girders*

*Figure 21 – Colombo Street bridge (Leon)*

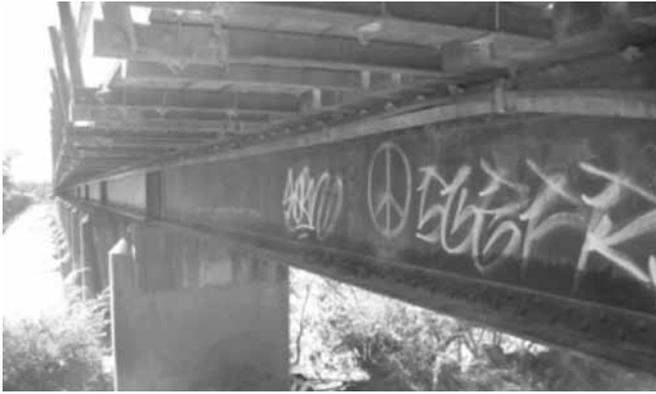
(a) Old rail bridge

Figure 22 – Waimakariri Bridges, South end, (MacRae)
