OVERVIEW OF BRIDGE PERFORMANCE DURING THE 2011 CHRISTCHURCH EARTHQUAKE

by A. Palermo⁽¹⁾, L. Wotherspoon⁽²⁾, L. Hogan⁽²⁾, A. Kivell⁽¹⁾,
M. Yashinsky⁽³⁾, M. Bruneau⁽⁴⁾ & E. Camnasio⁽⁵⁾

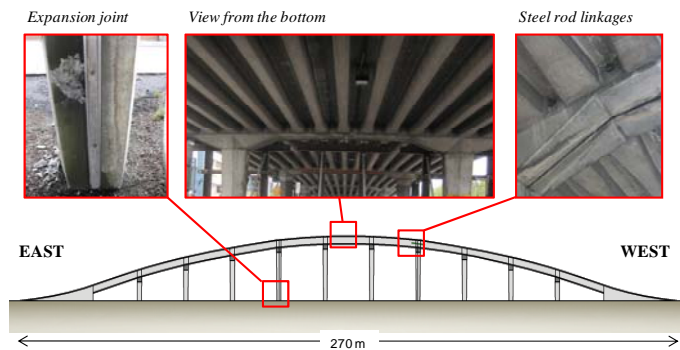
Figure 8. Moorhouse Avenue Overpass. Sketch of the bridge elevation with location of the expansion joints and steel rod linkages [Palermo *et al.* 2011a].

Significant pier damage developed during the Christchurch earthquake due to transverse ground shaking. The overall performance of the structure was unsatisfactory, with significant shear cracking and buckling of the piers. This damage affected the vertical load carrying capacity of the structure along with the lateral capacity. As a result of this damage, the bridge was closed following the February 2010 earthquake for over five weeks while strengthening works were undertaken.

The bridge sustained damage to one column near the north-east approach where a deck expansion joint was located. The insertion of steel rod linkages in the deck at the expansion joint at only one side of the bridge induced irregularity in the structures transverse response. In fact, with the west and central part of the bridge linked, the bridge pier at the eastern expansion joint suffered extensive displacement demand. The slenderness of the pier affected the vertical load carrying capacity of the structure along with its lateral capacity. The columns also had widely spaced transverse reinforcement, making the structure susceptible to shear failure (Figure 9a). Observations after the Christchurch event indicated that the damaged columns had started to buckle putting the central span at risk of collapse. In this instance, damage was induced by extensive ground shaking; large transverse horizontal accelerations may have caused a flexural-buckling failure mechanism in the columns.
