**Engineering and Organizational Issues Related to  
the World Trade Center Terrorist Attack**

**Overview of Damage to Buildings  
Near Ground Zero**

**By Michel Bruneau, Andrew Whittaker and Andrei Reinhorn**

March 2002

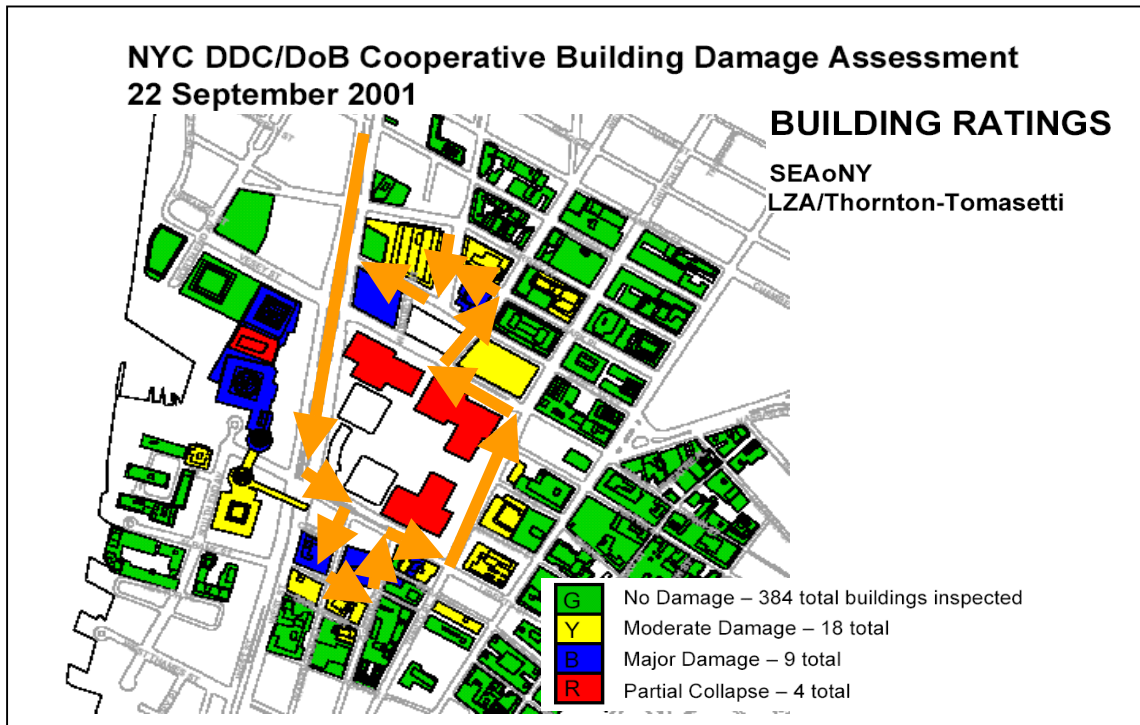
Figure 3.1. Arrows indicate the route followed by the MCEER reconnaissance team, superimposed on top of a map of the street layout by SEAoNY, LZA/Thornton-Tomasetti

The arrows in Fig. 3.1 indicate the route followed by the MCEER reconnaissance team on September 21, 2001. This route follows the edge of the debris pile at Ground Zero. Fig. 3.1 also provides an overview of damage as reported by a team from the Structural Engineers' Association of New York (SEAoNY), who conducted a rapid evaluation of buildings near Ground Zero. This rapid inspection was conducted for the New York City Department of Design and Construction/Department of Buildings (DDC/DoB) by members of SEAoNY and coordinated by LZA/Thornton-Tomasetti to establish which buildings were safe to reoccupy. For those buildings rated as having suffered damage, no distinction was made between structural and architectural damage in the figure.

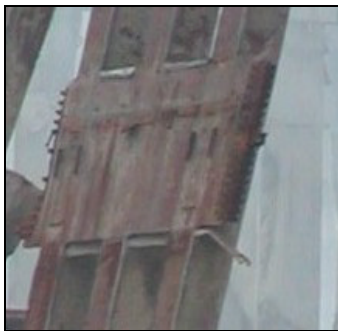
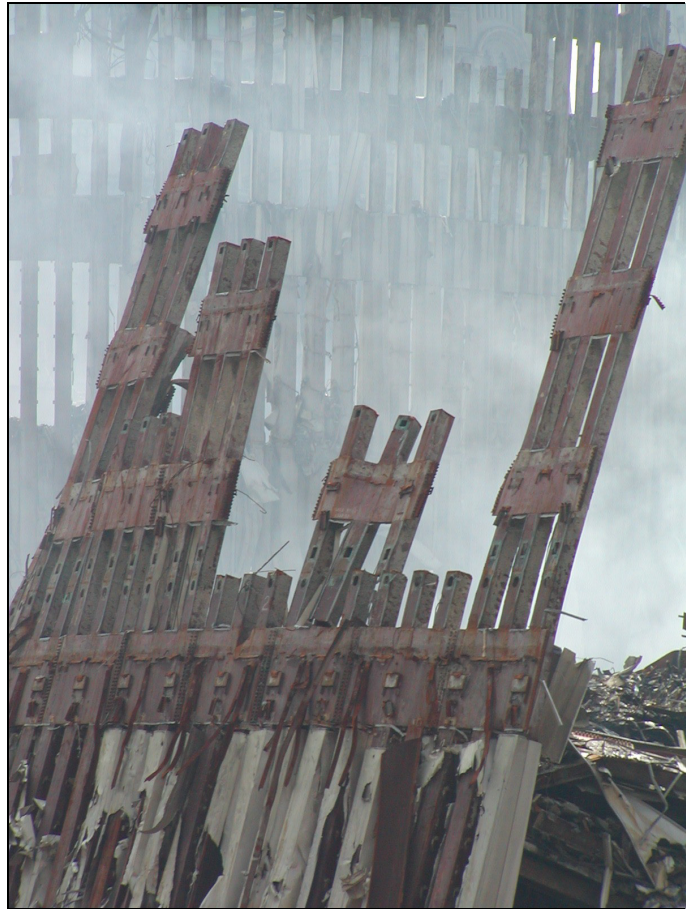
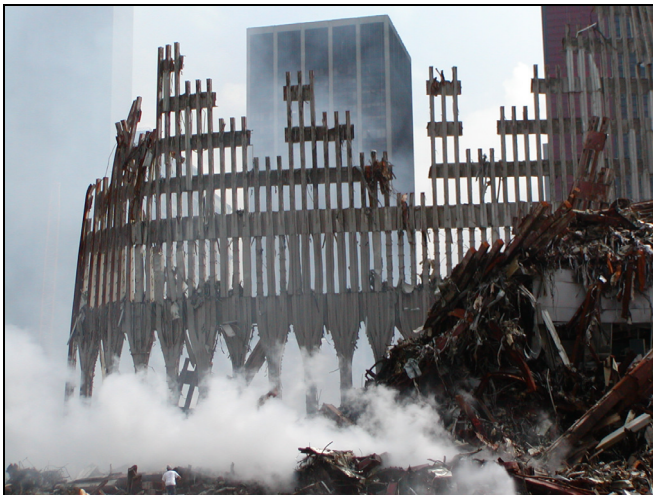
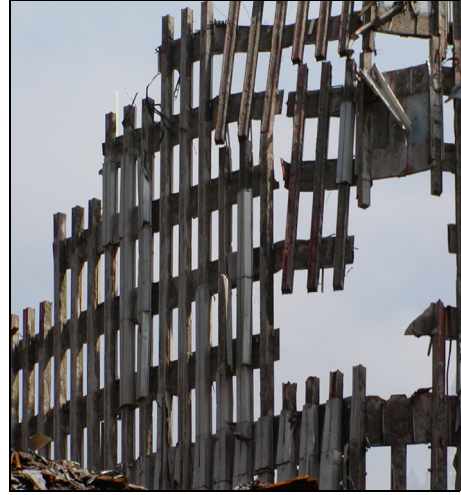
*Figure 3.6. Modular construction of the towers*

The only recognizable portions of WTC 1 and 2 on September 21, 2001, were parts of the exterior tube described above that remained standing in the debris pile (Figure 3.5). Some evidence of the building modular construction described in the previous paragraph could be observed from these parts of the building structural shell (Figure 3.6). The typical four-bolt column splices could be also observed (Figure 3.7), along with the hole on the side of each hollow rectangular column that provided access for erection of the frames (Figure 3.7, bottom photograph). As will be seen in the subsequent sections, some of these three-column modules became multi-ton projectiles that impacted and damaged adjacent buildings as the towers collapsed. The interior of the building shell (see Figure 3.6, top photographs) shows some evidence of where the supporting seats were located for the floor joists.
