Effects of the 1985 Michoacan Earthquake on Water Systems and Other Buried Pipelines in Mexico

A.G. Ayala and M.J. O'Rourke

Technical Report NCEER-89-0009

March 8, 1989

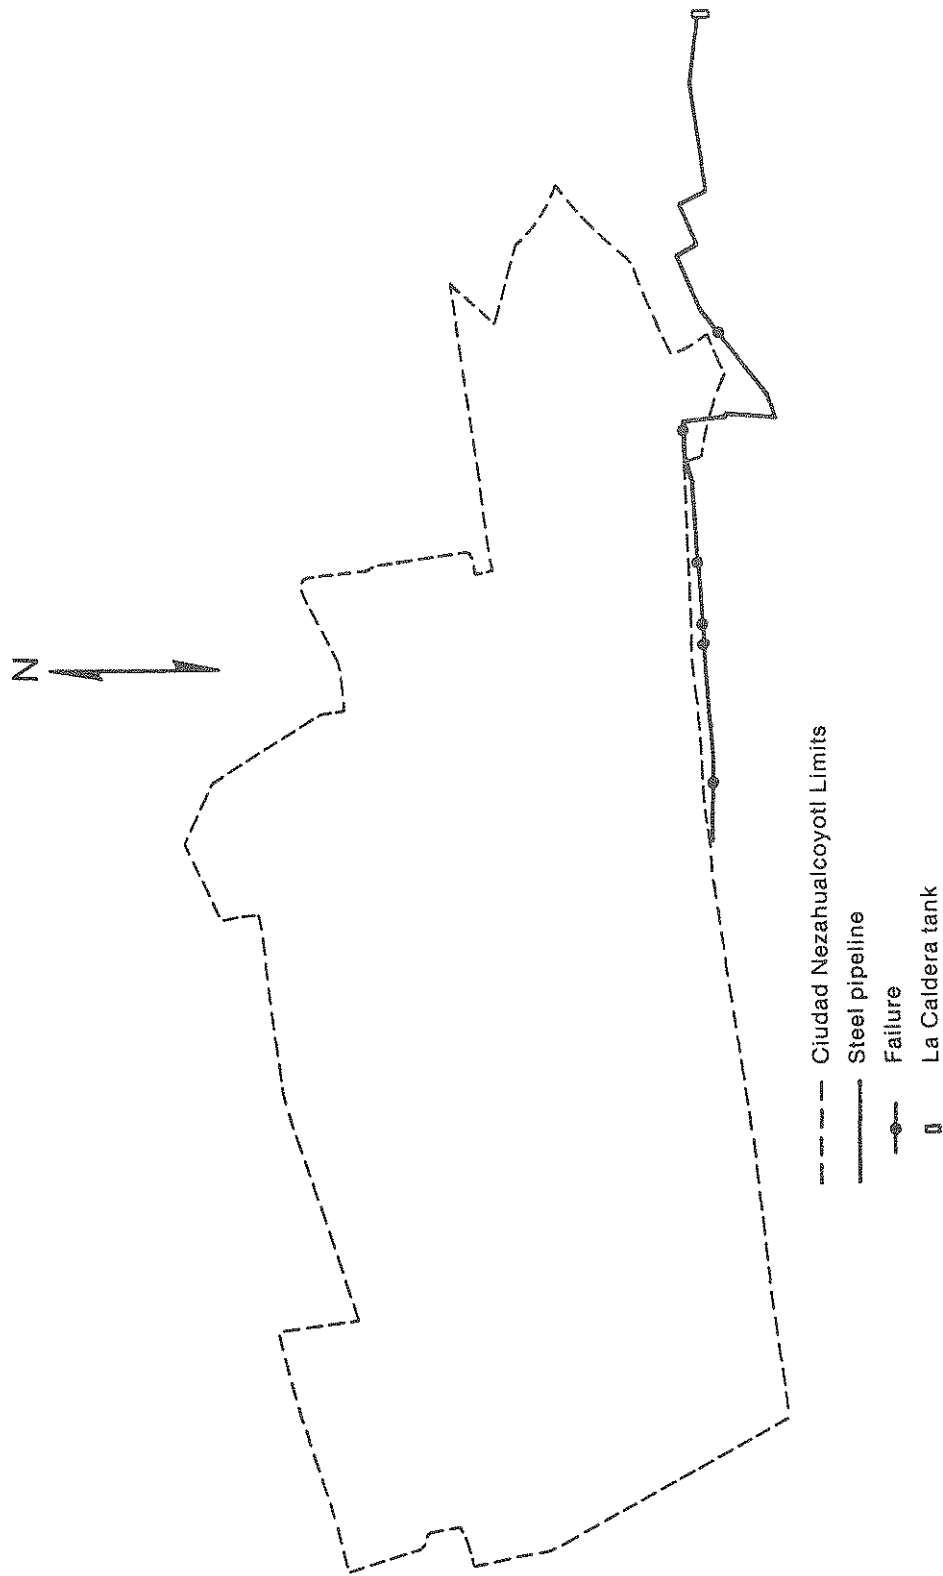
FIGURE 7-5 Reported Failures Along Steel Pipelines In Ciudad Nezahualcoyotl (E.de.M.) in 1985

Seismic damage occurred at a minimum of eight locations along the 9 km length of the line. At six of these points, circumferential cracks resulting from wrinkling deformations (ie, local buckling) were observed as shown in figures 7-2 and 7-3. In addition, a 36"φ butterfly valve located in an air relief valve box, was broken, as shown in figure 7-4. Breaks also occurred at a welded joint along the pipeline and on a 14"φ asbestos cement pipe connection to the steel pipeline. The locations of these failures are shown in figure 7-5. It is believed however that there were more failures than those shown in figure 7-5 since several engineers involved in the repair work reported that failures occurred consistently at 300 to 500 m intervals along the line. As mentioned previously, there was no evidence of liquefaction in the metropolitan area. In addition there was no evidence of permanent ground deformation in the metropolitan area, except for the previously mentioned subsidence. Hence it would appear that the seismic damage to the welded Ciudad Nezahualcoyotl pipeline as well as the other segmented pipelines in the water system was due to seismic wave propagation.

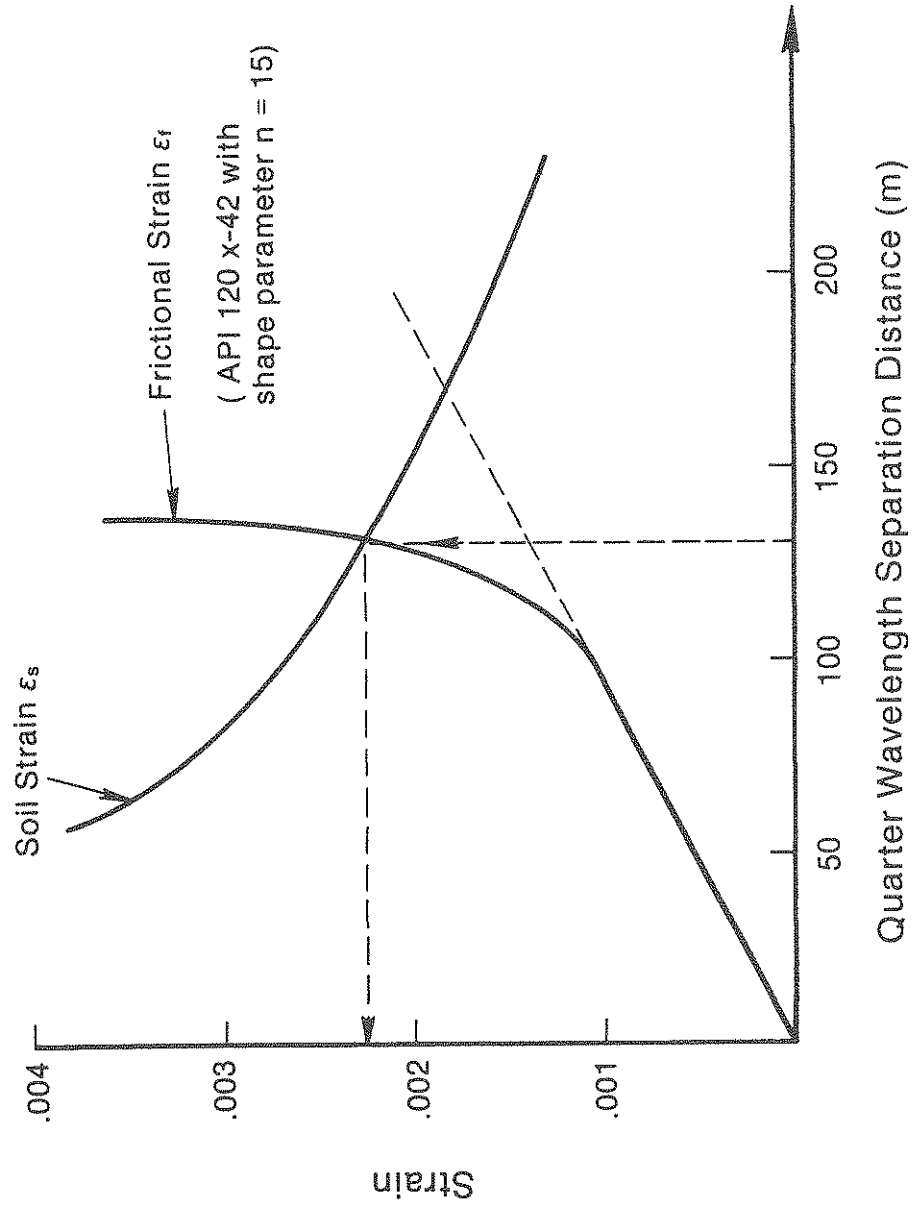
FIGURE 7-9 Soil And Friction Strain For Ciudad Nezahualcoyotl Pipeline

The actual maximum pipeline strain is the smaller of the ground strain ϵ_g or the frictional strain ϵ_f . Note for a quarter wavelength separation distance of about 130m, $\epsilon_g = \epsilon_f$ and hence the actual maximum pipe strain is about 0.0023 by the procedure described above. Again using a Ramberg-Osgood model with shape parameter $n=15$ for the API 120x-42 material, the corresponding actual maximum pipeline stress is about 40.9 ksi.

As mentioned previously, the observed locations of compressional wrinkling were at 300 to 500 meter spacings. Note that at any particular instant in time, the procedure described above suggests that areas of high compressive stress would occur at a spacing of about 520m. That is high compression regions are a wavelength apart, or 520m for the critical quarter wavelength of 130m.

In summary, the compressive stress in the pipeline due to R-wave propagation is estimated to be about 40.9 ksi while the local buckling stress is estimated to be about 42.6 ksi. That is, this analysis procedure suggests that the pipeline was very close to buckling. Given the scatter between predicted and observed buckling stresses presented by Schilling (14) it is not surprising that the pipeline did, in fact, suffer a local buckling failure.

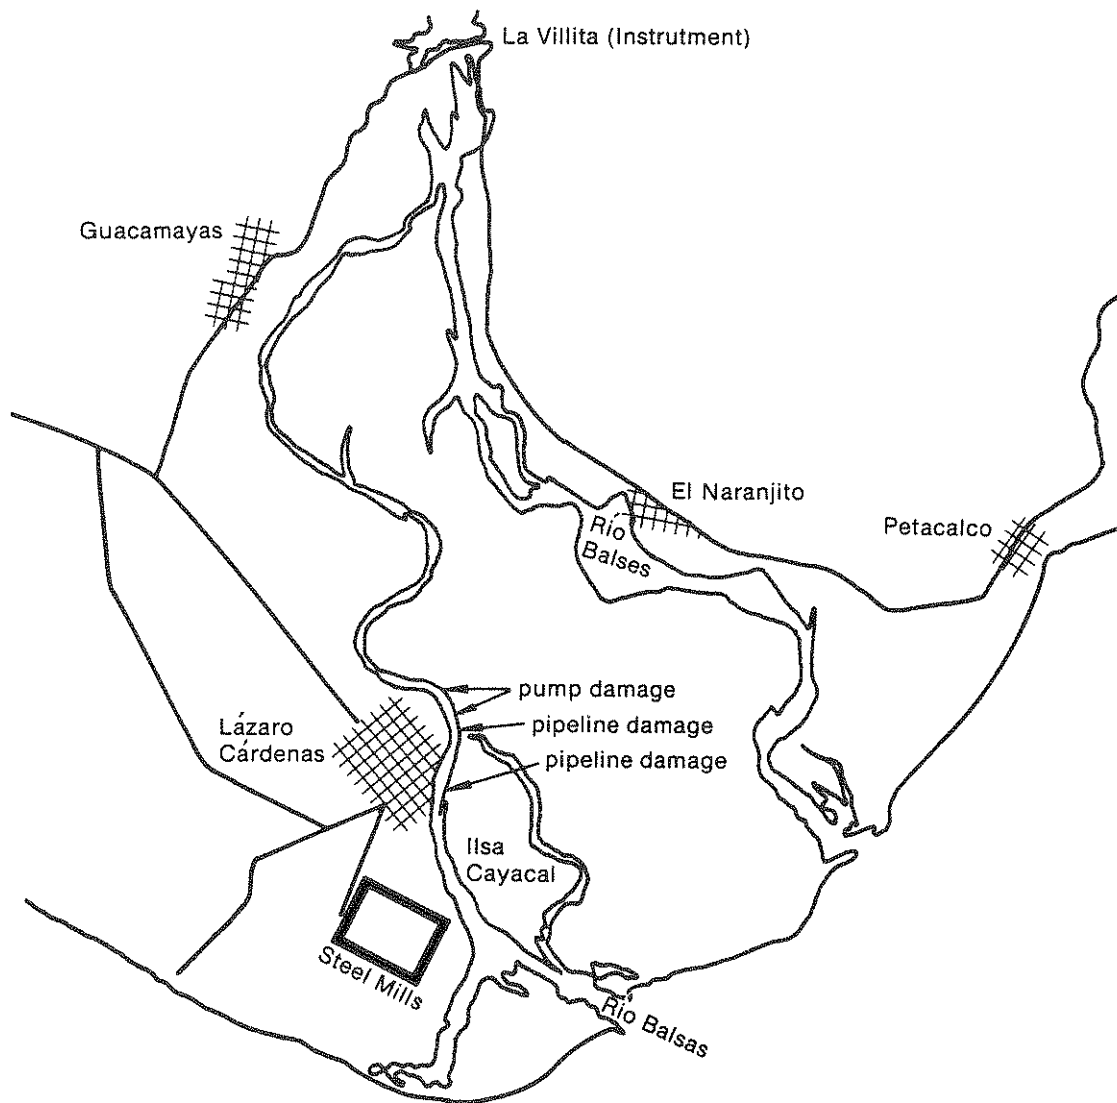
FIGURE 9-1 Water System Damage In Epicentral Region - 1985 Michoacan Earthquake

In contrast to the heavy damage experienced by the Mexico City water systems, water supply in the epicentral region was lightly damaged. In the industrial part of Lazaro Cardenas, wells, above ground pipelines and buried pipelines were damaged. The locations of water system damage in the epicentral region is shown in figure 9-1. Presented below is a description of the specific damage.

The 72"φ reinforced concrete pipeline mentioned above in (b) was buried over part of its length. Seismic damage along the buried portion of this line occurred near a thrust block.

At first glance it may seem strange that water system damage in the epicentral region was significantly less than in Mexico City which is located about 400 km (240 miles) northeast of the epicenter. A ground motion station at La Villita is close to the September 19, 1985 epicenter. As shown in figure 9-1 La Villita is also reasonably close to Lazaro Cardenas. The peak horizontal ground acceleration recorded during the September 19, 1985 event at La Villita were 125 gals (N-S) and 122 gals (E-W). Referring to Tables 5-I and 5-II, these epicentral accelerations were three to four times larger than those recorded in the Hill Zone of Mexico City but were about the same amplitude as those recorded in the Lake Zone of Mexico City. Note that the two Tlahuac stations recorded peak horizontal ground acceleration of 136 gals (TLHB N-S), 107 gals (TLHB E-W), 118 gals (TLHD N-S) and 115 gals (TLHD E-W). That is, in terms of peak ground acceleration, the decrease in ground motion due to attenuation between the epicentral region and Mexico City was essentially canceled by amplification due to soft soil deposits in the Lake Zones of Mexico City. However, of more importance to buried lifelines are differences in the frequency content and resulting ground velocities and displacements between the epicentral region and Mexico City. The marked difference in frequency contents are shown in figure 9-4 and 9-5 which present horizontal acceleration time histories at La Villita and Tlahuac Bombas. Note that the epicentral record (La Villita) has a much higher frequency content than the Lake Zone Mexico City record (Tlahuac Bombas). Hence although the peak ground accelerations were comparable, the longer period motion in the Lake Zone of Mexico City resulted in significantly higher peak ground velocities and peak ground displacements than in the epicentral region.
