The Northridge, California Earthquake of January 17, 1994: General Reconnaissance Report

Edited by J. Goltz

Technical Report NCEER-94-0005

March 11, 1994

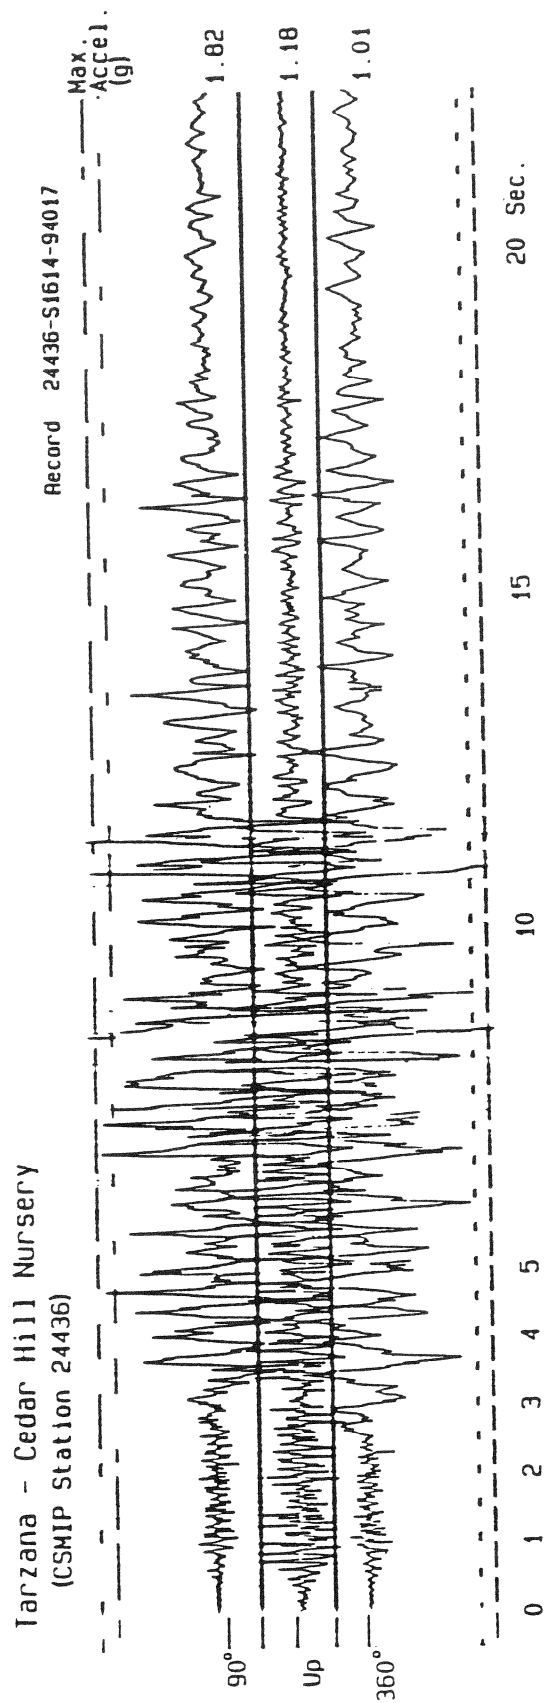
The second instance of topographic effects on ground motion is at the Tarzana Cedar Hill Nursery located about 7km from the epicenter. The ground motion record at this site displays an unusually large number of pulses with peak acceleration values of 1.82g and 1.01g in the two horizontal directions, and of 1.18g in the vertical direction. Figure 2-4 shows the traces of ground motions recorded in Tarzana. Such anomalous ground motions had also been recorded in Tarzana during the 1987 Whittier earthquake. Tarzana is located in the northern foothills of the Santa Monica Mountains. Local soil and, especially, topographic conditions at the recording station, may have played an important role in amplifying of the rock motions at this site.

FIGURE 2-4 Ground Motion Records from the Recording Station in Tarzana [1]

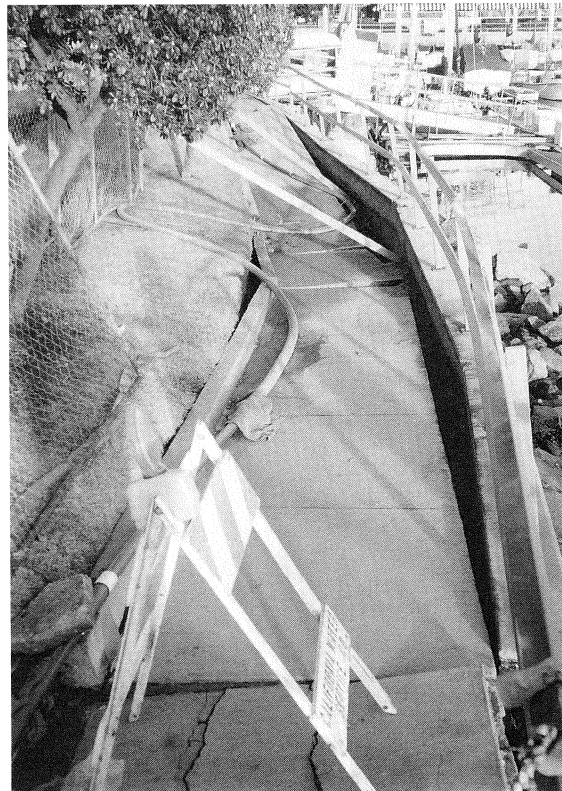
In Redondo Beach, about 45km from the epicenter, evidence of liquefaction of the sands, used in the construction of the pier, was observed. Figure 2-7 shows a 1.50 meter high retaining wall that was constructed upon a rock berm. The top of the rock berm is estimated to be about three meters above the mudline. There is evidence of lateral movement at and near the toe of the rock berm as shown by the tilting of the mooring piles (Figure 2-8). Furthermore, the ground surface level on the pier experienced significant subsidence. Figure 2-9 shows one of the two buildings on the pier that is founded on a concrete slab that experienced about 13 inches of settlement relative to the section of the pier that did not move. The failure mode of this pier is not yet clear. Further investigations of the geotechnical data and the profile geometry may reveal the mechanisms of this failure.

FIGURE 2-7 Movement of the Retaining Wall of the Pier in Redondo Beach

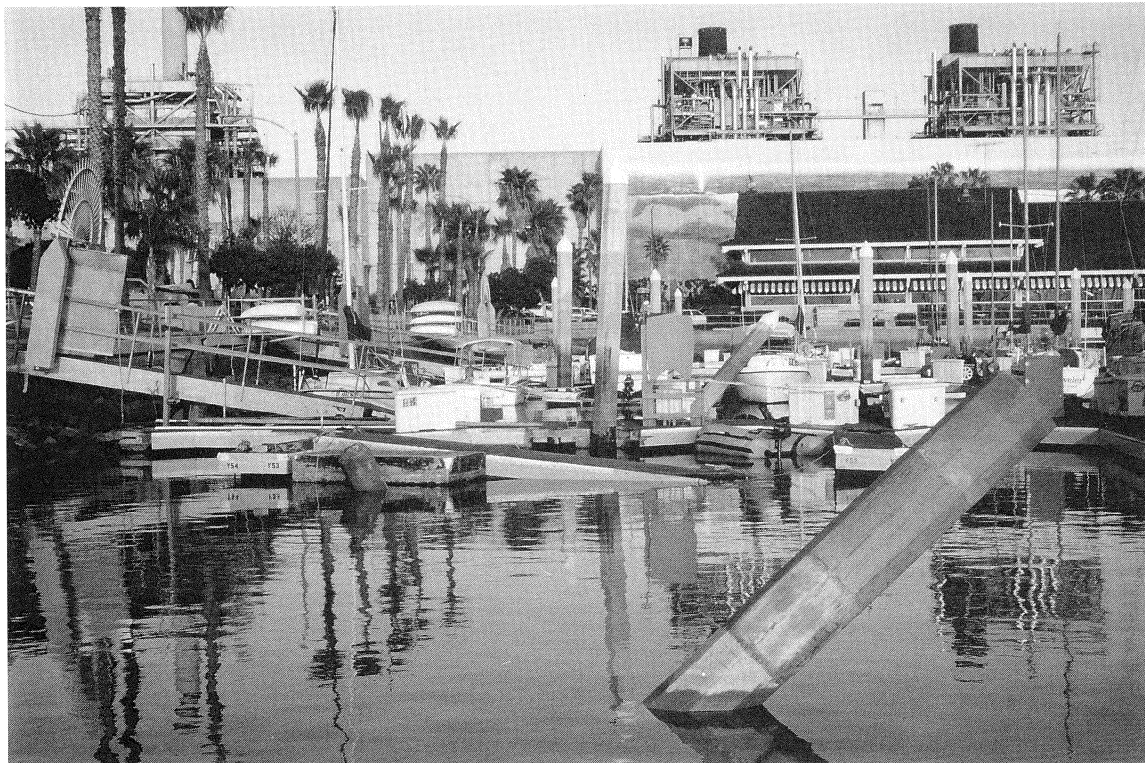
FIGURE 2-8 Tilting of the Mooring Piles at the Top of the Rock Berm of the Pier in Redondo Beach

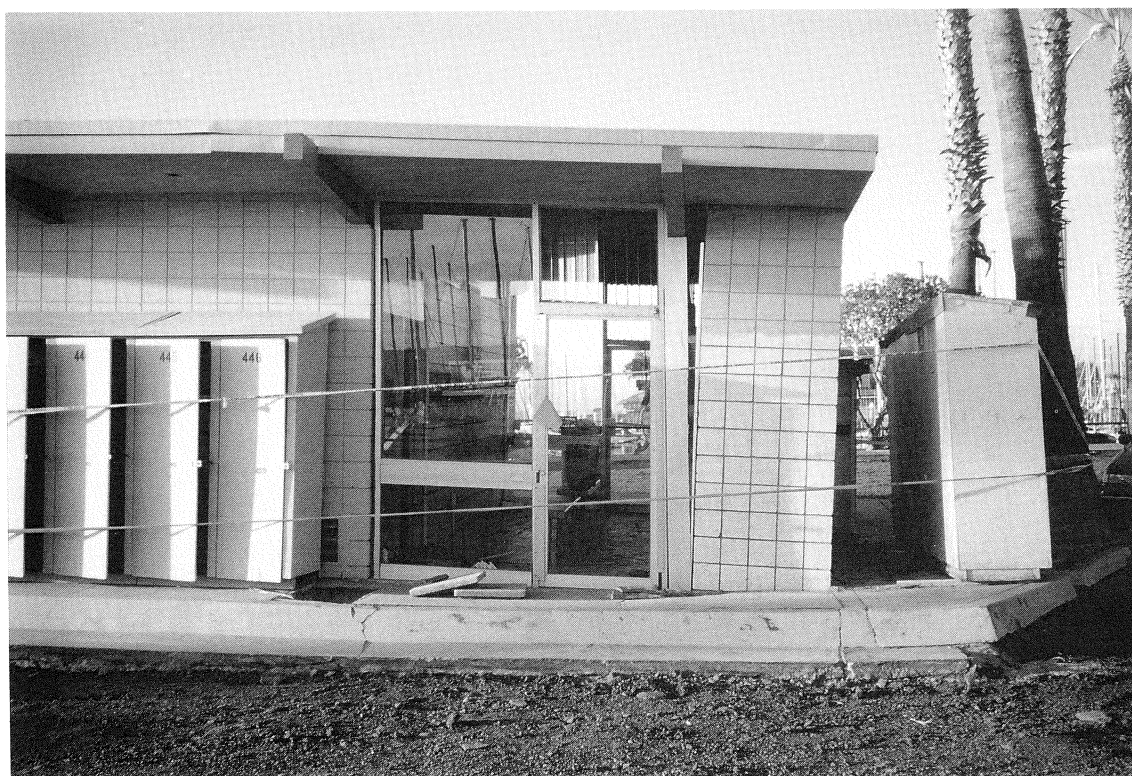
FIGURE 2-9 Liquefaction-induced Settlement of a Building on the Pier in Redondo Beach

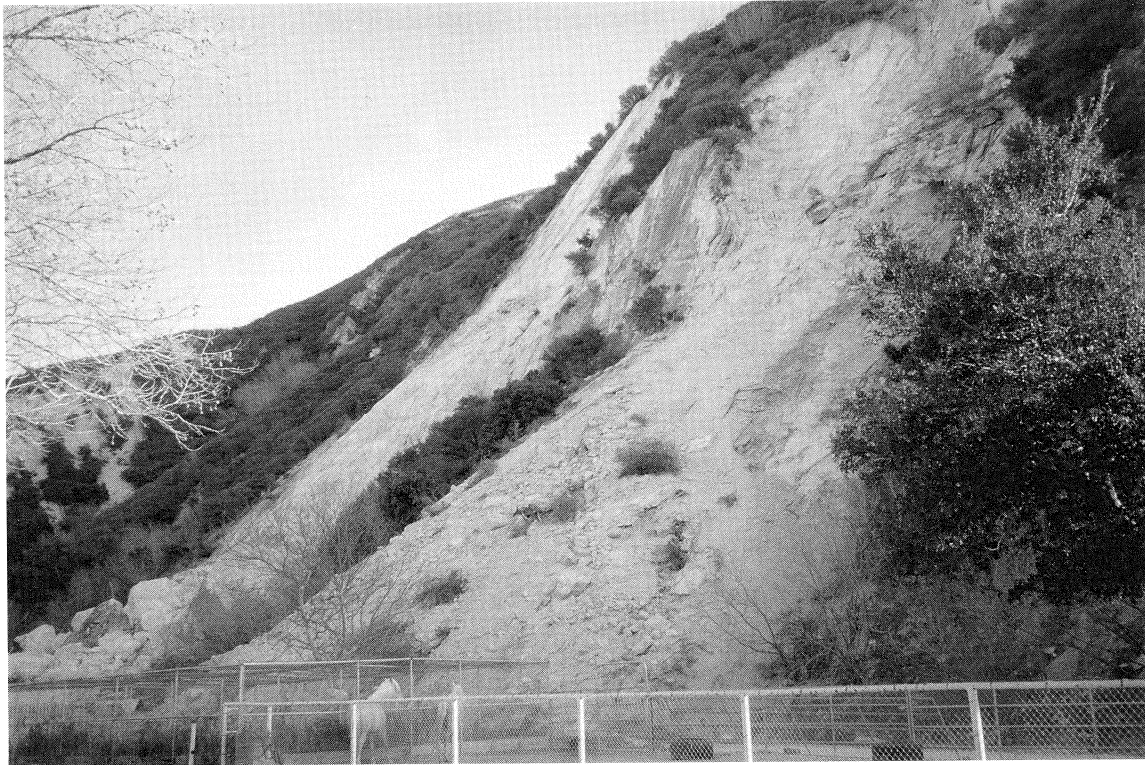
There were a number of rock slides that were observed mostly in the region north of the epicenter. Figure 2-10 shows photographs of typical rock slides. In Santa Monica, along the Pacific Coast Highway, spectacular landslides occurred damaging many of the homes built on cliffs overlooking the ocean. Figure 2-11 shows a section of this landslide. Also, in Simi Valley,

FIGURE 2-10 Rock Slides in the Region North of the Epicenter

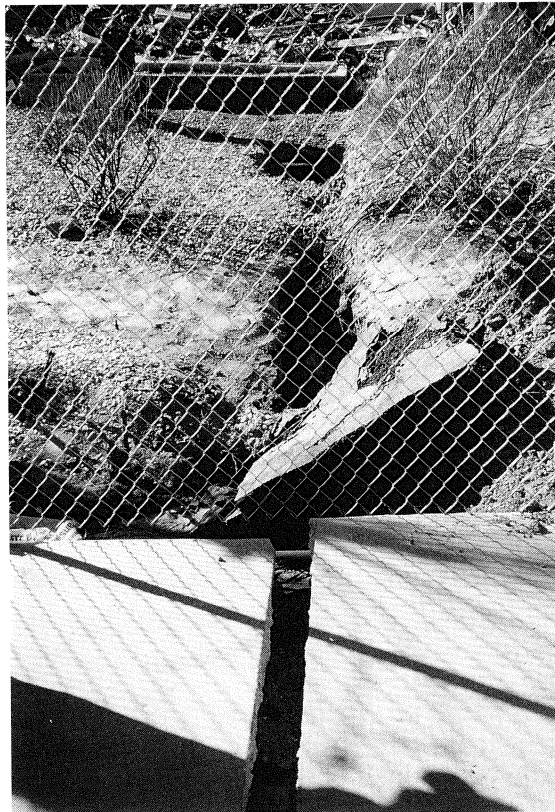
In Granada Hills, on Balboa Boulevard, immediately north of State Route 118, there was evidence of significant permanent ground deformation. About three blocks along this street, and on one block on each side of the street, there were many cracks in the ground running perpendicular to Balboa Boulevard. Some of these were tensile cracks with widths as large as six to ten inches, as shown in Figure 2-13. Other cracks were of the compressive type, resulting in ridges in the sidewalks, as shown in Figure 2-14. In this section of Balboa Boulevard, there were many ruptures of gas lines leading to fires that destroyed nearby houses. Also, the water main (Figure 2-15) in this same section ruptured causing major floods. The cause of these ground fissures is not yet well understood. Since the fault in this region is closer to the surface than anywhere else in the San Fernando Valley, it is possible that the ground deformation in this region resulted from fault rupture. Alternatively, since the cracks in the ground are limited to the section of Balboa Boulevard that is on a hill, shallow slope failures, where blocks of soil moved downhill and relative to one another, cannot be ruled out as a reason for these cracks.

FIGURE 2-13 Ground Fissures Along Balboa Boulevard in Granada Hills

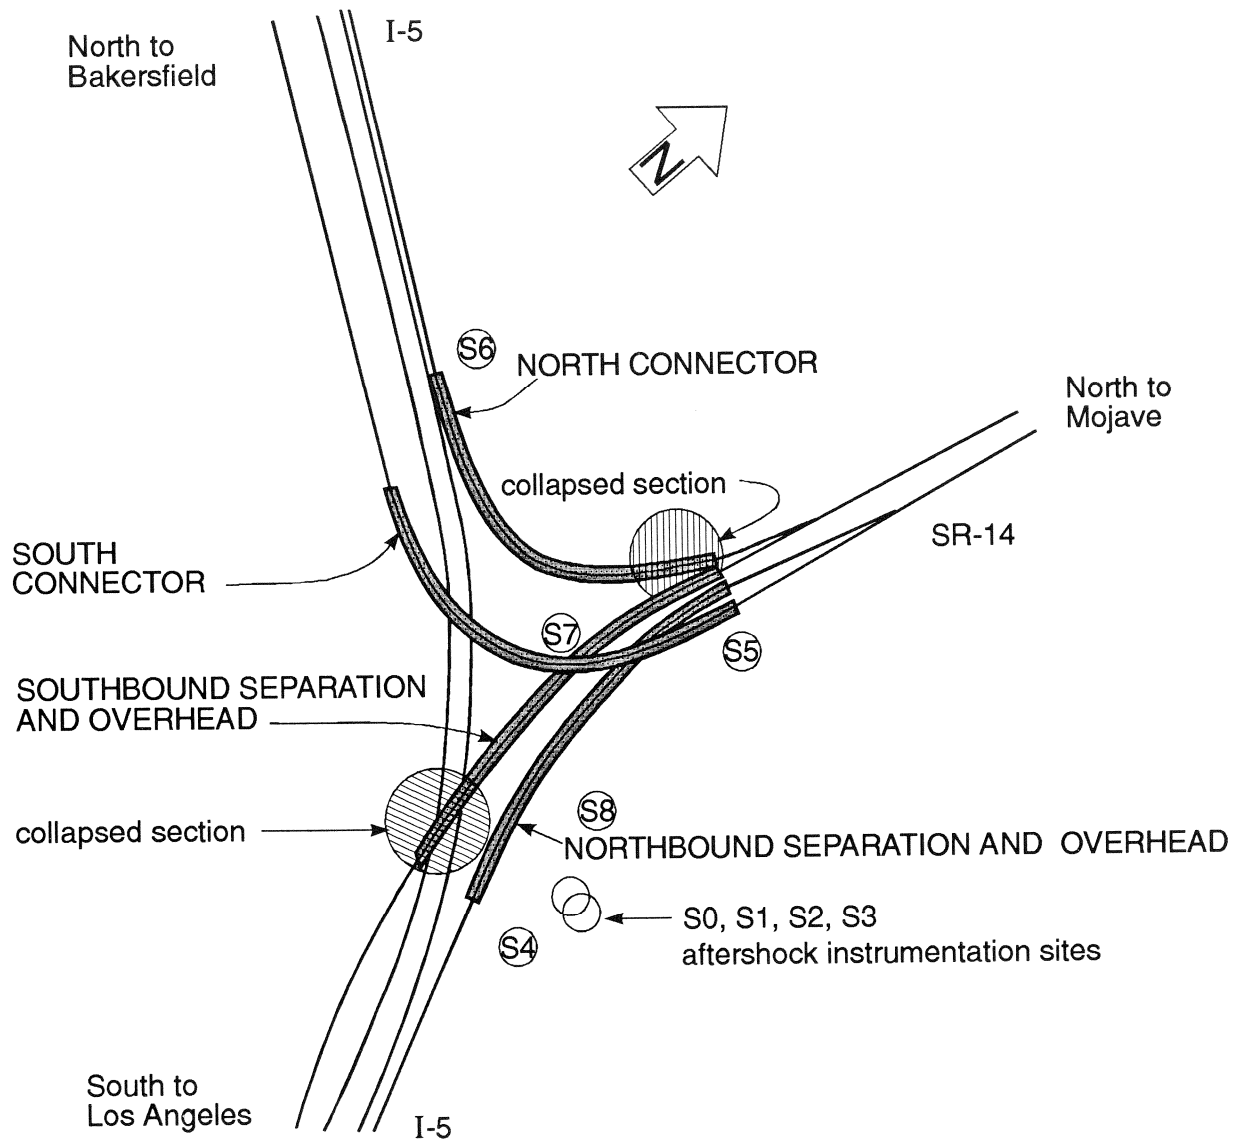
Two of the five viaducts in this interchange (Figure 3-3) suffered partial collapse and a third sustained major abutment and hinge seat damage. Hinge restrainer and abutment shear keys were also damaged in the remaining two bridges but the level of damage was relatively minor. Many of these structures are shown in a general view of the interchange given in Figure 3-4. As described in [13], aftershock ground motions were recorded at this location for the purpose of studying spatial variation effects. Sites instrumented by the Lamont-Doherty Earth Observatory are shown in Figure 3-3. Data collected are discussed in [13].

**FIGURE 3-3 SR14/I-5 Interchange -
Simplified Plan and Locations of Sites where Aftershock Motion was Recorded**

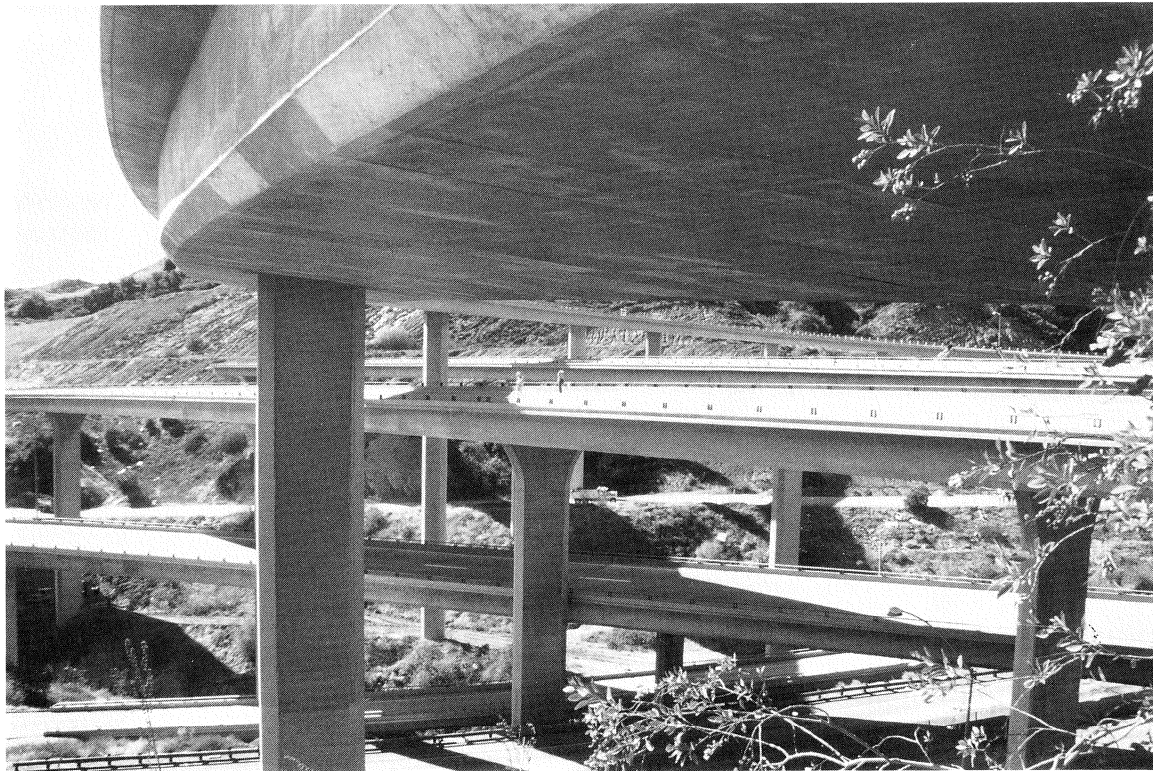
**FIGURE 3-4 SR14/I-5 Interchange -
General View from Abutment 10 of the South Connector Looking Southwest**

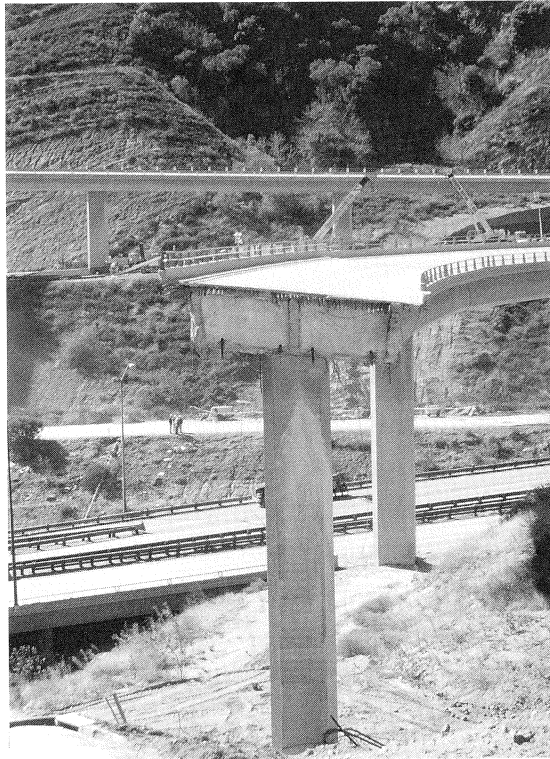
The North Connector is also a 10-span continuous, cast in place, concrete box girder bridge. Constructed in five segments, the total length is in excess of 1,500 feet with a radius of curvature of 550 feet. As with the Southbound Separation and Overhead, the southernmost end segment collapsed and again the sequence of collapse may have been the shear failure of a short squat end pier (pier 2) followed by shear failure of the superstructure at the face of pier 3 and unseating of the girder at the abutment (Figure 3-6). In the absence of rigorous analysis, the sequence of failure is uncertain but it is possible that pier 2 attracted a much higher proportion of the lateral load than assumed in design because of its relatively short height. Further, there was probably a significant reduction in the axial load in the pier due to both the severe curvature in the bridge and the high vertical accelerations in the ground motion. This reduction in axial load may have reduced the shear capacity of the column to less than the demand leading to the failure of the pier.

**FIGURE 3-6 SR14/I-5 North Connector -
Collapsed End Spans After Demolition**

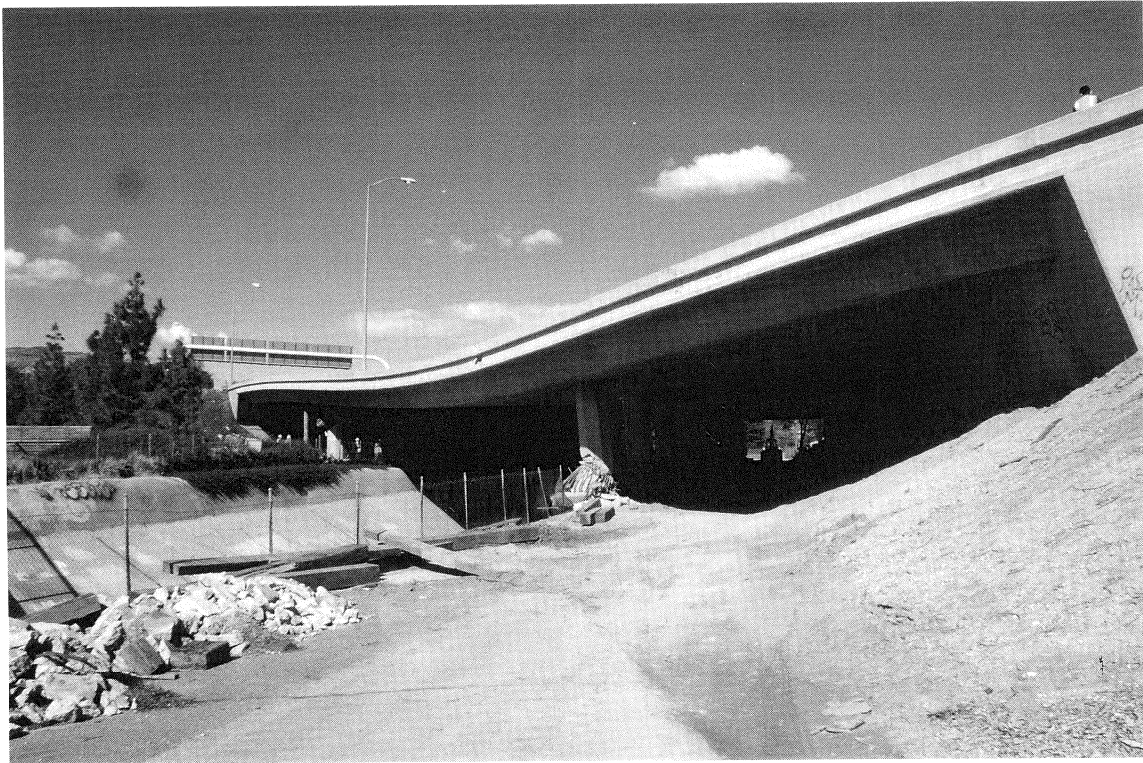
Three bridges on this freeway sustained major collapses and/or damage to their abutments. The Bull Creek Canyon Channel bridge is a three-span multi-cell box girder bridge carrying SR118 over a small drainage channel. Both multicolumn bents suffered hinge failures causing the superstructure to settle vertically with only slight translation horizontally (Figure 3-8). Each column in the eastern bent failed just above a training wall for the channel. This wall appeared to be structurally connected to each of the columns in the bent and most probably gave substantial restraint to these columns. This restraint was presumably unintended and it led to premature shear failures in the columns due to the reduction in the clear height of these members. The western bent was not adjacent to the drainage channel and accidental restraint and premature shear failures did not appear to be present. Nevertheless, the flexural hinges that did occur, did so just below the termination of the spiral reinforcement at the top of each column indicating an inadequate length of this confining steel.

**FIGURE 3-8 Bull Creek Canyon Channel Bridge -
Side View**

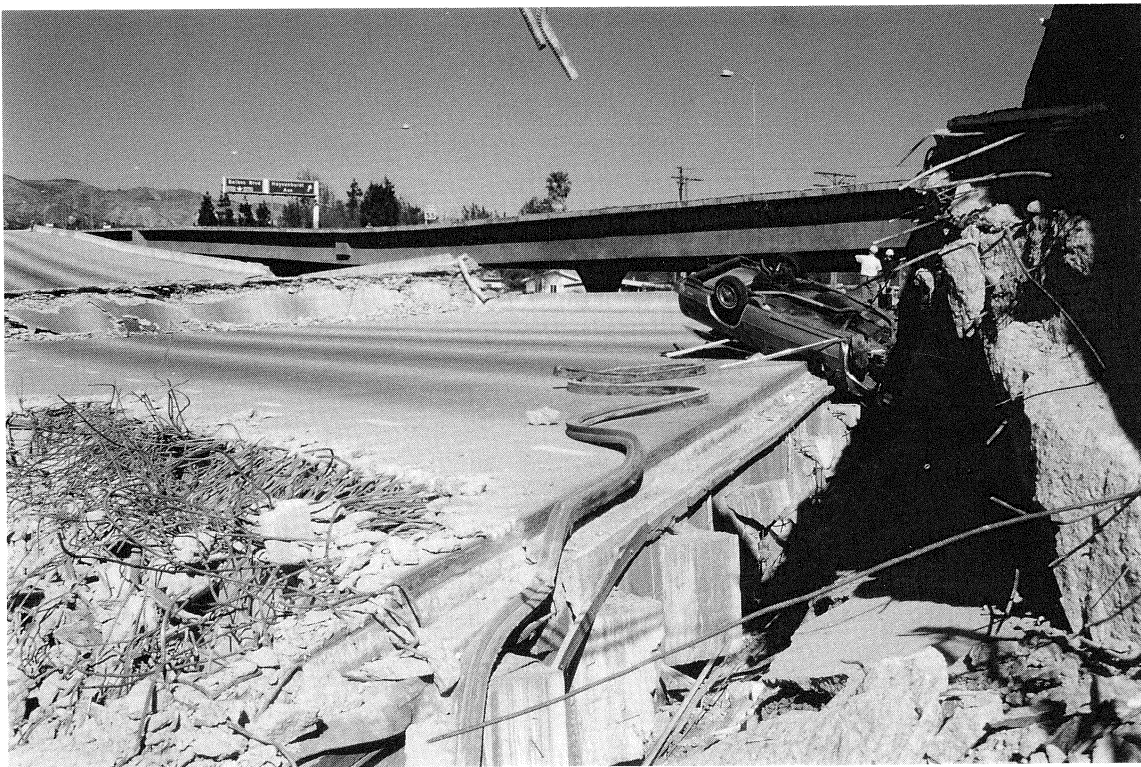
The Mission-Gothic Undercrossing has abutments on opposing 45° skew alignments and thus the length and number of spans differs between the eastbound and westbound structures. During the earthquake, the eastbound bridge sustained major damage to shear key and columns leading to the partial collapse of the eastern end span (Figure 3-9). It seems likely that the unusual skew geometry may have initiated this collapse. The non-uniform restraint of the abutment backfills may have permitted rotation of the bridge in plan. If so, this rotation would have been initially restrained by the abutment shear keys and the multicolumn bents. It seems likely that the abutment restraints immediately failed, leaving the columns to resist the lateral loads alone. However, the columns were flared from about their mid height to the top of the column. These flares are usually added for aesthetic reasons and not intended to add structural strength to the column. But in this case, unintended structural interaction between the column and the flare reduced the effective height of the column which in turn led to higher shear forces in the columns and to their subsequent failure immediately below the flare (Figure 3-10). These flares are a common feature of modern Caltrans bridges and their participation in the overall capacity of the column has been previously questioned. However, until now there has not been any field evidence of a problem with this detail.

**FIGURE 3-9 Mission-Gothic Undercrossing -
Span 4 and East Abutment of Eastbound Bridge**

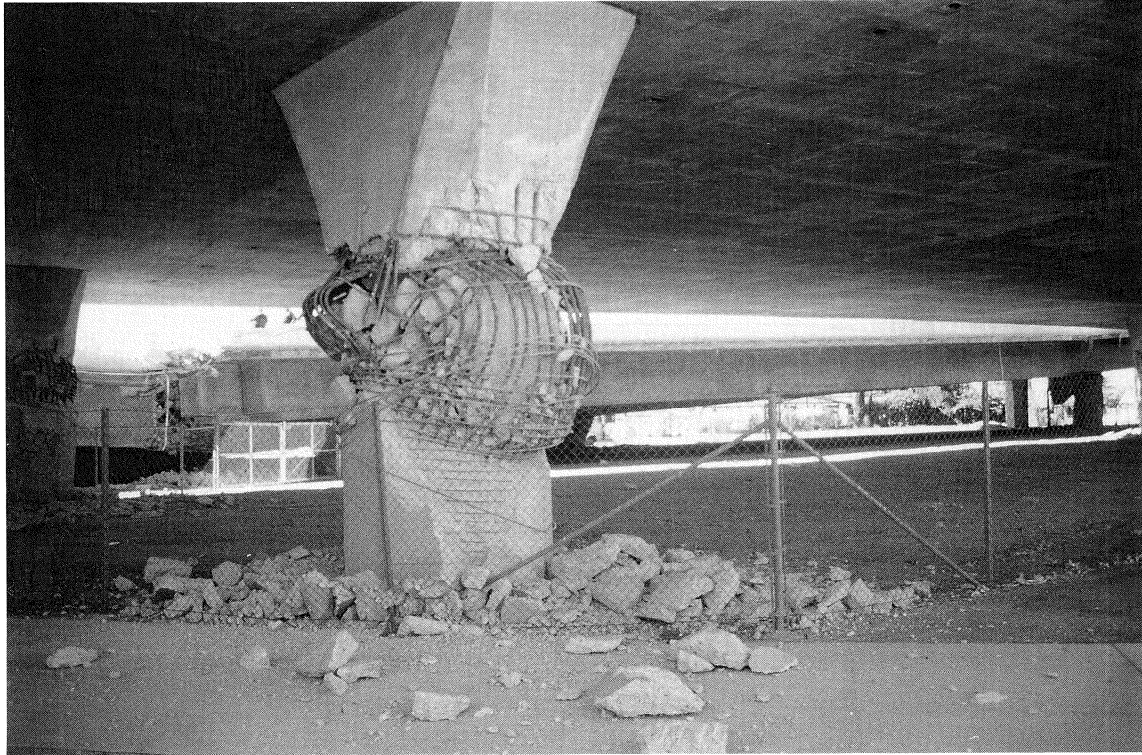
**FIGURE 3-10 Mission-Gothic Undercrossing -
Hinge Formation Below Flare in Column of Eastbound Bridge (Side View)**

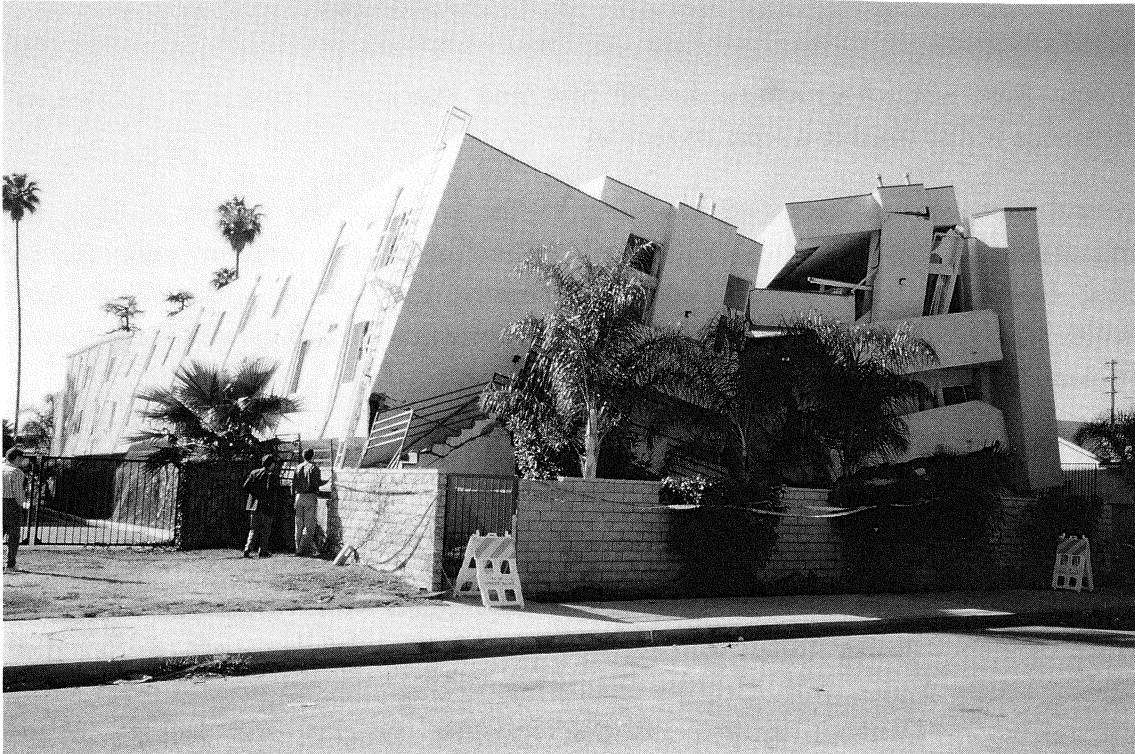
A large number of two- to four-story wood frame apartment buildings collapsed due to lack of suitable lateral resisting systems (see Figures 3-16 to 3-19). Most of the collapsed buildings were poorly engineered (or pre-engineered) using wood frames covered by stucco walls (or sheet rock panels) without diagonal braces or plywood shear walls (see Figure 3-20). Most buildings were based on shallow foundations and had carports at the ground floor leaving open spaces without walls or other bracing systems. Such structures developed flexible (and weak) first stories with subsequent first story column side sway collapse mechanisms. The single largest number of casualties occurred in the collapse of such a structure on Reseda Boulevard in Northridge (see Figure 3-21).

FIGURE 3-16 Apartment Buildings on Sherman Boulevard in Van Nuys

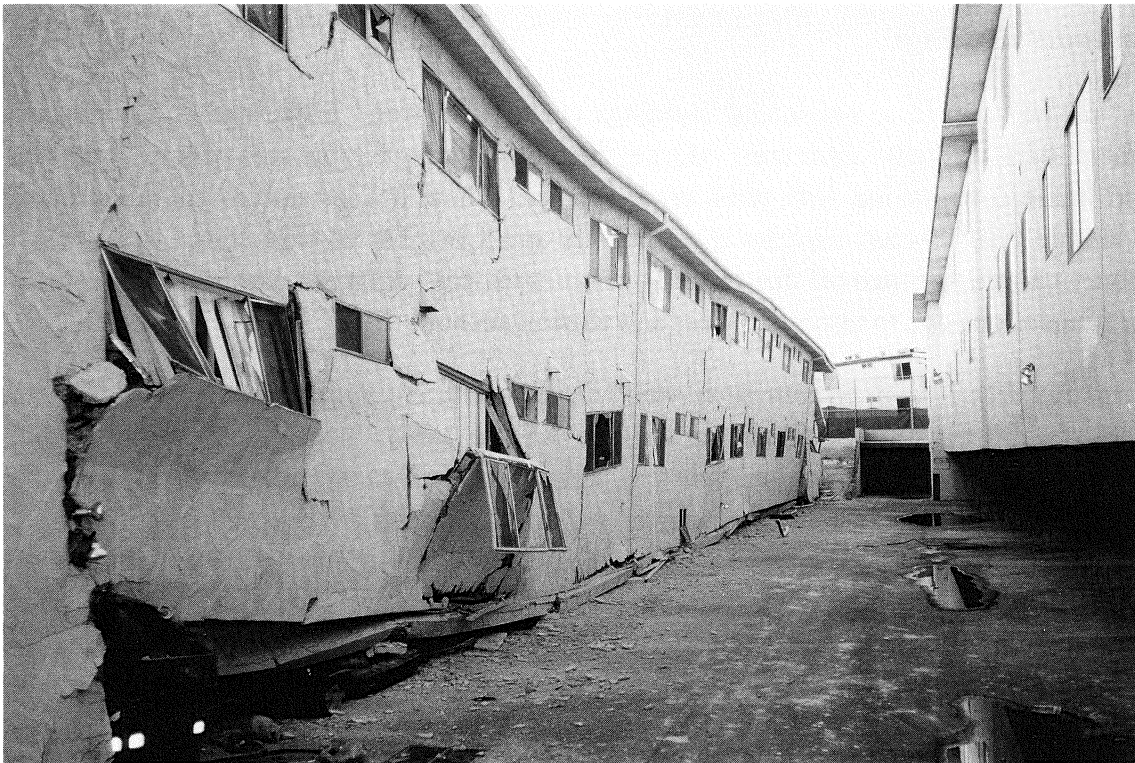
FIGURE 3-17 Wood Frame Apartment House with Collapsed Carport on Reseda Boulevard in Northridge

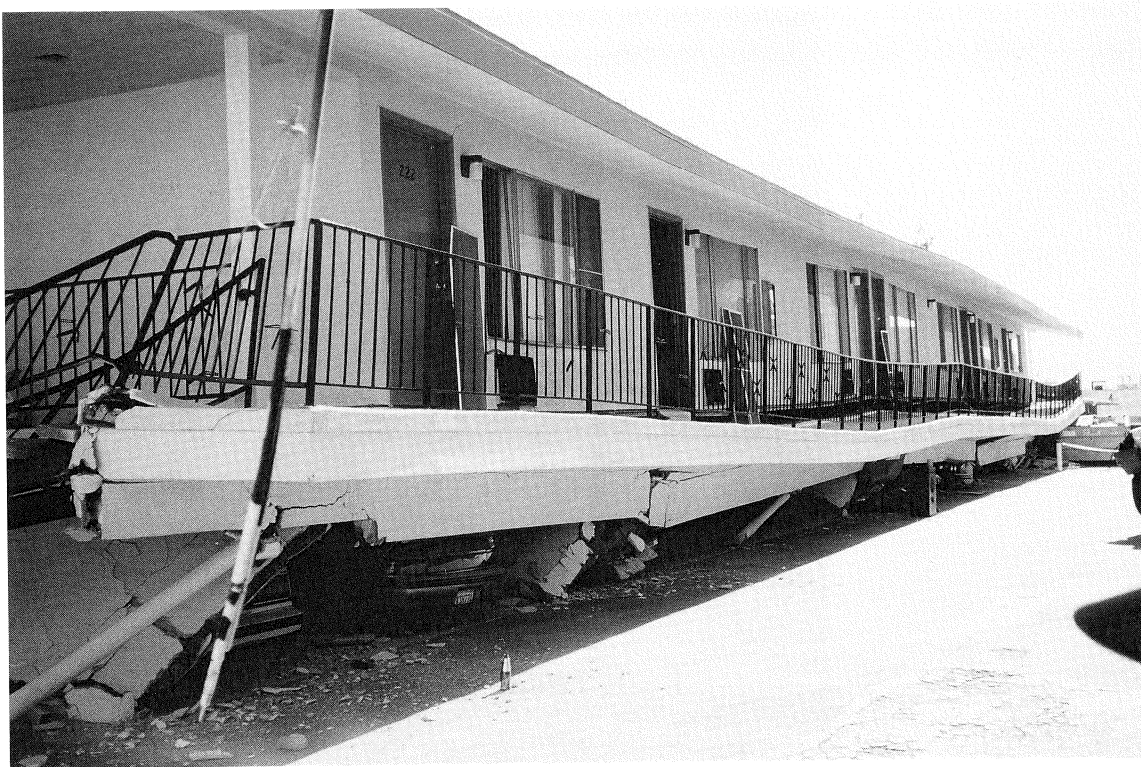
FIGURE 3-18 Wood Frame Apartment with Collapsed Carport on Reseda Boulevard in Northridge

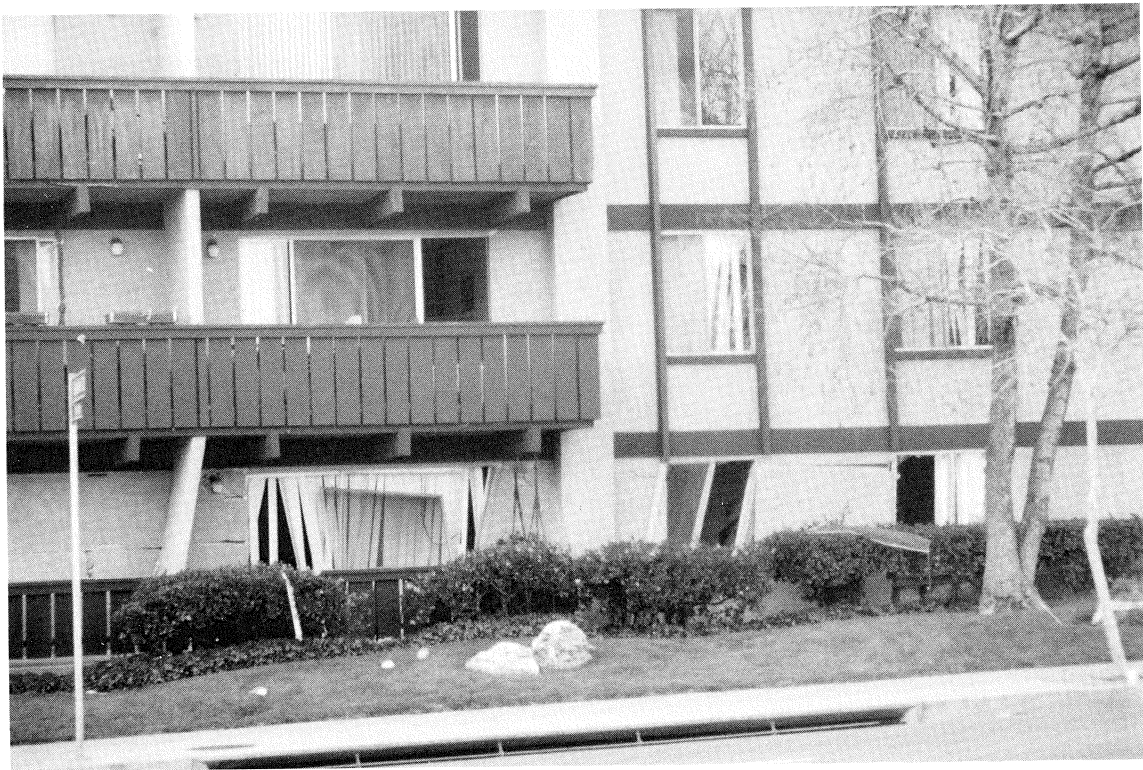
FIGURE 3-19 Lateral Deformations in the Ground Floor of Wood Frame Structure on Reseda Boulevard in Northridge

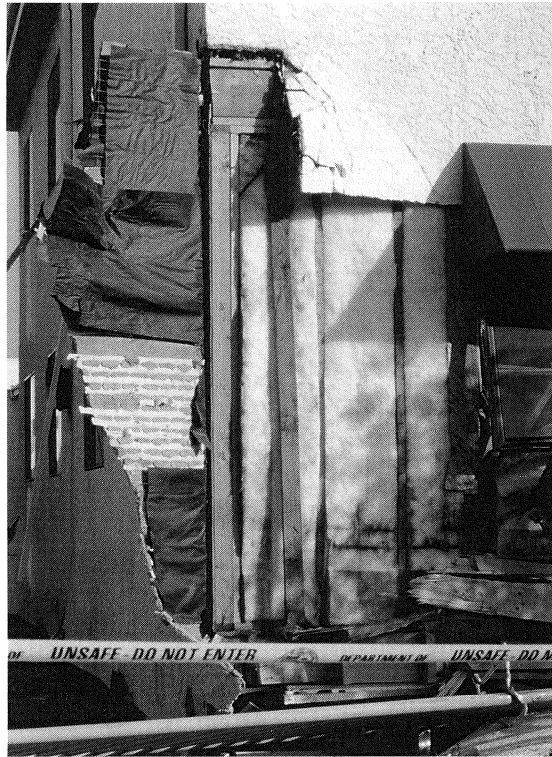
FIGURE 3-20 Typical Construction of Walls in Wood Frame Structures

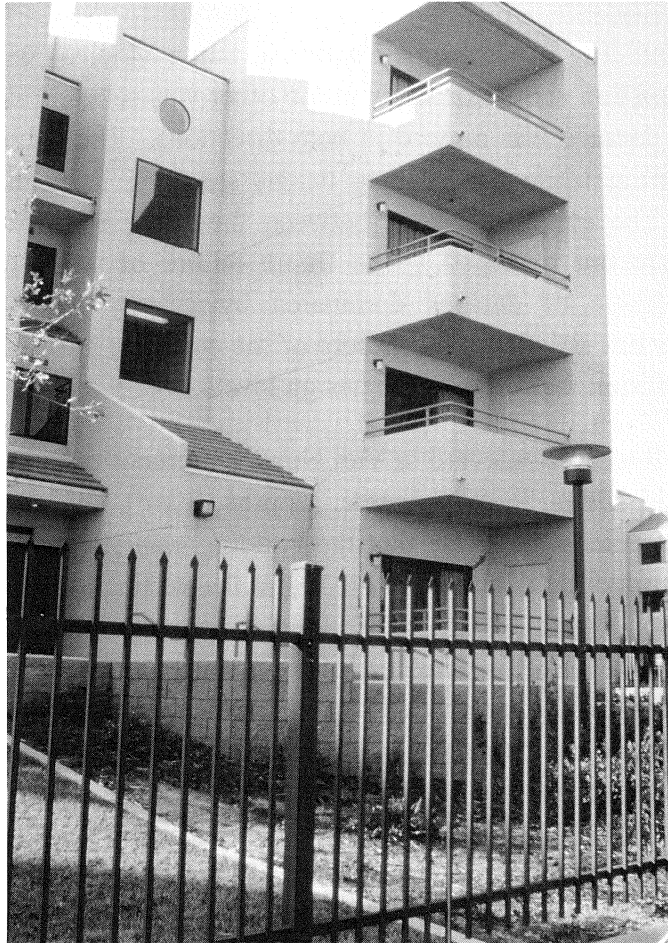
not occur. In fact, several newer wood-frame structures with plywood shear walls survived the earthquake with minor repairable damage (see Figure 3-22). The Northridge area is characterized by wood frame structures lacking shear walls, thus a thorough evaluation of all buildings and eventual retrofit should be performed to improve their performance in future earthquakes.

FIGURE 3-22 Newer Wood Frame Buildings at California State University, Northridge

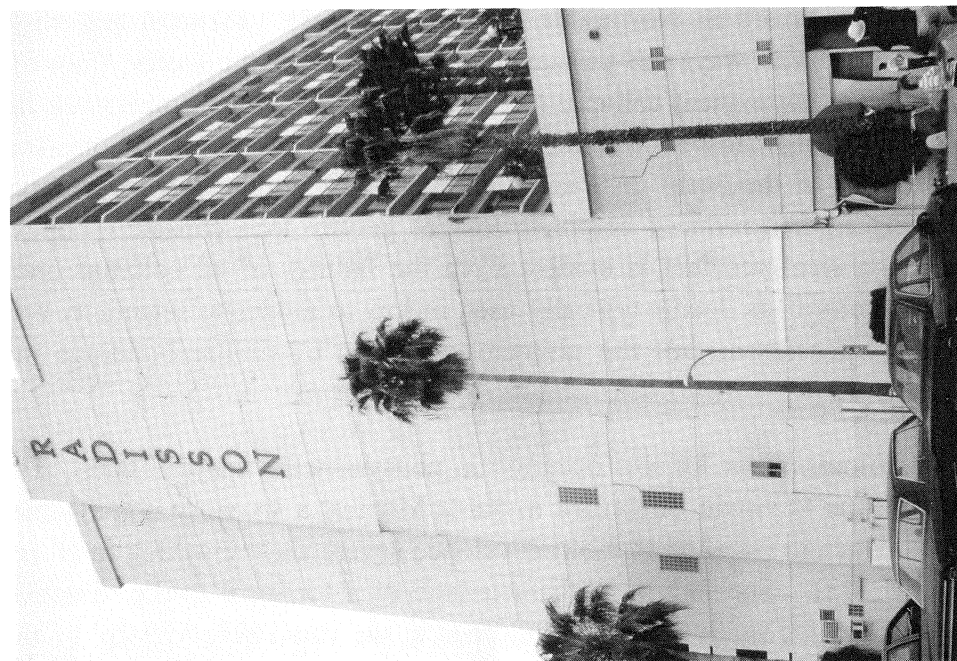
Among more lightly damaged hotels, a 13-story moment-resisting space frame structure suffered severe shear split cracking in its corner columns at lower stories (see Figure 3-26). The failure was most severe at the beam-column joint connection of the main tower with the structural system of a larger front annex (see Figure 3-27). A more thorough investigation might be necessary to assess the status of such structures.

FIGURE 3-26 Thirteen-Story Hotel with Moment Resisting Frame in Sherman Oaks

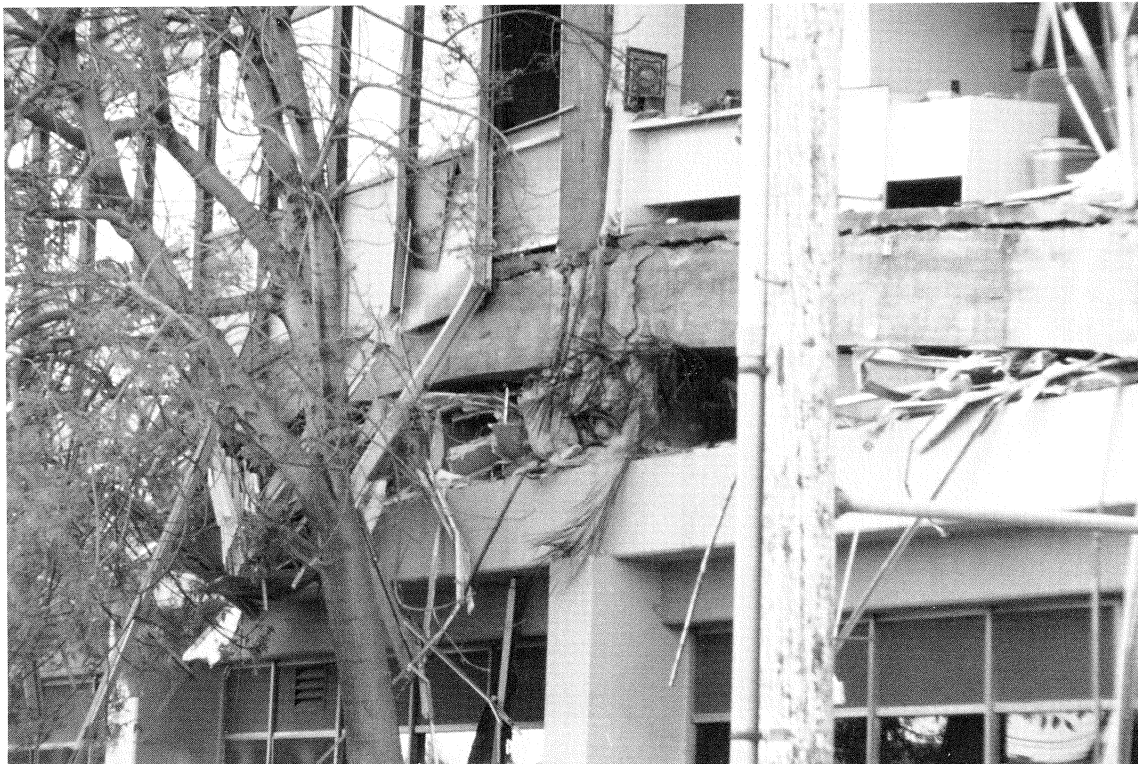
Most damage occurred in insufficiently ductile members. The most prominent and extreme example is the partial collapse of the five-story administrative office of Kaiser Permanente on Balboa Boulevard in Northridge (see Figure 3-28). Flexural and shear failure of columns produced lateral sways and permanent deformations in the second floor of the moment resisting frame, with subsequent collapse (see Figure 3-29). Shear compression failure of beam-column joints produced substantial reduction of capacity of the entire system (see Figure 3-30). Bond slip failure in the beam ends and joint failure of poorly detailed components in the moment resisting frame produced complete loss of gravity load capacity (Figure 3-31). The lack of confining reinforcement is evident from the failures of all columns and beam-column joints. This structure has details typically used in low to moderate seismicity areas. Its failure should trigger a reassessment of the ultimate capacities of similar buildings in areas of less severe seismicity.

FIGURE 3-29 Collapse of Second Story of Office Building in Northridge

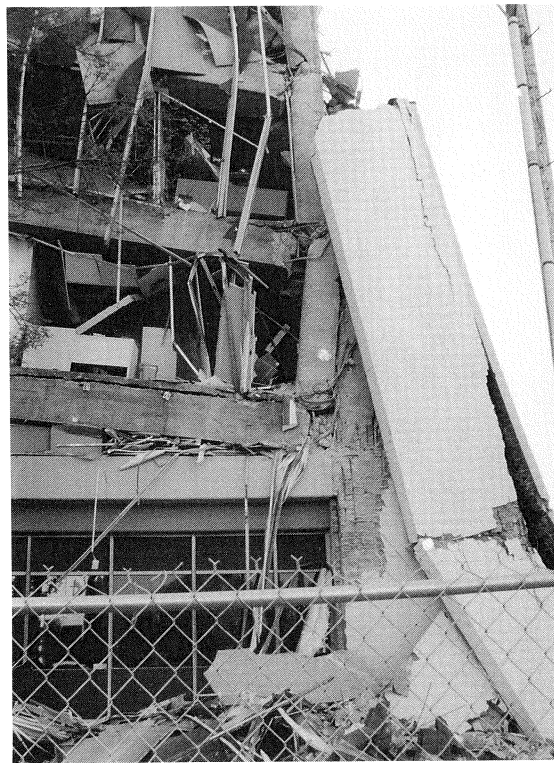
FIGURE 3-31 Failure of End Beam-Column Joint Connections in Office Building in Northridge

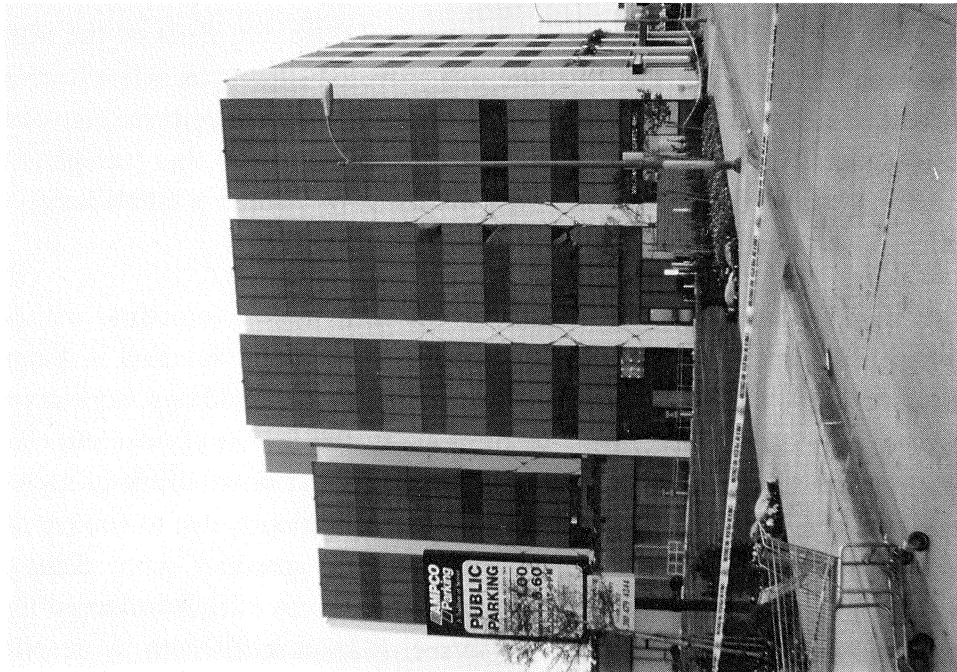
Short column shear failures occurred in nonsymmetric space frames. The Barrington Medical Building on Olympic Boulevard in Santa Monica, a six-story non-symmetric moment resisting frame structure (see Figure 3-32) developed severe shear cracking in all peripheral columns (see Figure 3-33). The failure is characteristic of a torsional cyclic vibration. The building was demolished for safety reasons. Buildings in the immediate vicinity of this office also showed evidence of structural damage. The ground motion recorded for Santa Monica in the vicinity of city hall reached 0.87g in the horizontal direction with a peak velocity of approximately

FIGURE 3-32 Nonsymmetric Moment Resisting Space Frame of Barrington Medical Building in Santa Monica

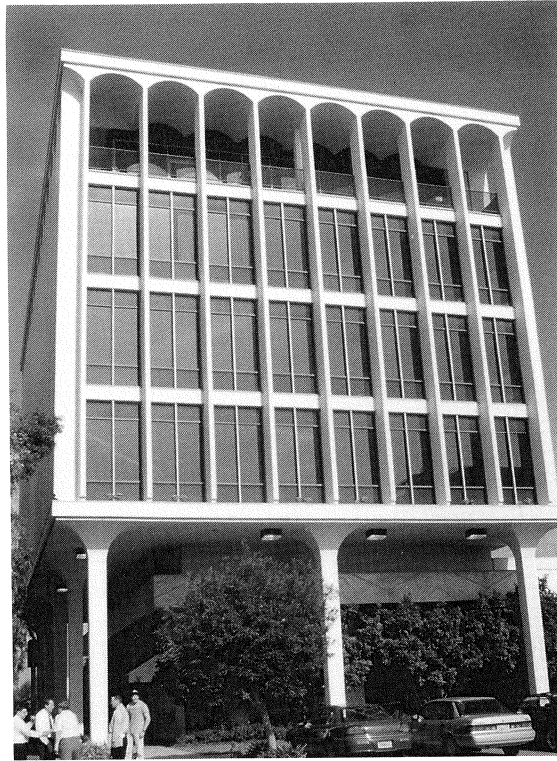
A number of office buildings observed during this reconnaissance trip were built with hybrid construction. One five-story structure located approximately 10km from the epicenter (see Figure 3-36) was constructed with only one moment resisting frame along the centerline of one direction and short shear walls on the side of the eccentric stairwells, in the other direction. The structure developed torsional response with severe flexural and shear cracking in the walls with delamination of concrete and exposure of an insufficient lap splice of reinforcement at the base of each story (see Figure 3-37). Although the structure lost strength capacity, it can be repaired after further evaluation. Such structural systems are not recommended in the newer codes.

FIGURE 3-36 Five-Story Office Building Near Epicenter

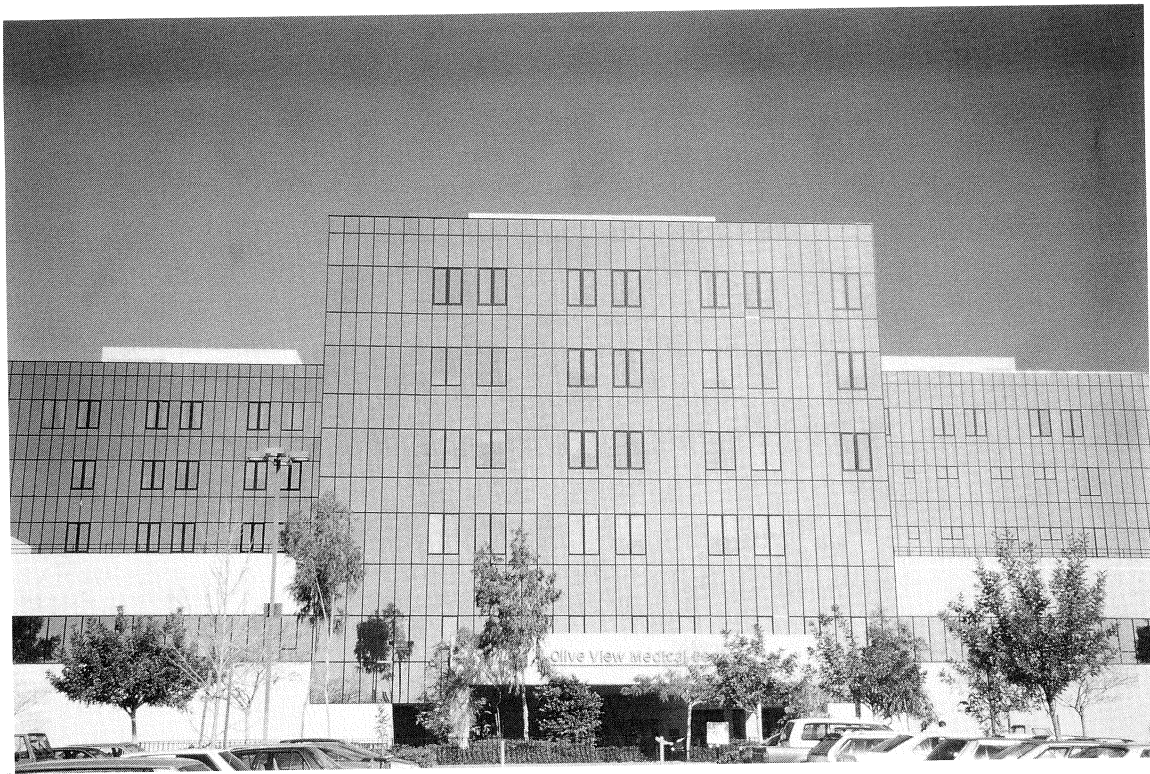
mechanical room on the roof. The structure survived this extreme motion without serious damage (see Figure 3-40), however, the contents were severely damaged (see Section 5.5).

FIGURE 3-40 Olive View Hospital in Sylmar
