The Northridge, California Earthquake of January 17, 1994: General Reconnaissance Report

Edited by J. Goltz

Technical Report NCEER-94-0005

March 11, 1994

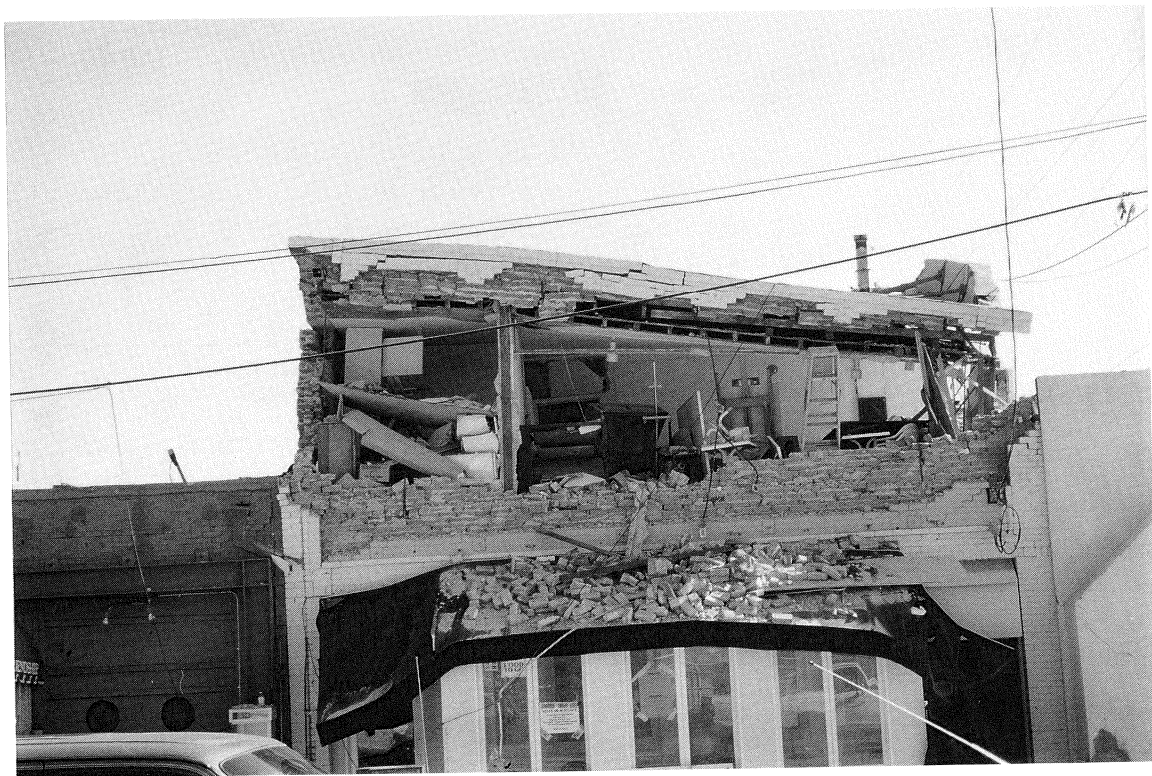
Many of the commercial and some residential buildings were constructed with load bearing unreinforced masonry (URM) walls or with nonstructural cladding masonry walls. As in most of the previous earthquakes in Southern California, these structures sustained severe damage (see Figure 3-41). In many instances, the roof supported on such walls collapsed (see Figure 3-42). Walls constructed with insufficient horizontal reinforcement and anchors sustained substantial damage (see Figure 3-43).

FIGURE 3-41 Collapse of Unreinforced Masonry Wall

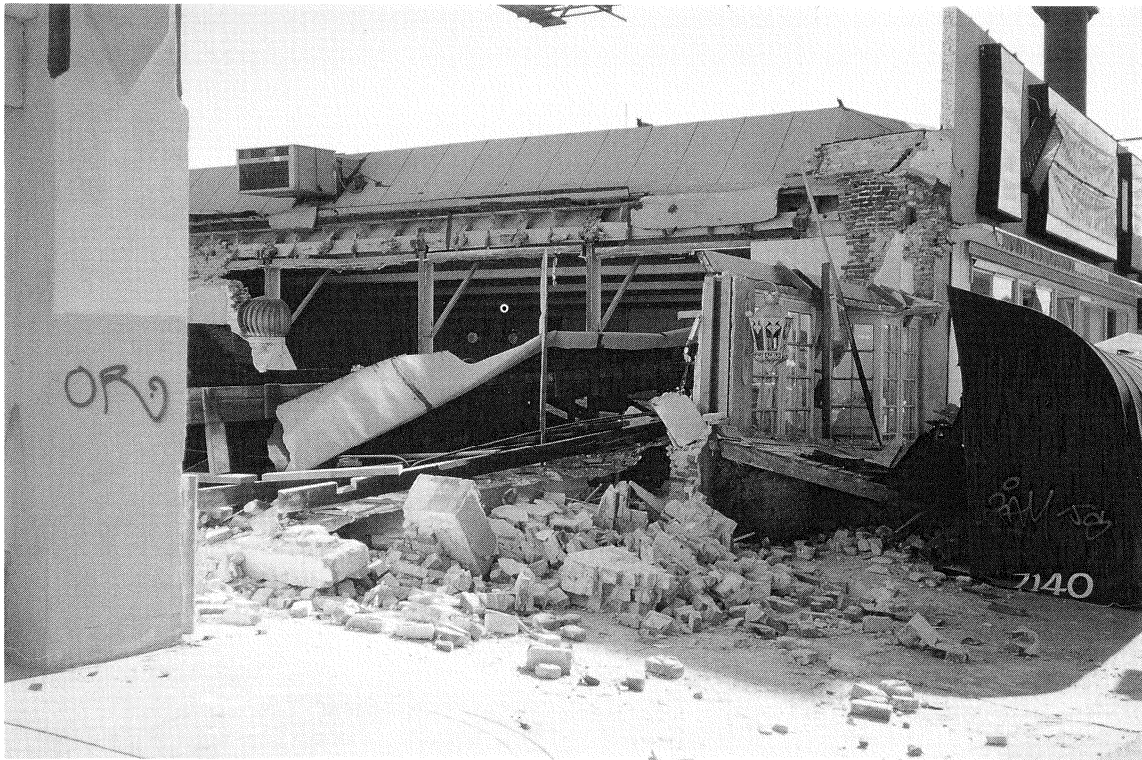
**FIGURE 3-42 Collapse of Load Bearing Unreinforced
Brick Masonry Wall and Roof in Northridge**

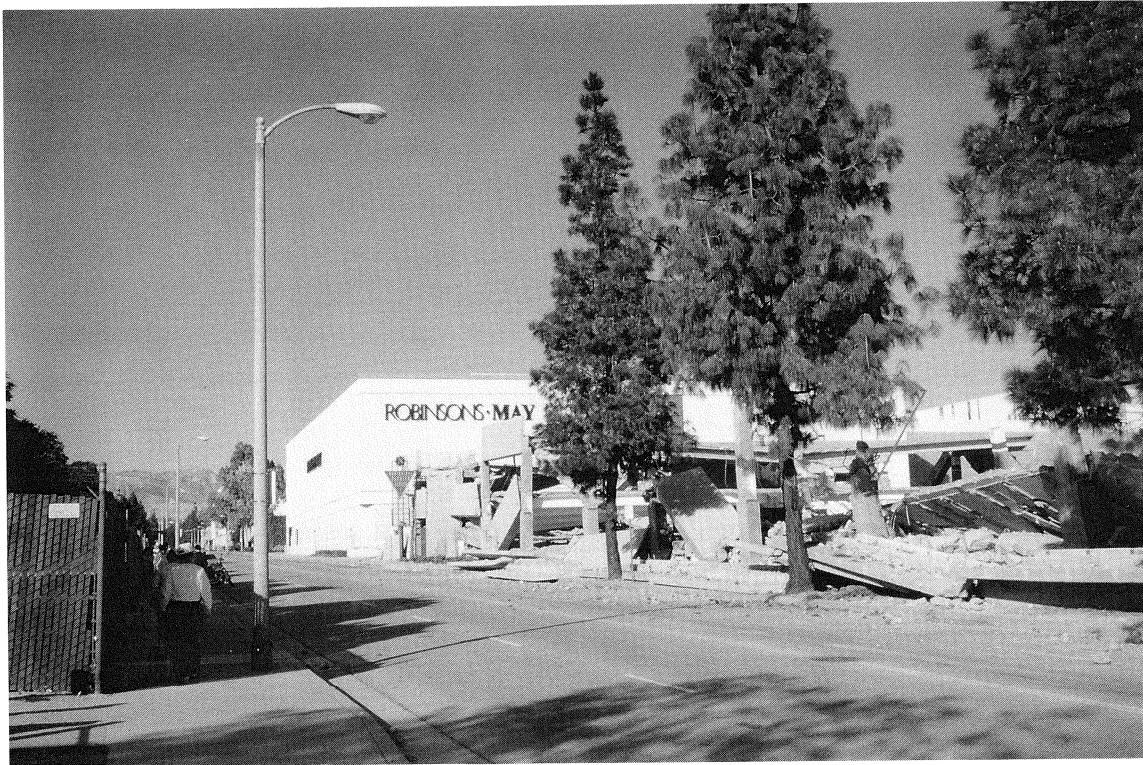
Several examples are noteworthy: The two- and three-story parking garages at the Northridge Fashion Center Mall were constructed with unidirectional moment resisting frames. On one hand, the shaking produced double hinged columns in the direction of the strong frames with excessive column side sway mechanisms (with excessive deformations that rendered these garages unusable, see Figure 3-45). On the other hand, the shaking led to complete collapse of several other parking structures when it was perpendicular to the strong direction (see Figure 3-46) and no secondary system was available to absorb the effects.

**FIGURE 3-46 Collapse of Precast Parking Garage
at Northridge Fashion Center**

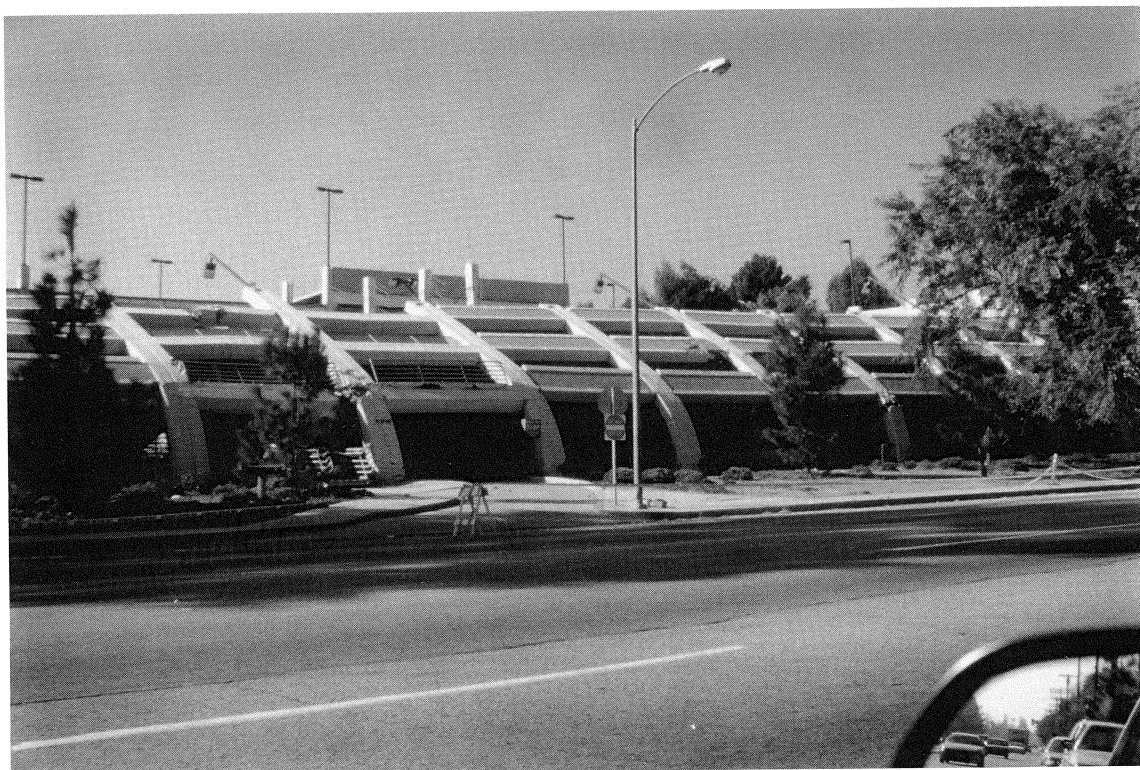
The three-story parking garage at California State University at Northridge, a three year old precast structure with prestressed, cast-in-place slabs, collapsed due to lack of a suitable lateral resisting system (see Figure 3-47). The precast girders were unseated from the short untied corbels due to large lateral sways (see Figure 3-48) and lack of moment resistance of the slab column joint. The precast columns which bend without breakage exhibited excellent ductility, with only distributed cracking (see Figure 3-49). In general, the precast construction included a connection between a welded plate under the girder to a seat angle at the corner of the corbel. Such details proved to be difficult due to weld breakage and corbel corner failure in other garages which collapsed at the Glendale Civic Center and in downtown Los Angeles. In addition, high vertical ground shaking combined with deficient details and lack of redundancy are probably responsible for the total collapses.

**FIGURE 3-47 Collapse of Precast Parking Garage
at California State University, Northridge**

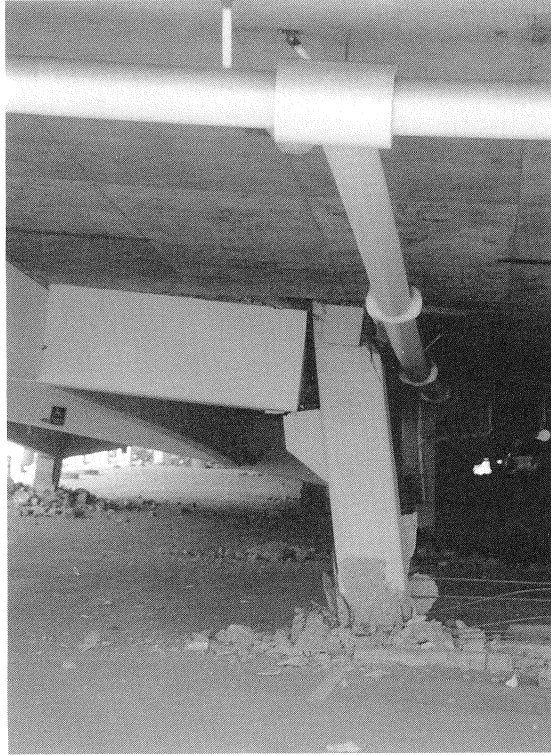
**FIGURE 3-48 Unseating of Girders in the Parking Garage
at California State University, Northridge**

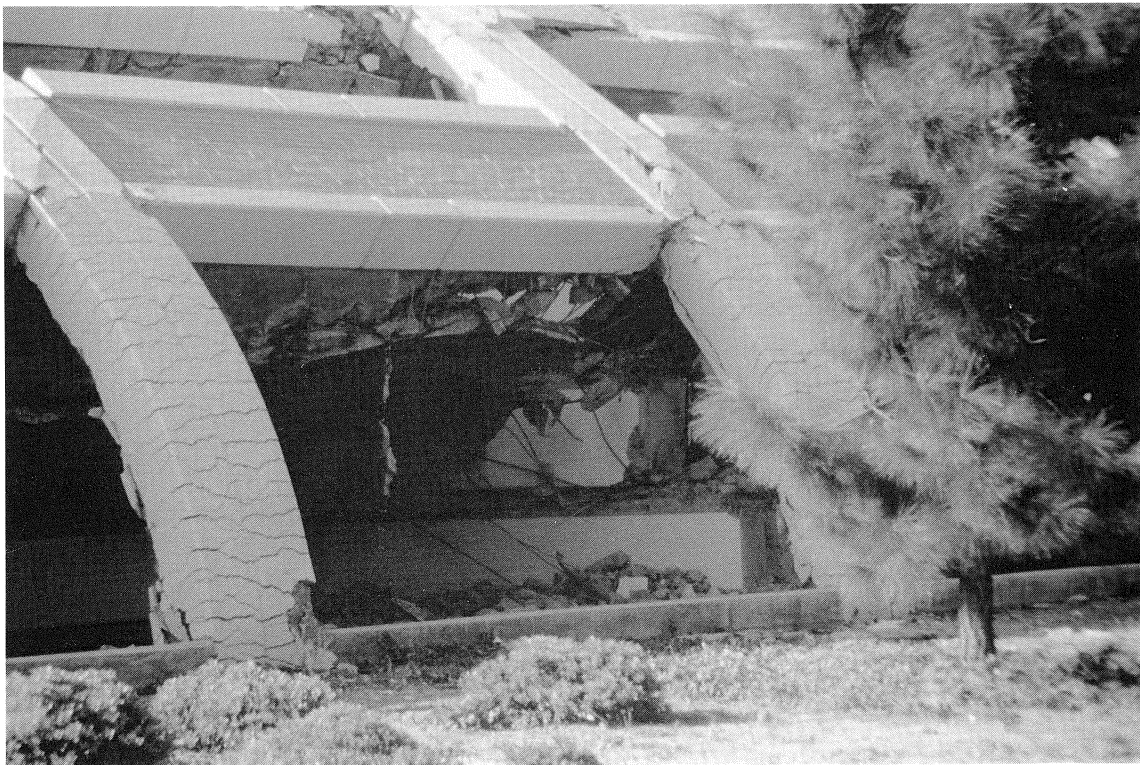
**FIGURE 3-49 Curved Unbroken Columns in the Parking Garage
at California State University, Northridge**

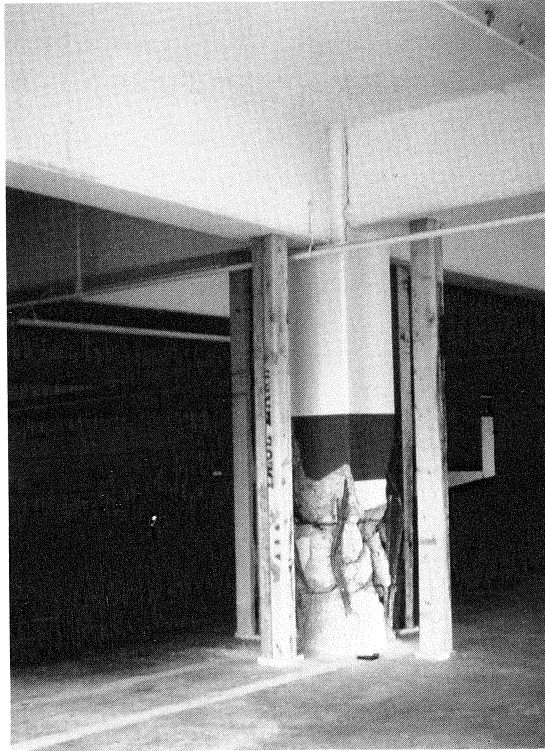
Cast-in-place garages also experienced severe damage, but not complete collapses. The oversized beams, constructed for large spans, led to weak-column side sway mechanisms with short column shear failure when the openings were partially filled with half height masonry walls (Glendale Civic Center), or to shear-flexural-compression failure (see Figure 3-50). The weaker direction of most of these garages proved to be more vulnerable, developing damage such as the lateral shear shift of more than two and one half inches (63mm) of all columns above their pedestal foundations as shown in Figure 3-51 from a garage in Glendale.

**FIGURE 3-50 Shear Compression Failure in Column of
Cast-in-Place Garage in Sherman Oaks**

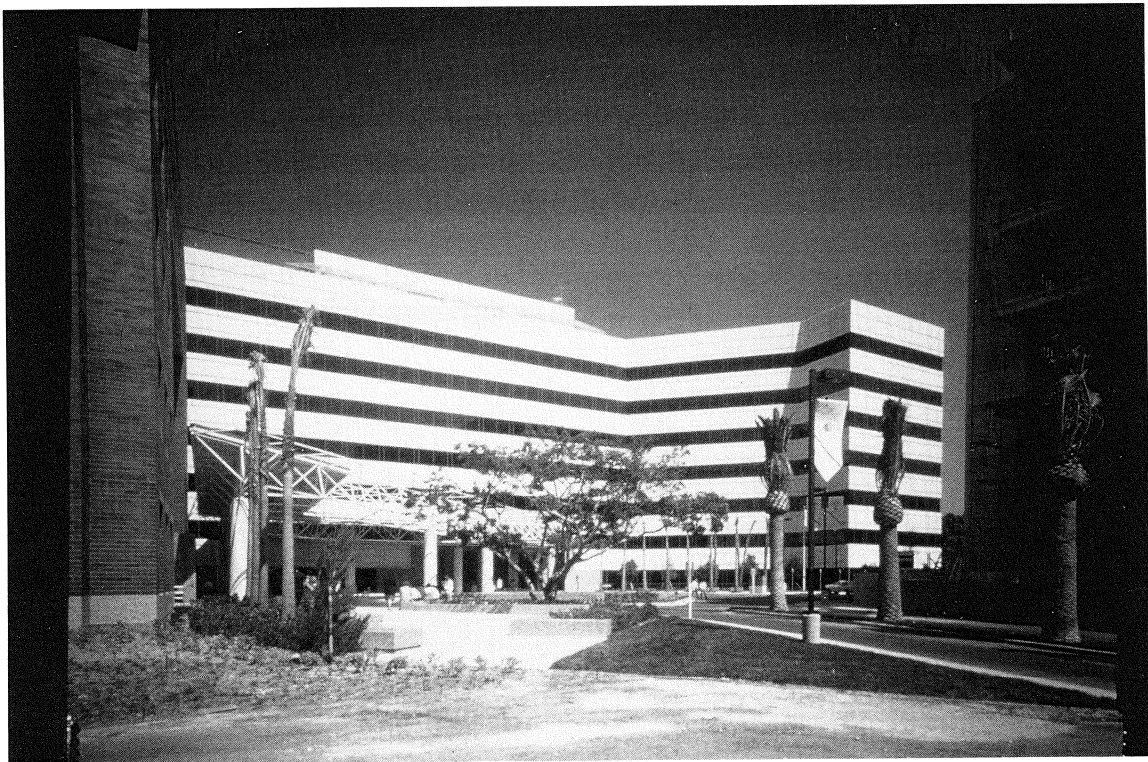
The USC hospital, 36km from the epicenter, was subjected to ground motion in the north-south direction with a peak of 0.49g (measured in the field) that produced an acceleration of 0.37g under the isolators. This is the strongest shaking that has excited any full scale base isolated building to date. The eight-story hospital is constructed with a steel braced frame supported by 81 standard natural rubber bearings and 68 lead-rubber isolators (see Figures 3-52 and 3-53).

FIGURE 3-52 University of Southern California Teaching Hospital

The peak acceleration response above the isolators was reduced to 0.13g, while the roof acceleration reached only 0.21g (effectively only 57% of the base excitation).

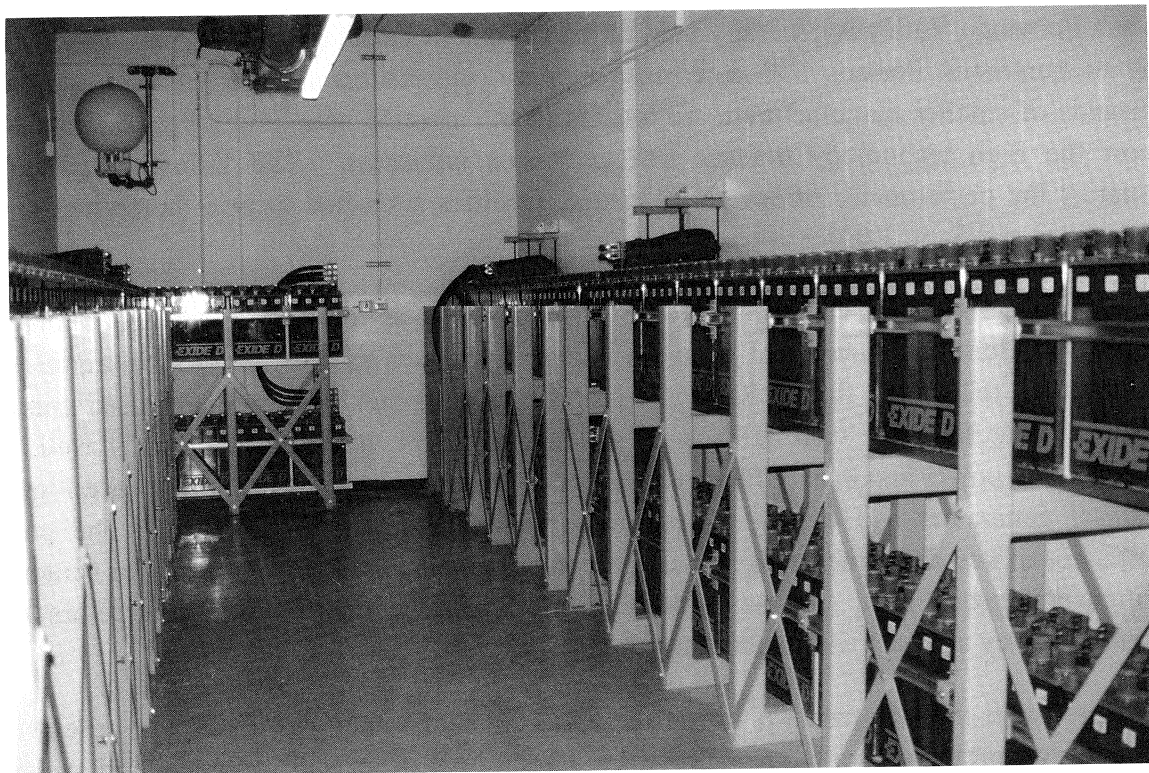
FIGURE 3-55 Engineered Equipment such as these Braced Battery Racks were not Effected by the Earthquake

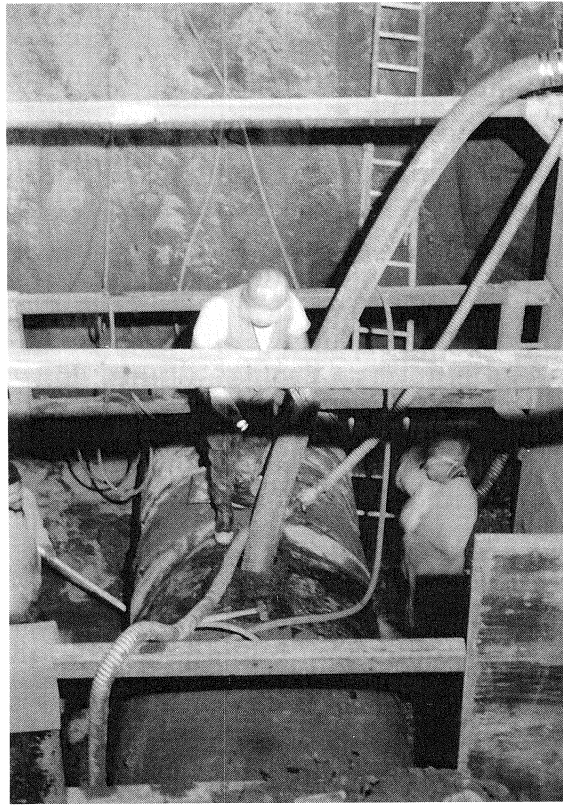
FIGURE 4-2 Repair of Van Norman Pumping Station Discharge Line (54" wsp)

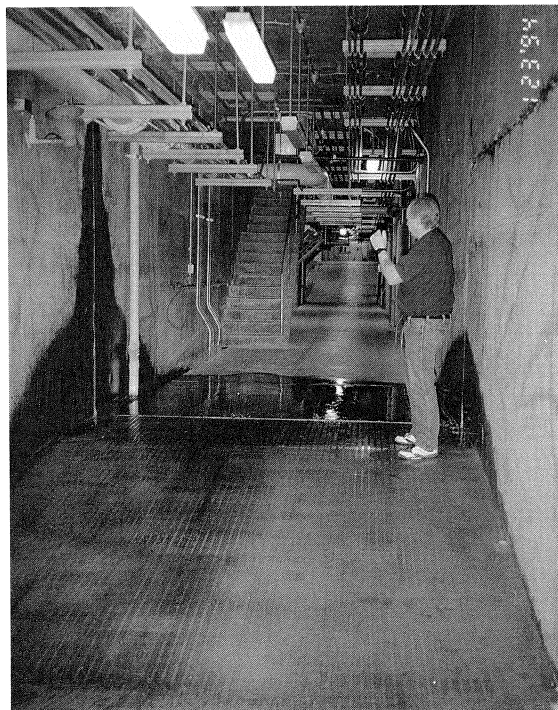
FIGURE 4-7 Utility Gallery in the 600-mgd Water Treatment Plant (Note water leaking out of cracks in concrete basin. Extensive cracking of concrete structures and basins was observed at this facility.)

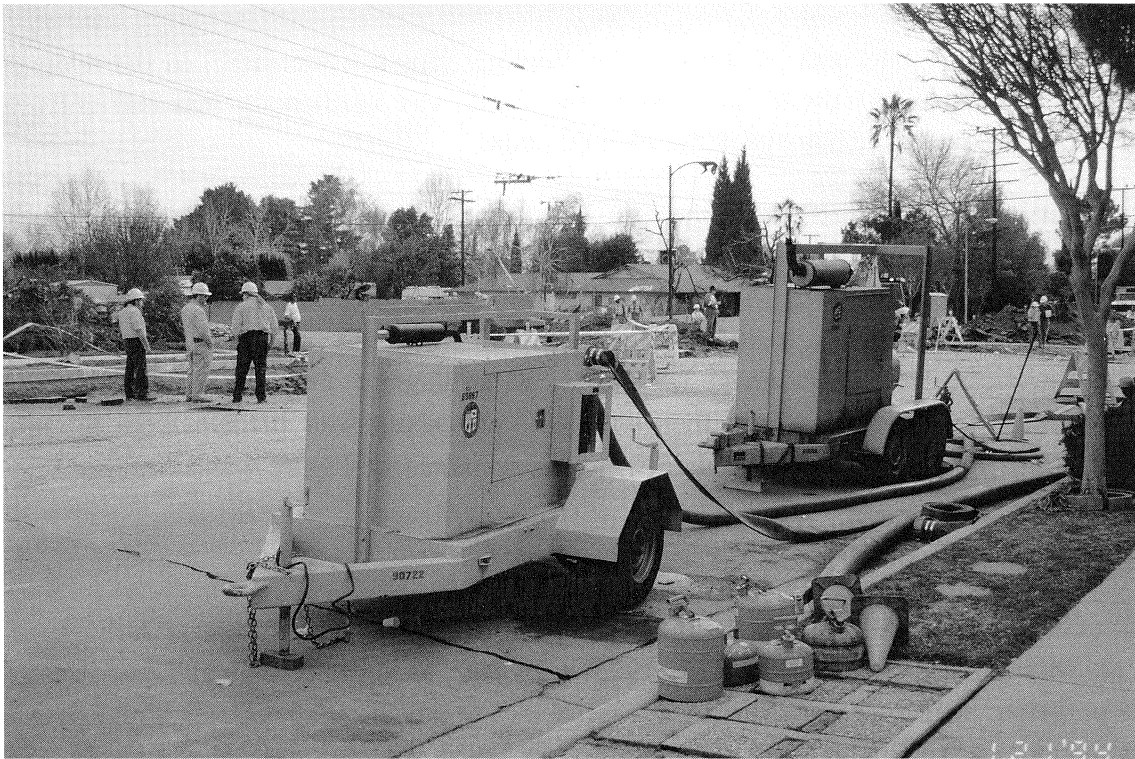
FIGURE 4-14 Portable Bypass Equipment (to Bypass Sewage Flow) Used in Support of Televised Inspection of Underground Sewer Lines

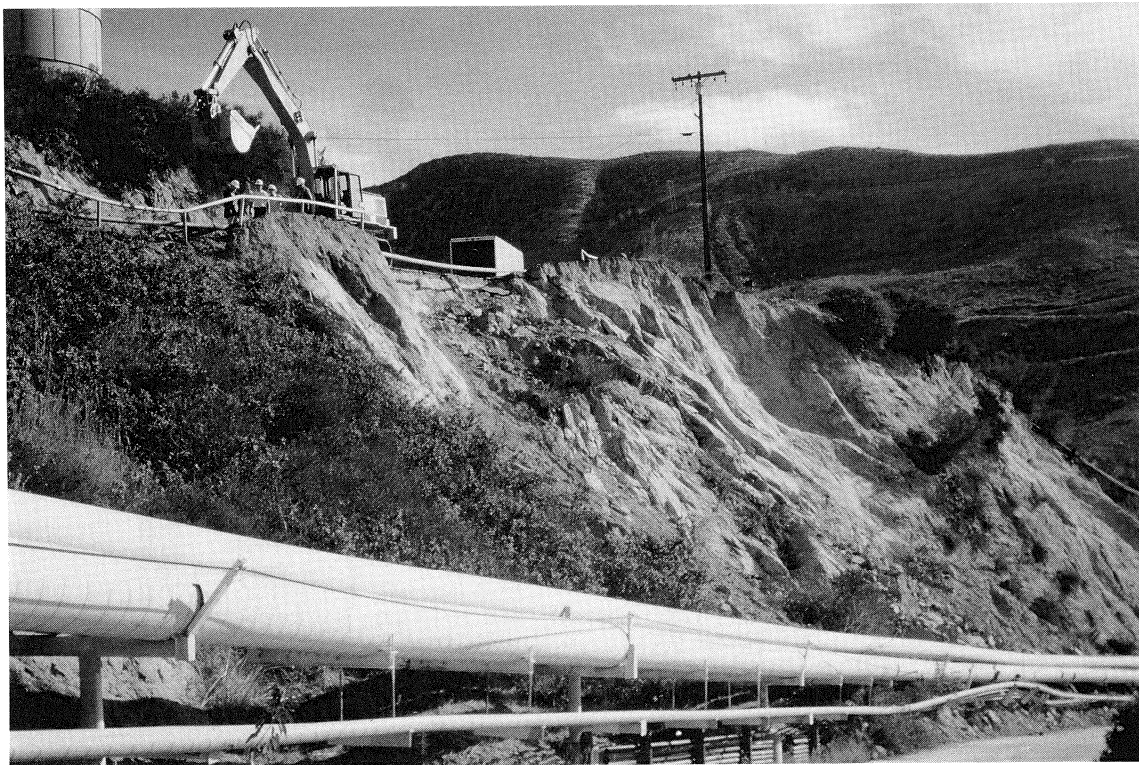
FIGURE 4-21 Local Landslide in Sandstone and Overlying Soil at the Aliso Canyon Gas Storage Facility

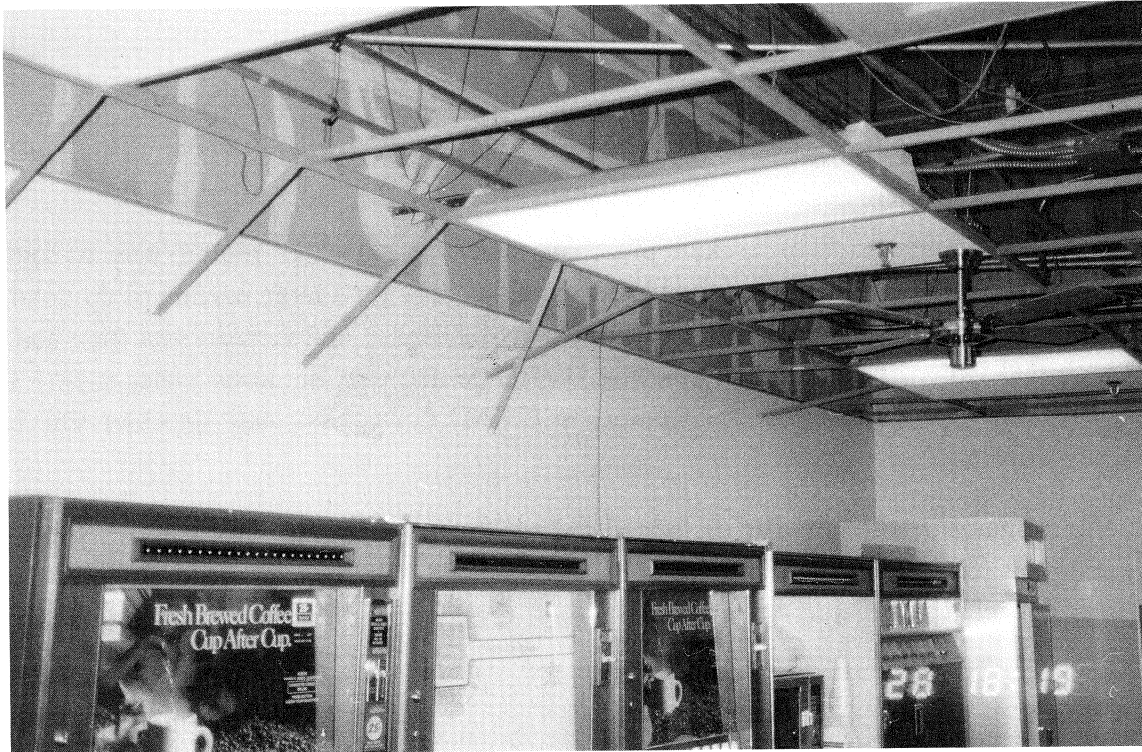
FIGURE 5-1 Typical Post-Earthquake Suspended Ceiling

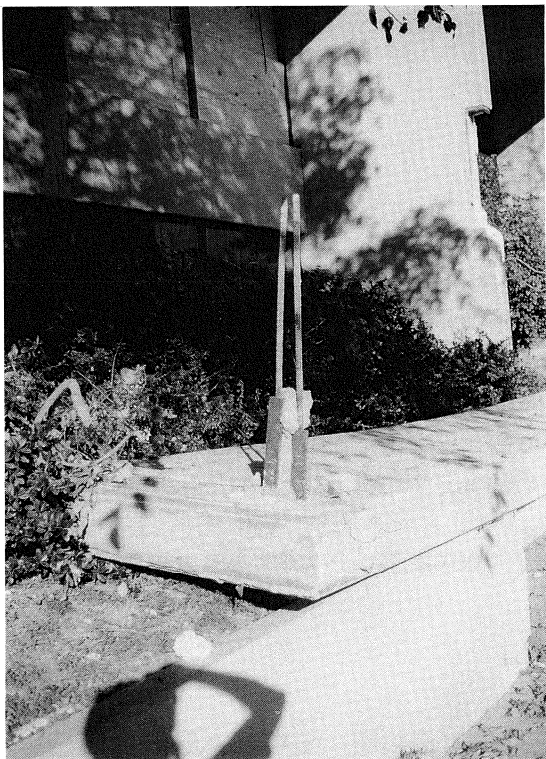
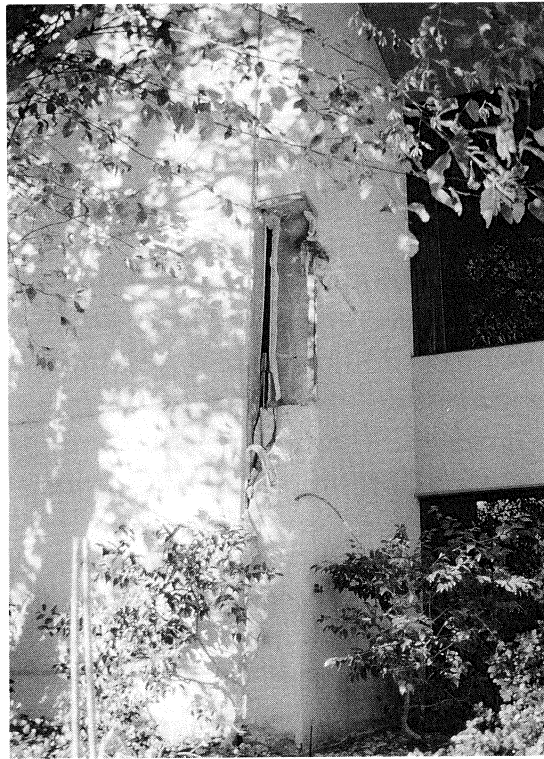
facades to the structure often provide weak anchorage. The vulnerability of non-ductile connections was demonstrated in the Northridge earthquake as shown in Figure 5-4.

FIGURE 5-4 Failure of Concrete Facade Anchorage Details
