Overview of Building Damages in 921 Chi-Chi Earthquake

K.C. Tsai¹⁾ Chiang Pi Hsiao²⁾ Michel Bruneau³⁾

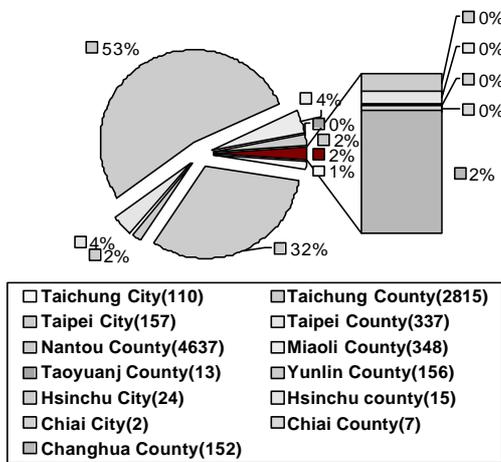
Fig. 4 Distribution of damaged buildings in Taiwan (number and percentage)

The 921 earthquake has resulted in a tremendous amount of damages in the central part of Taiwan. Figure 4 indicates that approximately 90% of the 8,773 damages are concentrated in Nantou County and its adjacent Taichung County. Over 300 damaged buildings are also observed in the Miaoli County, as well as in the Taipei County. The detail damages of Nantou County, Taichung County, and Taipei County are described below.

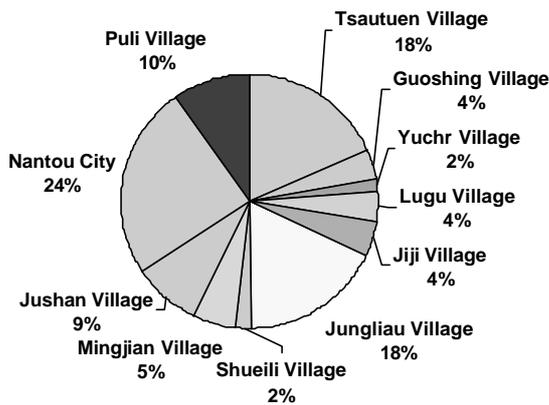
Fig. 5 Distribution of damaged buildings in Nantou County

Nantou County was severely impacted by this earthquake due to its epicenter location and the surface faulting. More than 4,500 structures, which equivalent to 53% of the island-wide damages, were surveyed in Nantou. Figure 5 illustrates

that Nantou City, Tsautuen Village, and Jungliau Village are the top three most damaged areas in this county; and their damaged building figures are 937, 846 and 823 respectively. The survey indicates that Nantou City, Tsautuen Village, Jushan Village, and Mingjian Village received substantial damages, because of the direct impact of the Chelungpu Fault.

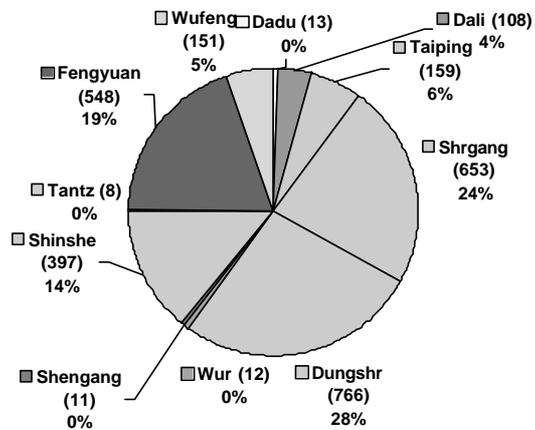
Fig. 6 Distribution of damaged buildings in Taichung County (number and percentage)

Being a highly populated county adjacent to Nantou, Taichung County also experienced significant damages of 3,200 building failures. It is observed from Fig. 6 that these damages in the Taichung County were concentrated at Dungshr Village, Shrgang Village, Fengyuan City, and Shinshe Village. The regional damage ratios of these four areas are 28%, 24%, 19% and 14% respectively.

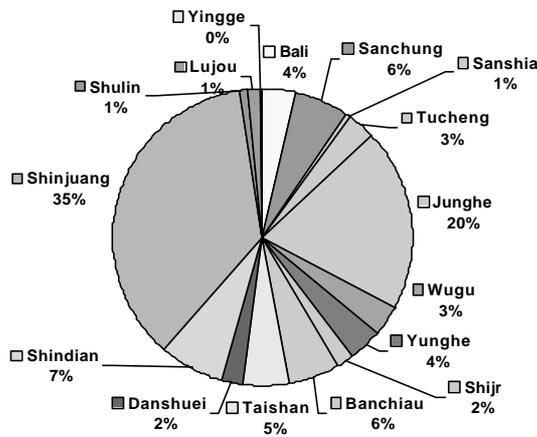
Fig. 7 Distribution of damaged buildings in Taipei County

Taipei County, a special seismic zone in the north region, is applicable to a different earthquake design requirement because of the Taipei basin location. Under a normal circumstance, the earthquake damage should be less significant since the Taipei County is so distant away from the epicenter. However, as the assessment indicates that the level of damage in Taipei County was greater than most of the counties in the northern region. Figure 7 indicate that the earthquake damages were concentrated at the Shinjuan City and the Junghe City, and their damaged building numbers are 122 and 66 respectively.

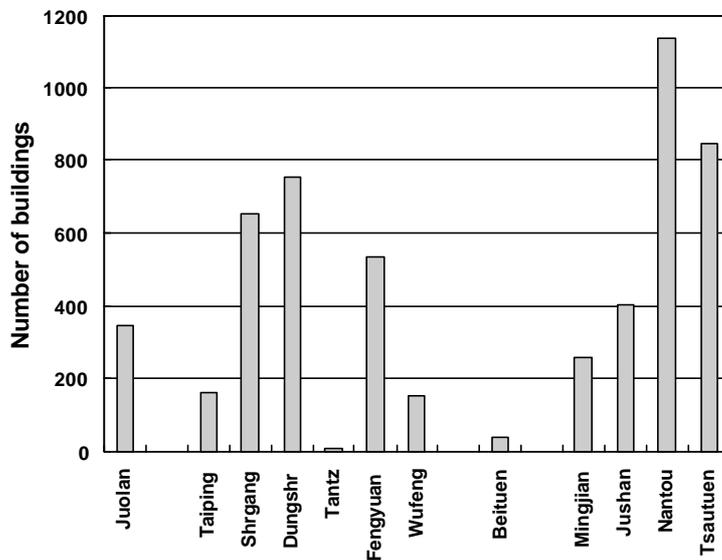
Fig. 8 Number of damaged buildings in cities near Chelungpu Fault

The epicenter location, Chi-Chi Village is located near southeast portion of the Chelungpu fault. The rupture length of the Chelungpu fault in this earthquake is over 100km long in the north-south direction, and its impacts are enormous. According to the post-earthquake geological investigation, the earthquake caused many permanent landslides and surface faulting in Miaoli County, Taichung County, Taichung City and Nantou County. Twelve areas are directly impacted: Juolan Village, Dungsht Village, Shrgang Village, Fengyuan City, Tantz Village, Beituen Village, Taiping City, Wufeng Village, Tsautuen Village, Nantou City, Mingjian Village, and Jushan Village. Figure 8 illustrates that 5,088 damages were reported, which is equivalent to 58% of the island-wide damages.

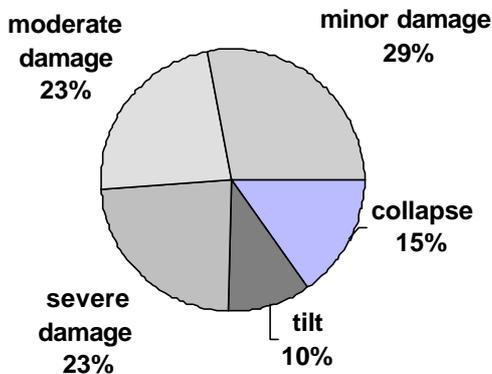
Fig. 9 Damaged percentage of RC structure

concrete structures become commonly constructed and represent a large portion of buildings. As the 921-earthquake damage survey indicates that the total number of the damaged reinforced concrete buildings has reached 4,325. Figure 9 indicates that 15% of the RC damaged buildings are the collapsed type, 10% of the damaged buildings are the tilted type, and 23% of the failures are the severely damaged type. The result indicates that over 48% of the RC damaged

structures are surveyed as sever damaged or more seriously damaged.

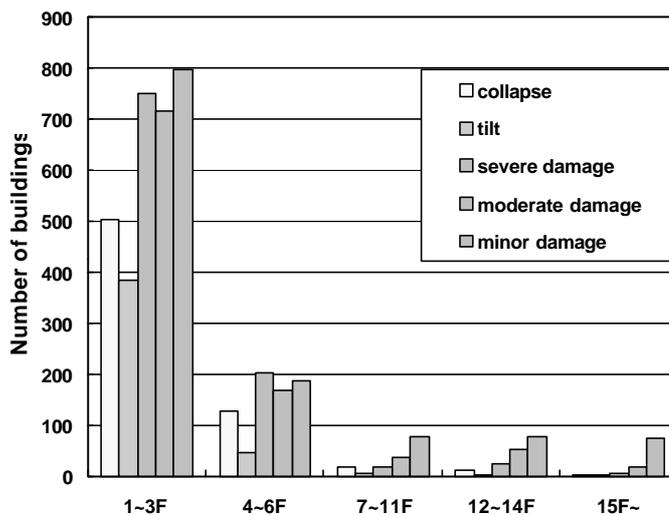
Fig. 10 Number of damaged RC structures with different number of stories

The 921 earthquake created a tremendous amount of damages in both Nantou and Taichung County. Since many low-rise single family houses are constructed and widely spread over these two areas; therefore, large numbers of low-rise buildings failures are recorded in this assessment. Figure 10 shows that about 75% of the damaged RC buildings are the 1 to 3-story buildings, and 52% of these damaged low-rise buildings are classified as the severely damaged. It was observed that 17% of the damaged structures are the 4 to 6-story height, and the lesser damages were observed for the higher buildings. Although only five percent of the total damages is the high-rise failures, but each accident has an immediate impact on the safety of dozens of residents and families. The unsatisfied seismic performance of these 200 modern high-rise building are unexpected and needs to be carefully investigated.

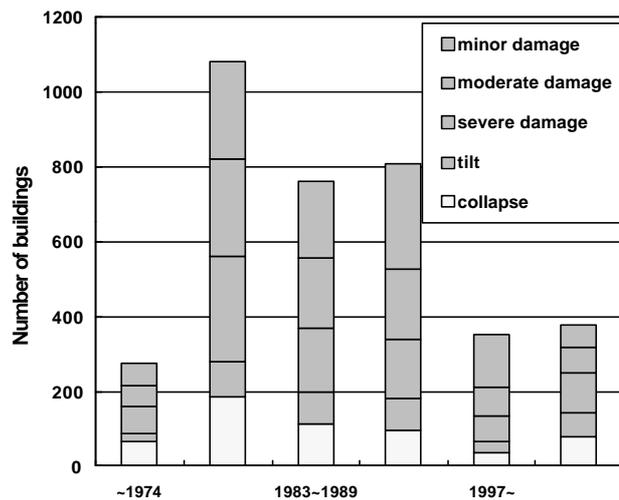
Fig. 11 Number of damaged RC structures with respect to construction periods

In order to find out the correlation between the structural damage level and the construction period, five construction periods are used in this survey: before 1974, 1975 to 1982, 1983 to 1989, 1990 to 1997, and after 1997. This breakdown can reflect the level of seismic design requirements prescribed by different versions of the design code. Figure 11 illustrates the damage level and the construction period of the damaged RC buildings. Since limited RC structures were constructed prior to 1974; therefore, roughly 7% of the total RC failures are constructed at that time. In

general, it was observed that the newly constructed buildings suffered a fewer damages. Approximately 30% of the RC damages were constructed between 1975 to 1982, and approximately 20% of damages were constructed between 1983 to 1989, and from 1990 to 1997. One exception is observed that the number of damaged buildings constructed during 1990 to 1997 is higher than the number of damaged buildings constructed during 1983 to 1989. In order to find out reasons, further investigations on the total number of buildings constructed in these two periods of time are required.

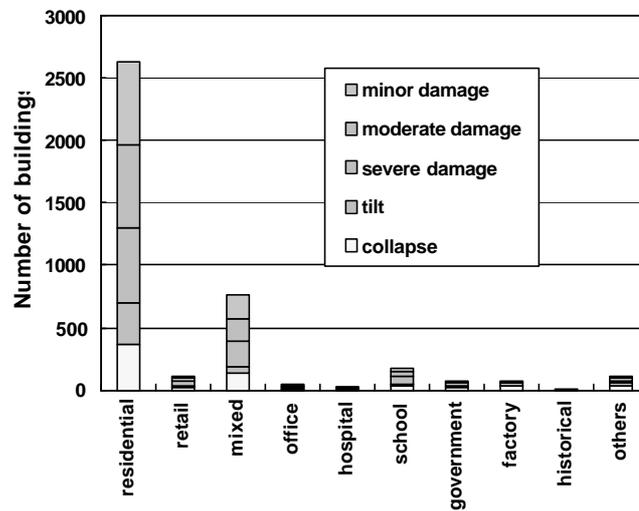
Fig. 12 Number of damaged RC structures with respect to building usage

In Taiwan, most of the buildings are constructed for the residential purpose, and a certain percentage of the buildings are the retail stores and the residential/commercial mixed buildings. In comparison, the historical buildings, the hospitals, and the offices are the minority. Figure 12 indicates that about 65% of the RC damages are the residential buildings, this high percentage of damages is related to their large constructed amount.

However, approximately half of these damaged residential structures are described as severely damaged or worse, which has caused a significant impact on the human life. It was also observed that 20% of the RC damages are the residential/commercial mixed buildings. The school buildings also suffered significant damages, over 60% of the failed buildings were classified as severely damaged or worse. Since the factory, the offices, the hospitals, and the historical buildings are

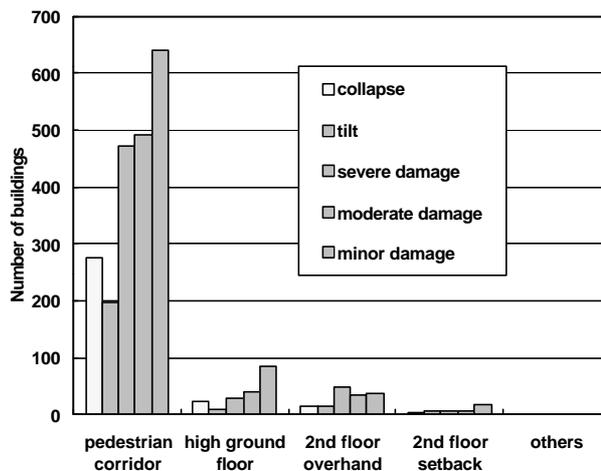
Fig. 13 Number of damaged RC structures with respect to vertical configuration

Figure 13 indicates that approximately 84% of the RC damaged structures are the pedestrian corridor buildings, and roughly 45% of the pedestrian corridor buildings are classified as severely damaged or worse. The damage ratios of the other vertical configurations are relatively lesser. Approximately 7% of the damages are the buildings with a tall floor on ground level, 6% of the damages are the buildings with an overhang on the 2nd floor, and 1.5% of the damages are building with setback on the 2nd floor.

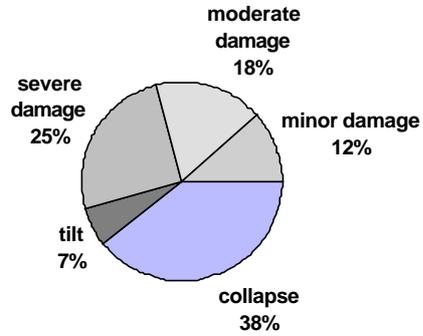
Fig. 14 Damaged percentage of brick structure

In the early agricultural age, the un-reinforced brick buildings were commonly constructed due to its low cost and simple manufactory. Because the un-reinforced brick block has a low seismic resistance, 2,014 un-reinforced brick building damages were recorded during this earthquake. The un-reinforced brick damaged buildings represent the second large group of the damaged structures. Figure 14 indicates that 1,428 damaged buildings, approximately 70% of the total damage, were classified as severely damaged or worse. The percentages of the damages for the collapsed buildings, the tilted buildings, and the severely damaged buildings are 38%, 7%, and 25% respectively. The poor seismic response and the brittle failure of the brick buildings had clearly illustrated during this earthquake.

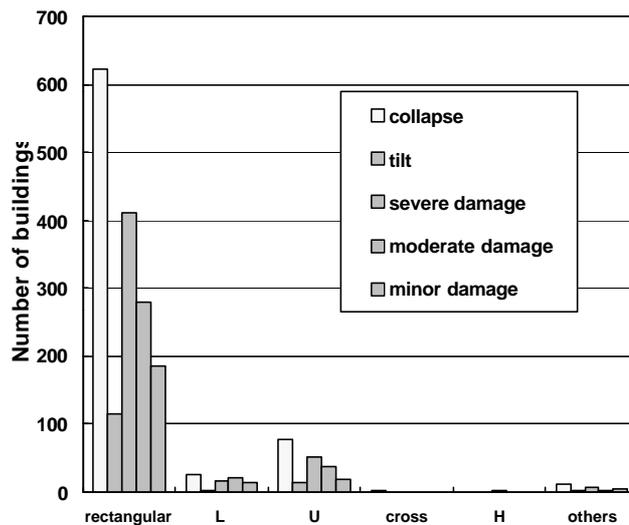
Fig. 15 Number of damaged brick structures with respect to plan configuration

also used in some rural area. Figure 15 shows that the majorities of the damaged structures are either rectangular shape or U shape floor plans. There are 1,615 damaged buildings with rectangular floor plan, which are equivalent to 84% of the total failures. And the buildings with the U shape plan configurations are another 10% of the failed structures. The remaining 6% of the damaged building are either cross shape, H shape, or other plan configurations.

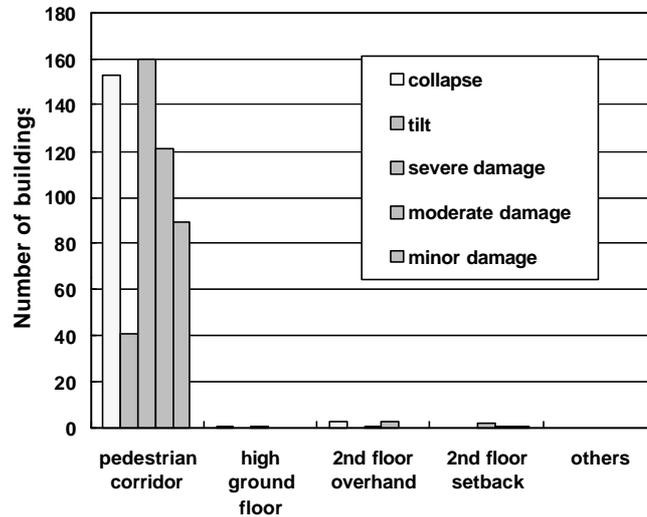
Fig. 16 Number of damaged brick structures with respect to plan configuration

It was observed from Fig. 16 that the majorities of the damages are the build-

ings with pedestrian corridors. Other types of vertical configurations are the minorities.

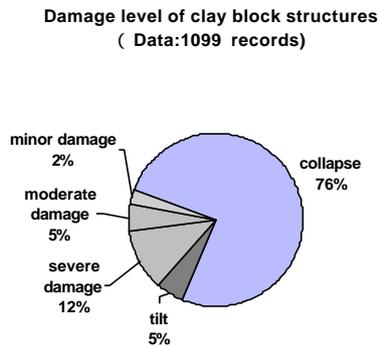
Fig. 17 Damaged percdntage of clay block structure

In the early agricultural age, prior to the introduction of the seismic design, the un-reinforced clay block is simple for the manufacture and the common usage for one story cottage construction. Lacking the seismic design concept, these buildings were constructed as a shelter for the weather protection only. Under the strong earthquake shaking, the severe damages were observed. In this report, total 1,099 un-reinforced clay block cottages were damaged, which represent the third large group of the structural failures. Figure 17 indicates that over 75% of the failed cottages are collapsed, 5% of the damaged buildings are tilted, and 12% of the failed structures are severely damaged. The poor seismic resistance of this brittle material is shown, such that over 93% of these damaged cottages are recorded as severely damaged or worse.
