Liquefaction Hazards and Their Effects on Buried Pipelines

T.D. O'Rourke and P.A. Lane

Technical Report NCEER-89-0007

February 1, 1989

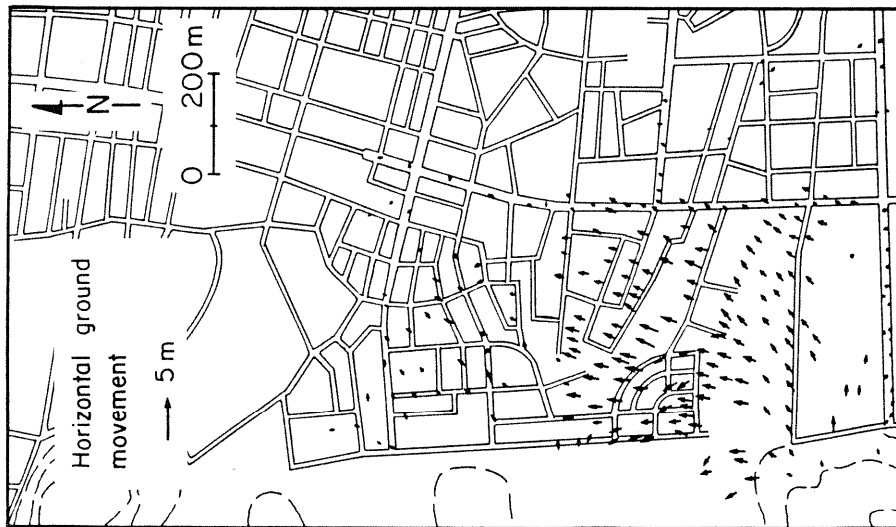
Figure 2-11 shows the relationship between the magnitudes of horizontal displacements and the damage to lifeline systems in Zone A of Noshiro City. Magnitudes and directions of horizontal soil displacements are shown by the arrows in Figure 2-11a. In Figures 2-11b and 2-11c, locations of damage to low pressure gas lines and to water supply lines, respectively, are mapped. There is a clear correlation between the magnitude of horizontal displacements and the extent of damage to buried pipelines. The figure also shows that the most severe damage was sustained by the gas distribution network.

FIGURE 2-11. Relationship Between Ground Displacements and Damage to Pipelines in Zone A, Noshiro City [after Hamada, et al., 1985] (© ASCE. Used by Permission.)

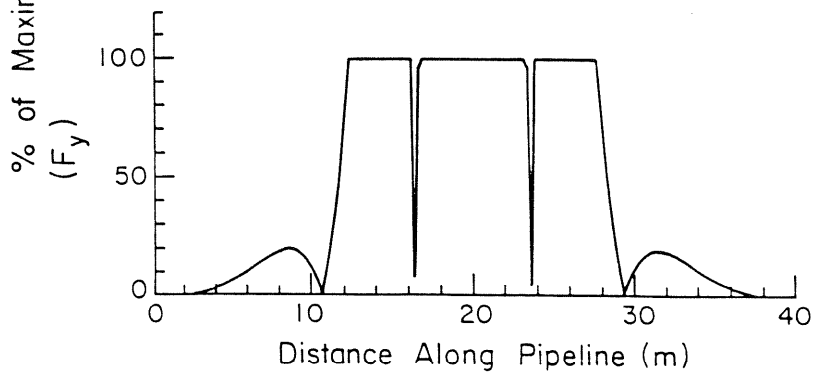
a) Soil and Pipeline Displacements

b) Maximum Tensile and Compressive Strains

c) % of Maximum Soil Force, F_x , Mobilized

d) % of Maximum Soil Force, F_y , Mobilized

FIGURE 4-7. Analytical Results for Trial 1; $B = 10$ m, $\bar{\phi} = 35$ Degrees

Figures 4-7 through 4-11 summarize the analytical results for each of the five trials. In part (a) of each of these figures, transverse horizontal soil displacements, given by solid lines, and the corresponding pipeline displacements, given by dashed lines, are plotted as a function of distance along the pipeline. Two sets of curves are shown for a maximum imposed soil displacement of 0.75 m and 1.5 m, respectively.

The percentages of the maximum longitudinal and horizontal soil forces which were mobilized at 1.5 m of soil displacement are plotted as a function of pipeline length in parts (c) and (d), respectively, for each of the trials.

Trial 1. The displacements shown in Figure 4-7 are associated with a lateral spread width of 10 m, the smallest width studied. There is a substantial difference between the soil and pipeline movements, with a maximum 0.70 m relative displacement for a total soil movement of 1.5 m. The maximum pipeline strains correlate with the location of maximum pipeline curvature, and approximately correspond to the location of maximum curvature in the soil displacement profile. The largest strains of 2.00% in tension and 1.38% in compression are located at the center of the spread. The full longitudinal frictional resistance is mobilized from the point where soil and pipeline displacements are equal, at about 3 m from the center of the slide, to about 4 m from where the pipeline was anchored. Full horizontal soil resistance is mobilized across the central 15 m of the pipeline, with the exception of two relatively small lengths near the location of equal

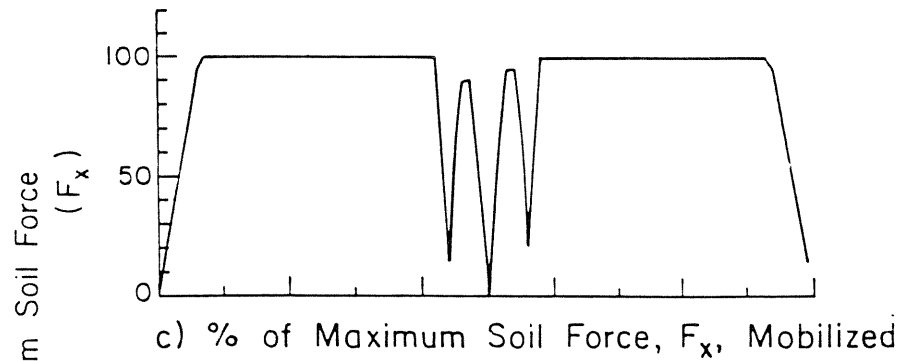
a) Soil and Pipeline Displacements

b) Maximum Tensile and Compressive Strains

c) % of Maximum Soil Force, F_x , Mobilized

d) % of Maximum Soil Force, F_y , Mobilized

FIGURE 4-11. Analytical Results for Trial 5; $B = 30$ m, $\bar{\phi} = 45$ Degrees
