# **PSEUDO-DYNAMIC TESTING OF UNREINFORCED MASONRY BUILDING WITH FLEXIBLE DIAPHRAGM**

A full-scale one-story unreinforced brick masonry specimen having a wood diaphragm was subjected to earthquake excitations using pseudo-dynamic testing. The specimen was designed to better understand the flexible-floor/rigid-wall interaction, the impact of wall continuity at the building corners and the effect of a relatively weak diaphragm on the expected seismic behavior. After a first series of pseudo-dynamic tests, the unreinforced masonry walls of this building were repaired with fiberglass materials and re-tested. The overall building was found to be relatively resilient to earthquake excitation, even though cracking was extensive. The repair procedure was demonstrated to enhance this behavior. The results were compared with predictions from existing seismic evaluation methodologies. It was found that even though the diaphragm did not experience significant inelastic deformation, some (but not all) of the existing seismic evaluation methodologies accurately capture the rocking/sliding behavior that developed in the shear walls under large displacement.

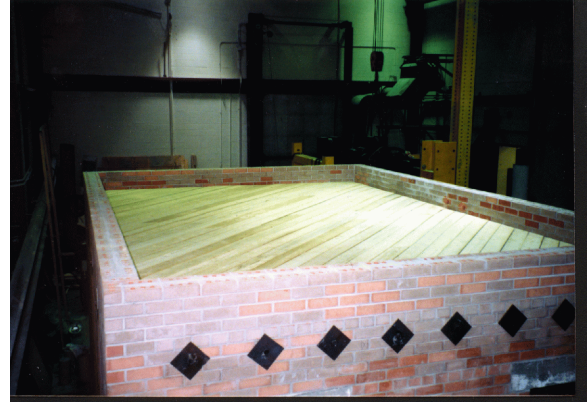
Figure 2. Wood diaphragm.

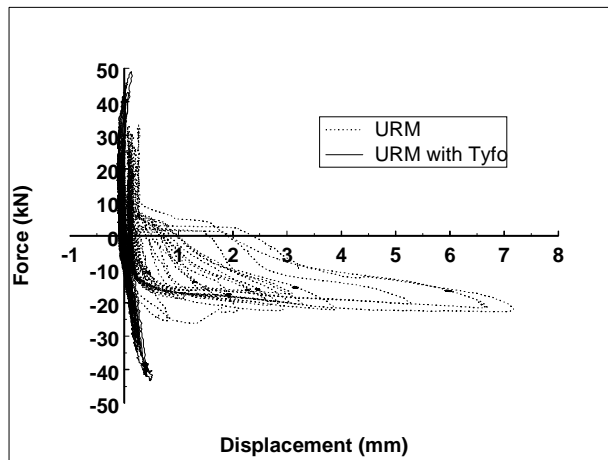
Figure 4. Door pier rocking response at the base before and after Tyfo repair for La Malbaie x 2.0.

The specimen was re-tested with the same input motion as before. For comparison, the time history of the diaphragm center-span displacement is shown in Fig. 8. This repair solution increased the stiffness of the specimen as shown by the reduced rocking motion (Fig. 4). The repaired unreinforced masonry specimen was able to resist up to large peak ground amplifications (up to nearly 2.0g). At this level of excitation, some strips started to de-bond but still provided enough capacity to allow rocking as shown in Fig. 9 where a crack opening of 22 mm is easily visible. However, for the pier having a bed-joint sliding behavior, the Tyfo strips provided limited resistance, as shown in Fig. 10, and failed in shear. Some tears were observed in the Tyfo Web wrapping the corners due to out-of-plane tensile cracks (Fig. 11). Finally the specimen was subjected to more conventional cyclic-testing, by increasing center-span displacement until a large proportion of the Tyfo material (strips and web) was almost completely de-bonded from the shear wall surface. Evidence suggests that repointing prior to the repair would not have improved the observed behavior. However, a different behavior could have been observed in a retrofit perspective because the original structure would not have been pre-cracked prior to application of the fiberglass material.

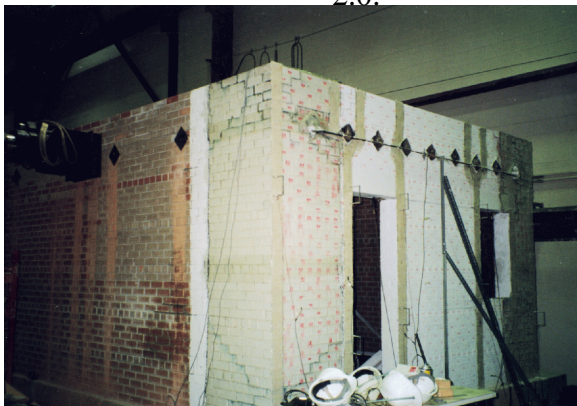
Figure 7. URM repaired with Tyfo material (strips and web).

The shear walls were repaired using Tyfo fiberglass strips as shown in Fig. 7. Note that these strips are frequently used to enhance the out-of-plane performance of unreinforced masonry walls. They typically enhance the flexural elastic resistance of walls undergoing out-of-plane displacements (Tyfo Systems 1997). The in-plane rocking behavior of unreinforced masonry walls is generally perceived as a stable desirable behavior, but there may be instances where the available rocking strength of such walls may still be inadequate. In that perspective, Tyfo strips were applied to the shear walls to increase their in-plane capacity. They were designed to increase the rocking force capacity of each pier, but to keep that rocking capacity below the pier shear capacity. Hence, the objective of this repair strategy is to use the Tyfo strips to preserve the desirable pier rocking mode, increase capacity and enhance the displacement ductility of the repaired shear walls. The corners of the continuous and discontinuous walls were wrapped with Tyfo WEB to increase their shear resistance. This fabric not only provides additional shear strength, but also maintains the wall's integrity by preventing spalled portions of the wall from breaking off and becoming safety hazards.

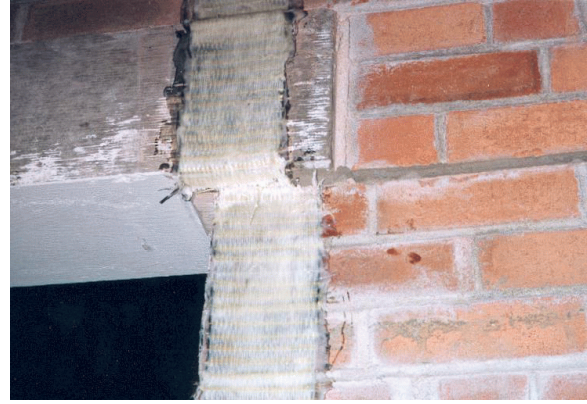
Figure 10. Tyfo strip failed in shear.

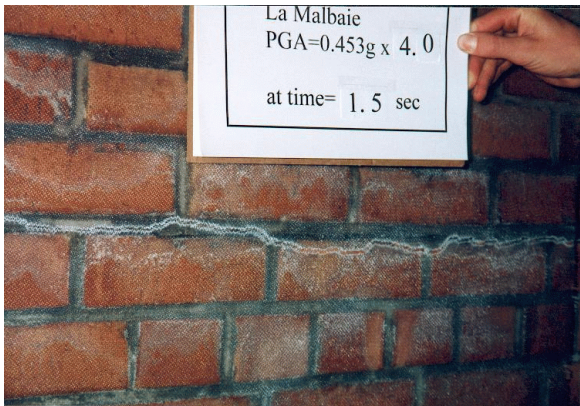
Figure 11. Tears in Tyfo WEB due to out-of-plane tensile cracks.

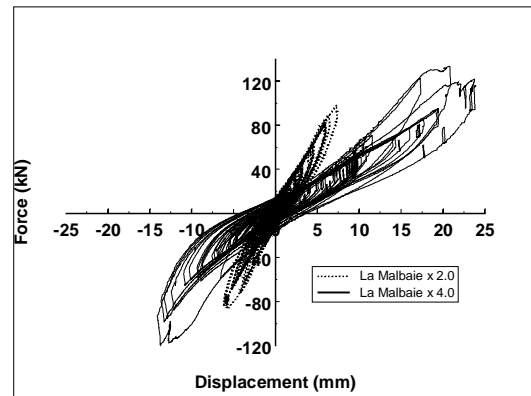
Figure 12. Comparison of diaphragm center-span hysteretic response with shear wall repaired with Tyfo material during La Malbaie x 2.0 and x 4.0.

Strengthening the shear walls with Tyfo materials did increase the force on the diaphragm, as shown in Fig. 12, comparing diaphragm response with shear walls repaired with Tyfo for La Malbaie x 2.0, and x 4.0. At La Malbaie x 4.0 for the repaired specimen, some nonlinear diaphragm behavior initiated, as seen in Fig. 12. However, because most of the Tyfo material had de-bonded and became ineffective in strengthening the shear walls, the diaphragm did not experience any additional nonlinear inelastic behavior, and thus simply slid like a rigid body on the top of the shear walls. After the test, examination showed that, contrary to pre-test calculations that predicted otherwise, the diaphragm remained relatively intact. Damage was limited to some popped out nails at each ends of the diaphragm, as shown in Fig. 13.

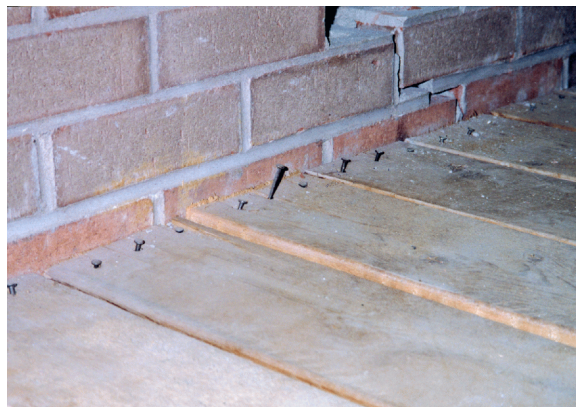
Figure 13. Popped out nails at end of diaphragm.
