# OUT-OF-PLANE SEISMIC EVALUATION AND RETROFIT OF TURN-OF-THE-CENTURY NORTH AMERICAN MASONRY WALLS

**ABSTRACT:** Three masonry walls with their wood backing were extracted from an old three-story residential building. These specimens are representative of a type of construction widely used in North America circa 1900, in which a single wythe exterior masonry wall was tied only with nails to the timber structure, leaving an irregular gap between the masonry and timber walls. To seismically retrofit such buildings, special seismic-resistant anchorage of the walls would be required at every floor at a minimum. Questions remained, however, as to the out-of-plane resistance of the remaining walls spanning between floors. To partly answer these questions, the three specimens extracted from the existing building were tested using a shake table, submitting them to multiple ground motions of progressively larger intensity until structural failure. These tests have demonstrated that such walls could resist significant out-of-plane inertial accelerations without failure. Performance can be increased by different retrofit methods such as providing anchors at midheight to force the wood and ma

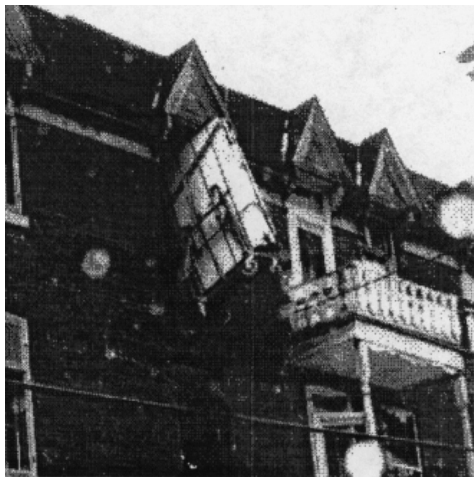
FIG. 2. Retrieval of Test Specimens from Existing Building

Careful retrieval of the specimens was critical to maintain the integrity of the masonry wall and wood-backing assemblies during extraction and transportation. First, horizontal saw cuts, 1.2 m long and spaced at 2 m vertically, were made through each wall. Steel plates with predrilled holes were inserted in each cut. Four steel threaded rods were tightly bolted between the plates, on each side of the wall. A plywood sheet was placed on each surface of the wall, and wedged by timber members against the threaded rods. The bottom portion of the wall underneath the bottom cut was demolished to the floor level. A rolling cart was introduced in the opening and secured to the bottom steel plate. Finally, the vertical sections of the specimen were saw cut. The crated specimen was rolled out of the wall and retrieved from the building by a boomed truck, as shown in Fig. 2.

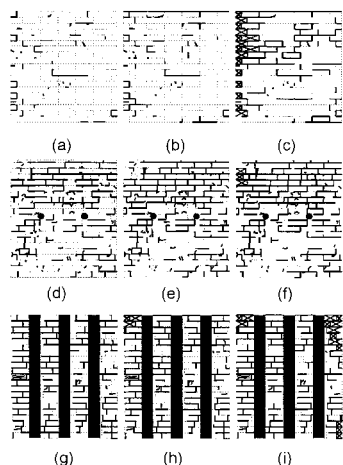
**FIG. 7.** Crack Pattern for As-Built Specimen at PHA of: (a) 0.4g; (b) 1.0g; (c) 1.5g. Cintec Specimen at PHA of: (d) 0.4g; (e) 1.0g; (f) 1.5g. Tyfo Specimen at PHA of: (g) 0.4g; (h) 1.0g; (i) 1.5g [Fallen Bricks Are Covered by an X; Solid Circles in (d), (e), and (f) Indicate Anchors]

as shown in Fig. 7(a). A parabolic deflected shape could be clearly seen during the response. At 0.8g, the response became more severe and dust emanated from the plaster inside the wooden belt. A full-width crack formed at the top just below the wooden belt, causing the wall to behave slightly more like a mix of a cantilever and simply supported beam. At 1.0g, a more severe response caused the plaster cover that was hidden inside the wooden belt to crumble, creating further dust. Due to the full-width crack at the top, as shown in Fig. 7(b), the wall was now sliding under the top row of brick. After a PHA of 1.25g, several cracks around numerous bricks were noticeable, mostly on the upper left portion of the wall, but no bricks had fallen. However, at a PHA of 1.5g, most of these bricks fell, as shown in Fig. 7(c), leaving the specimen in poor condition. At 1.75g, the as-built specimen completely failed, as shown in Fig. 8(a). Starting from the upper rows, all bricks fell down successively. The wood backing was still standing, and after close inspection, wood mortises were discovered between the 75 mm  $\times$  250 mm (3 in.  $\times$  10 in.) planks on the right side only.

7(g) and 7(h). At 1.25g, other bricks fell from the upper and bottom right corners, as shown in Fig. 7(i). The accumulation of mortar debris in the cavity between the two walls was rising above midheight. After a PHA of 1.5g, more bricks fell from the right side and from inside the wooden belt. At this point, there was a considerable gap inside the wooden belt, allowing the wall to behave first as a cantilever, until it hit the side of the belt, and then as a simply supported wall following that impact. The upper left portion only of the wall fell at a PHA of 1.75g, tearing a Tyfo strip above midheight in the process. The remaining portion of the wall stayed in place due to the other Tyfo strips being glued to the remaining piece of crated plywood inside the wooden belt. At 2.0g, the Tyfo strips debonded from the plywood, causing the remaining portion of the brick wall to fall like a rigid body held together by fiberglass strips, as shown in Fig. 8(c). Although difficult to quantify, it is expected that some improvement in behavior would have been observed if, for each specimen, the test at the highest PGA had been carried out without prior shaking at increasing amplitudes.

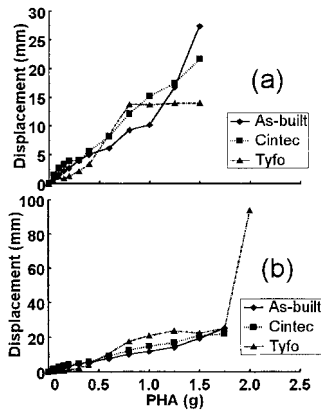
FIG. 15. Peak Displacement at Center of Wall: (a) Brick Side; (b) Wood Side

As shown in Figs. 15(a) and 15(b), the lateral maximum displacement at midheight increased as the level of input seismic motion increased. This increase is almost linear in the case of the as-built and Cintec specimens, except for a PHA greater than 1.0g for the as-built specimen, where maximum displacement increases more significantly. The maximum displacement of the Tyfo specimen at midheight appears to be nonproportional and limited to a certain value (approximately 14 mm) after a PHA of 0.8g. This is explained by Fig. 16, where the maximum inward and outward displacements of both the brick wall and the wood backing during testing are presented. It can be seen in Fig. 16(c) that, at a PHA of 0.8g and 1.0g, the inward displacement, which was greater than the outward displacement, was limited when the brick wall was moving toward the wood backing.

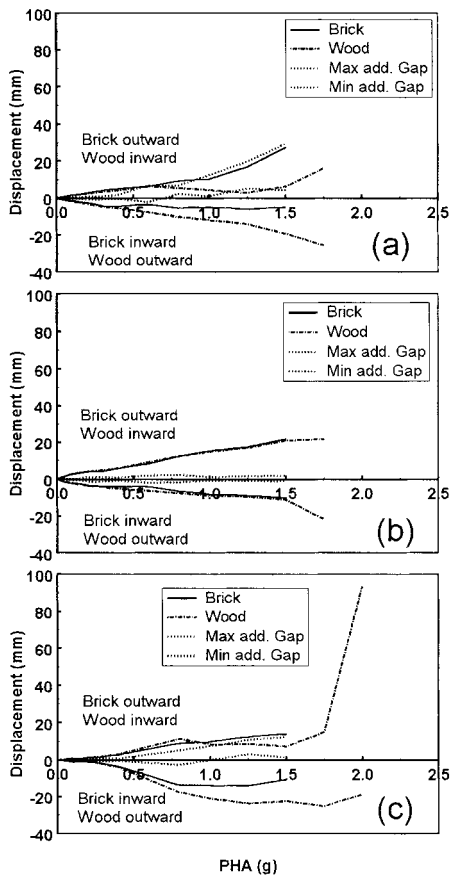
FIG. 16. Maximum Inward and Outward Displacement, and Progression of Gap between Wood and Brick Wall at Midheight of Wall for: (a) As-Built Specimen; (b) Cintec Specimen; (c) Tyfo Specimen. Maximum Additional Gap Indicates the Largest Increase in the Distance between the Masonry and Wood Wall, at Midheight, at Any Time and in Any Direction during the Response Time History. Minimum Additional Gap Is the Corresponding Smallest Increase (If Positive), or Largest Decrease (If Negative)

As shown in Fig. 16(a), the wood backing and brick wall of the as-built specimen were moving in-phase during the first test runs (as indicated by the brick and wood displacement curves closely following each other), and were moving more independently of each other as the level of excitation increased. As mentioned earlier, the wood and brick walls were connected together only by nails protruding from the wood backing and embedded in the masonry walls' mortar joints. As the level of earthquake intensity increased, these nails started to slide freely in the mortar. The gap between the wood and brick walls, originally 15–20 mm, expanded by an additional 29.7 mm.

As shown in Fig. 16(b), introducing anchors at midheight forced the two walls to move together and kept the gap between them from increasing noticeably during the test, with the additional gap generated being only 2.0 mm. Another way to confirm this behavior is by looking at the phase angle. By comparing the frequency content of the accelerometers located at midheight of the brick wall and wood backing, it is possible to determine the phase relation between the two walls. A phase angle of  $0^\circ$  means that both walls are moving in-phase, whereas an angle of  $180^\circ$  indicates that they are completely out-of-phase. Thus, as observed in Fig. 17, the phase angle is almost zero throughout the test for the Cintec specimen compared to the as-built specimen, which increased almost exponentially after a PHA of 1.0g. Interestingly, the fiberglass retrofit apparently also helped to keep the two walls together, even though no improvements were made to the nail connection. The additional gap observed in that case was about 12.3

mm, adding to an initial gap of 25–35 mm, as shown in Fig. 16(c).

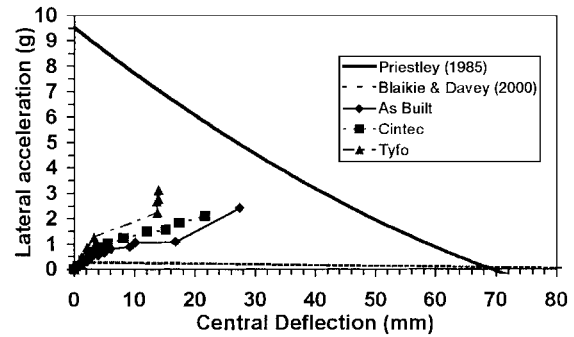
FIG. 18. Comparison of Lateral Acceleration–Displacement Response at Midheight with Various Analytical Models

Various analytical procedures have been tried in attempts to model the experimental behavior observed. A model by Blaikie and Davey (2000) was first considered. They have studied the seismic behavior of face loaded unreinforced masonry walls, modeled the walls as uncracked except at the diaphragm and midheight levels, and assessed their stability under lateral load using simple statics in the deformed configuration. The lateral load deformation calculated using this model for the as-built wall is plotted in Fig. 18. Note that while this model takes into account the self-weight and overburden load from a parapet or any upper story as contributing to the stability, the wall model is not restrained against vertical movements due to rigid body motions on open cracks. A model developed by Priestley includes the effects of stiff boundary conditions in which compression struts are formed as the wall cracks under lateral inertial accelerations. The corresponding membrane compression deformation relationship for the as-built wall is plotted in Fig. 18 and could be viewed as an upper-

bound limit. It appears that experimental results partly progressed toward the upper limit, as shown in Fig. 18, and largely exceeded the values predicted by the Blaikie and Davey model. However, it was observed during testing that while the specimens were restrained at the top, the lack of tight fit provided by the wooden belt increased as the level of seismic excitation increased. Therefore, the resistance provided by compression membrane action diminished until the upper brick portion of the wall sustained large displacements that triggered dynamic instability, causing the collapse of the wall.
