# Hysteretic behavior of existing and retrofitted concrete-encased riveted stiffened seat angle connections

Michel Bruneau <sup>a,\*</sup>, Marc Bisson <sup>b</sup>

Typical riveted stiffened seat angle connections taken from a 1910 building were tested to investigate their actual hysteretic behavior and potential moment resistance and to determine how they could be efficiently retrofitted with a minimum amount of structural modifications. In that building, columns had been embedded in low-strength concrete, as typically done at the turn of the century as a fireproofing measure, and connections were tested with that fireproofing concrete left in-place. This study shows that, in their as-is condition, these existing connections can develop a considerable moment resistance, but their pinched hysteretic curves indicate that they have a relatively low energy dissipation capability. Embedment of connections in the concrete is found to be of little benefit. A steel-band/fuse-plate retrofitting scheme is proposed to improve the connection's hysteretic behavior. This retrofit technique permits the connection strength and ductility to be enhanced, without requiring removal of the column co

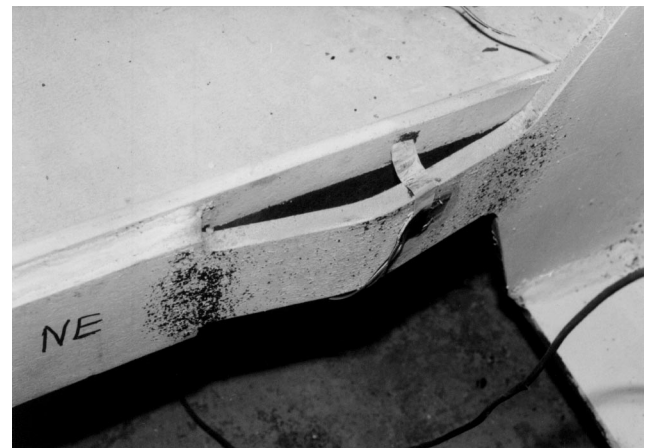
Fig. 10. Fuse-plate uplift from beam flange during buckling (Specimen 2).

three cycles, lifting up from the face of the beam by up to 20 mm during the 37th cycle (Fig. 10), while the north-west plate showed very little buckling (lifting 2 to 3.5 mm). The two fuse-plates on the south side buckled by relatively the same amount, lifting at mid-length by approximately 13 mm each.
