Pseudo-dynamic testing of unreinforced masonry building with flexible diaphragm and comparison with existing procedures

Abstract

Keywords: Unreinforced masonry; Wood diaphragm; Seismic response

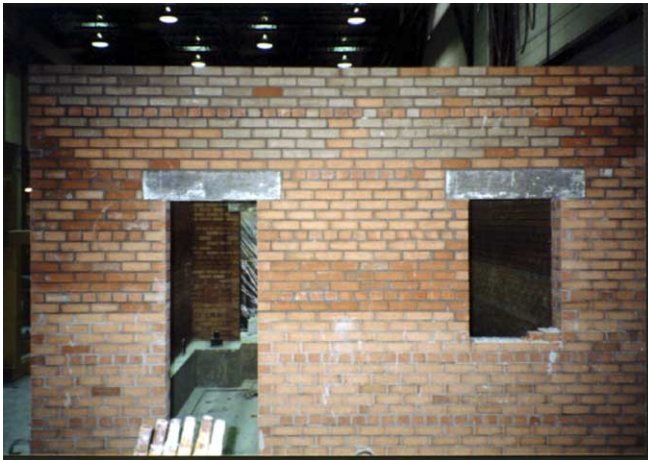
Fig. 2. URM specimen.

The single-story full-scale unreinforced brick masonry building constructed for this experimental program is shown in Figs. 1–3. This rectangular shaped building was constructed with two wythes solid brick walls (collar joint filled) and type O mortar was used to replicate old con-

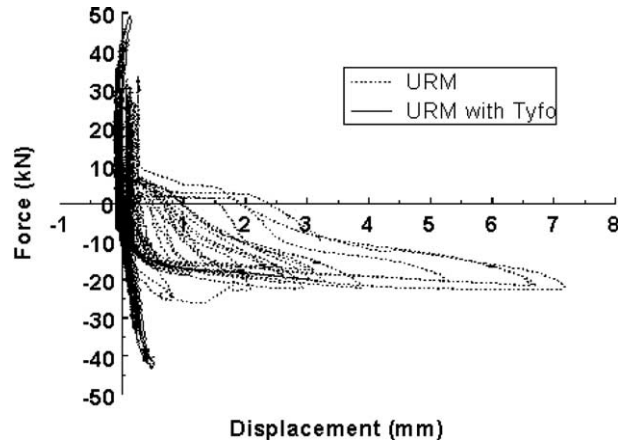
Fig. 8. Door pier rocking response before and after Tyfo repair for La Malbaie $\times 2.0$.

west and east shear walls is shown in Fig. 7(a), and (b), respectively. Special clip gages were installed at expected crack location around all the piers to record crack opening and closing during the pier's rocking cycle. This rocking motion is clearly shown in Fig. 8 where the crack opens when the force acts in one direction and remains closed in the reverse direction. A different stiffness for the east and west walls was observed at the beginning, during low intensity seismic motion. However, the hysteretic curves during a higher intensity seismic motion, La Malbaie $\times 2.0$,

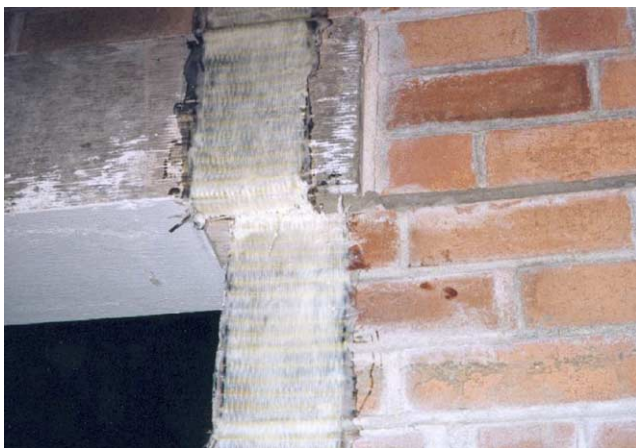
Fig. 13. Tyfo strip failed in shear.

The specimen was re-tested with the same input motion as before. During La Malbaie $\times 0.5$ and $\times 1.0$ pseudo-dynamic tests, the displacements of both east and west shear walls were considerably reduced while maintaining the same level of force as recorded for the original specimen. With the increasing ground motion, during La Malbaie $\times 1.5$ and $\times 2.0$, the wall response was characterized by larger forces and reduced lateral displacements as compared to the original specimen. Hysteretic force–displacement curves for the repaired and original specimen during La Malbaie $\times 2.0$ run are shown in Fig. 11(a) and (b). It can be observed that the lateral forces in the east and west wall were increased by approximately 48% as compared with the original specimen, whereas the corresponding displacements were considerably reduced. As a result of the increased stiffness of the repaired piers, the rocking motion was significantly reduced, as shown in Fig. 8. The specimen was then subjected to La Malbaie $\times 3.0$ test run, resulting in the development of new cracks in the walls and localized debonding of Tyfo material. Additional cracks were formed near the concrete foundation below the central pier on the west wall. As the level of excitation was increased, some strips started to de-bond, yet still providing enough deformation capacity to allow rocking as shown in Fig. 12 (note a visible 10 mm wide crack opening). However, for the central pier demonstrating a bed-joint sliding behavior, the Tyfo strips were mainly subjected to shear stresses and ultimately failed in shear by tearing, as shown in Fig. 13. Some tearing was also observed in the Tyfo WEB overlay at the corners due to out-of-plane tensile cracks. Finally, the specimen was subjected to La Malbaie $\times 4.0$. Additional de-bonding and tearing of the Tyfo material (strips and web) were observed and more extensive cracking developed in the walls. The repeated rocking and sliding behavior of the piers induced tears and de-bonding, limiting the wall capacity to approximately 66 kN, resulting in increased lateral displacements.

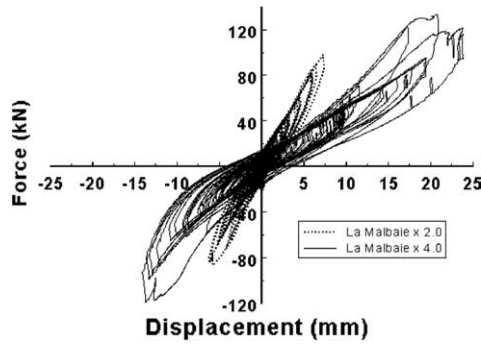
Fig. 15. Comparison of diaphragm center-span hysteretic response with shear wall repaired with Tyfo material during La Malbaie \times 2.0 and \times 4.0.

Strengthening the shear walls with Tyfo materials did increase the force on the diaphragm, as shown in Fig. 15, where some non-linear diaphragm behavior initiated during La Malbaie $\times 4.0$.

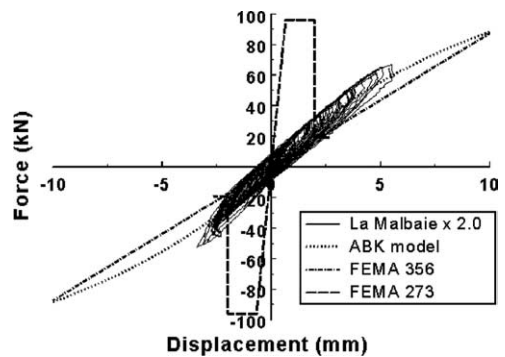
Fig. 18. Comparison of hysteretic response of wood diaphragm during La Malbaie \times 2.0 with FEMA 356, FEMA 273 and ABK force-deformation relations.

Using the data recorded by the three temposonics located across the span of the diaphragm as well as the LVDTs on each shear wall, the lateral force-deformation relationship of the diaphragm was investigated. The hysteretic response of the wood diaphragm during La Malbaie \times 2.0 is shown in Fig. 18, and is essentially linearly elastic. The maximum floor deformation (center relative to ends) recorded at mid-span was 5.54 mm under a 66.5 kN force. Using Eq. (1) from FEMA 356, the calcu-

lated mid-span deflection is 7.61 mm for chorded diaphragm. For the sake of comparison, FEMA 273 which uses a slightly different equation is also included in Fig. 18.
