RECOMMENDED MODIFICATIONS TO ATC-14

C. D. Poland and J. O. Malley

Technical Report NCEER-89-0012

April 12, 1989

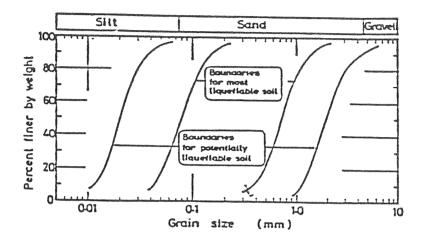
Figure 3.1 - Soil Potential for Liquefaction (Ishihara, 1985)

As discussed by Clough (1988), liquefaction is a phenomenon where a saturated soil, usually a sand, is subjected to a loading that causes the pore pressures in the soil to increase, and the effective stresses to decrease to the point that the soil can undergo large deformations under the actions of the ground loading. In other words, a saturated cohesionless soil is abruptly transformed from a solid to a liquid state as a result of increased pore pressure and loss of shear strength. When liquefaction is combined with conditions such as ground slope, surface loads, and the ejection of water and sediments, permanent movements develop such that structures supported or surrounded by soil can be severely damaged. Three conditions are necessary for liquefaction to occur. First, the earthquake must be at least a Richter Magnitude 5.5 event to generate noticeable liquefaction. Second, the groundwater table must be high. A groundwater table below 30 or 40 feet will likely suppress liquefaction. Third, the soils must be liquefiable. most susceptible are fine sands with gravels, course sands and silty soils being more resistant to liquefaction, but still potentially liquefiable. A plot of grain size data for soils indicating those most likely to undergo liquefaction is shown in Figure 3.1 (Ishihara, 1985).

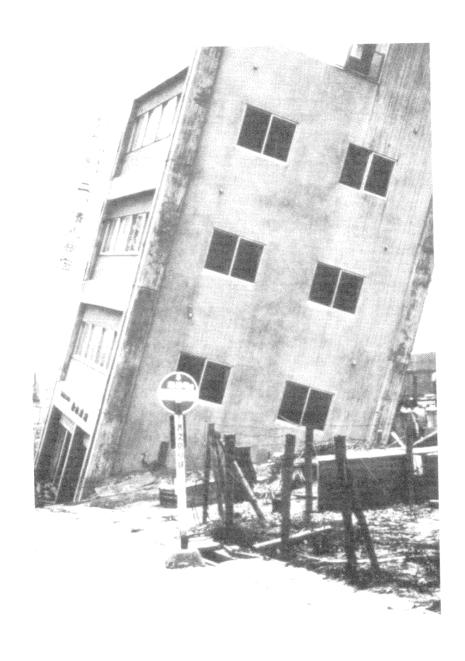
Figure 3.2 - Building Damaged by Soil Liquefaction (Seed and Idriss, 1982)

The structural consequences due to liquefaction range from very severe or catastrophic to negligible depending on the degree and extent of liquefaction-induced ground failure. It is useful to consider a few examples from this wide range of building damage. The more severe type of structural damage includes settlement and severe tilting and overturning of structures. Figure 3.2 provides a well known photograph of severe tilting and settlement that resulted during the Niigata earthquake of 1964. The Great Alaskan earthquake of 1964 caused massive liquefaction induced flow failures that carried away major portions of three towns. The Puget Sound earthquake of 1965 had additional examples of liquefaction-caused damage, most notably the failure of quay walls caused by liquefaction of soils behind the walls. Liquefaction can also degrade piling performance by reducing skin friction. Furthermore, pile buckling resistance may become acute because of lack of lateral support in liquefied soils and downdrag loads caused by settlement after liquefaction.

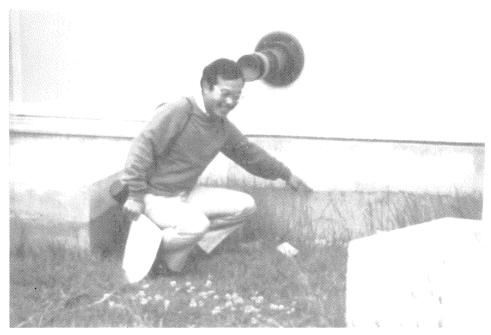
Figure 3.3 - Soil Settlement Due to Liquefaction (Bertero, et. al.,1985)

General settlement can also lead to serious differential settlement of buildings. Figures 3.3 and 3.4 are of damage caused during the Nihon-Kai-Chubu, Japan Earthquake of 1983 and provide additional vivid illustration that liquefaction can be the primary destructive effect rather than ground shaking. Figure 3.3 shows the settlement of soil about 16 inches as seen from a school building which is on piles. Figure 3.4 shows the inside of a pile-supported terminal building which had its slabs on grade settle over 4 feet, as shown by one of the investigators standing in the resulting pit.

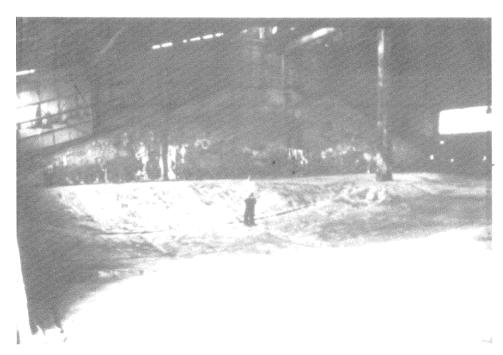
Figure 3.4 - Slab on Grade Settlement Due to Liquefaction (Bertero, et. al., 1985)

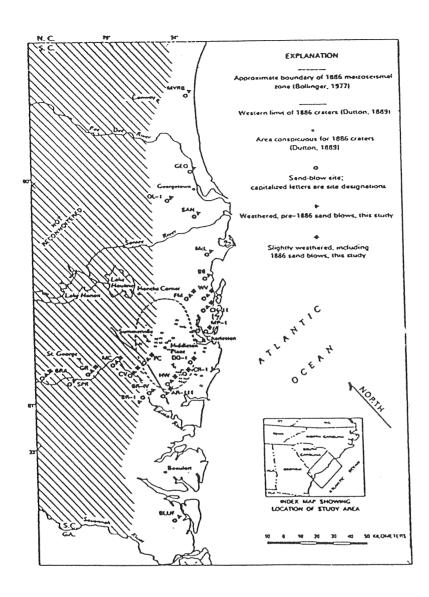
Figure 3.5 - Map of 1886 and Pre-1886 Sand Blow Sites in South Carolina (Gohn, et. al., 1984)

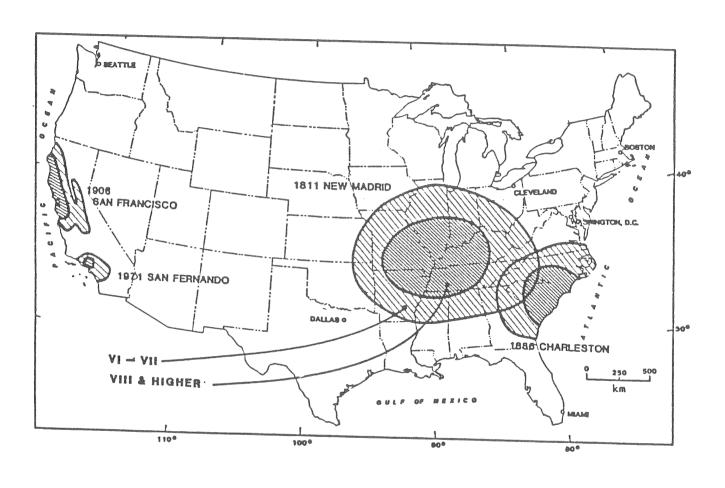
Figure 4.3 - Comparison of Isoseismal Contours for Earthquakes: San Francisco (1906), New Madrid (1811-1812), San Fernando (1971), and Charleston (1886)

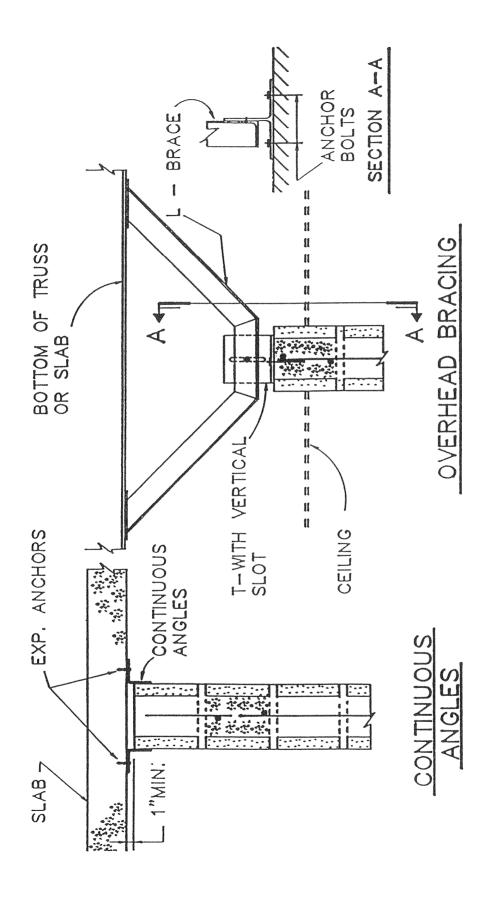
Figure 11.1 - Typical Details for Bracing Masonry Partition Walls

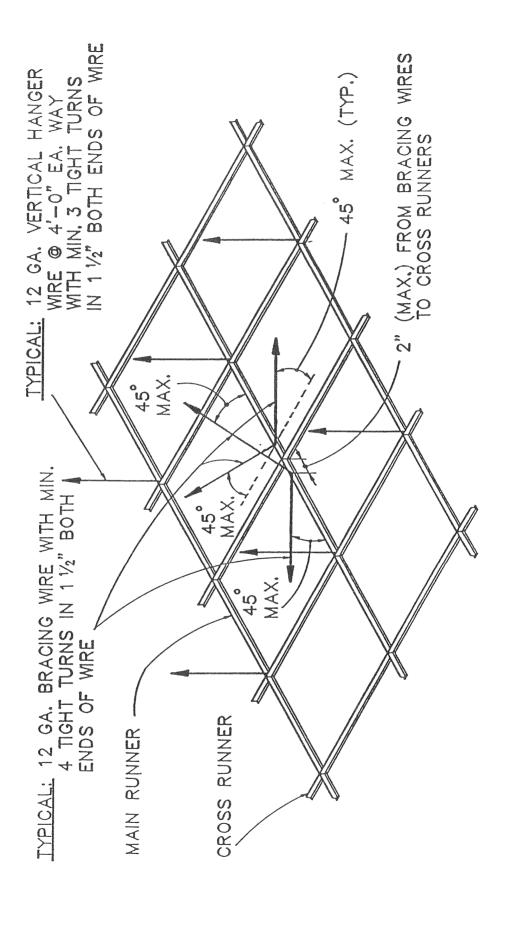
Figure 11.2 - Attachment of Acoustial Ceiling.Grid

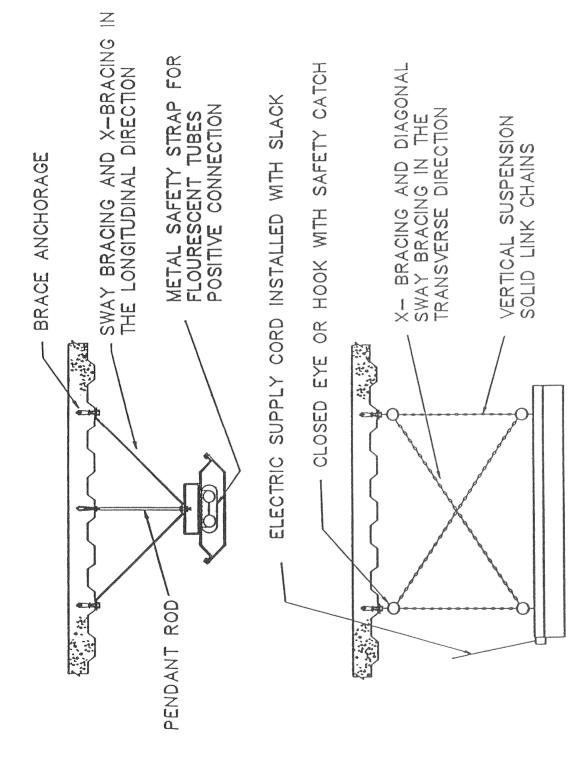
Figure 11.3 - Typical Anchorage of Suspended Lighting

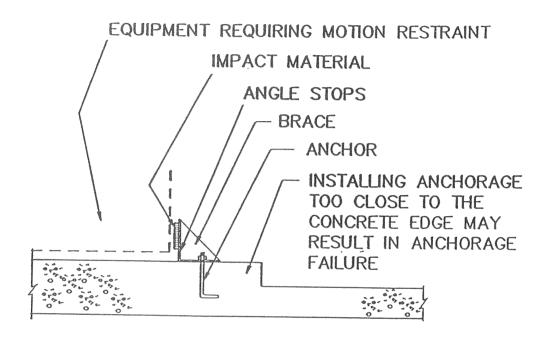
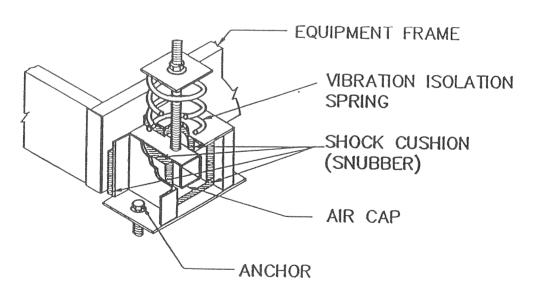
Figure 11.4 - Equipment Motion Restraint Systems

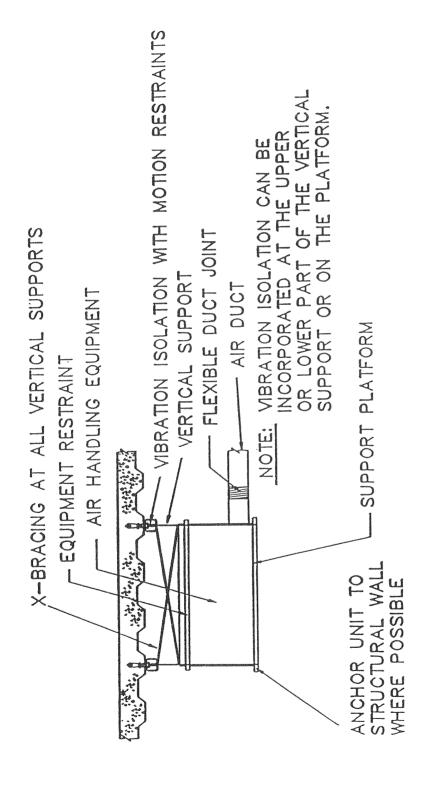
Figure 11.5 - Typical Anchorage of Air Handling Equipment

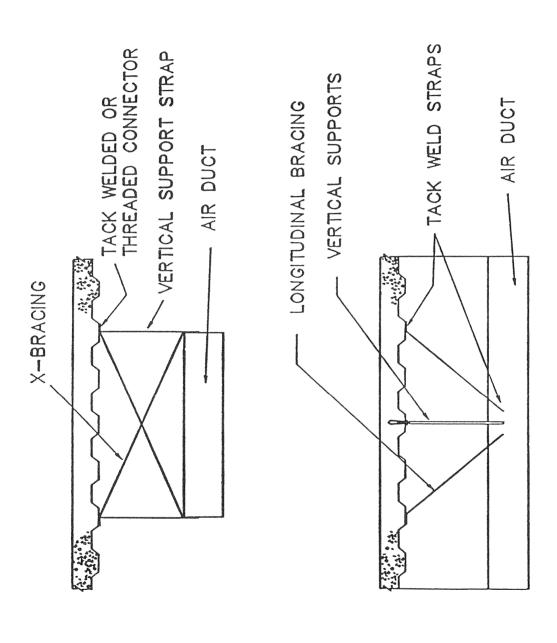
Figure 11.6 - Typical Suspension and Bracing of Ducts

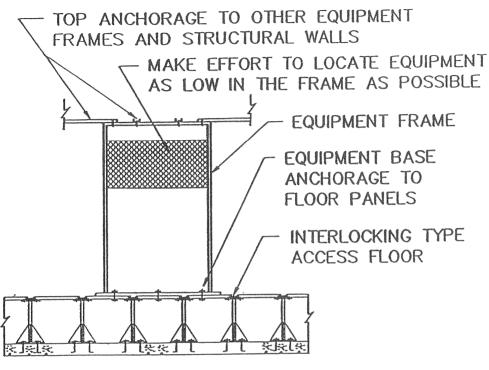
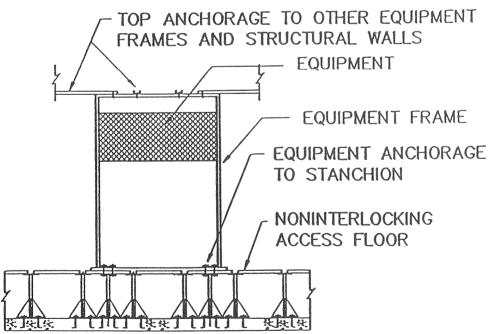
Figure 11.7 - Anchorage Details for Equipment Supported on Access Floors

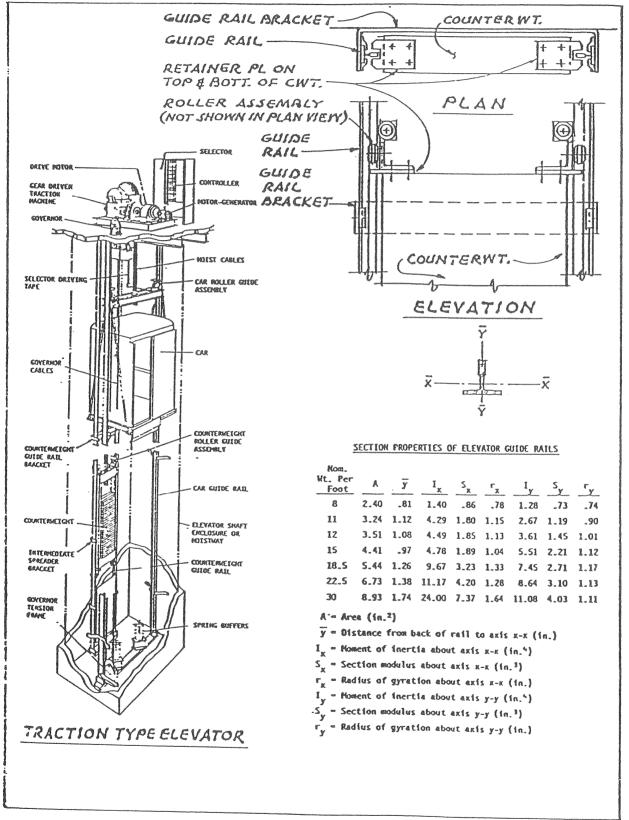
Figure 11.8 - Elevator Details

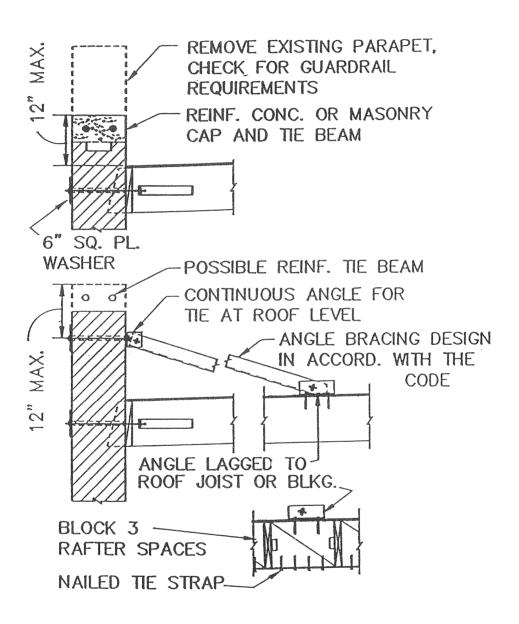
Figure 11.9 - Typical Parapet Anchorage Detail

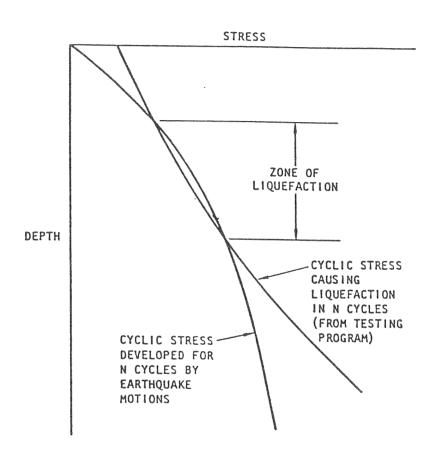
Figure B.1 - Method of Evaluating Liquefaction Potential (Seed and Idriss, 1982)

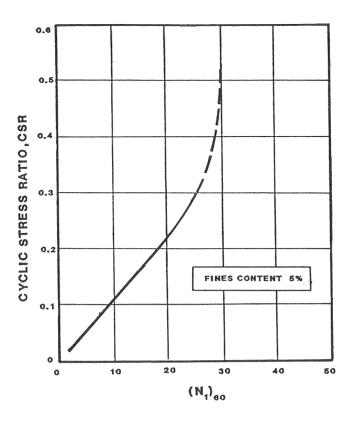
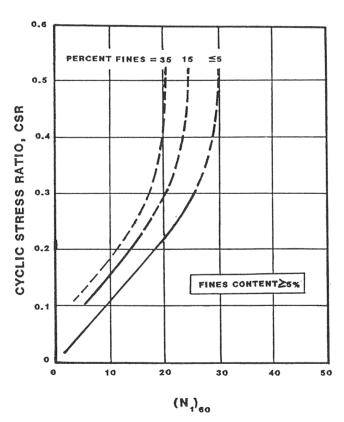
Figure B.2 - Empirical Relationship
Between Shear Stress
Ratio and SPT (Seed and
De Alba, 1986)

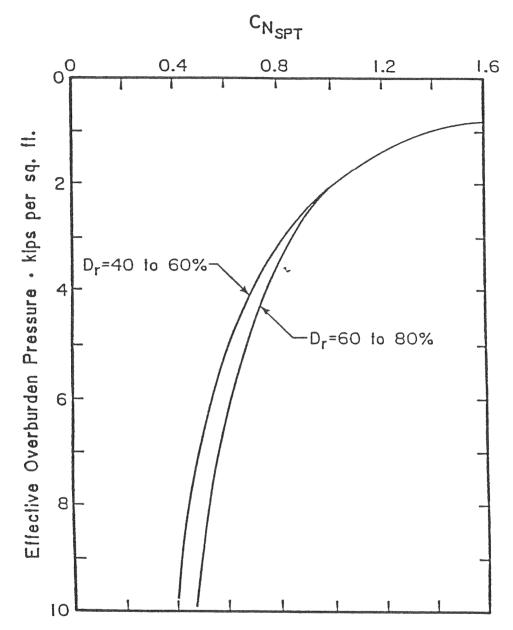
Figure B.3 - Overburden Correction Factor for N-Value (Marcuson and Bieganousky)

The N-value in Equation B.4 is determined using the SPT procedure prescribed by the American Society of Testing and Materials (ASTM) Standard D1586-84 (1986). A 140-pound (63.5 kg) hammer is dropped 30 inches (76 cm) onto an anvil attached to the drill rods. The hammer is typically held by a jute rope, which is wrapped twice around a motorized cathead, which raises the hammer. A 2 inch (5.1 cm) outside diameter, 1.4 inch (3.5 cm) inside diameter, split spoon sampler is attached to the drill rods, and driven 18 inches (46 cm) into the bottom of a borehole. The number of blows (N-values) was recorded from 6 to 18 inches (15 to 46 cm) during the driving of the tool.
