Testing of Full-Scale Two-Story Steel Plate Shear Wall with Reduced Beam Section Connections and Composite Floors

Bing Qu, S.M.ASCE¹; Michel Bruneau, M.ASCE²; Chih-Han Lin³; and Keh-Chyuan Tsai⁴

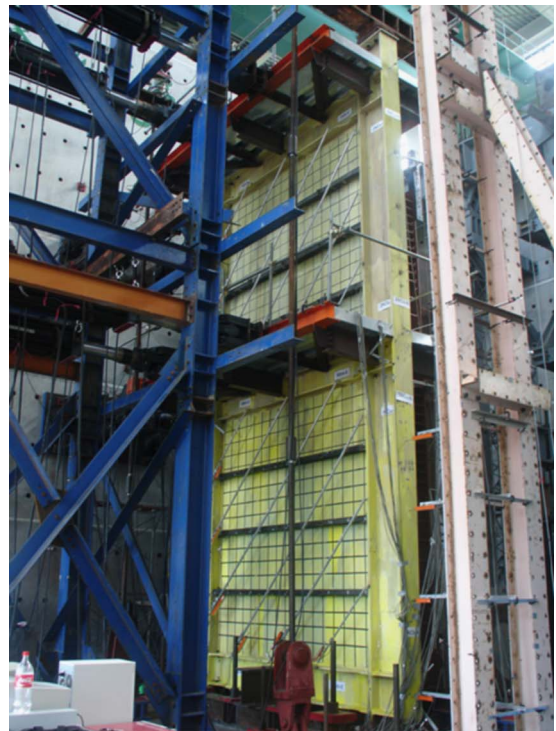
Fig. 3. Specimen and hysteresses of first pseudodynamic test of phase I: (a) specimen prior to Phase I tests; (b) hysteresses

In order to investigate the seismic behavior of SPSW in severe earthquake and aftershocks, the specimen was tested under three pseudodynamic loads using the Chi-Chi earthquake record (TCU082EW) scaled up to levels of excitations representative of seismic hazards having 2, 10, and 50% probabilities of exceedances in 50 years, subjecting the wall to earthquakes of progressively decreasing intensity. The ground accelerations were scaled so that the spectral acceleration (5% damping) associated with the first mode period (0.52 s) was equal to that in the design response spectra. Despite the numerous ancillary calculations that checked the adequacy of the specimen, the intermediate concrete slab suffered premature cracks and two anchor bolts fractured at the south column base at time steps of 9.5 and 24 s of the first earthquake

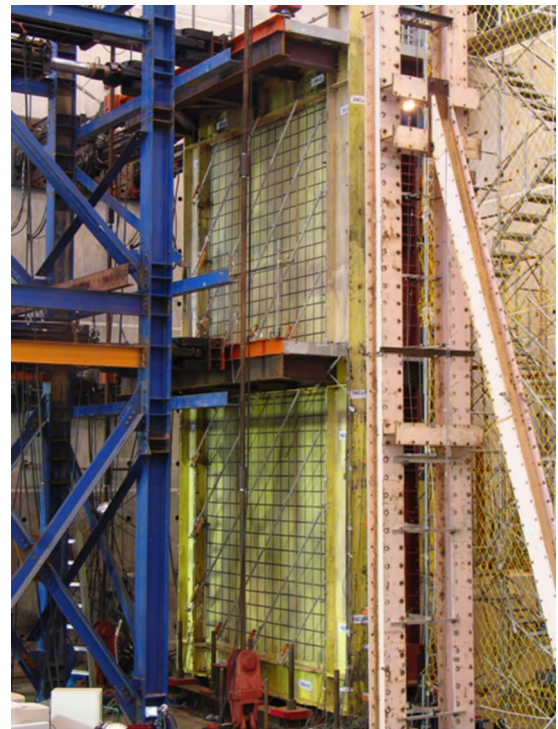
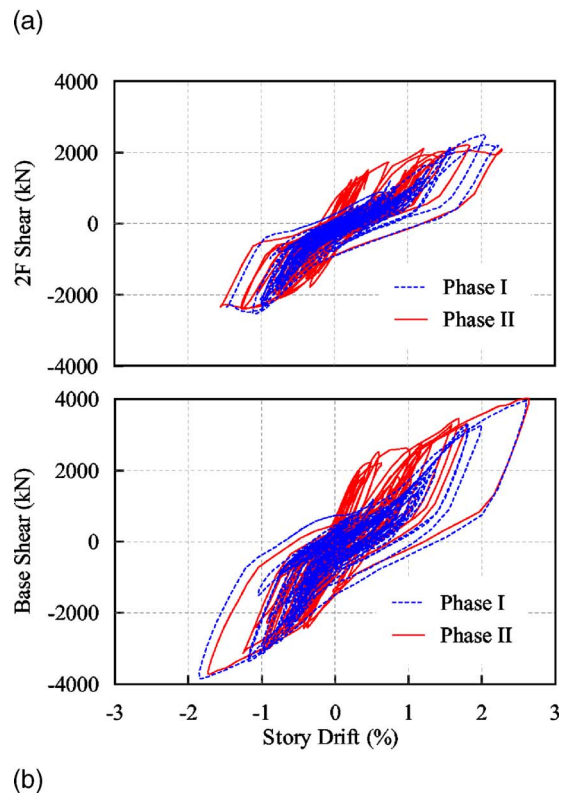
Fig. 5. Specimen and hysteretic curves: (a) specimen prior to Phase II tests; (b) hysteretic curves of Phase I and Phase II

The SPSW specimen and hysteretic curves obtained from the Phase II pseudodynamic test, along with the counterpart results obtained from Phase I for a similar level of excitation are shown in Figs. 5(a and b). Observation of the hysteretic curves obtained from Phase II shows that the first story dissipated more hysteretic energy than the second story. The infill panels buckled over both stories as anticipated, with maximum amplitude of out-of-plane deformations of 250 mm. Both the first and second story exhib-

ited stable force-displacement behavior, with some pinching of the hysteretic loops as the magnitude of story drifts increased, particularly after the development of a small fracture along the bottom of the shear tab at the north end of the intermediate beam at story drifts of 2.6 and 2.3% at the first and second story, respectively. After the pseudodynamic test, the boundary frame was in good condition (except for the aforementioned damage in the

Comparing the hysteretic curves from the Phase I and Phase II tests shown together in Fig. 5(b), the two specimens are found to behave similarly under the same strong ground motion except that the initial stiffness of the repaired specimen is higher than that of the original one. This is because the results shown for the specimen in Phase I are those obtained after the specimen was repaired due to the unexpected failures mentioned earlier. Therefore the infill panels had already experienced some inelastic deformation before these unexpected failures occurred.

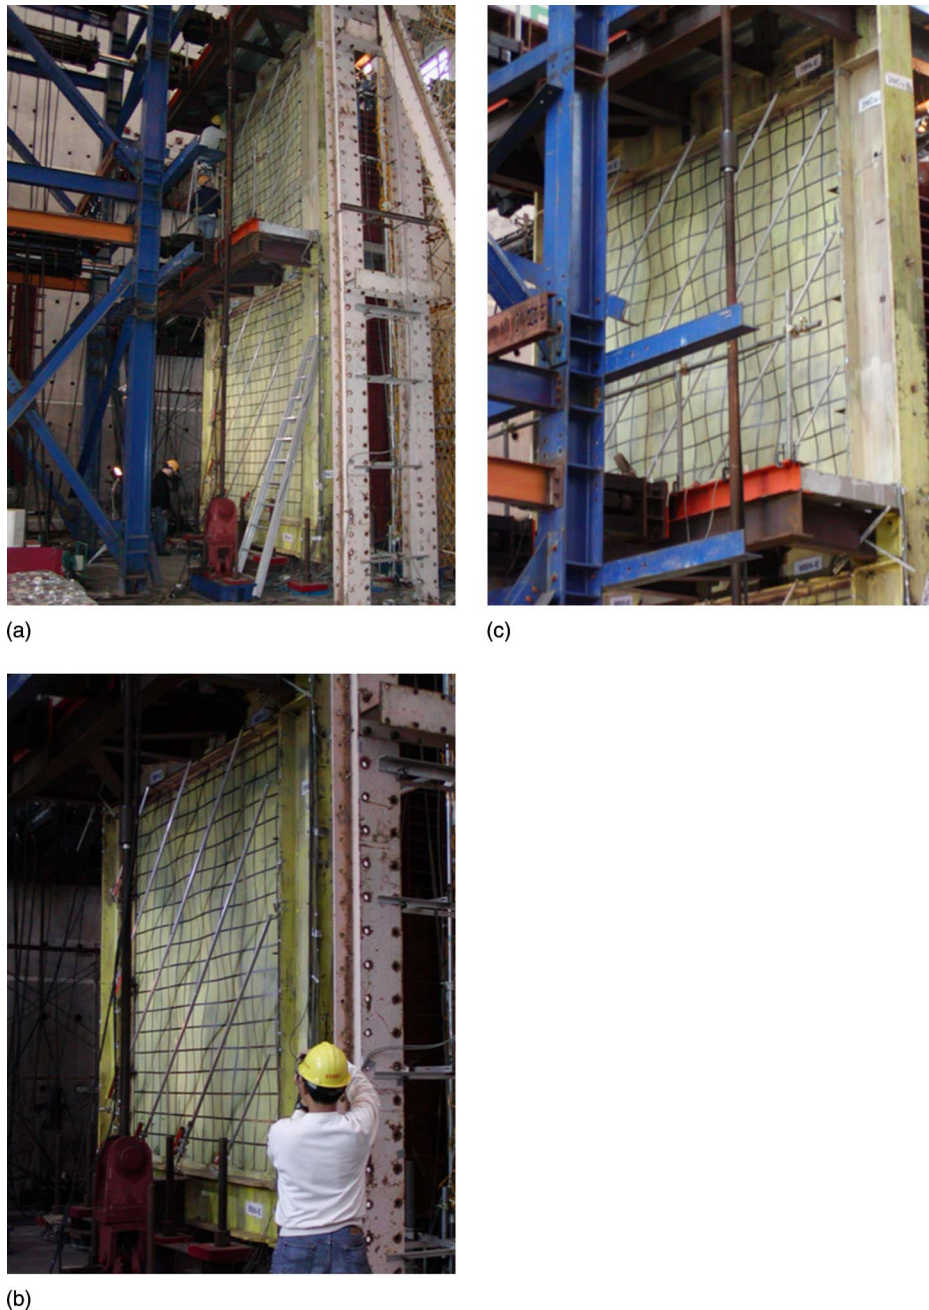
Fig. 6. Deformed specimen and buckled panels in Phase II pseudodynamic test: (a) specimen; (b) 1F panel; and (c) 2F panel

shear tab of the intermediate beam). There were notable plastic deformations at the column bases and RBS connections at all levels. Small fractures were found at the panel corners. All welds within the SPSW specimen were intact after the test. The deformed specimen and buckled panels after the Phase II pseudodynamic test are shown in Figs. 6(a–c) respectively.

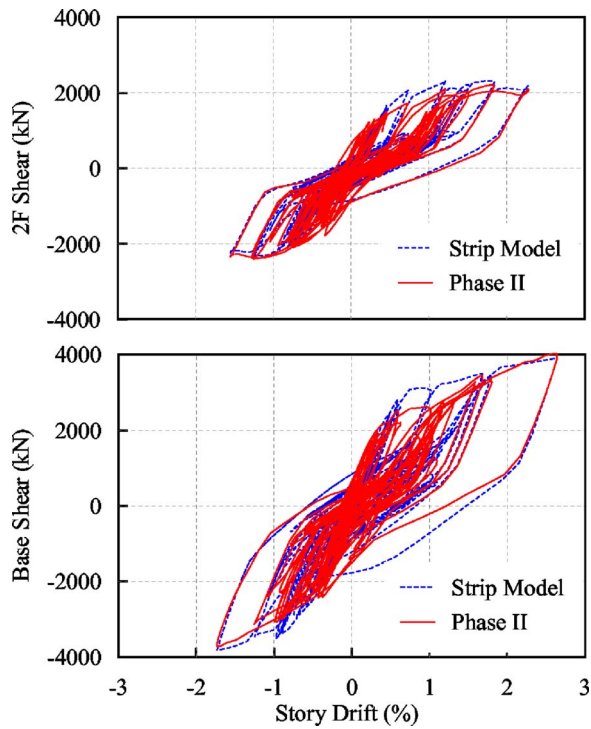
Fig. 8. Hystereses from strip model and Phase II pseudodynamic test

The hysteretic curves obtained from the above dual strip model are plotted on top of those experimentally obtained from the Phase II pseudodynamic test in Fig. 8. It is found that the global behavior of the SPSW specimen can be satisfactorily predicted by the dual strip model.

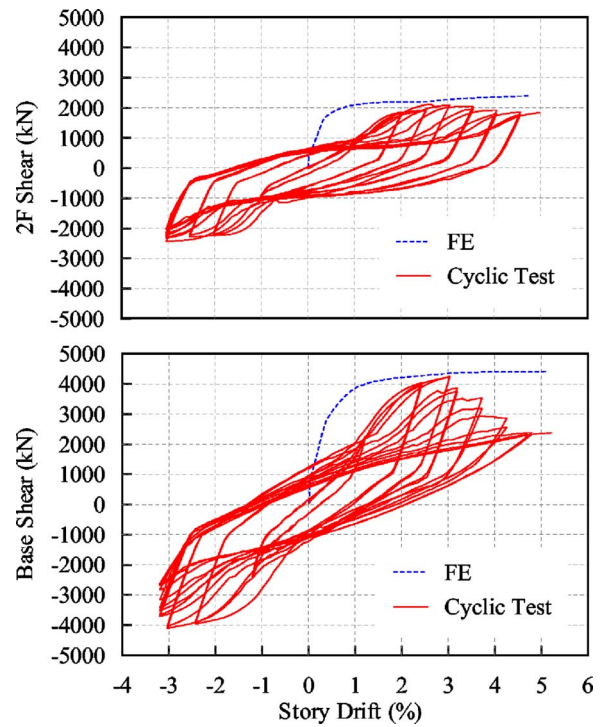
Fig. 9. Monotonic pushover curves and hystereses of Phase II cyclic test

The hysteretic curves resulting from the Phase II cyclic test, along with the results of a monotonic pushover analysis described in detail in the next section, are shown in Fig. 9. Comparing the hysteretic curves in Fig. 9 to those in Fig. 5(b), it is observed that the initial stiffness of the SPSW specimen in the cyclic test was smaller than that in pseudodynamic test. Because the previous

global structural response from this finite-element simulation was compared with the experimental results from the cyclic test, as shown in Fig. 9.

It is observed that the story shears from the FE analysis are greater than those obtained from the cyclic test prior to 2.6 and 2.3% story drifts at the first and second story, respectively. This is principally because the specimen was loaded into the inelastic range in the prior Phase II pseudodynamic test, resulting in the partial absence of tension field in the infill panel at low story drift levels. However, the story shears obtained from FE analysis fit well those obtained from the cyclic test at story drifts exceeding the maximum story drifts of 2.6 and 2.3% at the first and second story, respectively, reached in the Phase II pseudodynamic test. After story drifts of 3 and 2.5% at the first and second story, respectively, the story shears from cyclic tests are smaller than those from FE analysis due to the ruptures in the intermediate beam and failures of the welds connecting infill panels to fish plates.
