Engineering and Organizational Issues Before,
During and After Hurricane Katrina

Damage to Bridges from Wind, Storm Surge and
Debris in the Wake of Hurricane Katrina

**Damage to Bridges from Wind, Storm Surge and
Debris in the Wake of Hurricane Katrina**

MCEER-08-SP05
Red Jacket Quadrangle
Tel: (716) 645-3391; Fax: (716) 645-3399; Email: mceer@buffalo.edu
World Wide Web: <http://mceer.buffalo.edu>

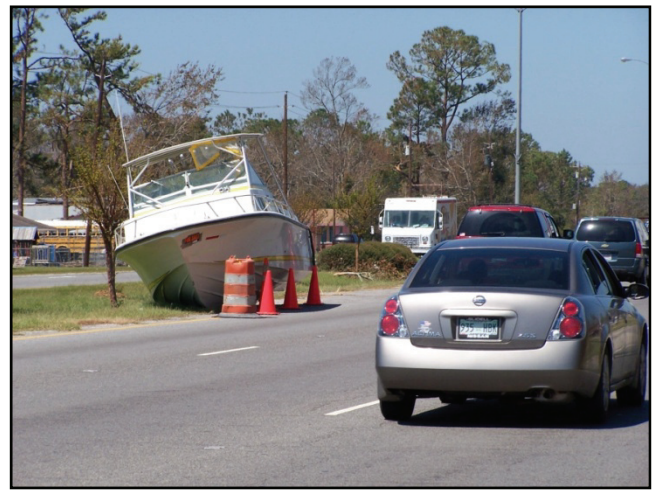
(d) Boats were caught up in the surge.

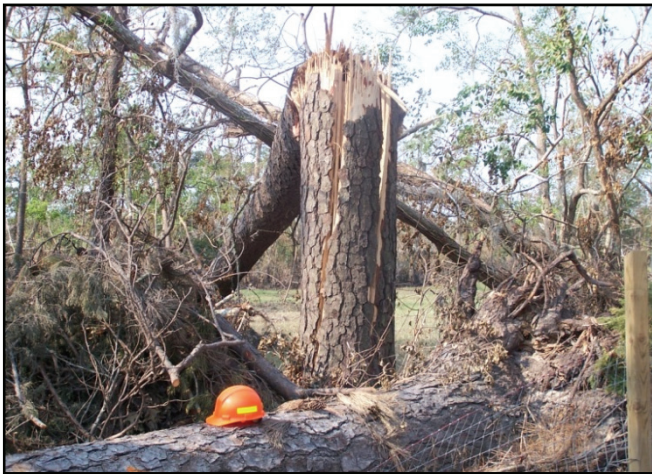
(u) This 28" pine tree was snapped off by the storm.

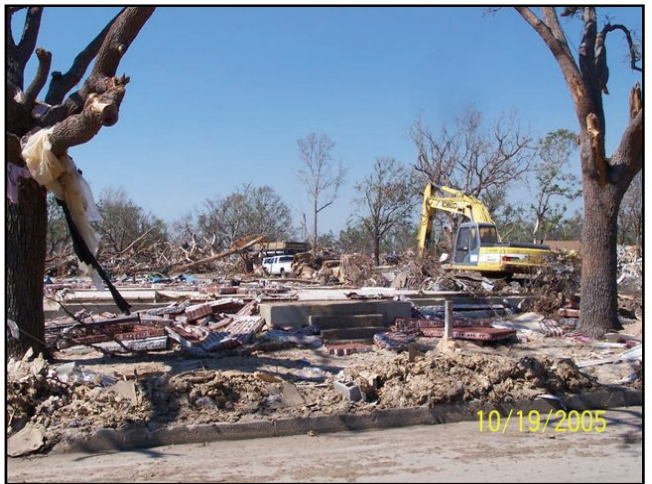
- w. Looking north from the Gulf shore, one can see that there was widespread destruction of anything within a half mile of the beach.
 - x. Most houses in this beach zone near Gulfport were leveled down to the foundation slab.

(x) Most houses near the beach were leveled.

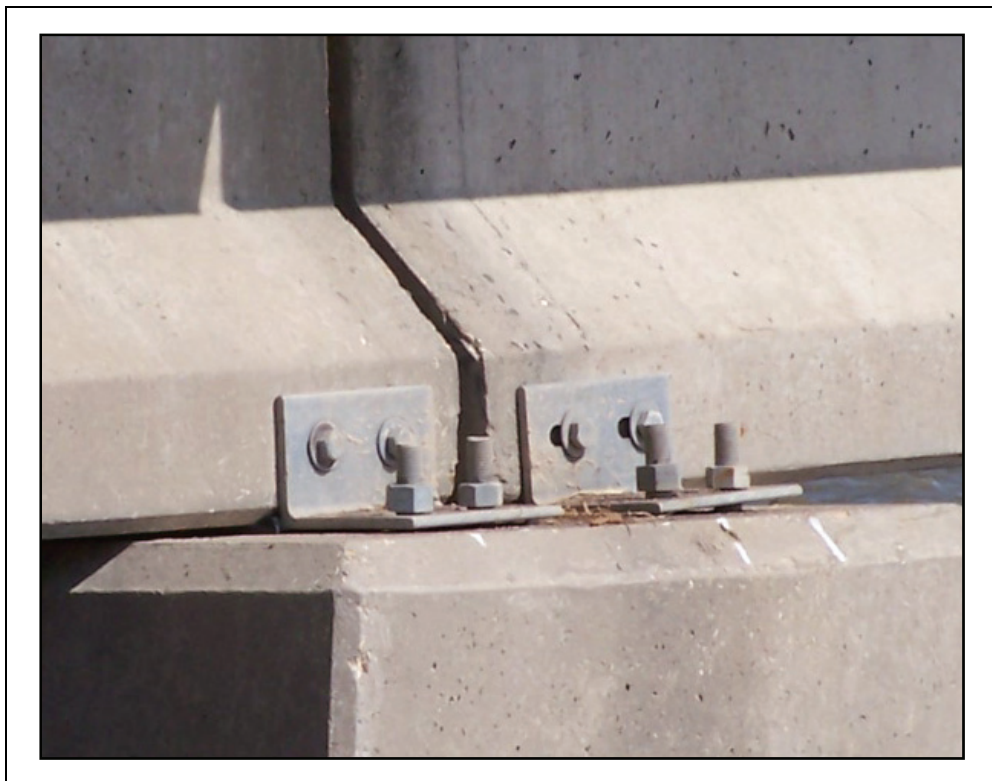
The design of the superstructure to pier cap connection does not seem to account for much lateral loading from wave action. Steel clip angles securing the P/S beams to the pier cap seem to be common detail in the region (Figure 2-5). The fact that the bridge is protected by the island and oriented in a N-S direction seems to have helped it weather the storm.

Figure 2-5. Tie down detail between the P/S beams and pier cap.

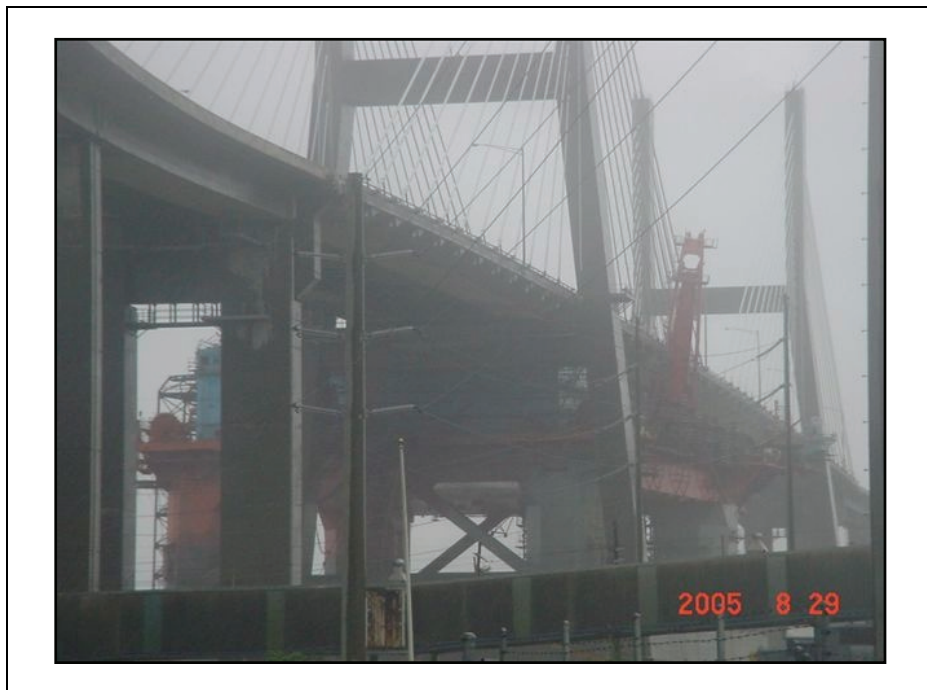
The Conchrane-Africatown USA Bridge is a newer cable-stayed structure that crosses the Mobile River at the north end of Mobile Bay. It was built in 1991 to carry four lanes of traffic. It is 7,291 feet long and 80 feet wide and normally has 140' of clearance underneath. As a result of Katrina, a 13,000-ton oil drilling platform (PSS Chemul) broke loose from dry-dock and was carried 1.5 miles north until it hit the center span and became lodged under it (see Figure 2-7 provided by the Federal Highway Administration). ALDOT immediately restricted traffic so damage could be assessed. In order to reduce live loading, a weight restriction was imposed and the number of traffic lanes on the bridge was reduced to one in each direction. Although not visible at the time of inspection, it was later reported that the bridge superstructure was pushed four inches into the bridge pier. Figure 2-9 shows the platform a week later, secured about a half mile south of the bridge.

Figure 2-7. An oil platform lodged up against the Conchrane-Africatown USA Bridge.

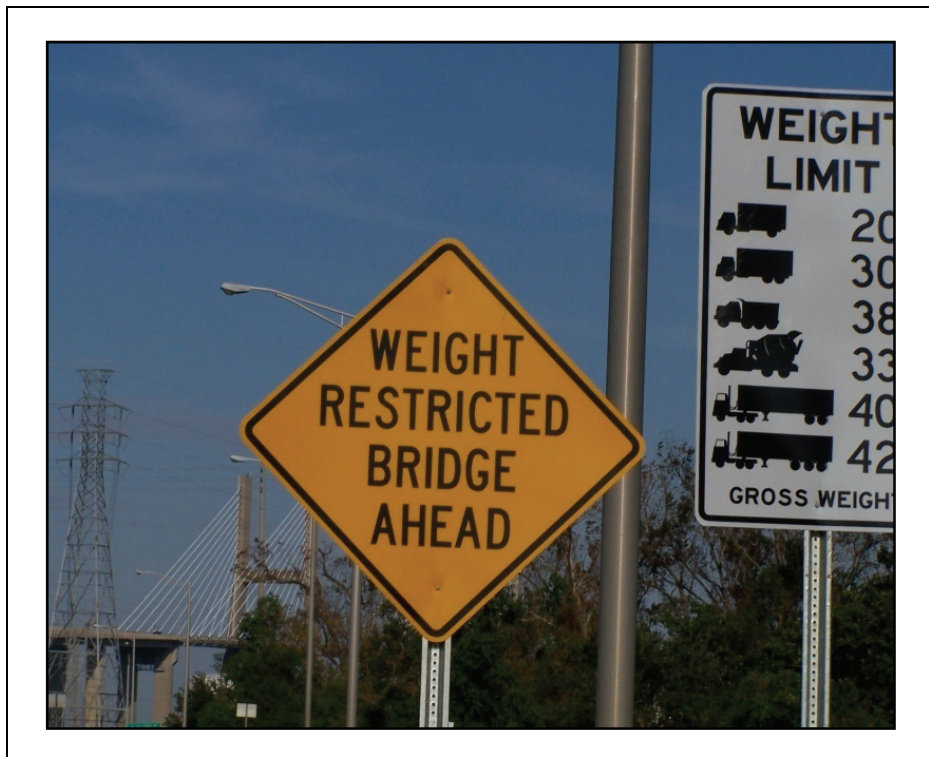
Figure 2-11. Lane and weight restrictions were necessary after the impact.

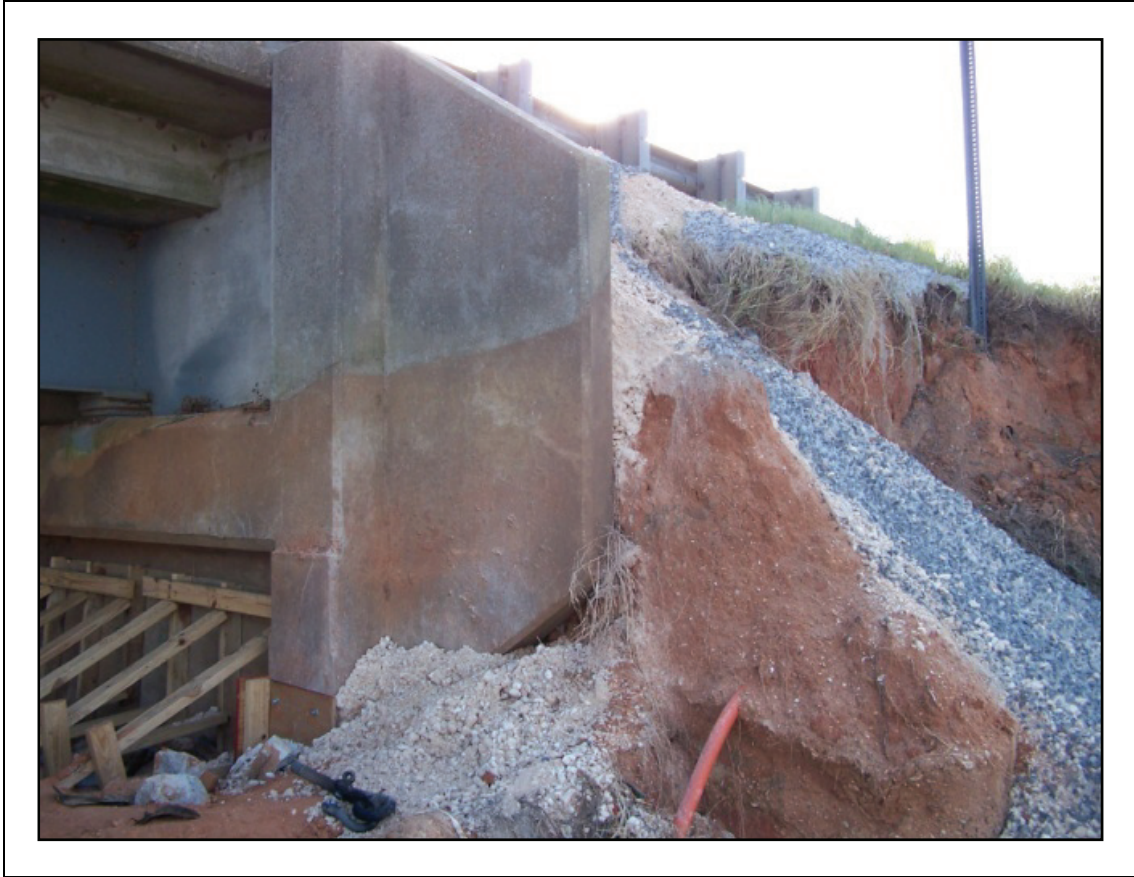
Figure 2-13. Concrete was used to fill erosion at the NW wingwall.

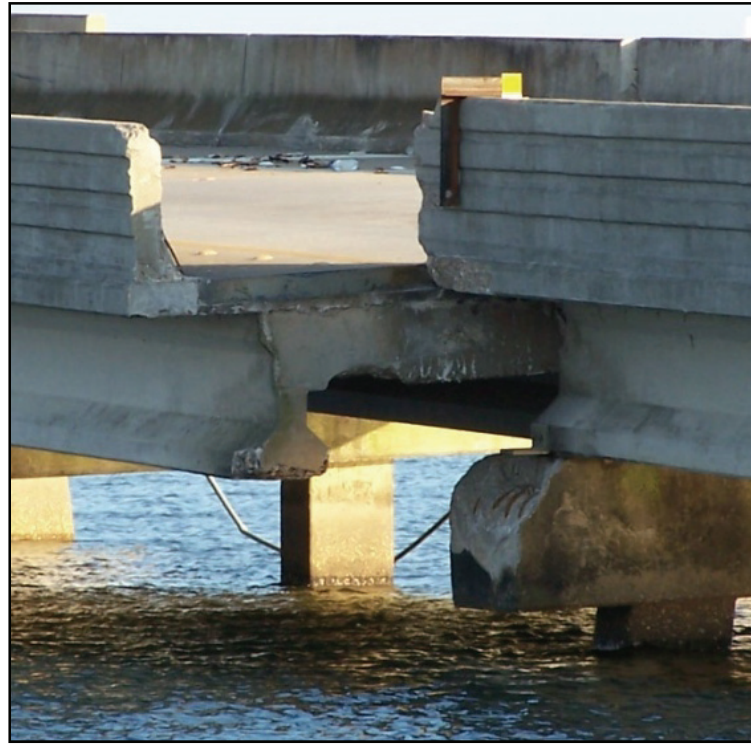
Figure 2-18. Tie down clips ripped out of the concrete pier cap.

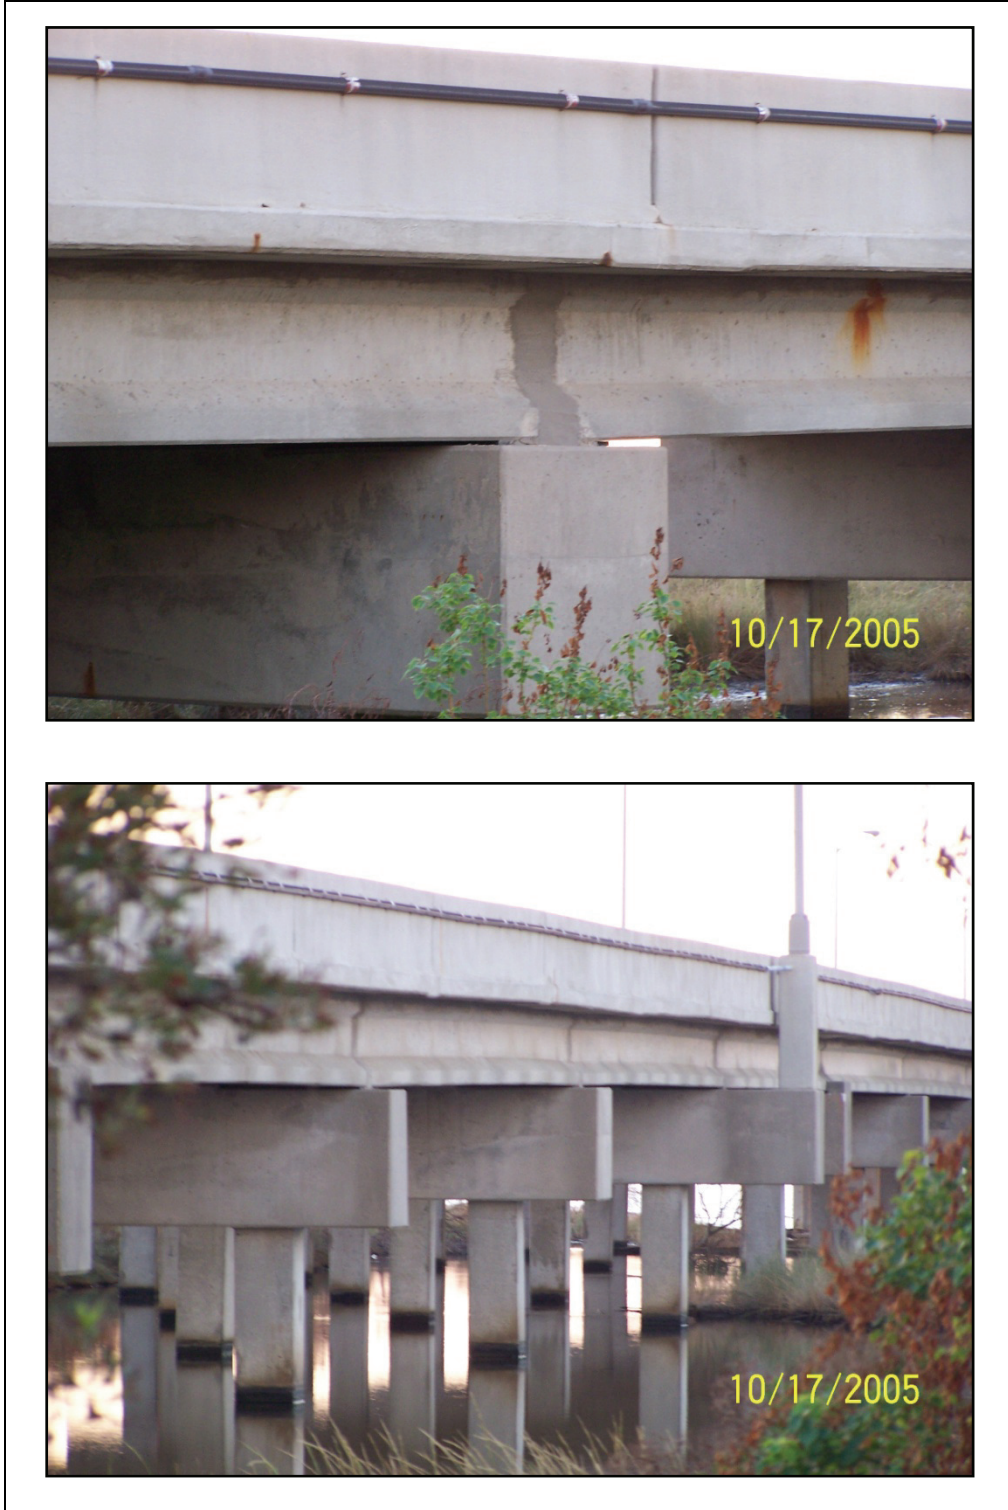
Figure 2-24. Typical connection between spans and pier configuration over a pier.

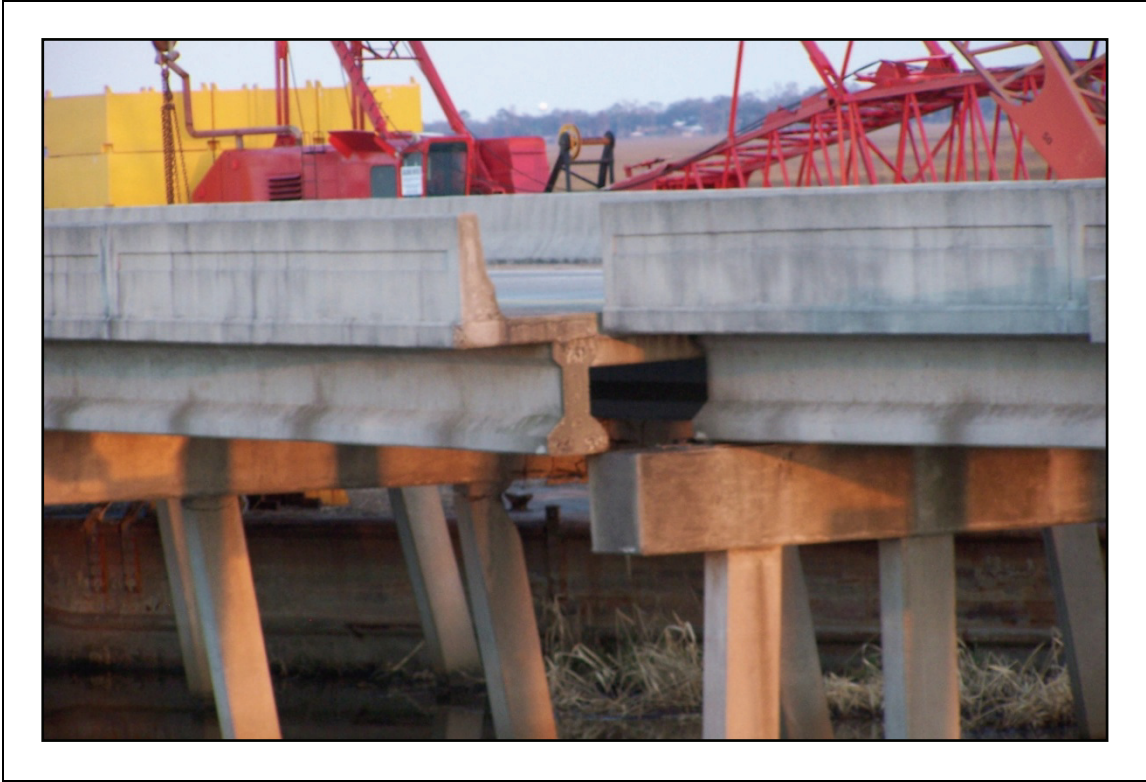
Figure 2-27. A vessel impact displaced six spans of I-10 EB.

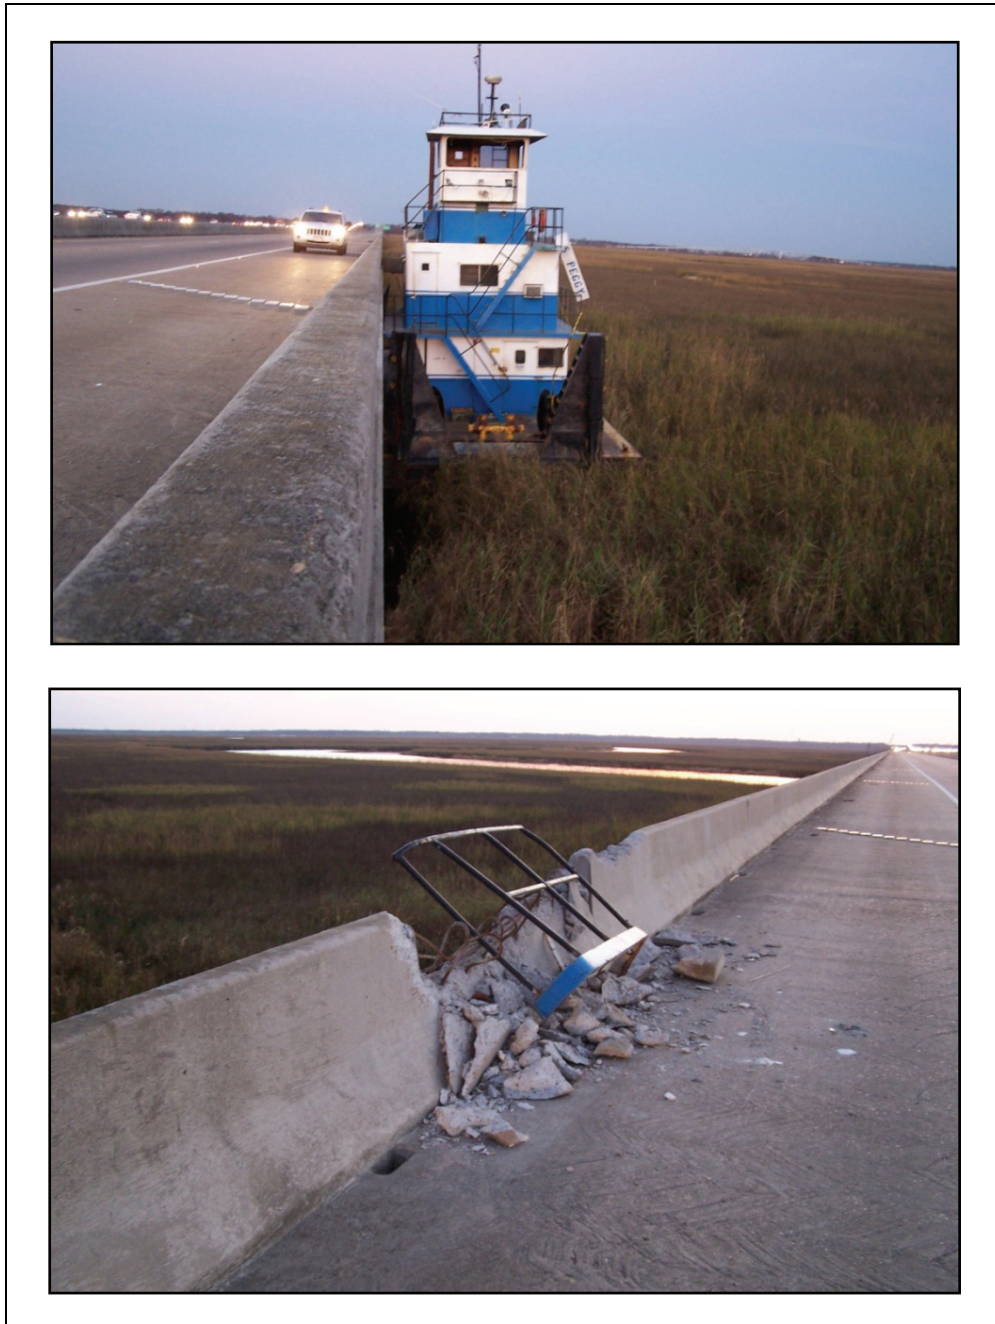
Figure 2-29. I-10 EB suffered multiple hits.

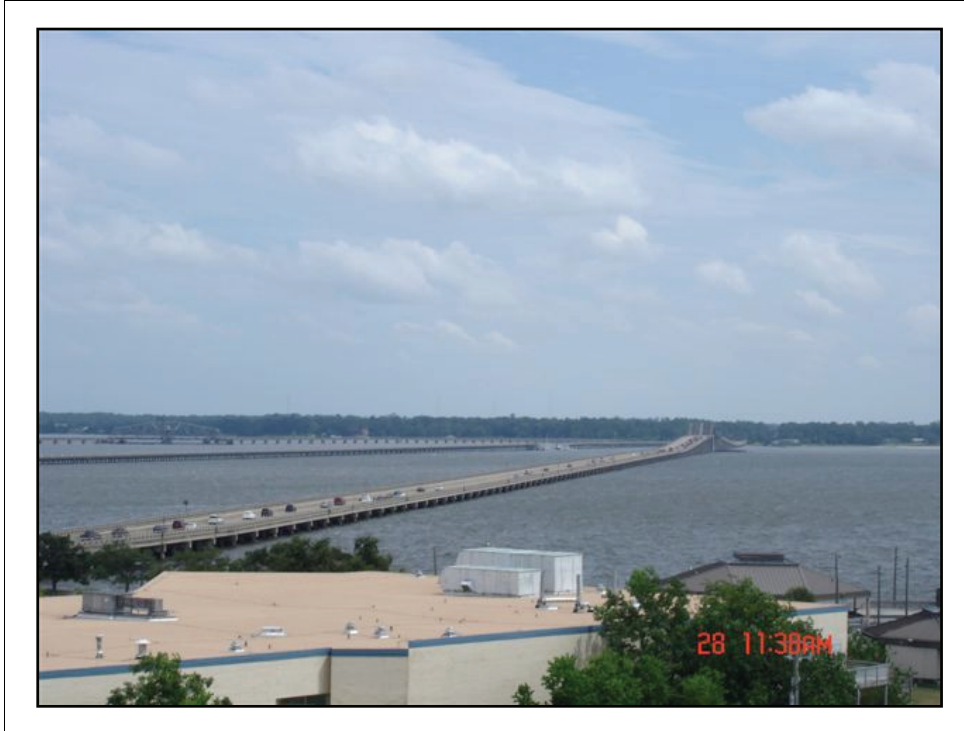
Figure 2-32. This pre-Katrina photograph (taken 8/28/05) shows the three bay crossings from Biloxi facing east toward Ocean Springs. Accessed 11/14/08 from <http://biloxi.ms.us/photogallery>

Figures 2-32 and 2-33 show a before and after picture, respectively, of the three bridges from the west shore of the bay. Note that only the US-90 spans at the highest elevation survived the 22-foot surge. Other spans were destroyed by the wave action or thrown into the water. The old highway bridge met the same fate. An aerial view in Figure 2-34 shows the east side of Biloxi Bay, facing SE. In the foreground is the CSX railroad bridge, the middle bridge is the old highway crossing, most recently used as a fishing pier, and farthest south is US-90. Figure 2-35(a) also shows the east side of Biloxi Bay, but faces north. In the foreground are the ruins of the US-90 bridge, in the middle is the old highway crossing, and on the far side is the CSX railroad bridge.

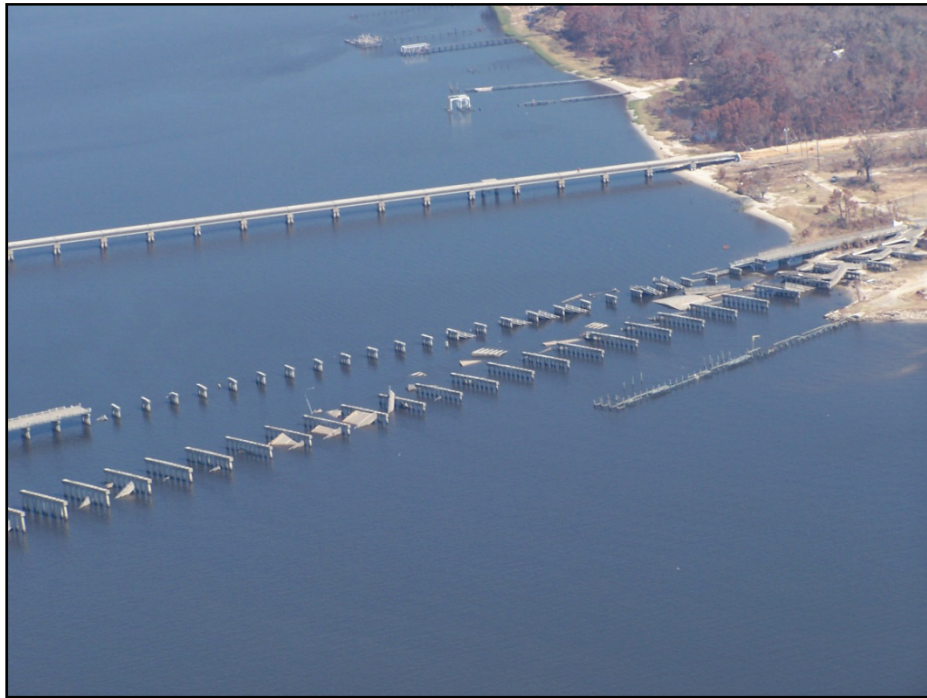
(a) Eastern shore of Biloxi Bay, looking North.

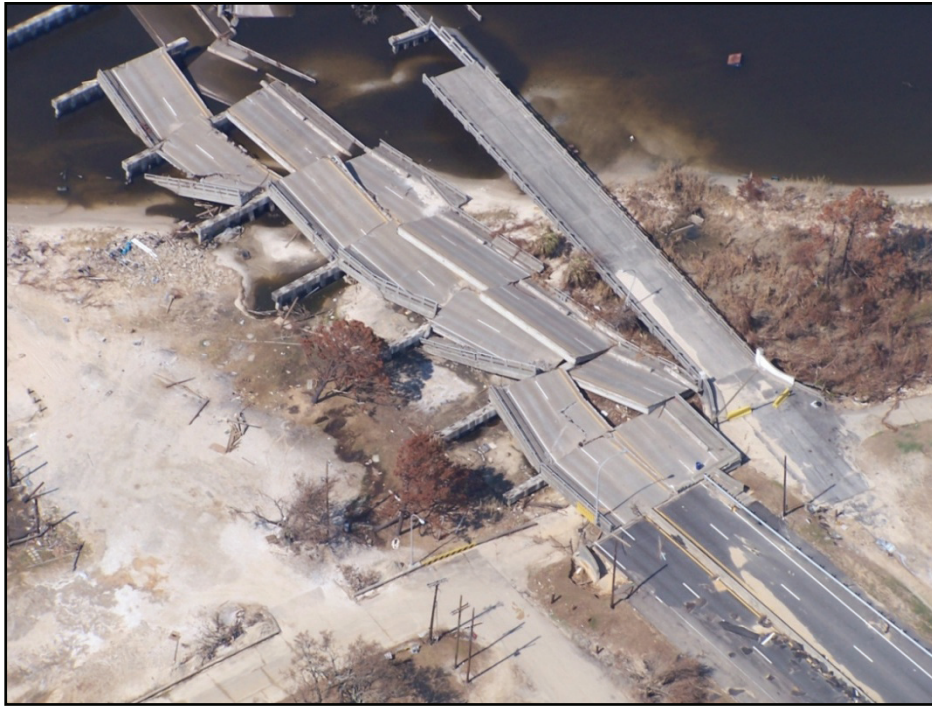
Figure 2-37. US-90 (and old route 90 on the right) at the east abutment, looking NW.

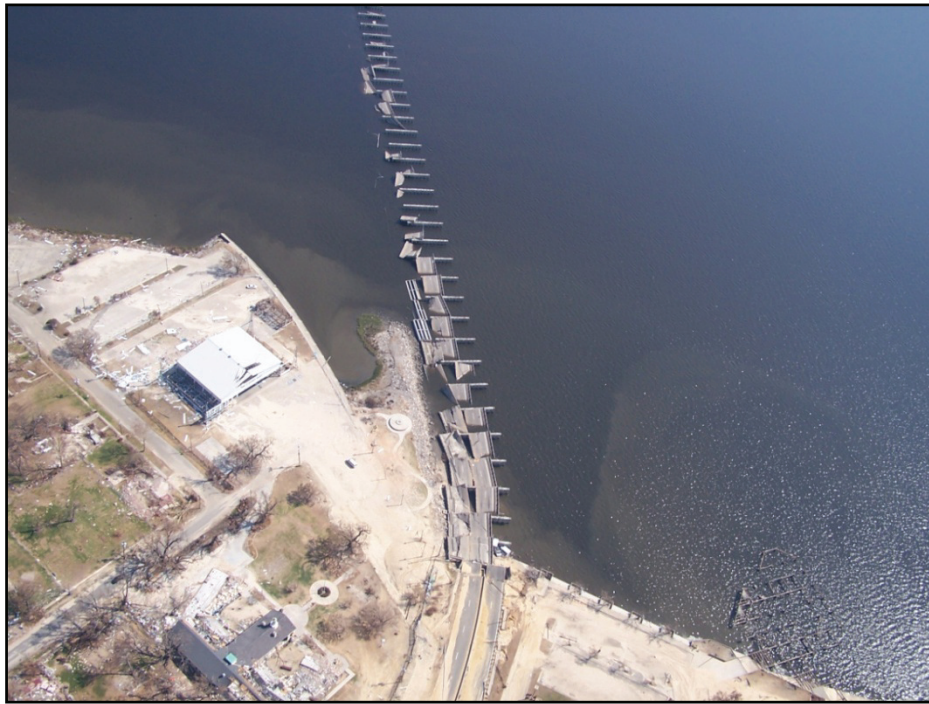
The west end of US-90, near the west abutment was severely battered. The authors interviewed a policeman and viewed a video that recorded turbulent wave action on the bridge. Video was taken until about 4:00 am August 29, 2005 before they left to find cover; the worst of the storm hit about 7:30 am. Upon their return, the bridge was in the condition shown in Figures 2-39 and 2-40. Large debris such as vehicles and shipping containers accentuated the problems (Figure 2-40).

Figure 2-38. US-90 over Biloxi Bay at the west abutment, facing east.

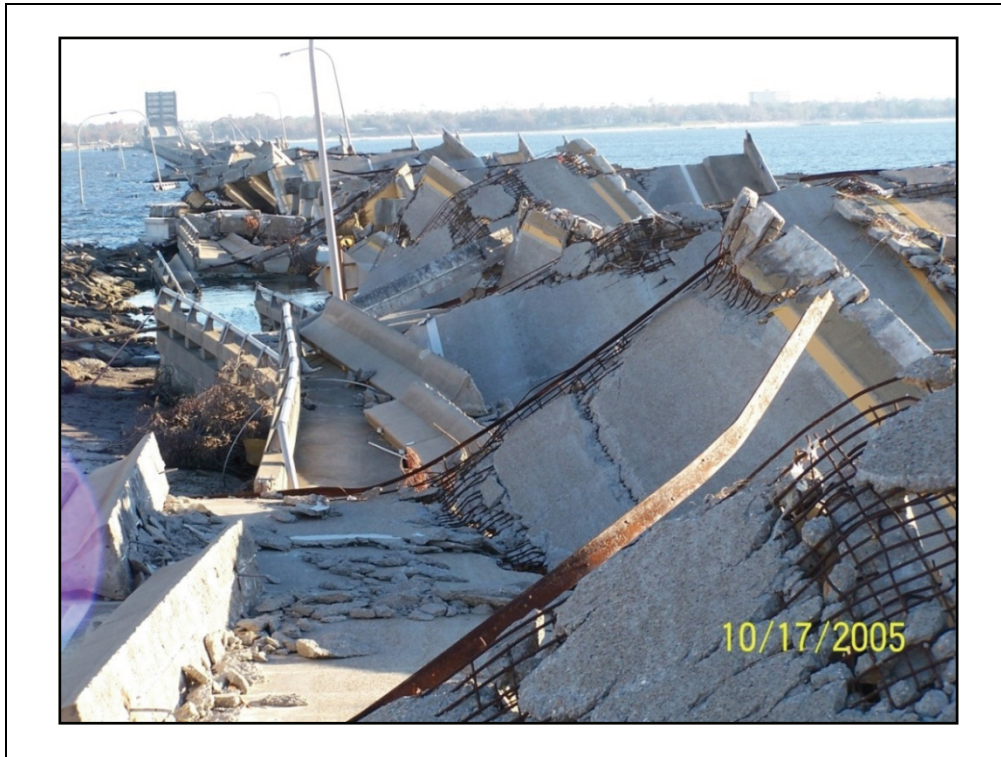
Figure 2-39. A close-up view of the west end of US-90.

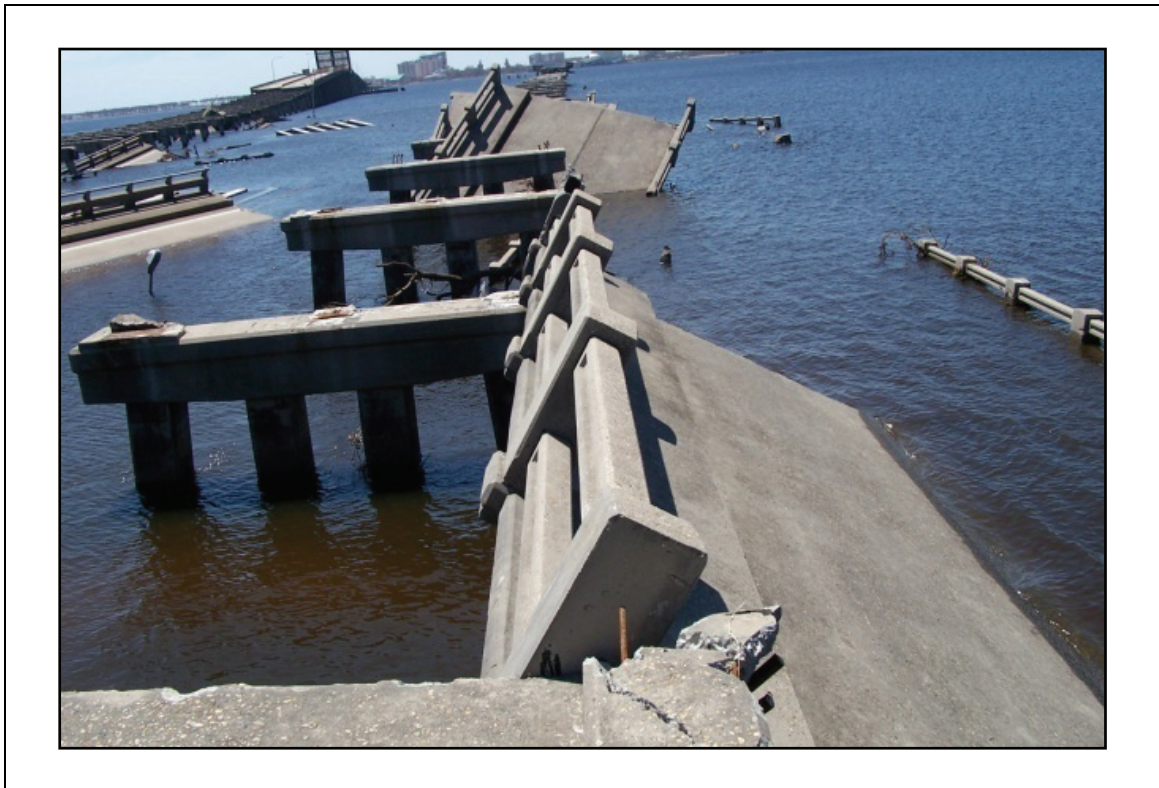
Figure 2-50. Looking west from the east abutment. US-90 is on the left.

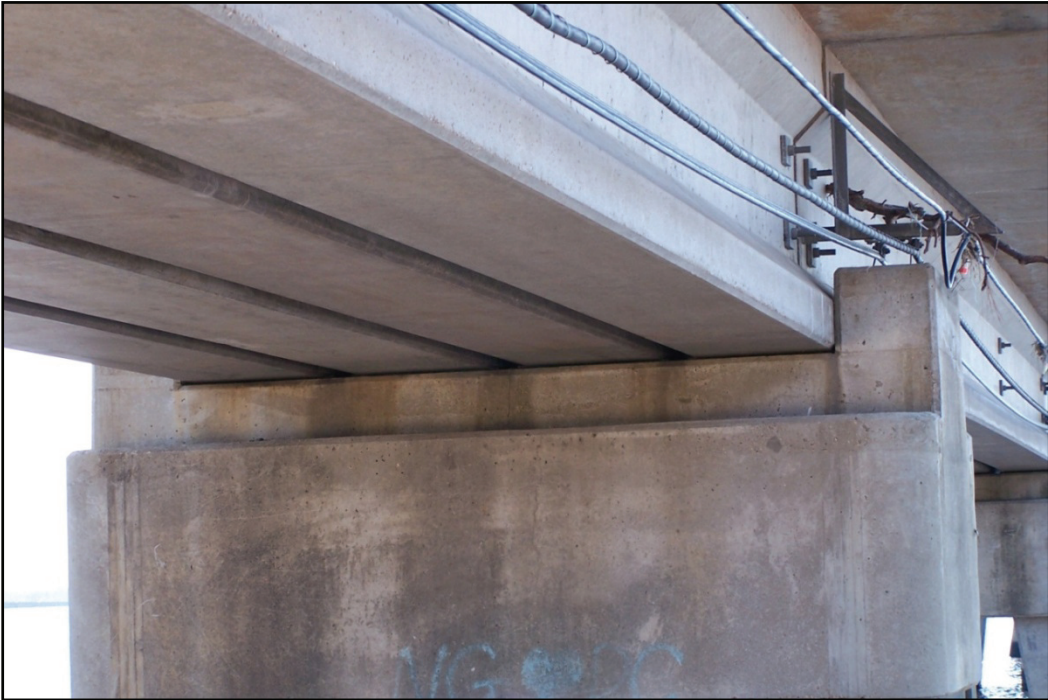
Figure 2-54. Pier and superstructure configuration of the CSX railroad bridge.

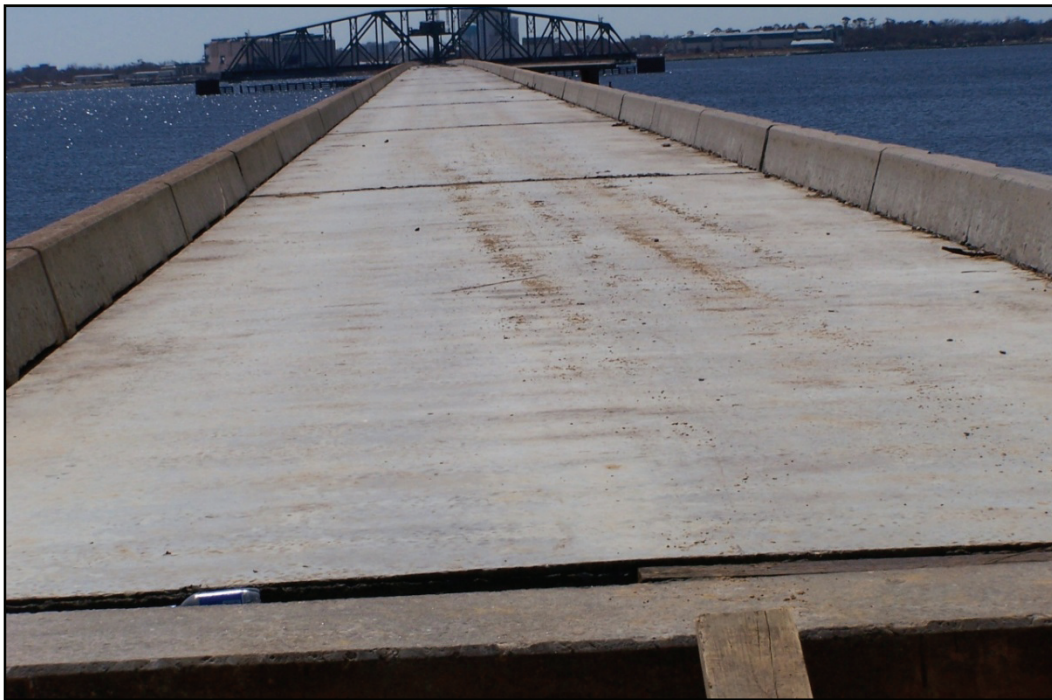
Figure 2-56. Tracks were completely stripped from the deck but the bridge survived.

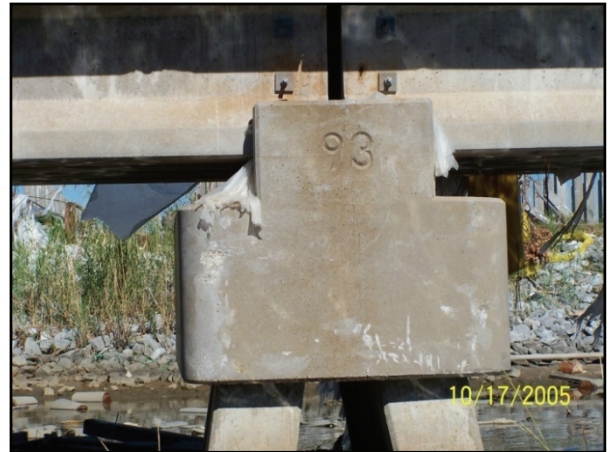
Figure 2-61. A simple concept, like permanently inscribing the pier number in the concrete, makes for positive identification and clear communication. This undoubtedly served the owner well when during repair operations as well as being useful during reconnaissance surveys.

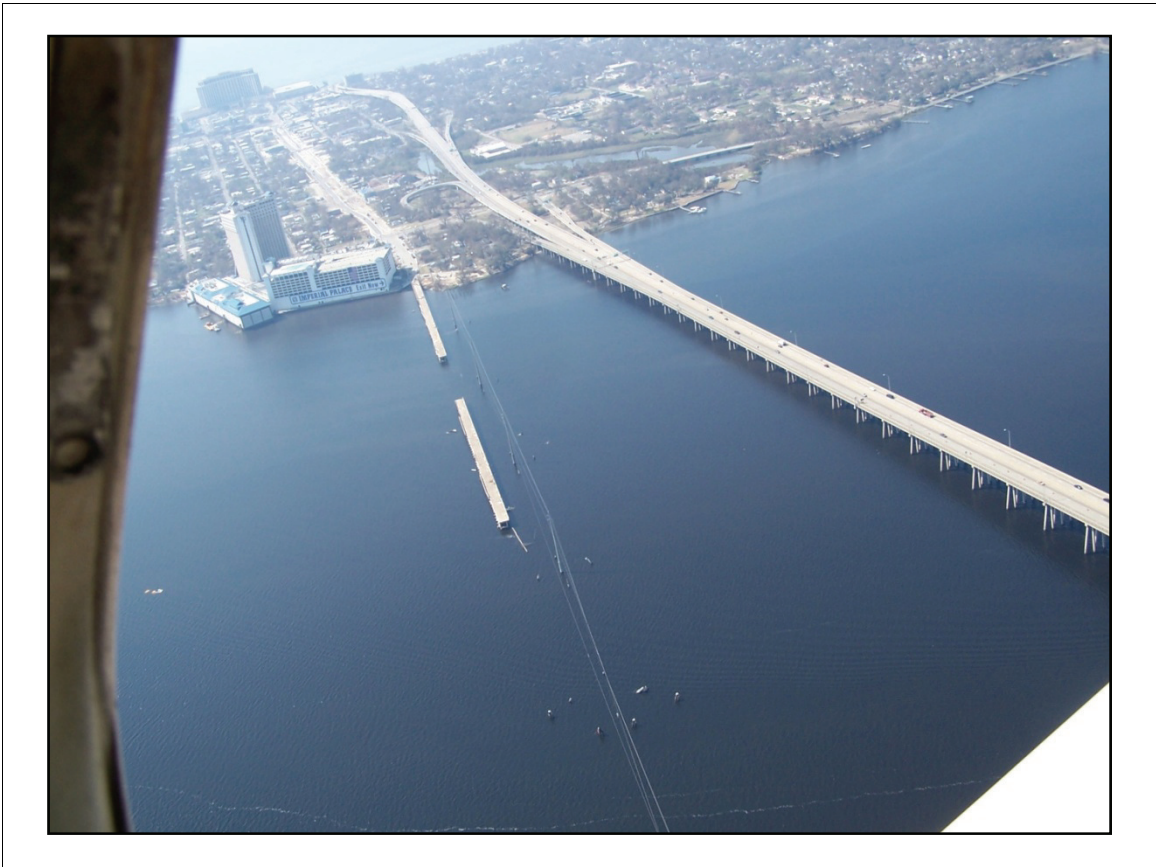
Figure 2-70. Facing south over Back Bay toward Biloxi and the Gulf.

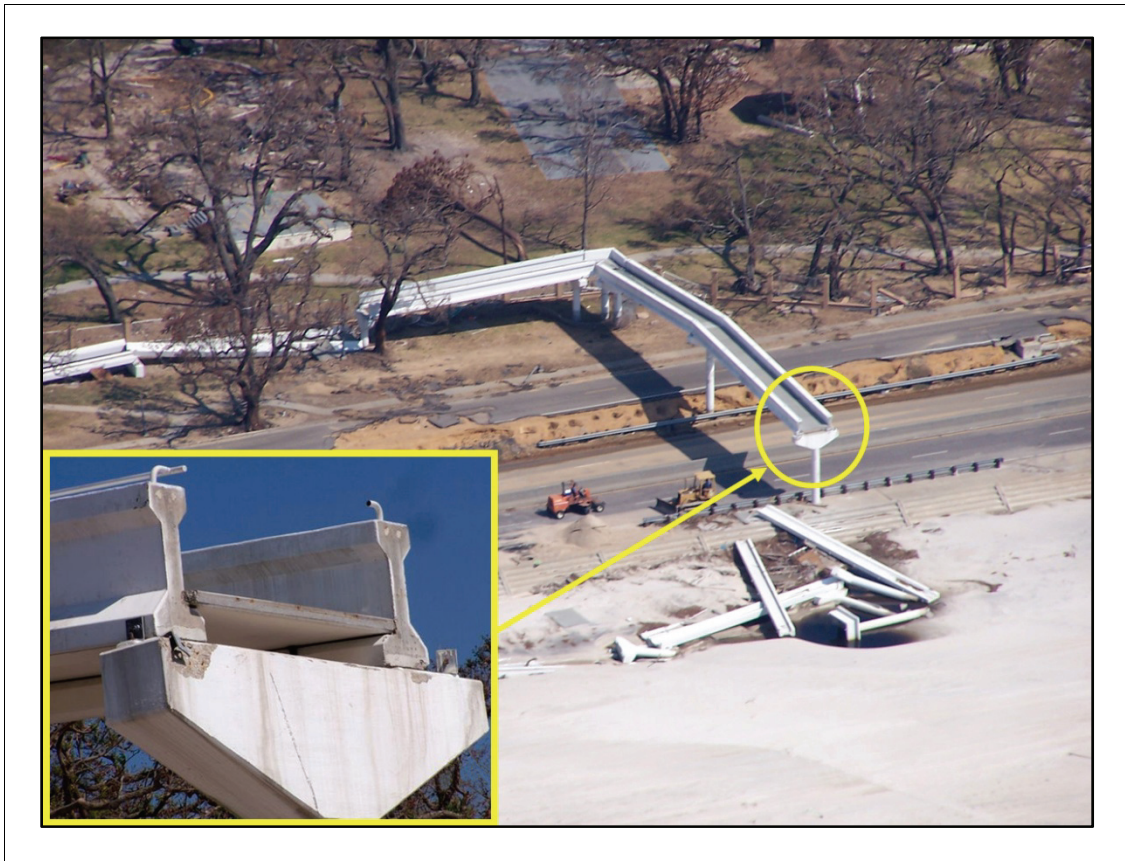
This pedestrian bridge crossed over US-90 near Gulfport, MS. It was assembled from precast concrete components but the connections were not sufficient to utilize the full strength of the components in resisting the wave forces that accompanied the surge. Eight of the eleven spans collapsed.

Figure 2-84. This pedestrian bridge utilized precast construction shown in the inset.

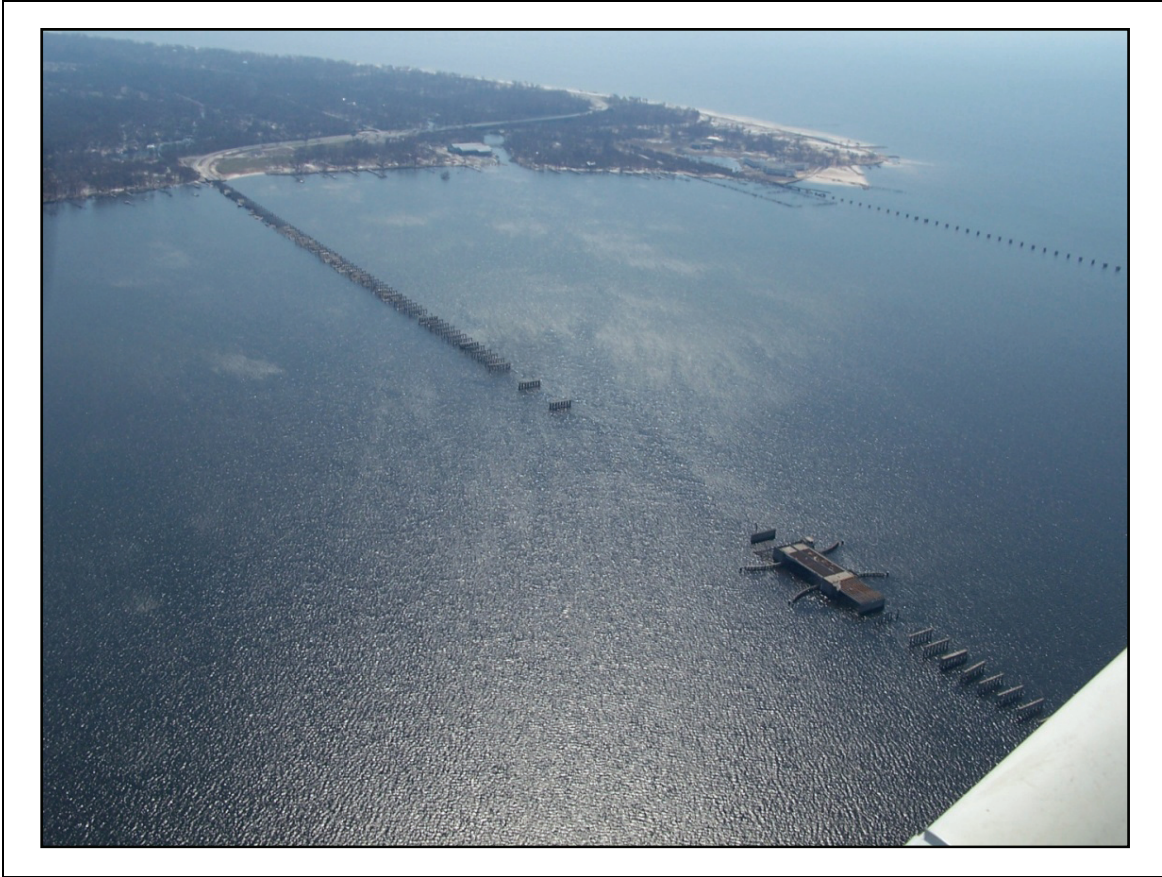
*Figure 2-87. US-90 over St. Louis Bay, facing SE.
The CSX railroad bridge is on the right.*

Bay St. Louis is very close to where the eye of Hurricane Katrina hit land, and the site of the greatest surge. Surge height depth exceeded 30 feet in St. Louis Bay, much greater than had ever been experienced at this location. The photograph in Figure 2-87, taken facing SE toward Pass Christian, shows the remains of US-90 over St. Louis Bay. All spans were tossed from their supports except the moveable span over the navigation channel. Several piers in the middle of the bay were scoured out completely. Figure 2-88 shows the destruction to the west abutment and approach, even though there was a break wall built to protect it.

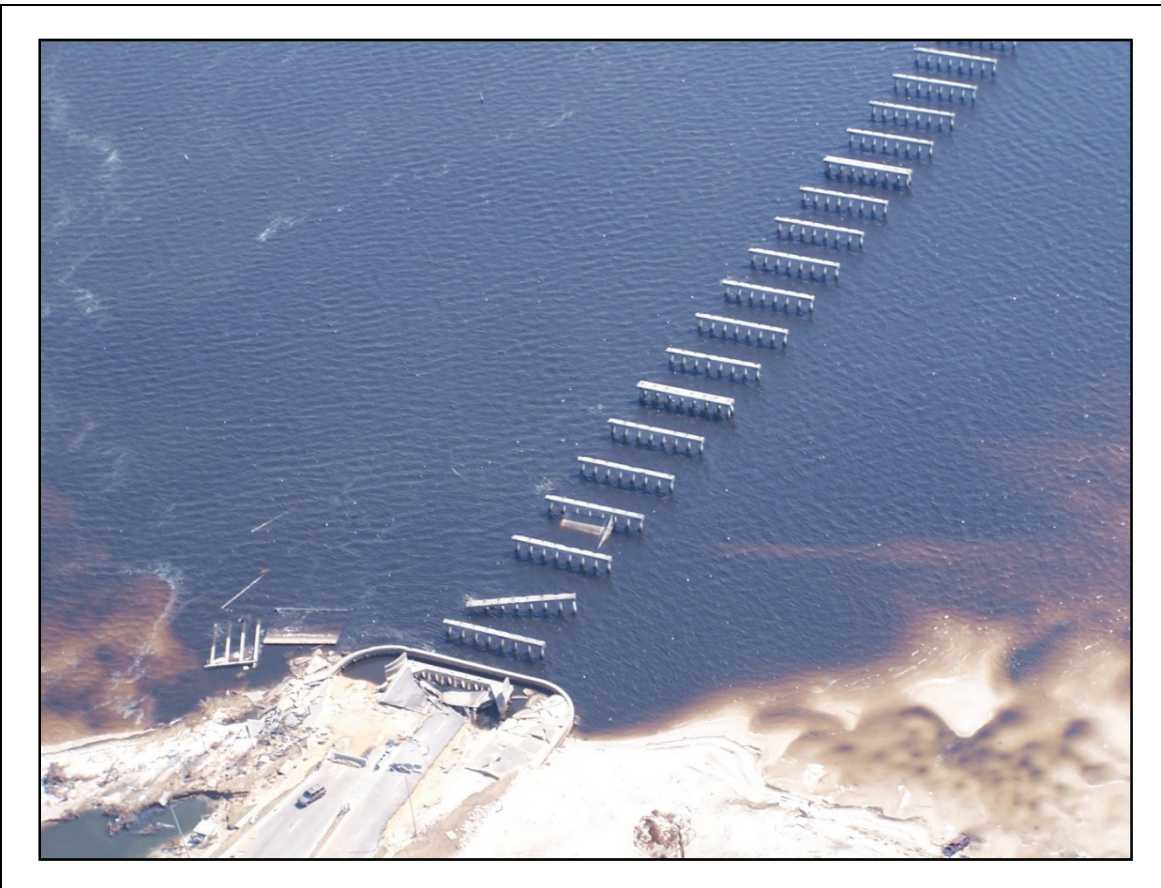
Figure 2-88. Western terminus of US-90 over St. Louis Bay, facing east.

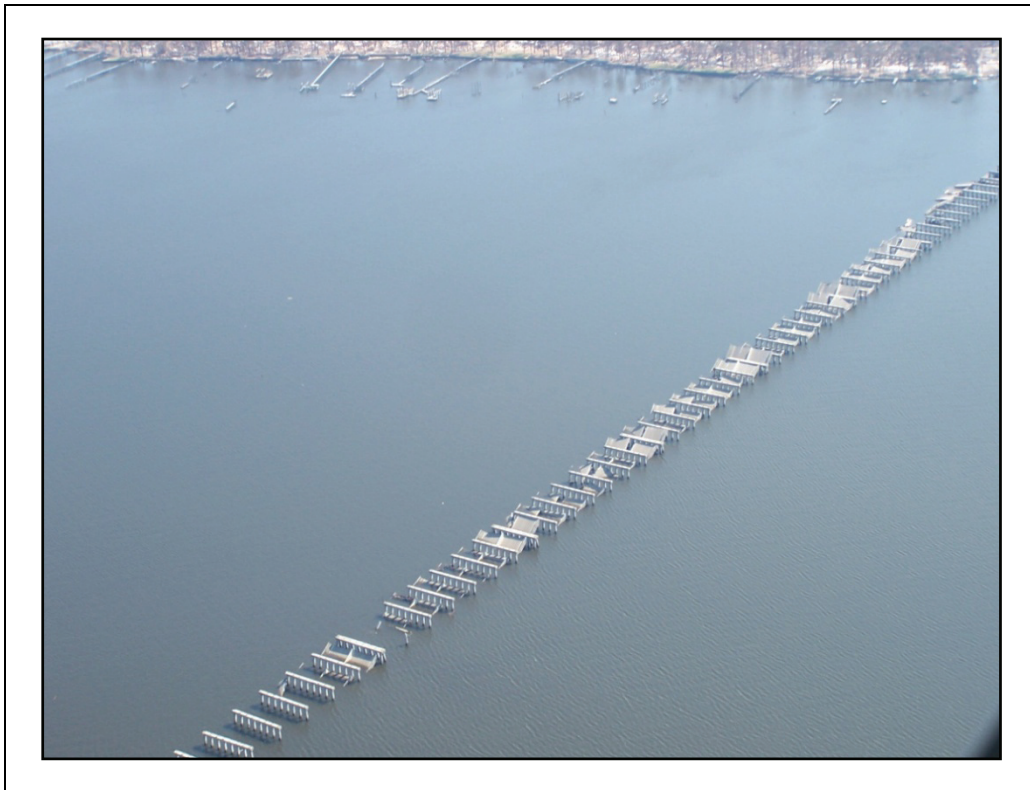
Figure 2-90. All superstructure spans were stripped from the piers.

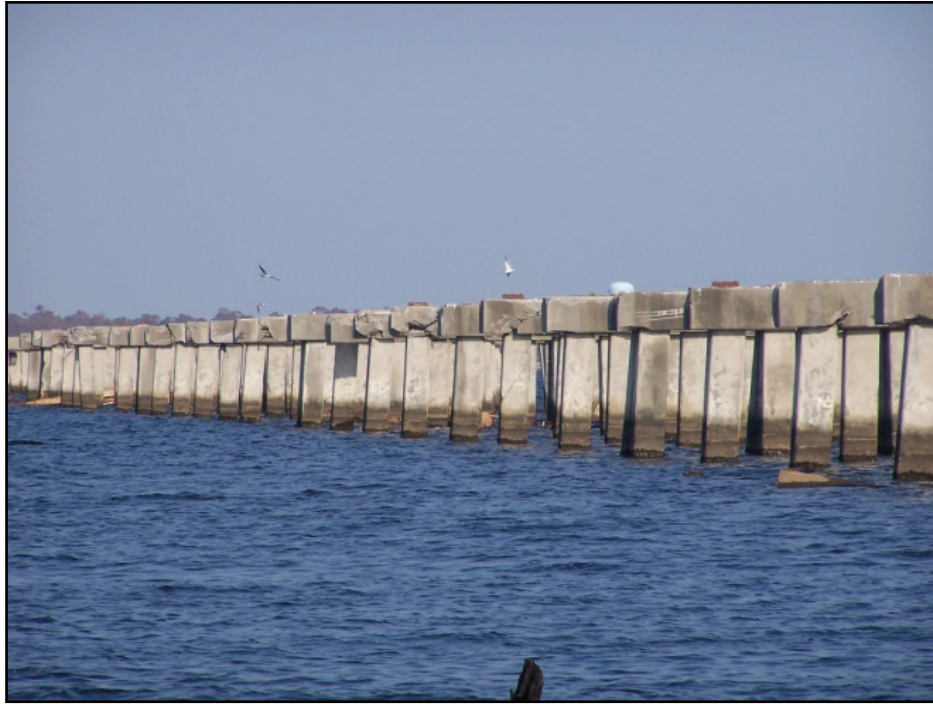
Figure 2-93. Facing east. Piers standing after their superstructure spans were washed off.

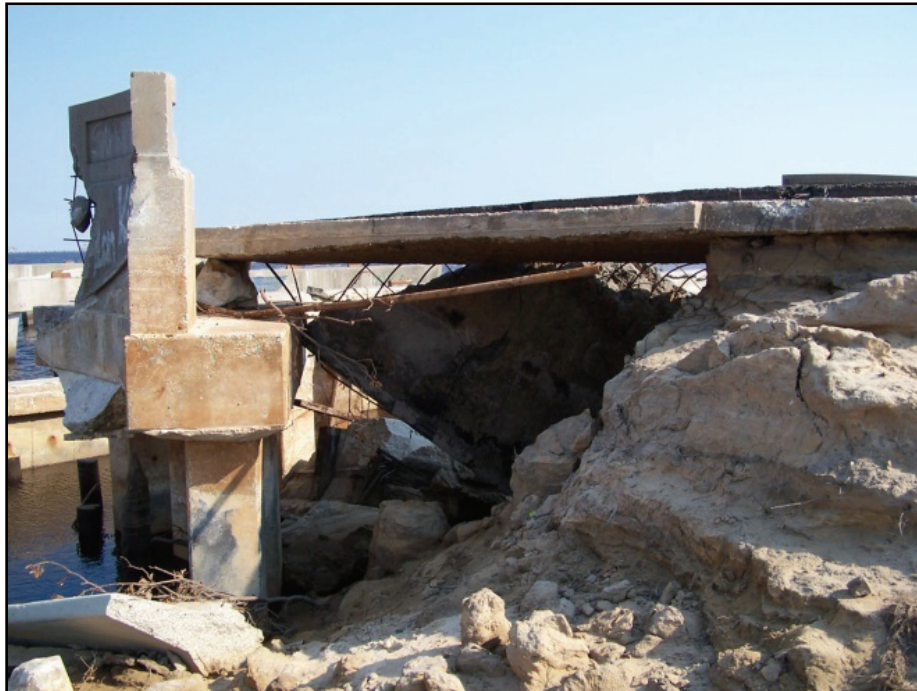
Figure 2-94. Extreme scour at the west abutment and undermining of the approach.

Armoring of embankments to bridge approaches could minimize the risk of them being washed out and rendering the structure unusable (Figures 2-85 and 2-94).
