Engineering and Organizational Issues Before,
During and After Hurricane Katrina

Damage to Bridges from Wind, Storm Surge and
Debris in the Wake of Hurricane Katrina

**Damage to Bridges from Wind, Storm Surge and
Debris in the Wake of Hurricane Katrina**

MCEER-08-SP05
Red Jacket Quadrangle
Tel: (716) 645-3391; Fax: (716) 645-3399; Email: mceer@buffalo.edu
World Wide Web: <http://mceer.buffalo.edu>

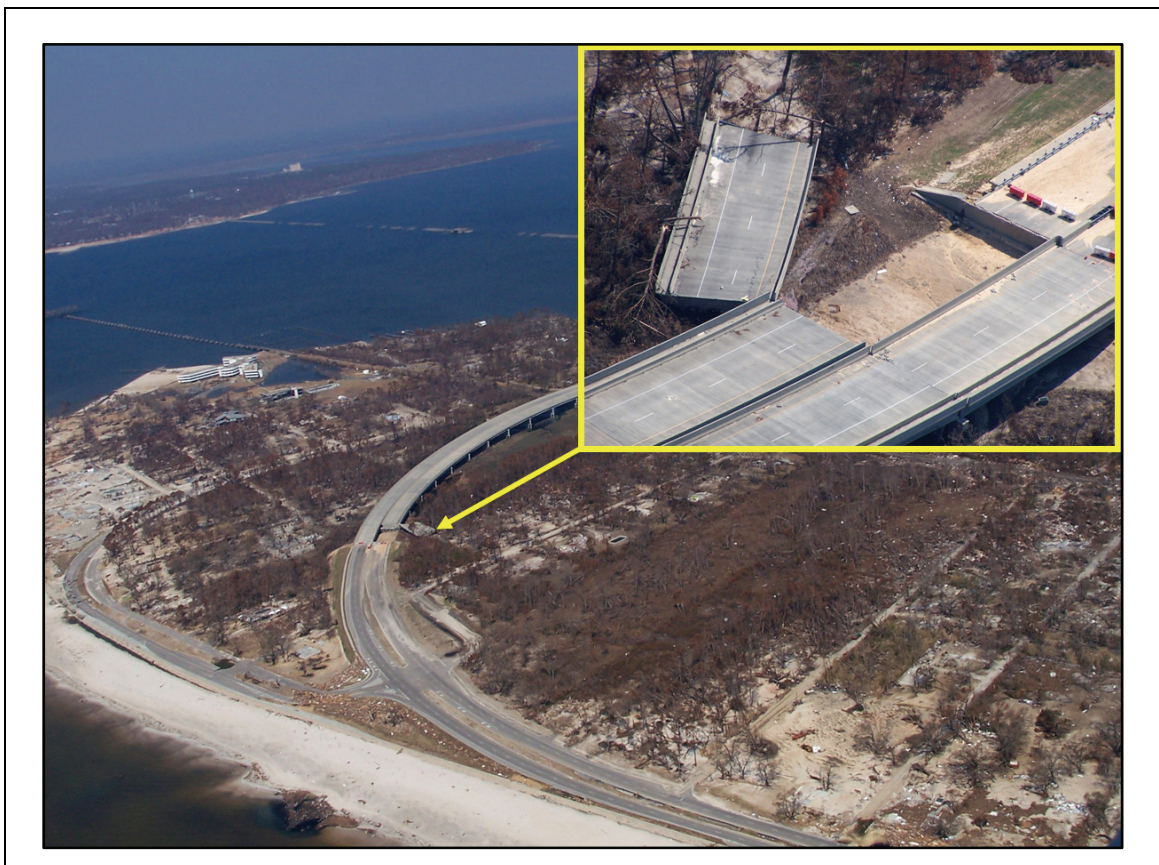
On the east side of St. Louis Bay, US-90 turns south, then east again as it enters Pass Christian at Henderson Point. The eastern-most span the WB bridge was lifted out of place by the surge, rotated and dropped to the north. The eastern-most span the EB bridge rotated slightly but was not lifted out of place.

*Figure 2-101. Henderson Point, east of St. Louis Bay at Pass Christian.
The photo was taken facing NW.*

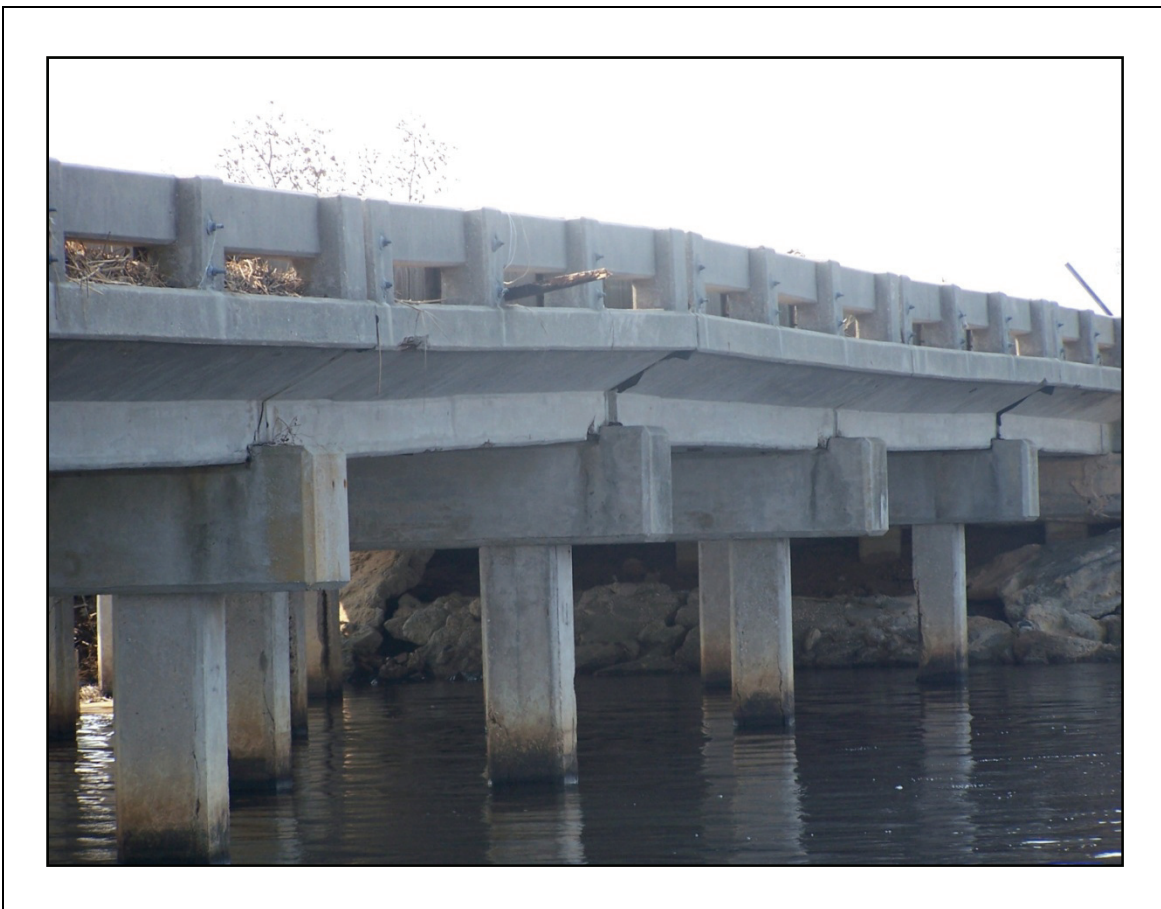
The bridge over Salt Bayou was built in 1955 as a five span bridge with simply supported spans. There is evidence of pier settlement but it was still functional. Notice the kinks in the vertical alignment in Figure 2-103. A local business owner said that some of the settlement had occurred during a previous hurricane (Camille in 1969). Note the shear blocks at the end of the pier caps. This detail probably helped retain the superstructure.

Figure 2-103. Rte 433 over Salt Bayou was inundated but survived with little damage.

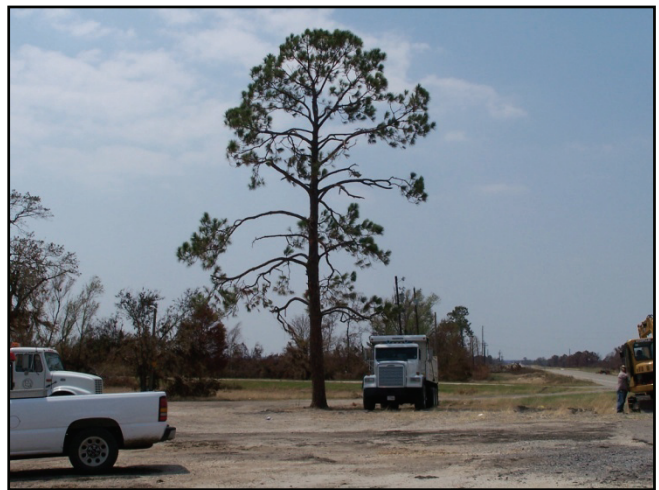
Figure 2-109. A boat captain who rode out the storm said water levels were near this top of this tree.

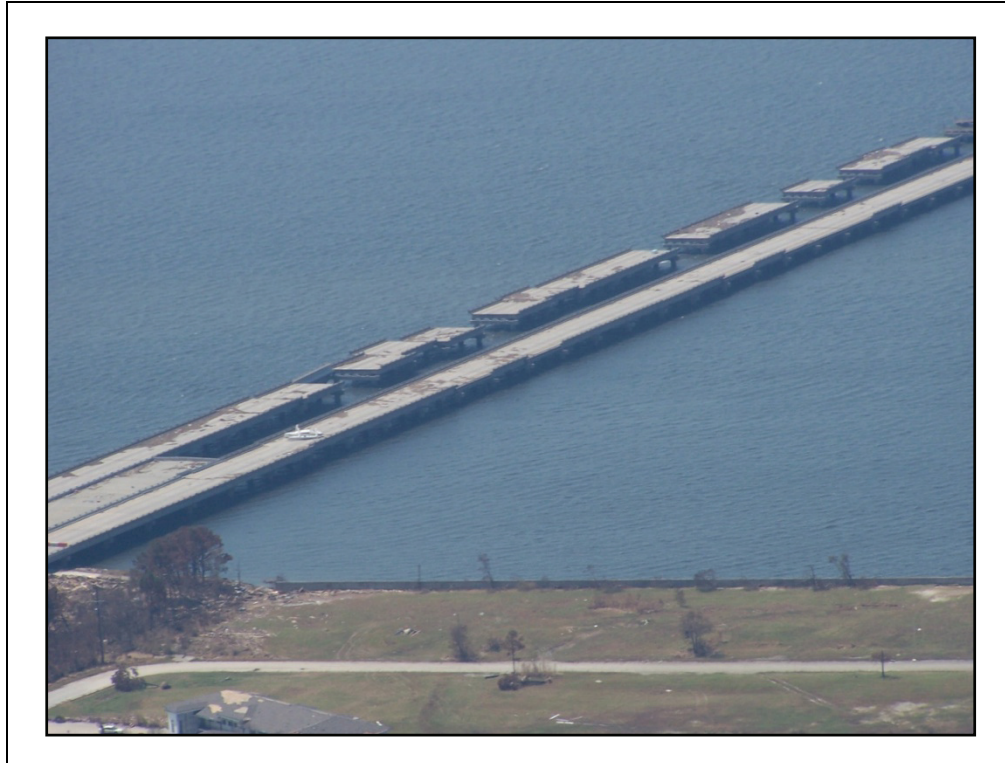
Figure 2-114. I-10 EB & WB over Lake Pontchartrain at East terminus, facing south.

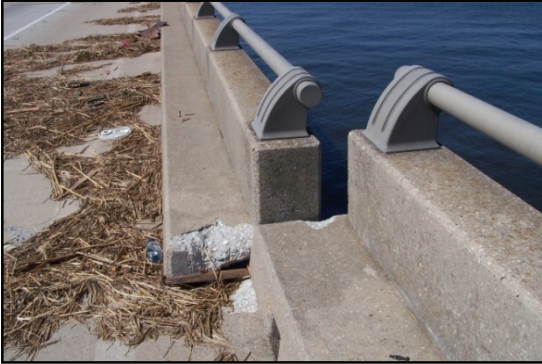
Figure 2-123. Relative displacement between spans.

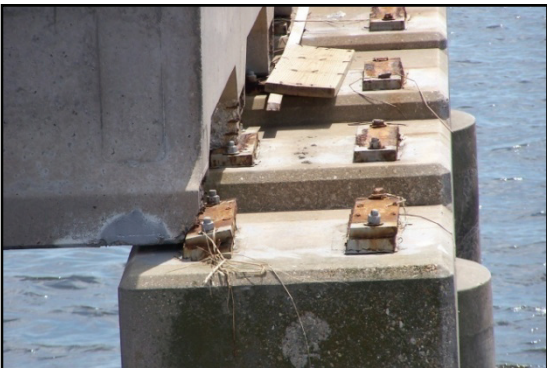
Figure 2-131. Seat length has been an important consideration in earthquake designs.

Seismic detailing can be used to reduce the number of catastrophic failures due to hurricanes. It was evident that some simple, inexpensive details could have made a difference in some of the bridges inspected. Concrete **shear blocks** can be employed to resist lateral forces induced by wind and waves as well as to protect from earthquakes (see Figures 2-58, 2-60 and 2-66). Even in cases where lateral loading cannot be envisioned, it may be wise to incorporate it into the design. Hits from vessels, debris or motor vehicles are never planned, but on occasion, they do occur. If protection can be added for little additional cost, it would be worthwhile. It may be analogous to a dovetail joint used in quality furniture making. It may not be necessary, but it provides a belt and suspenders approach that will serve the owner long after the glue joint dries out. Likewise, providing extra seat width (or **seat length**) on a pier cap might prevent the loss of a span that has been displaced due to dynamic loading (see Figure 2-131).

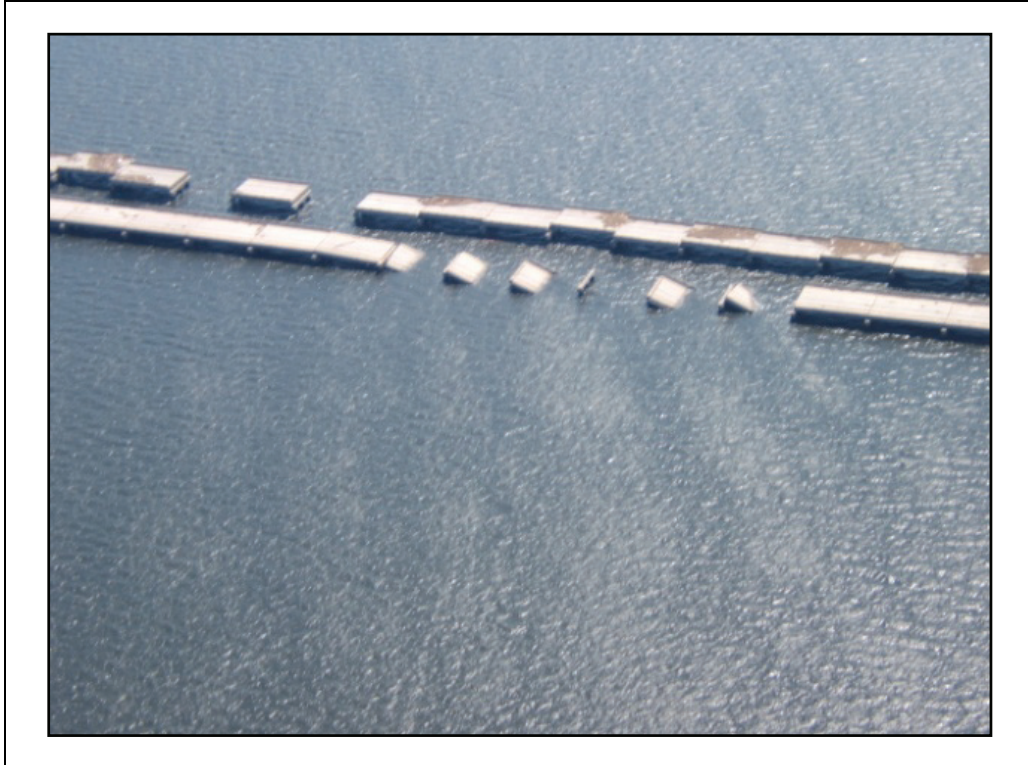
Figure 2-134. Some spans dropped in an inclined manner, and some moved sideways.

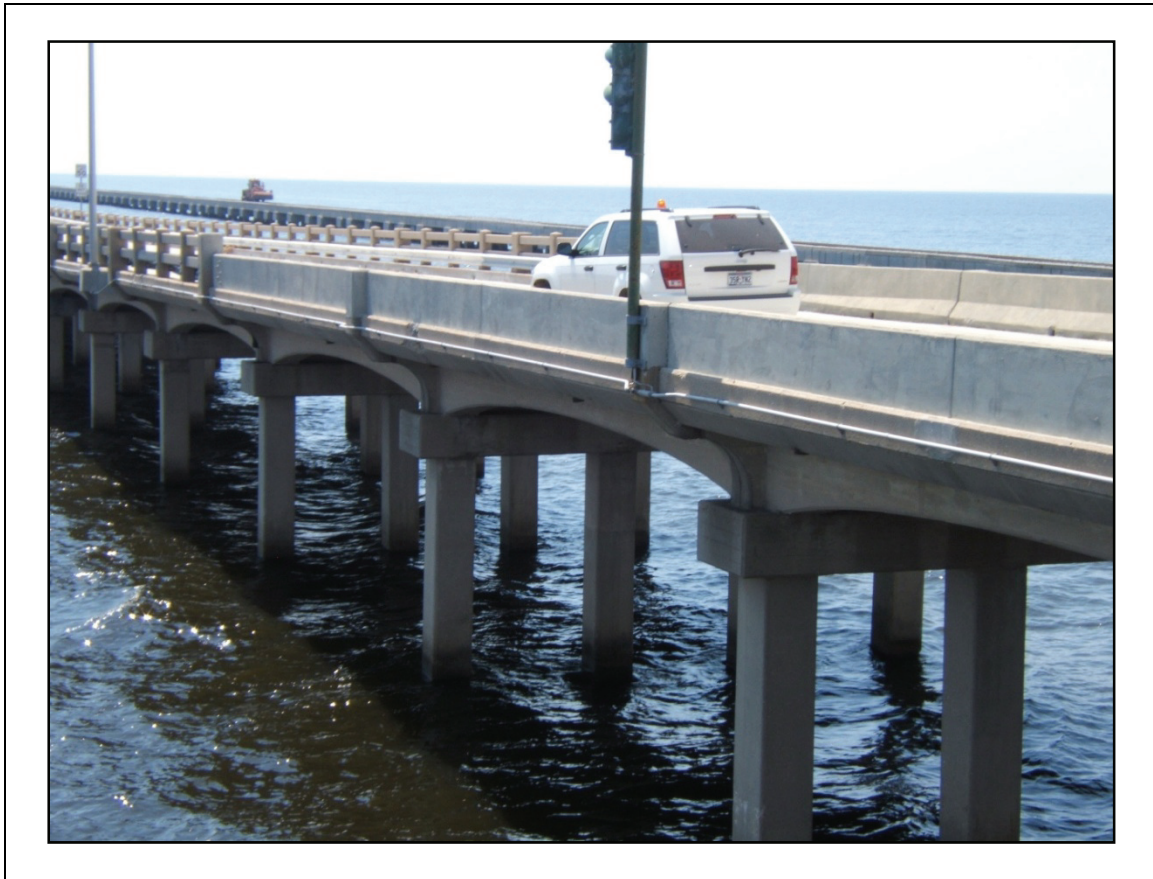
Figure 2-135. Though older and lower, US-11 performed better than I-10.

Continuity can help spans of a multiple span superstructure act as a unit and resist loadings that could topple individual spans. (The deck replacement on US-11 in 2001 apparently made the bridge continuous for live load and tied the spans together (see Figures 2-135 and 2-136).

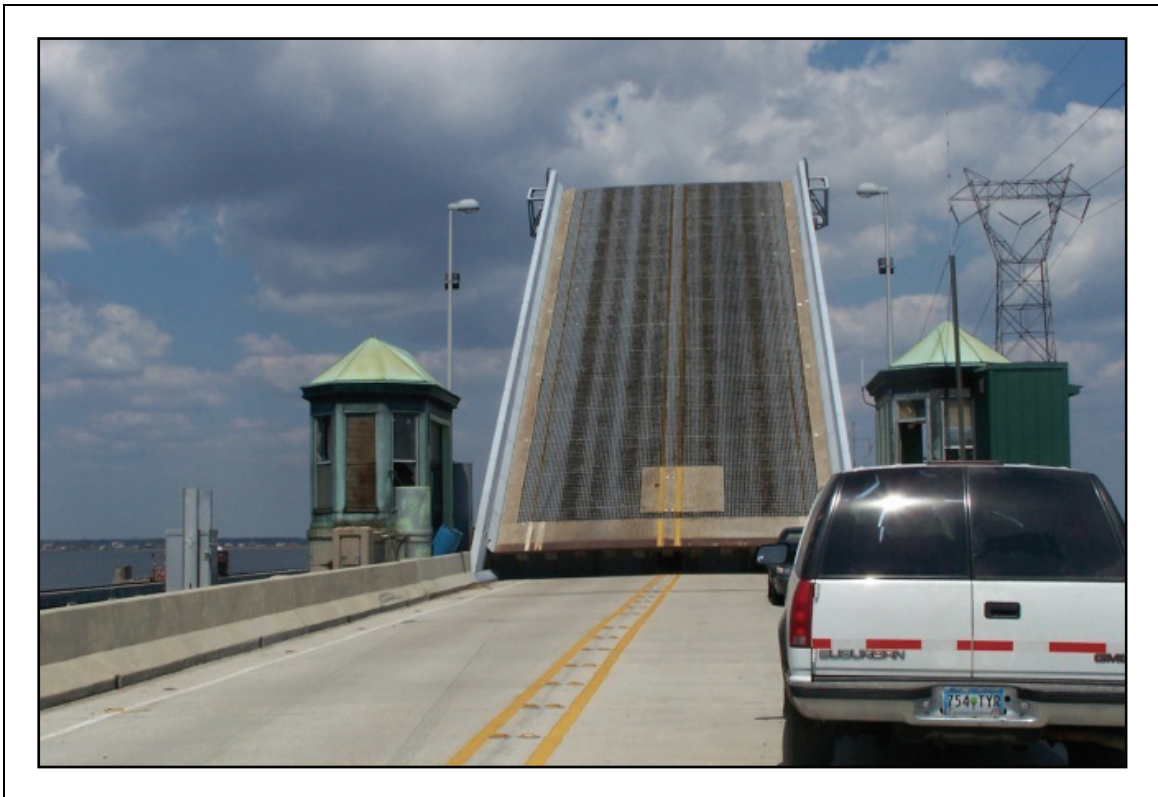
Figure 2-136. The bridge was functional, even though some repairs were necessary.

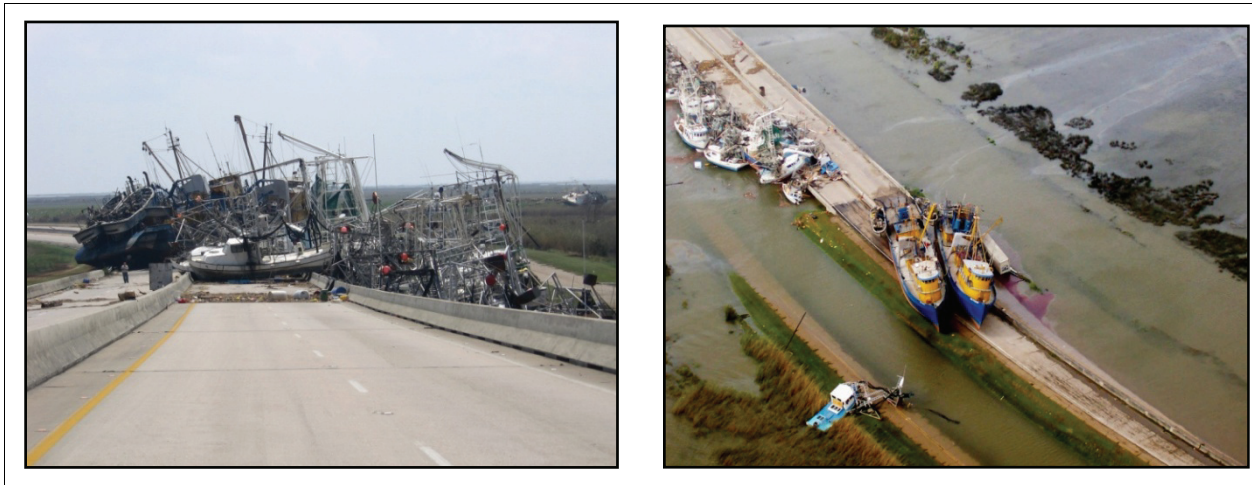
Figure 2-143. Boats grounded on the Empire Bridge.

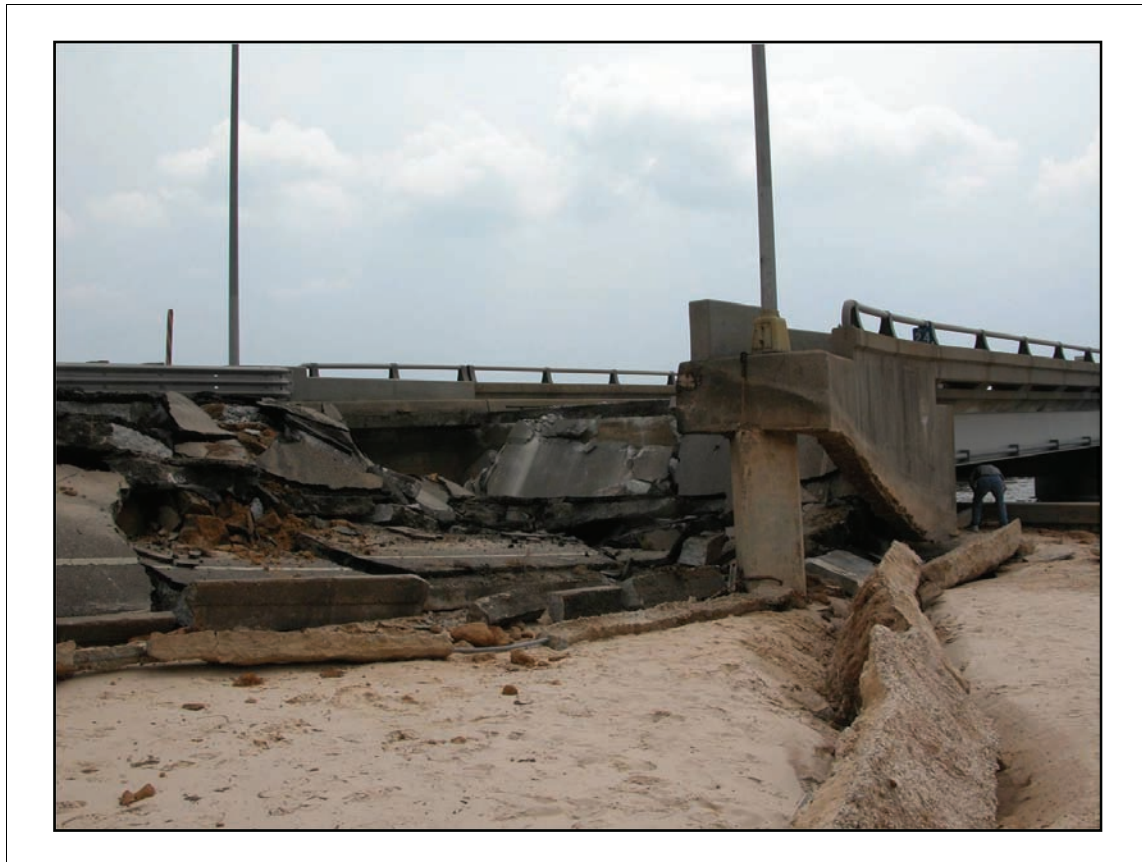
Figure 2-144. The north approach to the Lake Pontchartrain Causeway.

Although the Causeway survived pretty well, it was not immediately useable because the north approach had washed out. It was already repaired when the reconnaissance team visited on September 8, 2005. In addition, some of the low lying turnaround spans were lost.

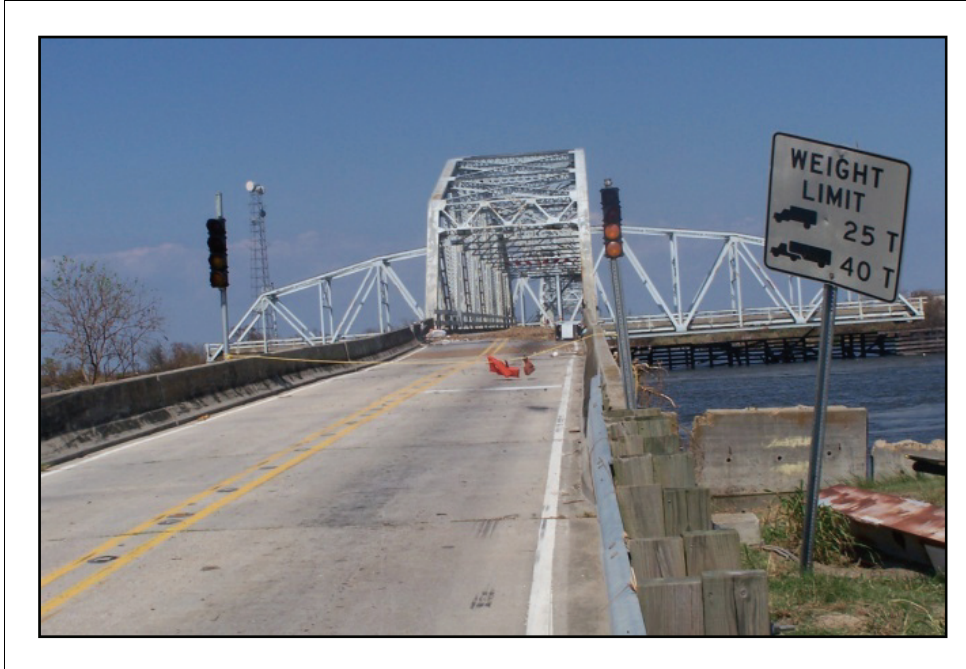
Figure 2-150. US-90 remained closed months after the storm.

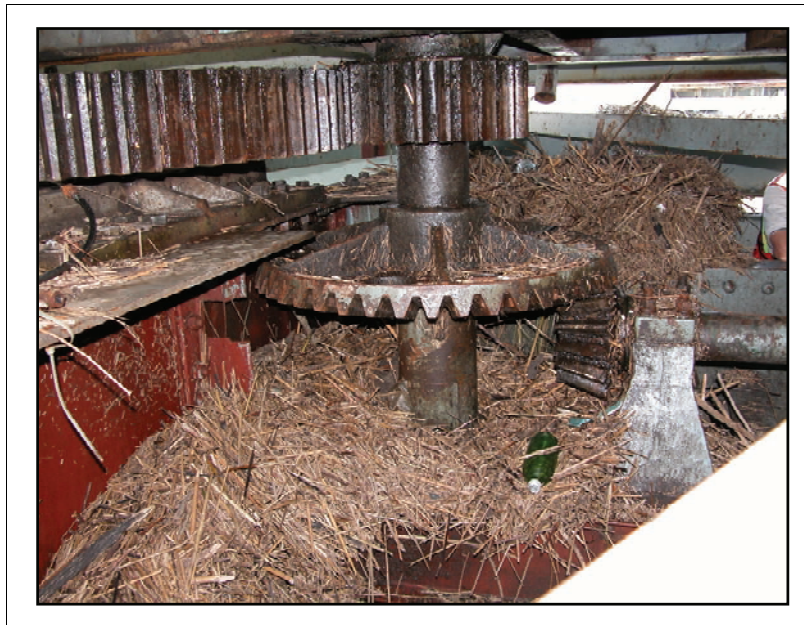
Structurally, most of these bridges survived the forces of Hurricane Katrina. Most however, were rendered inoperable because of flood damage to electro-mechanical motors and controllers. Flooding of control rooms and/or mechanical rooms caused damage to the gear mechanisms and electrical systems. Vegetation and other debris was jammed in lift mechanisms and had to be cleared (see Figures 2-152 and 2-153). Even when repairs were made quickly, commercial power was typically unavailable for several weeks after the storm. In some cases, auxiliary diesel generators were available to operate the bridges; however, such operations are time-consuming and are undertaken only in emergency situations. At St. Louis Bay, a span became inoperable in the down position and had to be removed under emergency contract to clear the navigation channel for vessel traffic (Figure 2-154).

Figure 2-152. Typical debris buildup in the gear mechanism of a moveable bridge.

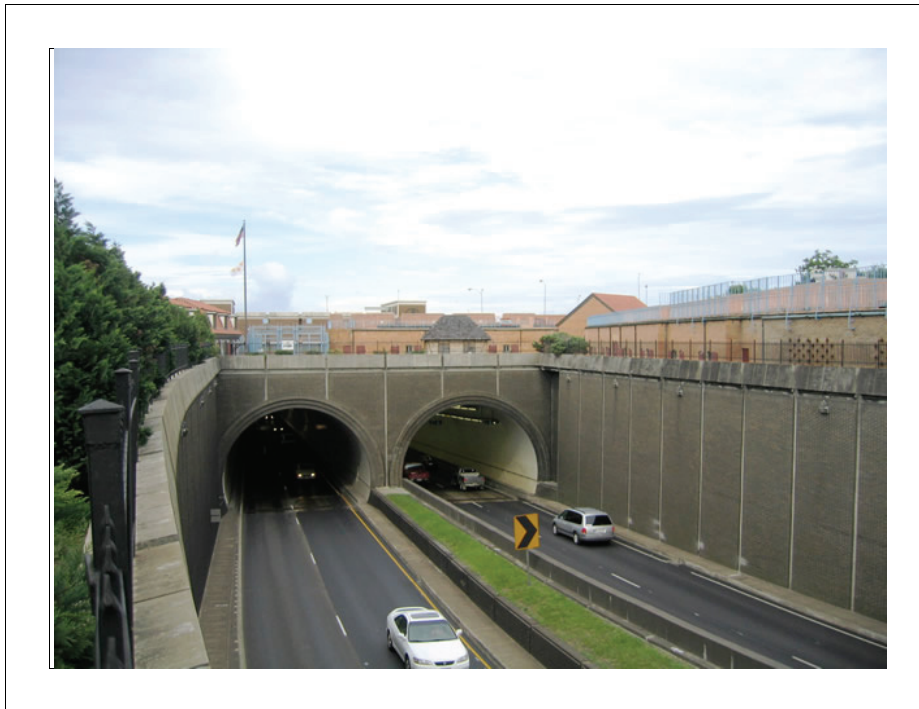
Figure 2-156. George Wallace Tunnel, I-10 in Mobile, AL.

When the George Wallace Tunnel was built in the early 1970's, it was constructed with provisions to counteract flooding. Unfortunately, the tunnel was not immune to the rising waters of Hurricane Katrina. During the event, a valve broke and backflow from the storm surge in the bay filled up the sump pumps and pump room at the east end of the tunnel. The pumps were original and not the submersible type so they quickly shorted out.

Damage to the Wallace Tunnel cost Alabama DOT \$1,117,048 in repairs and upgrades to the tunnel pumping system. The work included cleaning, tile repair, valve and pump repair, new electric power control circuits, paint, insulation, and video monitoring equipment. In the event of a reoccurrence, ADOT will connect temporary power to submersible pumps and keep the tunnels open.
